SUBJECT: REFERRAL TO THE PUBLIC SAFETY NEIGHBORHOOD AND QUALITY OF LIFE COMMITTEE TO DISCUSS THE CITY GETTING A NEW COST ESTIMATE TO REHABILITATE THE BARCLAY PLAZA APARTMENT BUILDING.

This Feasibility Study for the Barclay Building at 1940 Park Avenue in Miami Beach will review the current conditions of the building and evaluate two options for renovation.

Barclay Building Feasibility Study

The Barclay Plaza Apartments Building
1940 Park Avenue
Miami Beach, Miami-Dade County, FL 33139

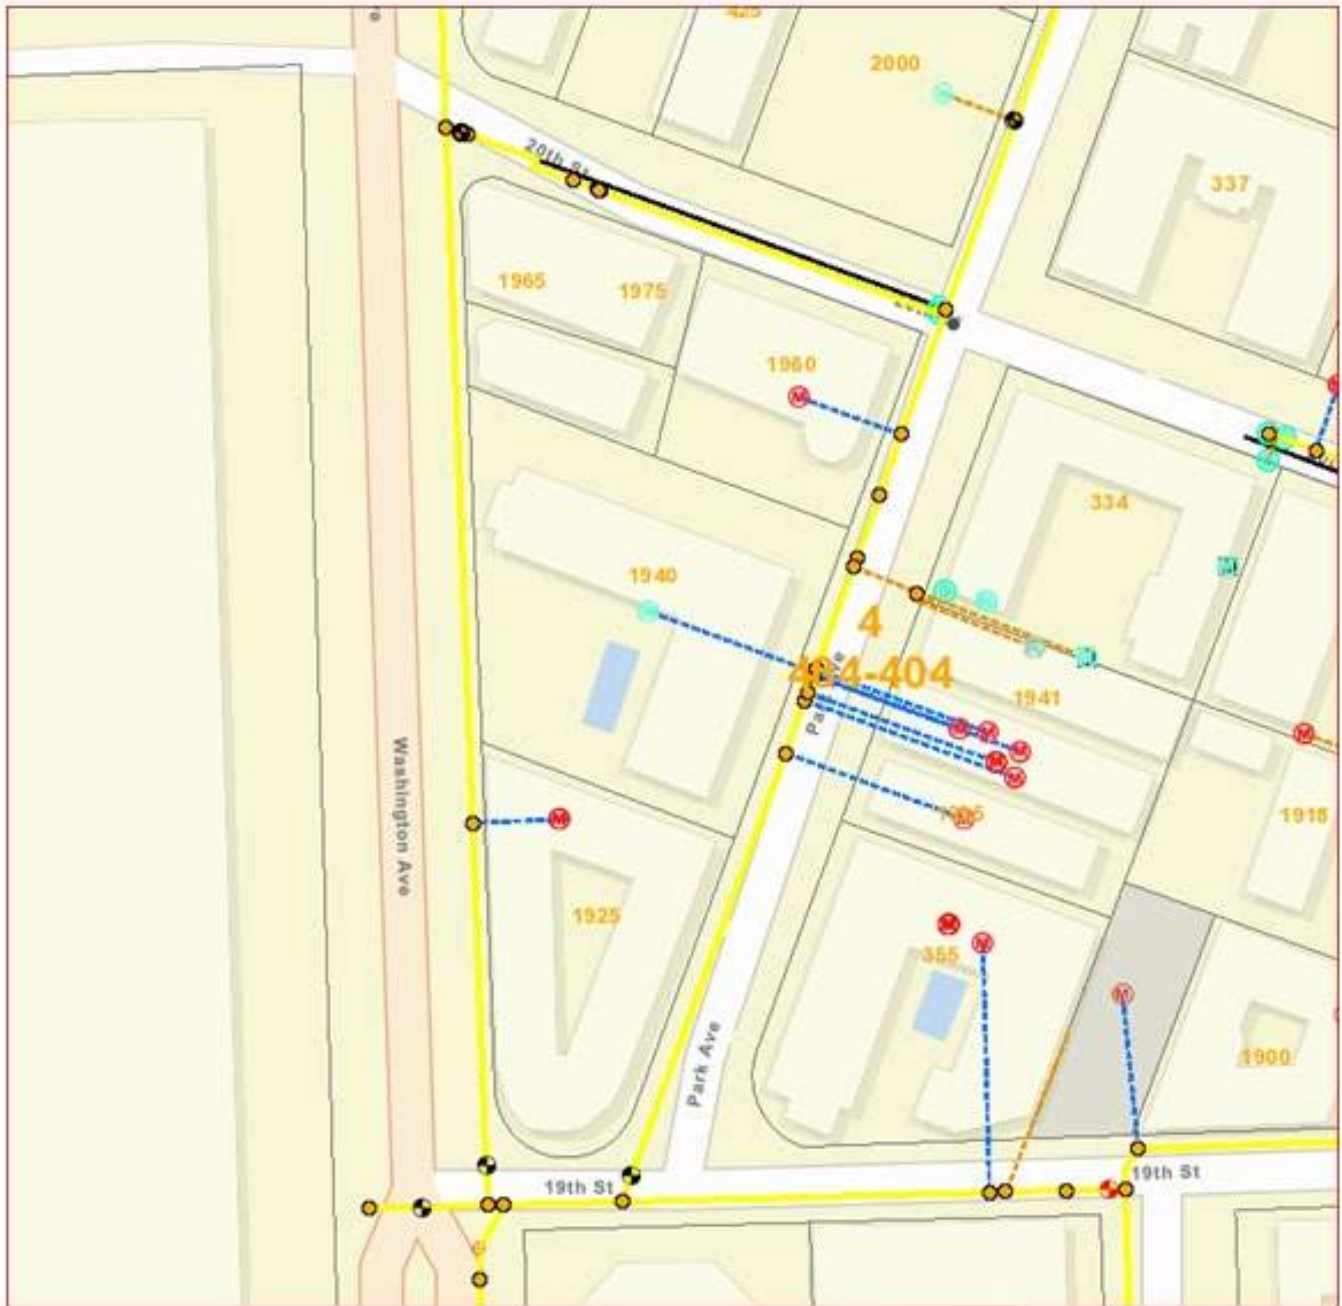
EXHIBIT H – TECO PEOPLES GAS (CON'T)

Yellow lines along Washington Avenue, 19th Street, Park Avenue and 20th Street 6" coated steel gas distribution lines.

The dotted orange lines are distribution lines.

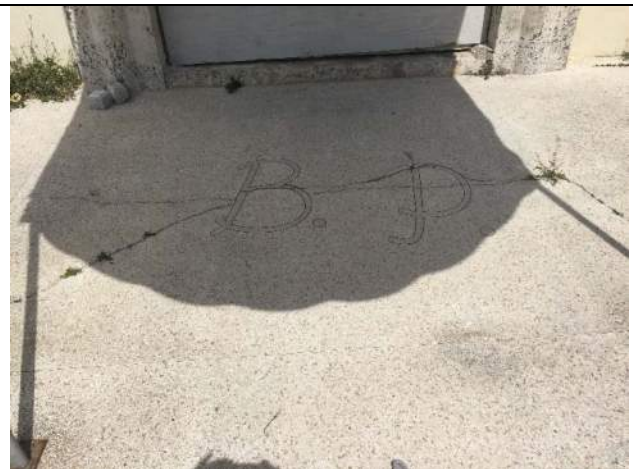
Main Entrance – Terrazzo cracked; logo “B.P.”
Step up to lobby (ADA issue)

- ADA parking space proposed
- Provide ADA access at Park Avenue (Front of Building)
 - Existing terrazzo is cracked; remove all
 - Provide terrazzo on new slab, steps in same configuration as exists

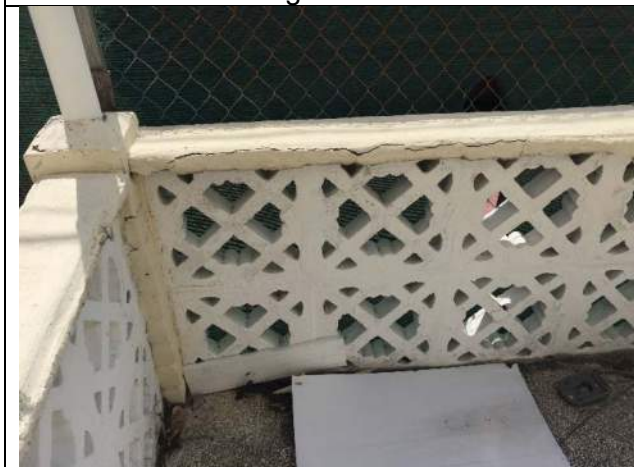
Main Entrance – Terrazzo terrace.
Low wall and lighting fixtures detail.

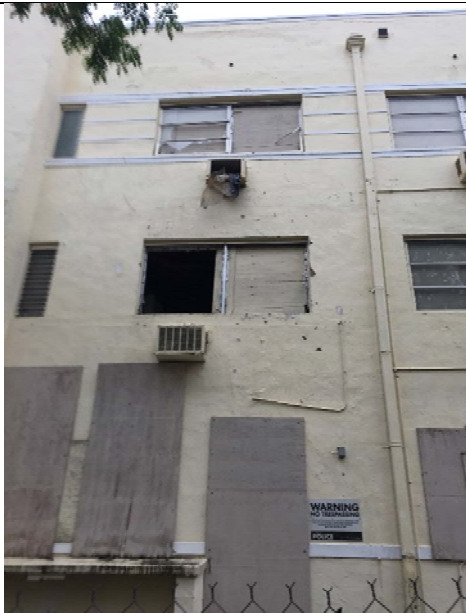
North Elevation
Missing windows, water infiltration issue

- Replace all exterior doors.
 - Replace all exterior windows.
 - Remove all through wall air conditioners, infill wall, restore plaster moldings.
 - Rework, replace, or provide new exterior railings to meet current code.

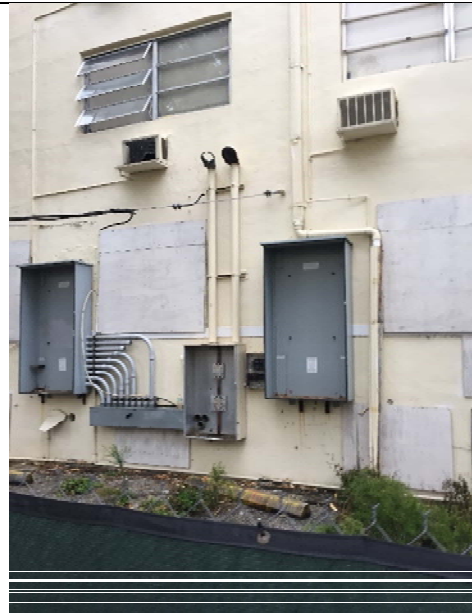
North Elevation
Former electrical service location

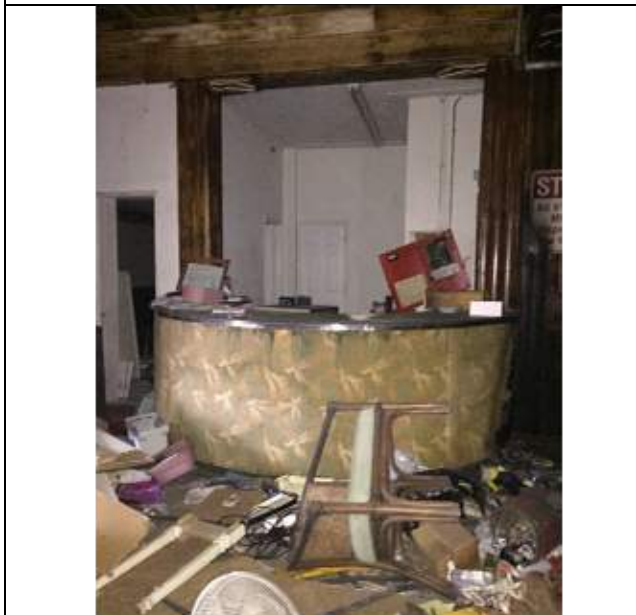
Lobby – desk, fire damage on right in image

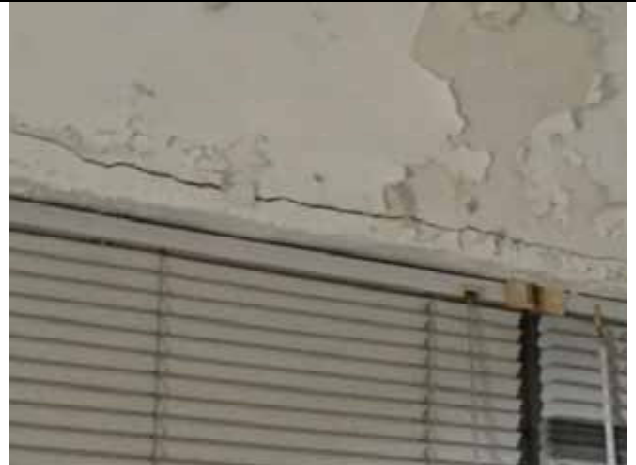
Apartment – cracking above window

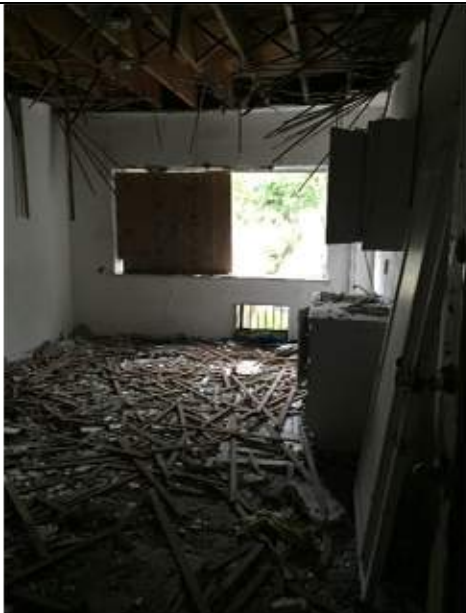
Apartment – exposed to elements
