## **2108 NORTH BAY ROAD DOCK PROJECT**

## **PERMIT DRAWINGS**

PERMITTED CONDITIONS WITH MARINE RESOURCE **OVERLAY** SCALE : AS SHOWN

2108 North Bay Road Dock Project Marine Resource Survey – August 2022 Representative Photographs

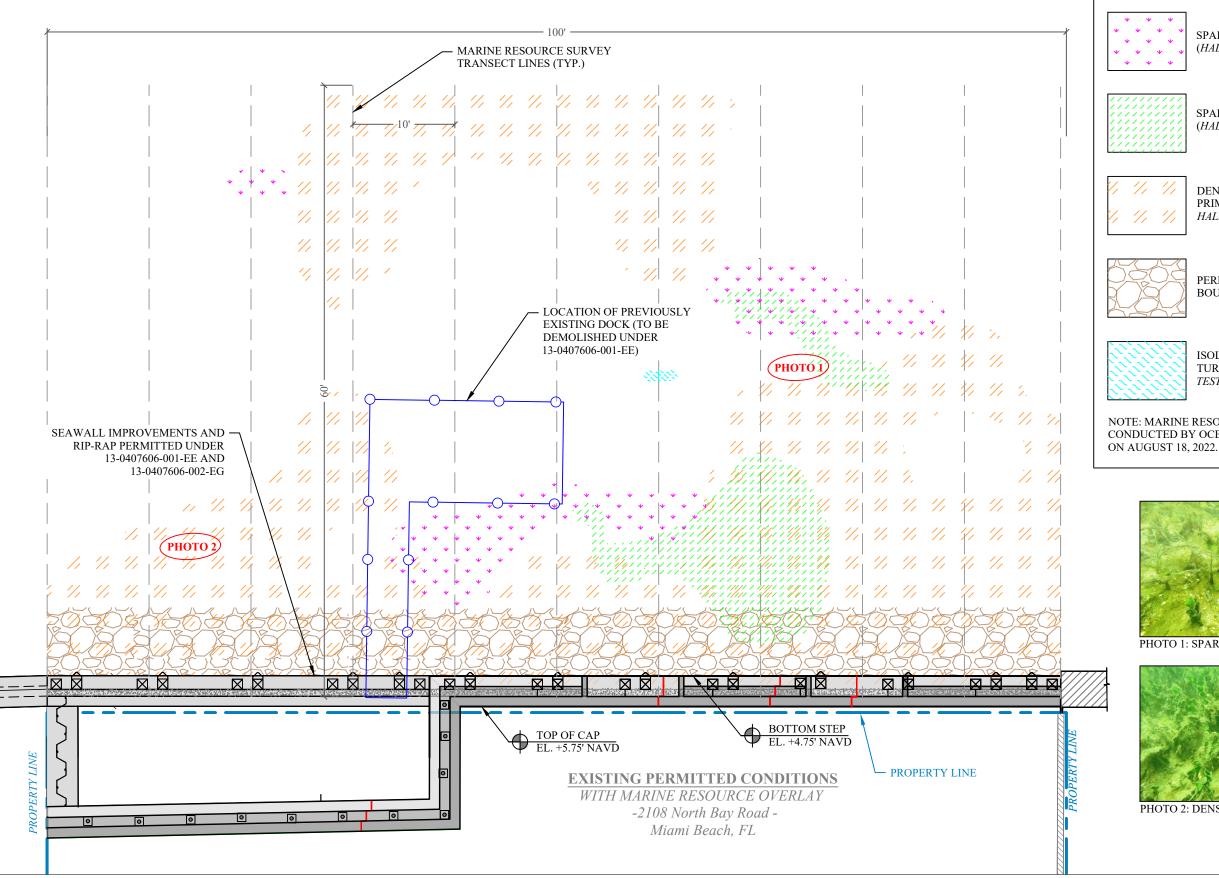
SPARSE PADDLE GRASS (HALOPHILA DECIPIENS): <5%

SPARSE SHOAL GRASS (HALODULE WRIGHTII): <15%

DENSE MACROALGAE, PRIMARILY OF THE GENUS HALIMEDA

PERMITTED RIPRAP BOULDERS

ISOLATED PATCH OF TURTLE GRASS (THALASSIA TESTUDINUM): <5%

PHOTO 1: SPARSE SHOAL GRASS

PHOTO 2: DENSE MACROALGAE

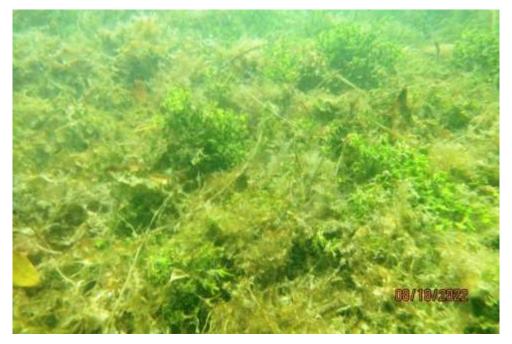
Photo 1 (above): Dense macroalgae, primarily of the genus *Halimeda*, covers most of the nearshore baybottom adjacent to 2108 North Bay Road.

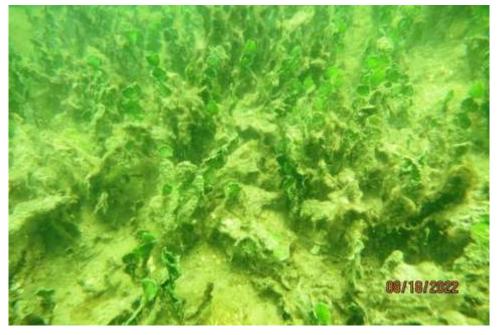
Photo 2 (above): Dense macroalgae obscuring the baybottom adjacent to 2108 North Bay Road.

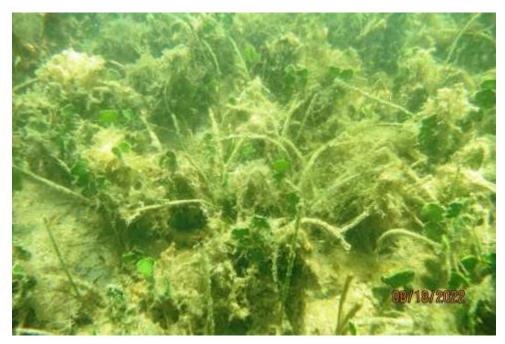
Photo 3 (above): Sparse Shoal Grass (*Halodule wrightii*) was observed growing within the dense macroalgae at the northern end of the surveyed area.

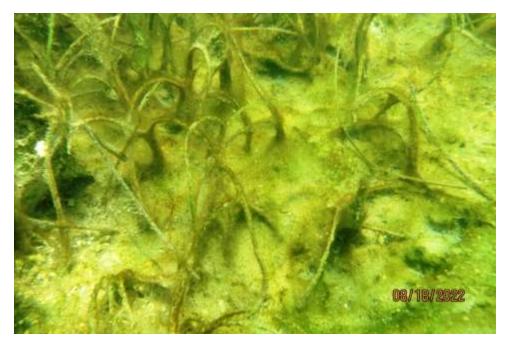
Photo 4 (above): Most of the baybottom, including the vegetation (Shoal Grass shown above), was found to be covered in a thick cyanobacteria film. This film is seasonal and is associated with high nutrients within the water column.

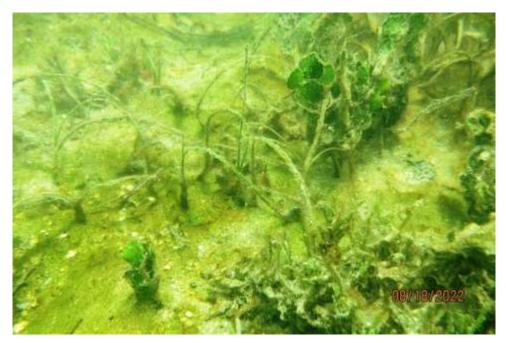
Photo 5 (above): Sparse Shoal Grass.

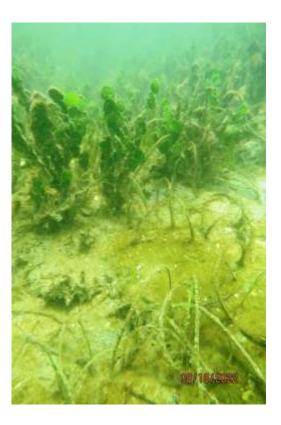
Photo 6 (right): Sparse Shoal Grass growing within an area adjacent to a patch of dense macroalgae.

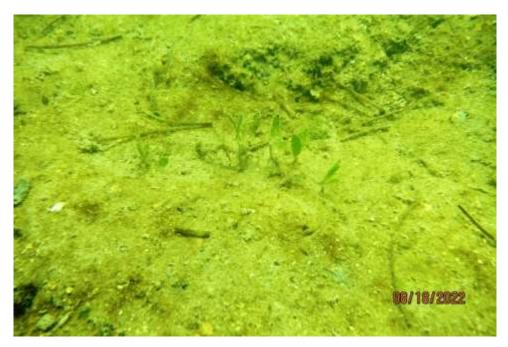
Photo 7 (above): Sparse Paddle Grass was observed beneath the existing dock (to be demolished under 13-0407606-001-EE), and in areas not containing dense macroalgae adjacent to the dock.

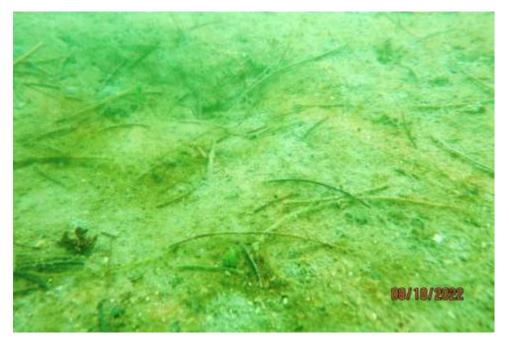
Photo 8 (above): Barren silty baybottom within the southern end of the surveyed area.

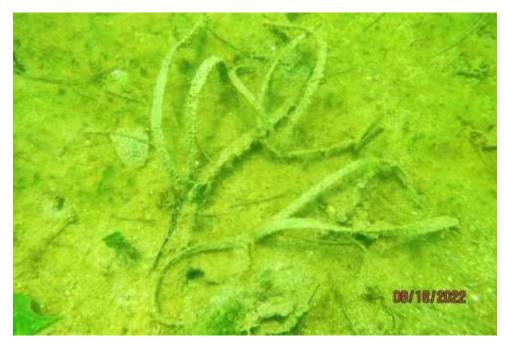
Photo 9 (above): A single isolated patch of Turtle Grass (*Thalassia testudinum*) was observed adjacent to the center of the Project site shoreline, approximately 30' offshore.

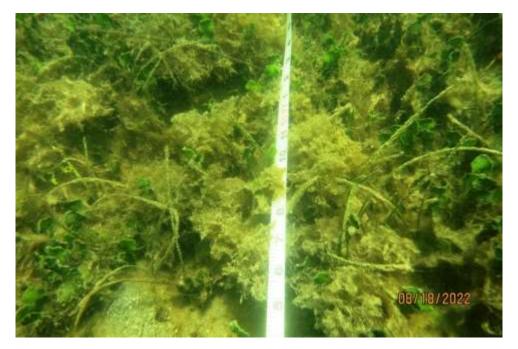
Photo 10 (above): Dense macroalgae, interspersed with Shoal Grass. beneath the survey transect tape.
