CONDITION ASSESSMENT REPORT

KEVIN ARROW - BEATLES MANDALA (AMOR = LOVE)

Date of Assessment: August 13, 2021

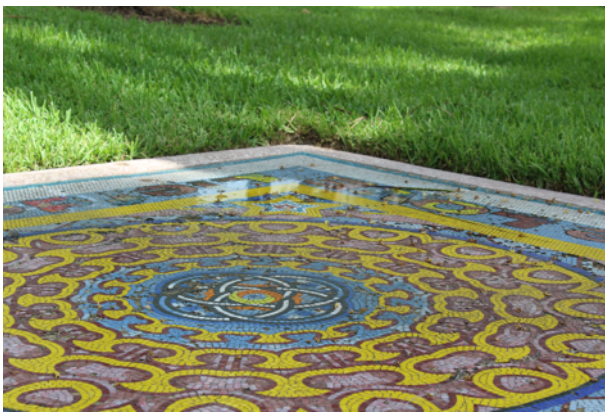
This mosaic has been problematic almost since it was installed. The underlying issue in its damage seems most likely to be the result of the concrete slab onto which it has been set, which was not canted to slough off water. Standing water appears to be the issue in the deterioration of the artwork. The areas of tesserae detachment clearly correspond to dips in the mosaic surface.

Standing water on southeast side of the mosaic.

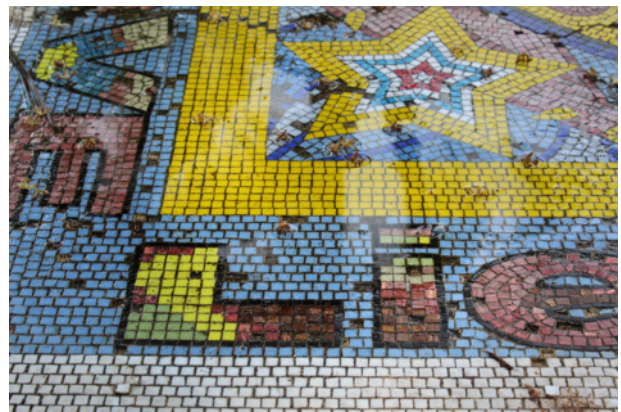
Where the tesserae have been displaced, adjacent tesserae pop out with ease. Approximately 50% of the tesserae remain securely attached, specifically if the adjacent tesserae are secure as well. The intact tiles are in fair condition with no delamination or breakage observed. There are multiple areas of minor repairs. These include tesserae that have been reattached using an unknown (likely commercial grade) adhesive. Areas such as these are minimal and though the material are likely incompatible with the original, they do not appear to be causing additional deterioration to the mosaic. In general, the surface is slightly dirty with debris and the grout is stained a dark grey color. Algae was visible where the tesserae had been displaced, likely due to the stagnant water and prolonged periods of shade, which are favorable to micro biological growth.

Detail of pooling water with visible algae on the grout and in areas where tiles have been displaced.

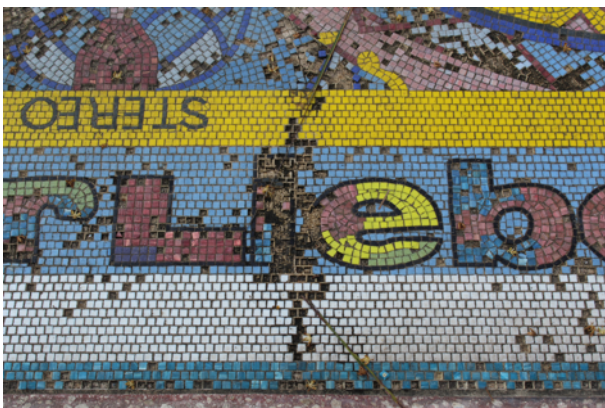
Approximately 5-8% of the tesserae are displaced or missing altogether. Several large sections of tile are missing in each color. Many of these losses occur throughout the mosaic with no identifiable pattern; however, there are 2-3 areas of linear losses. In these areas, there are linear losses spanning a width of 1-6 tesserae that suggest their detachment could possibly correspond to a subsurface condition. Underlying conditions could include pooling of water or an additional fault with the concrete pad and/or bedding mortar.

Detail of missing tesserae both spread out and in a linear pattern as seen in the center of the image.

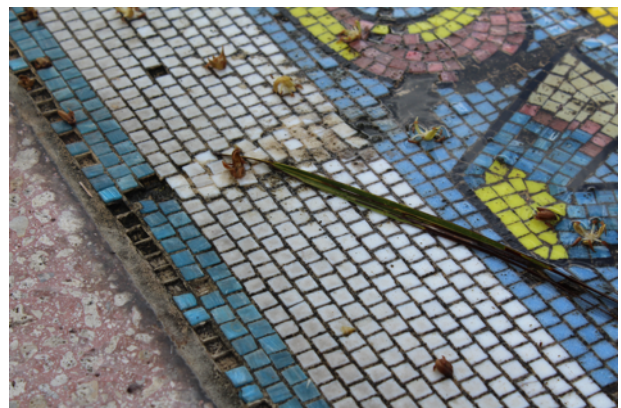
Detail of tile loss, standing water, dirt, and debris sitting on the mosaic

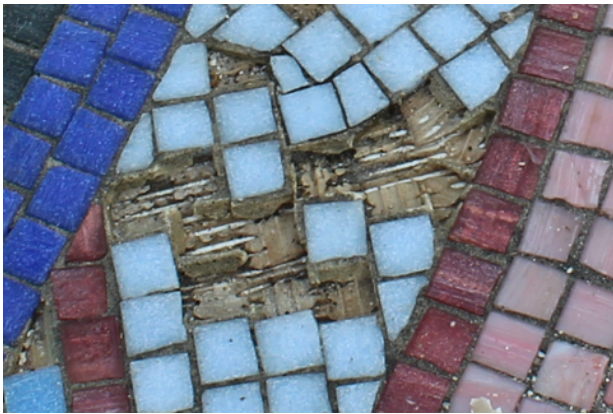
Grout remains overall but is missing where there are larger areas of missing tesserae. In instances where only one or two tesserae have been displaced, the grout line appears to remain in place. Bedding mortar also appears to remain in most locations. The fiberglass mesh is visible in some areas but appears to be missing in areas where tesserae are lost. This condition suggests that the issue appears to be one of poor bonding between the tesserae and the bedding mortar.

Detail of visible fiberglass mesh

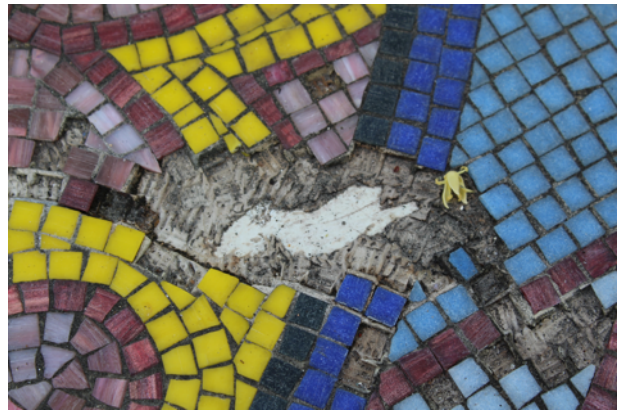
Detail of the bedding mortar and underlying fiberglass and mesh.
