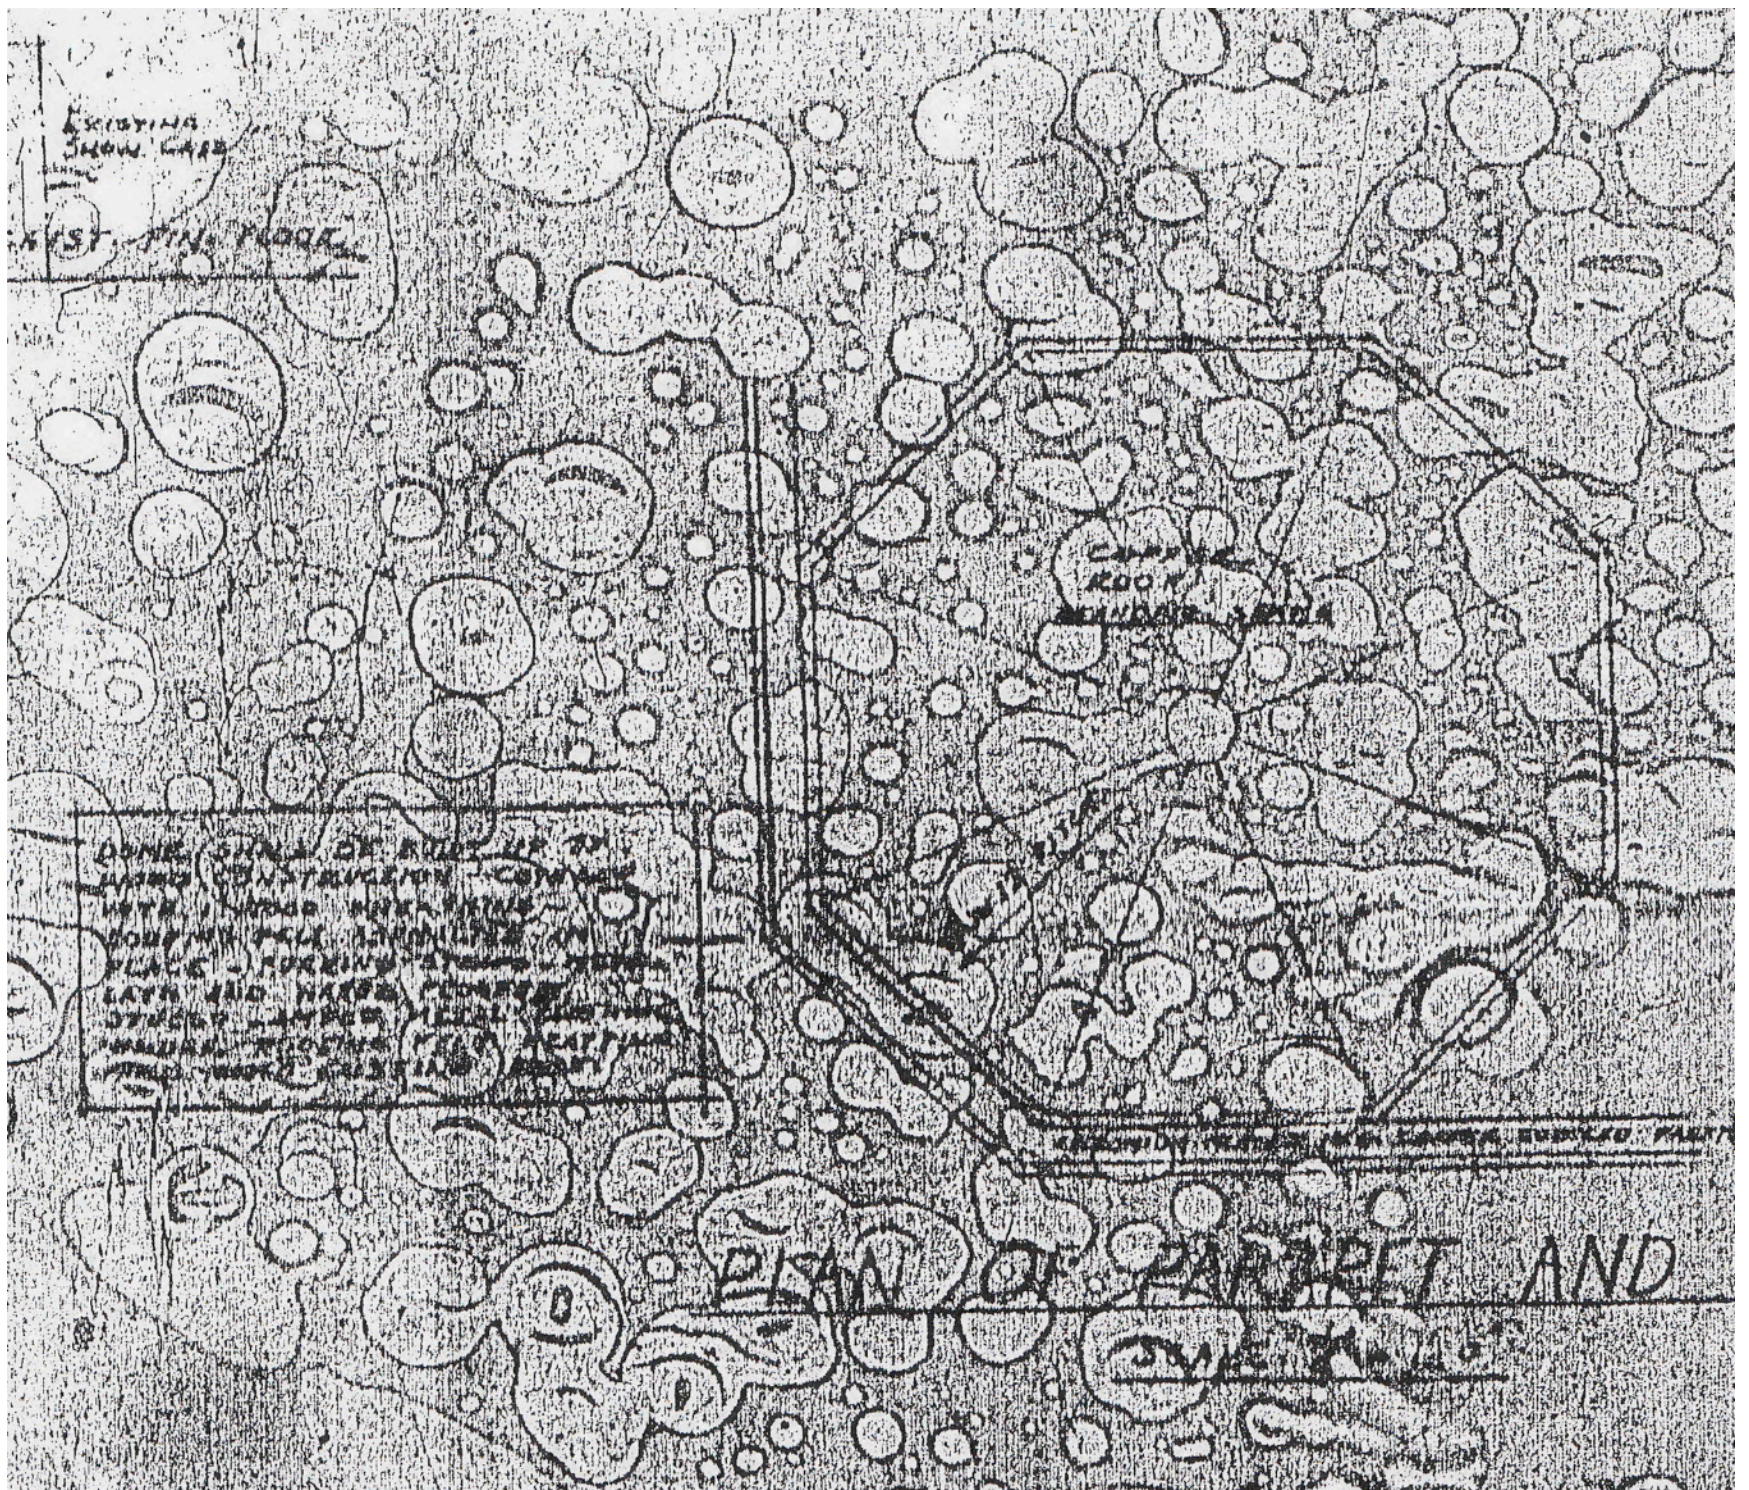
Partial roof plan showing the eight-sided copper cupula. (8)

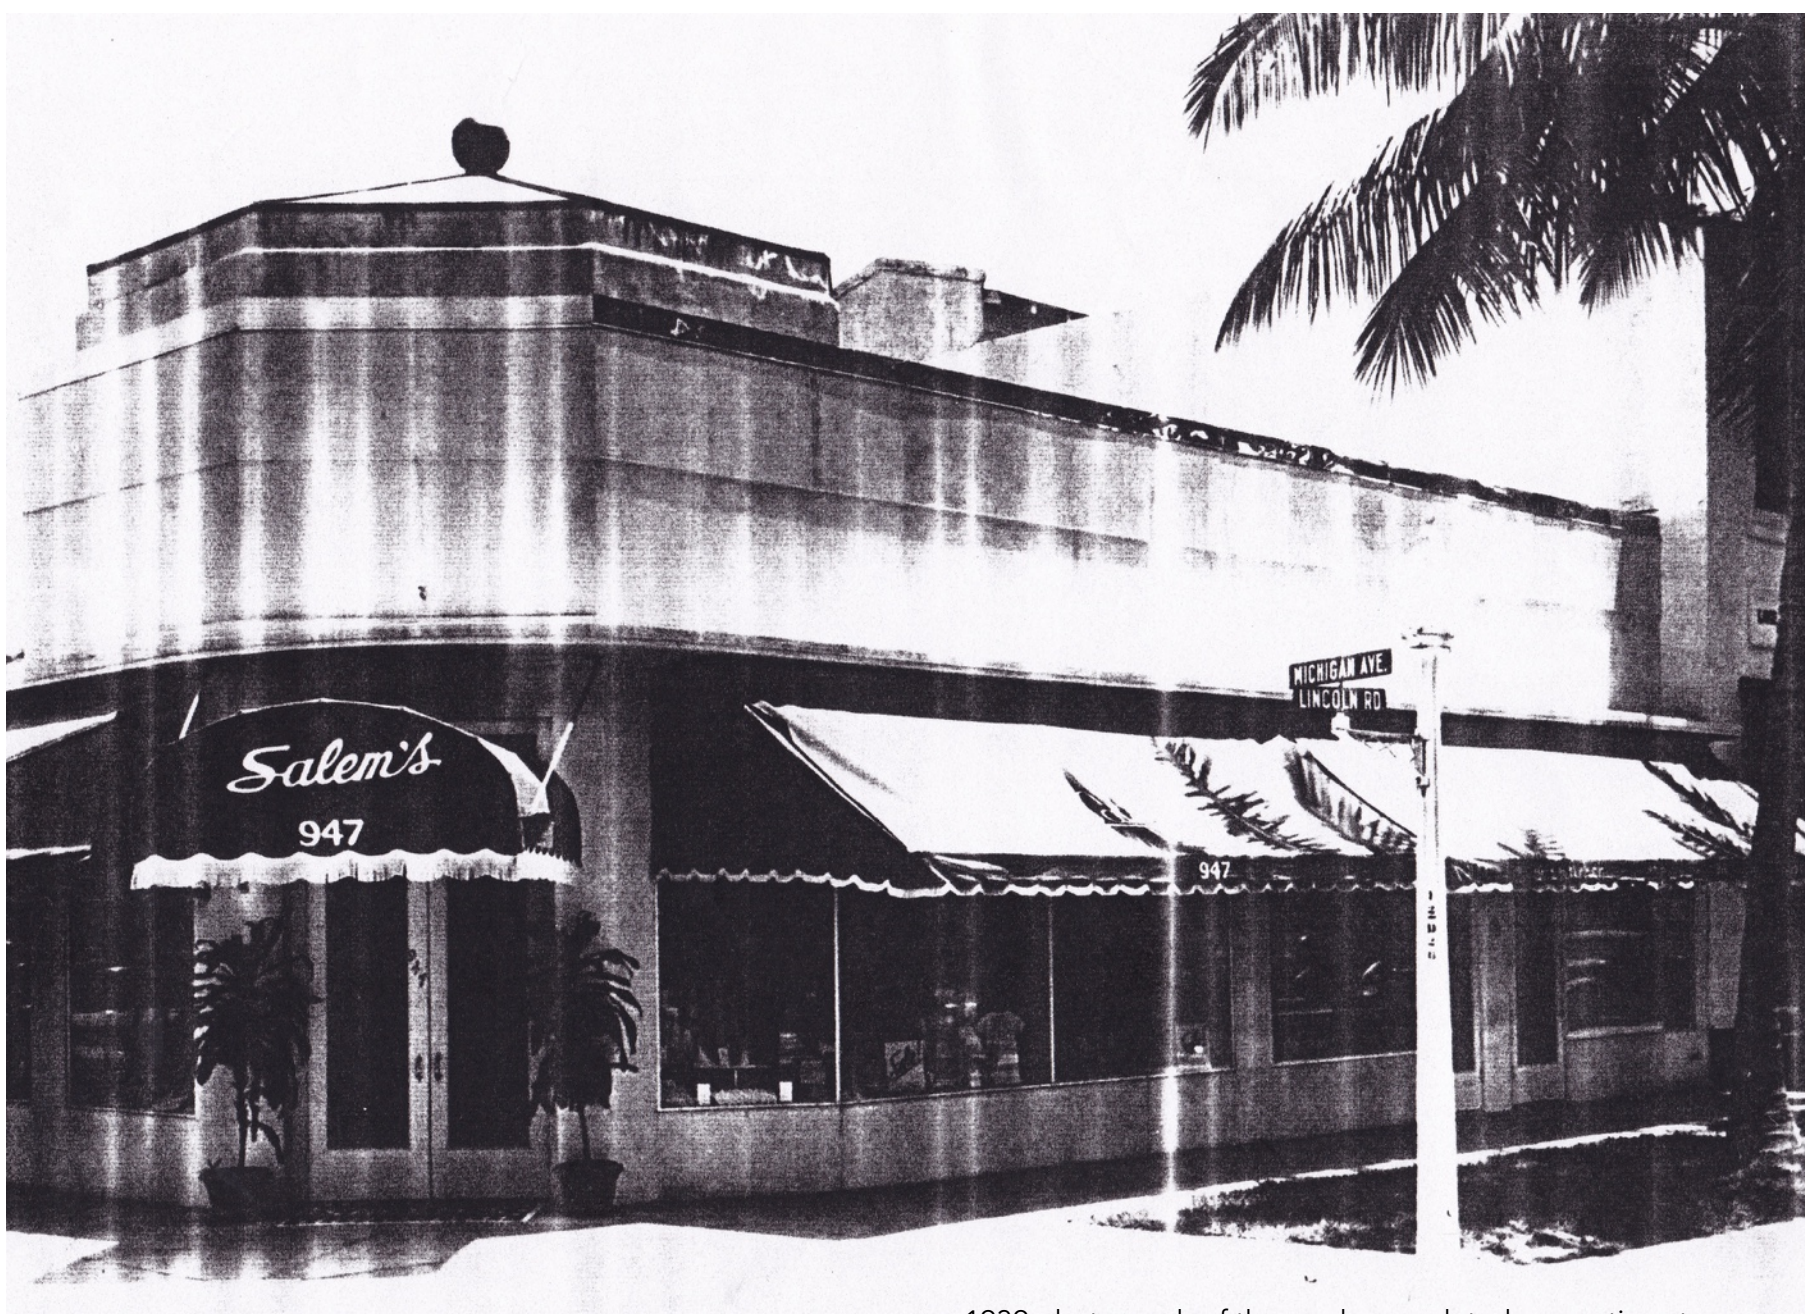
1939 photograph of the newly completed renovations to 947 Lincoln Road including the addition of a corner roof-top eight-sided copper cupula. (9)

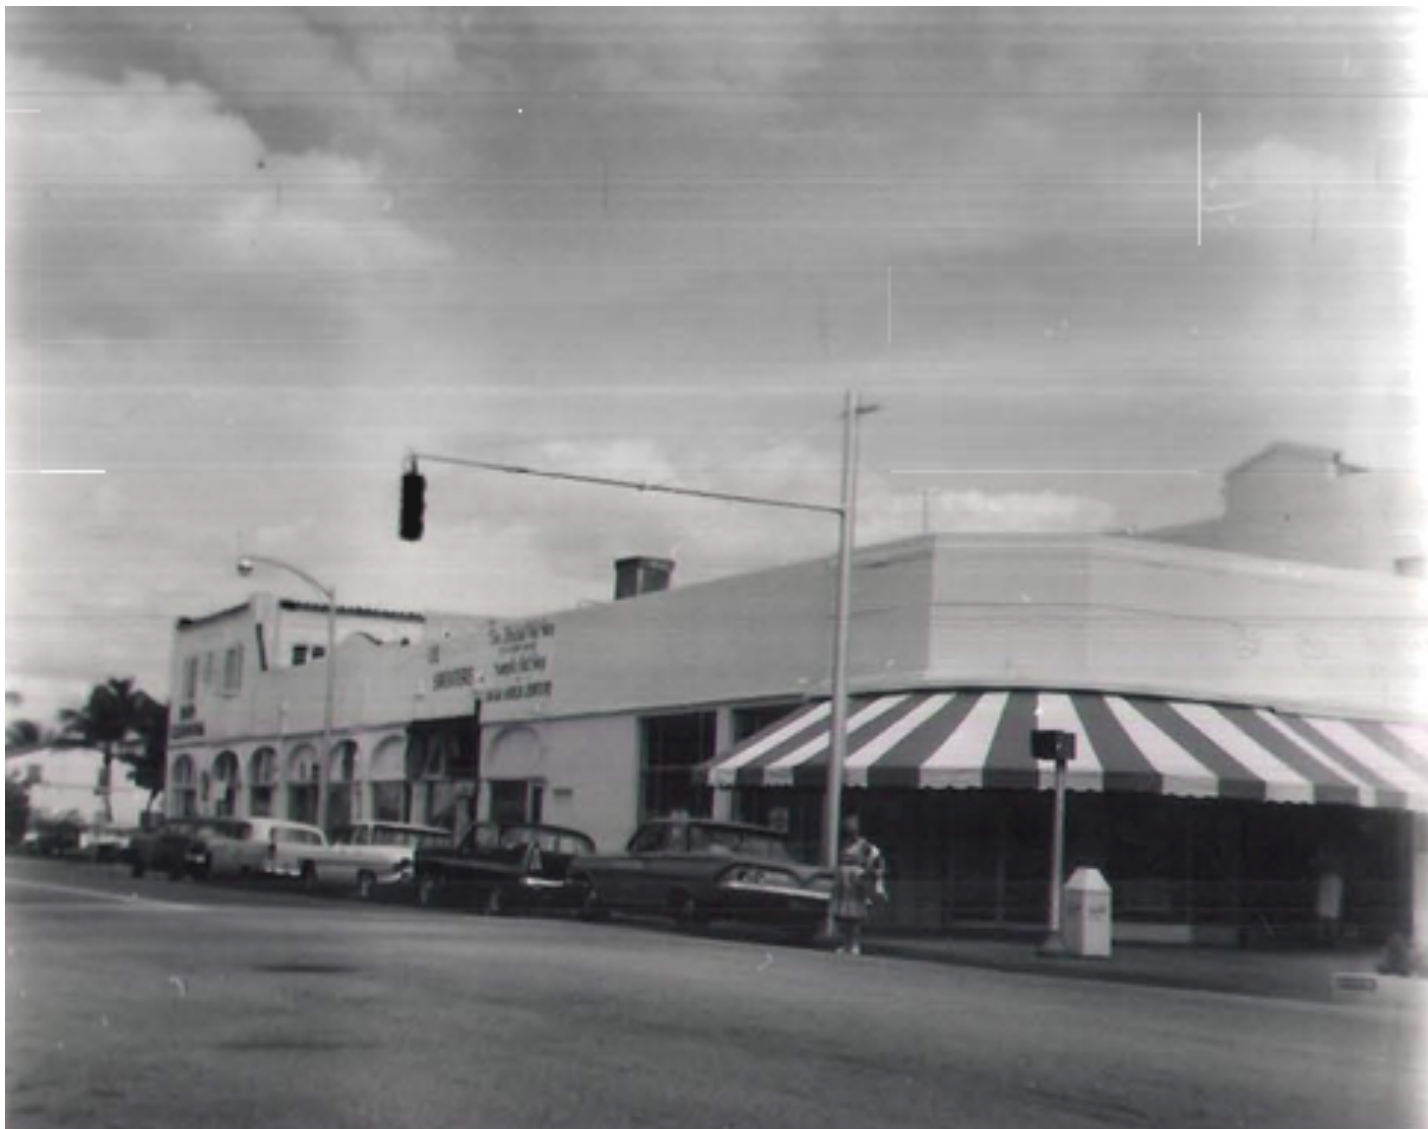
1962 photographs of 947 Lincoln Road - corner and Michigan Avenue elevations courtesy of the Miami Dade Property Appraiser Office. By this time the cupula had already be removed. (10)

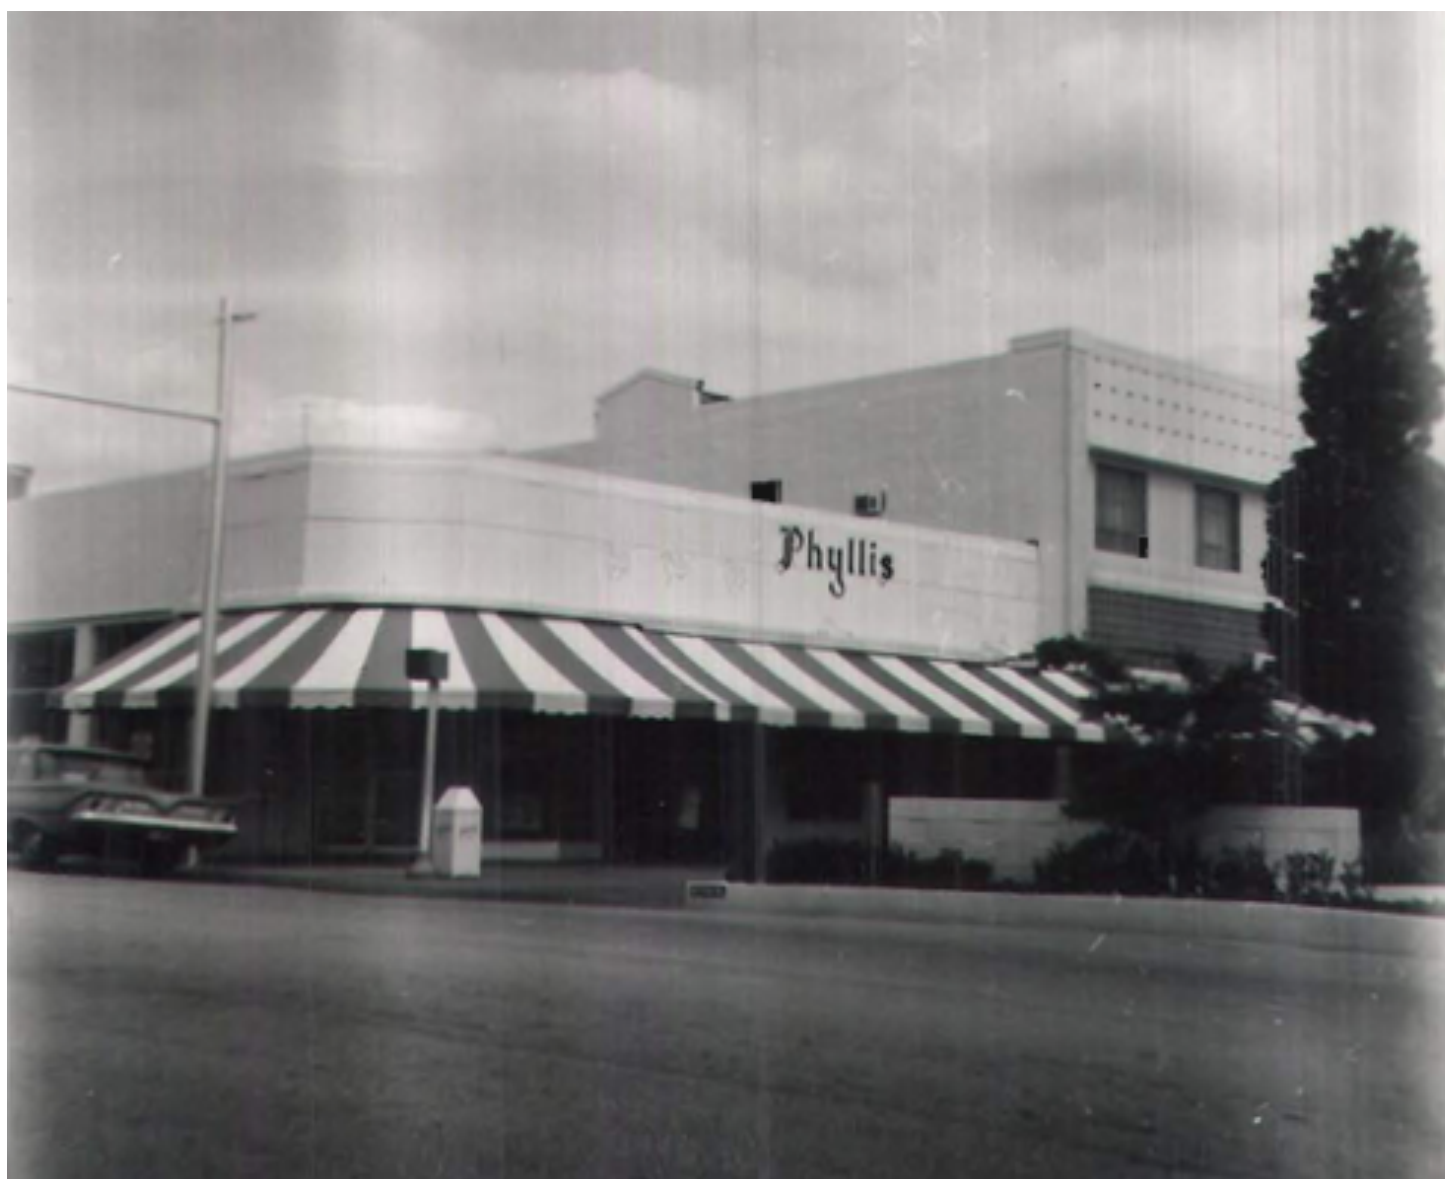
OCT • 62

Above Photo: North and rear (Lincoln Lane) elevation with partial east elevation at left.

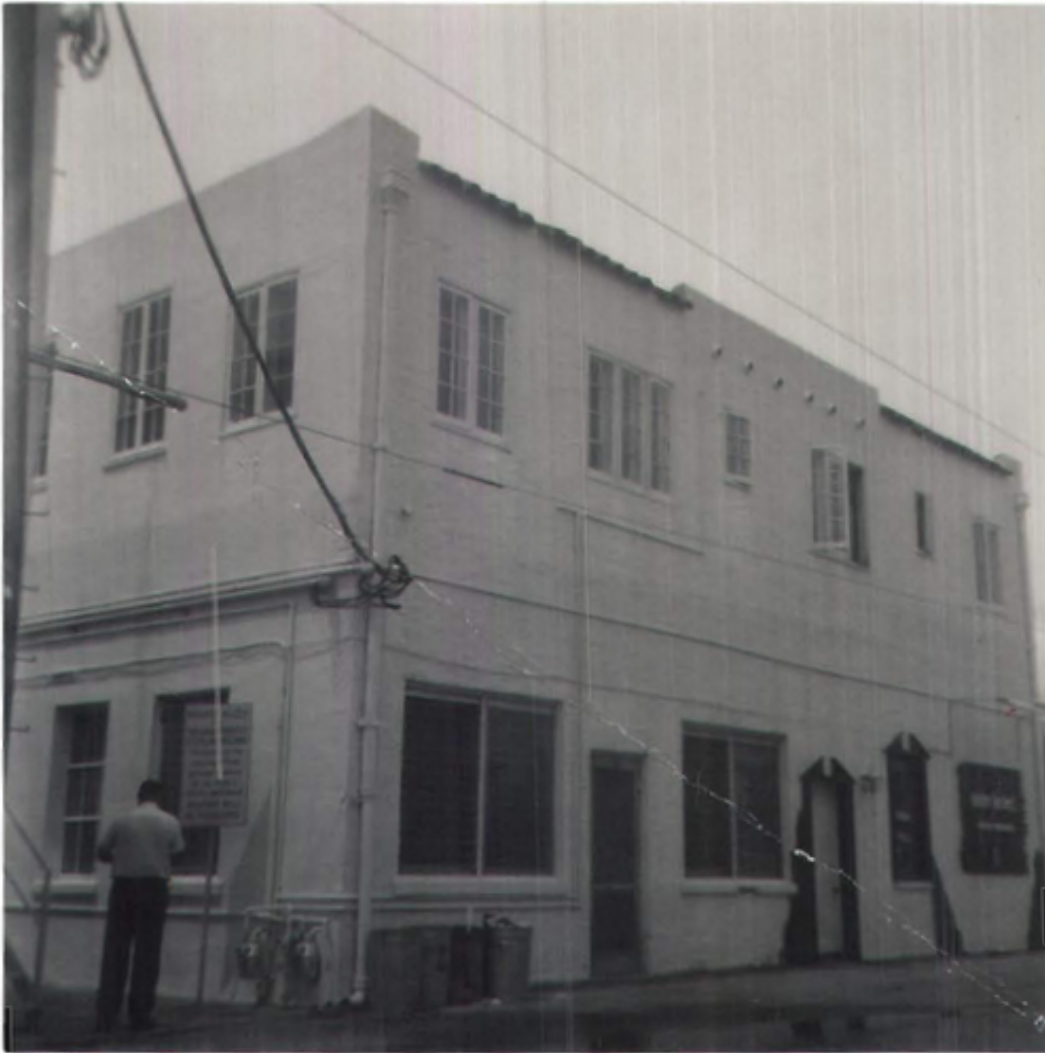
JUN • 63

Below Photo: North (Lincoln Lane) elevation at left and Michigan Avenue elevation at right.

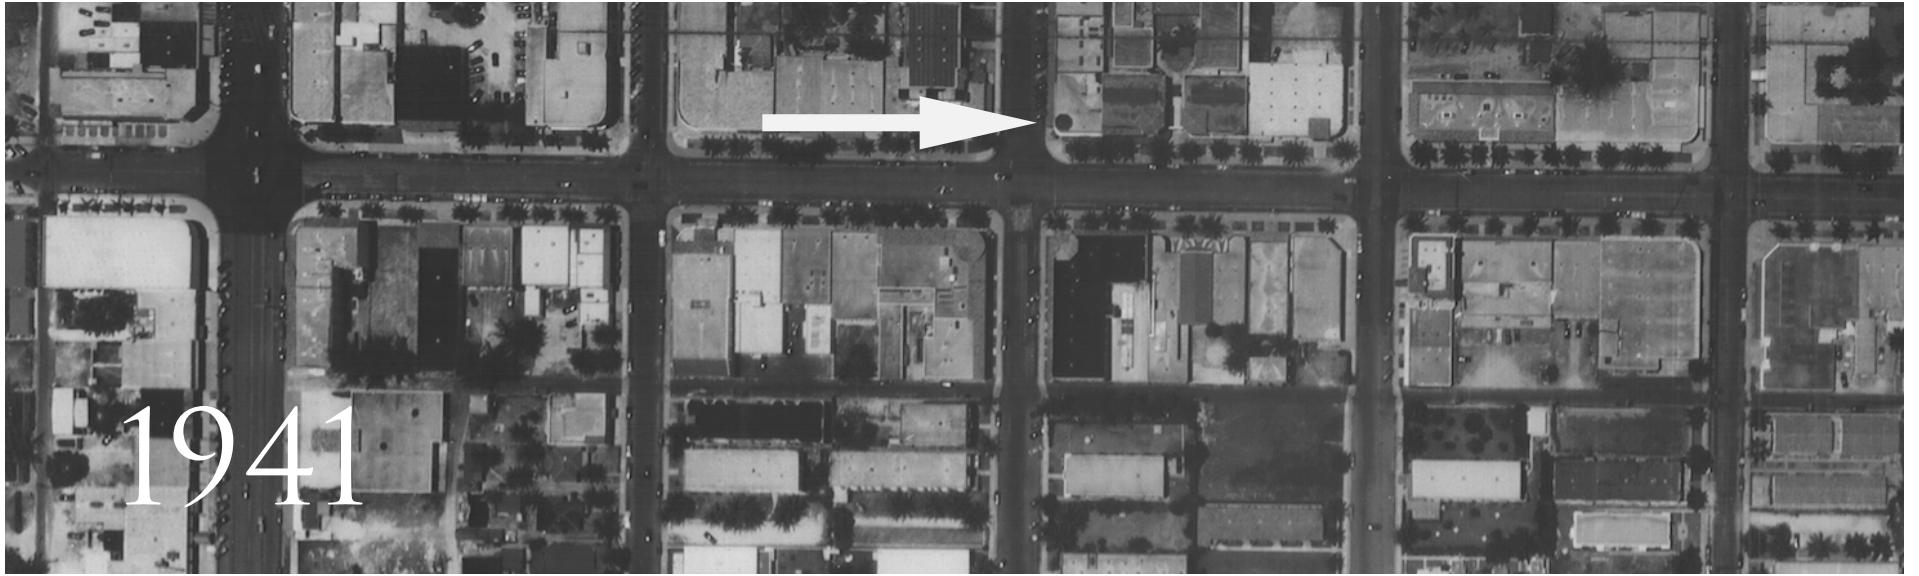
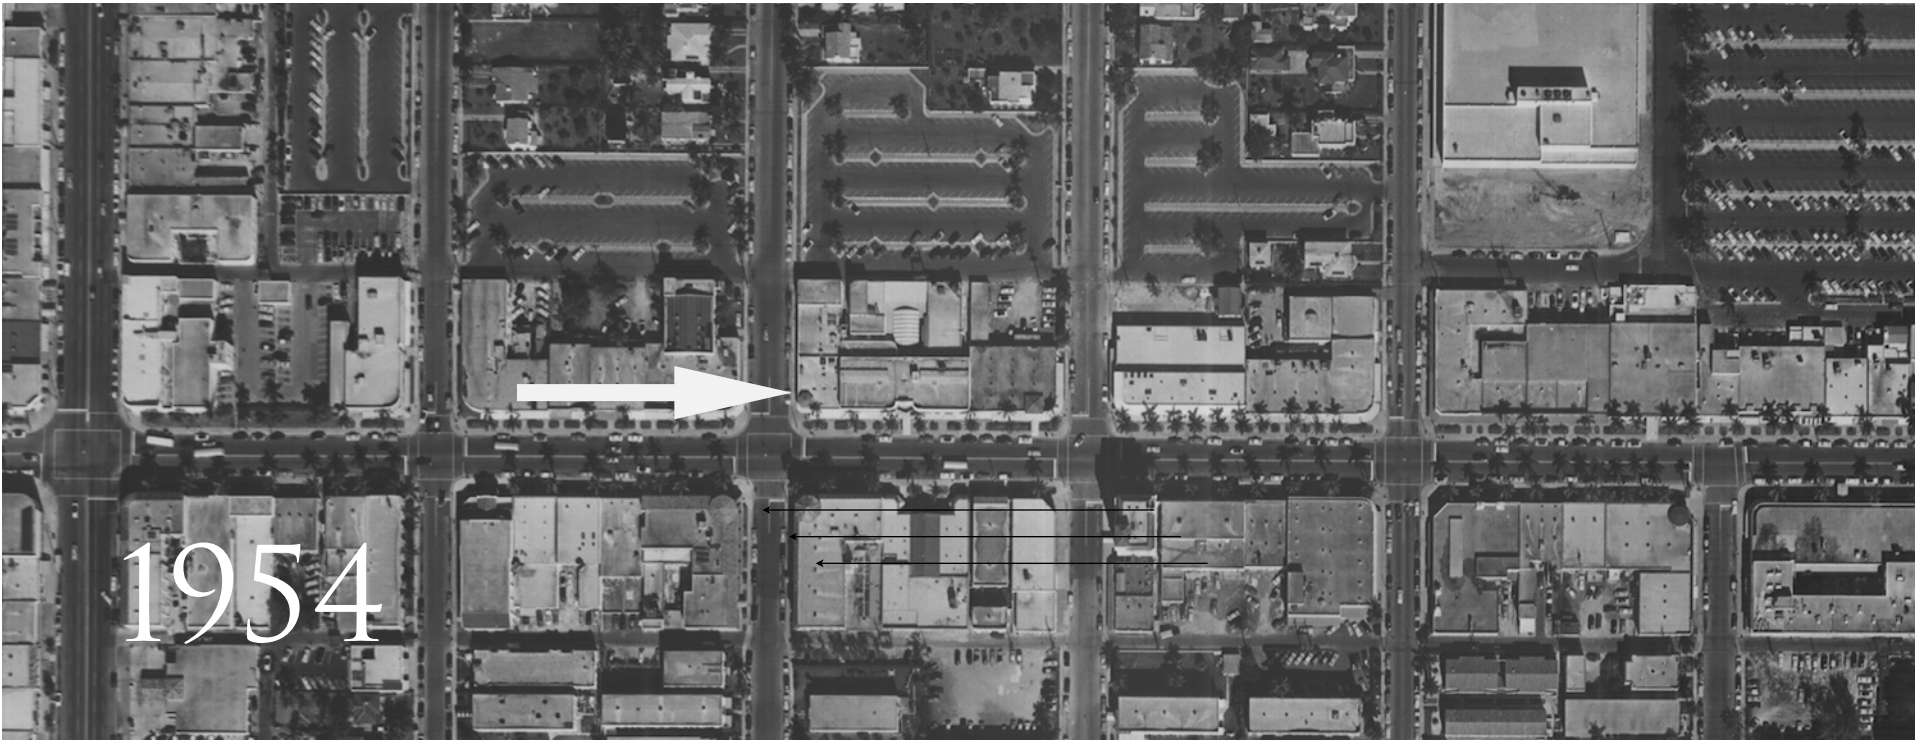
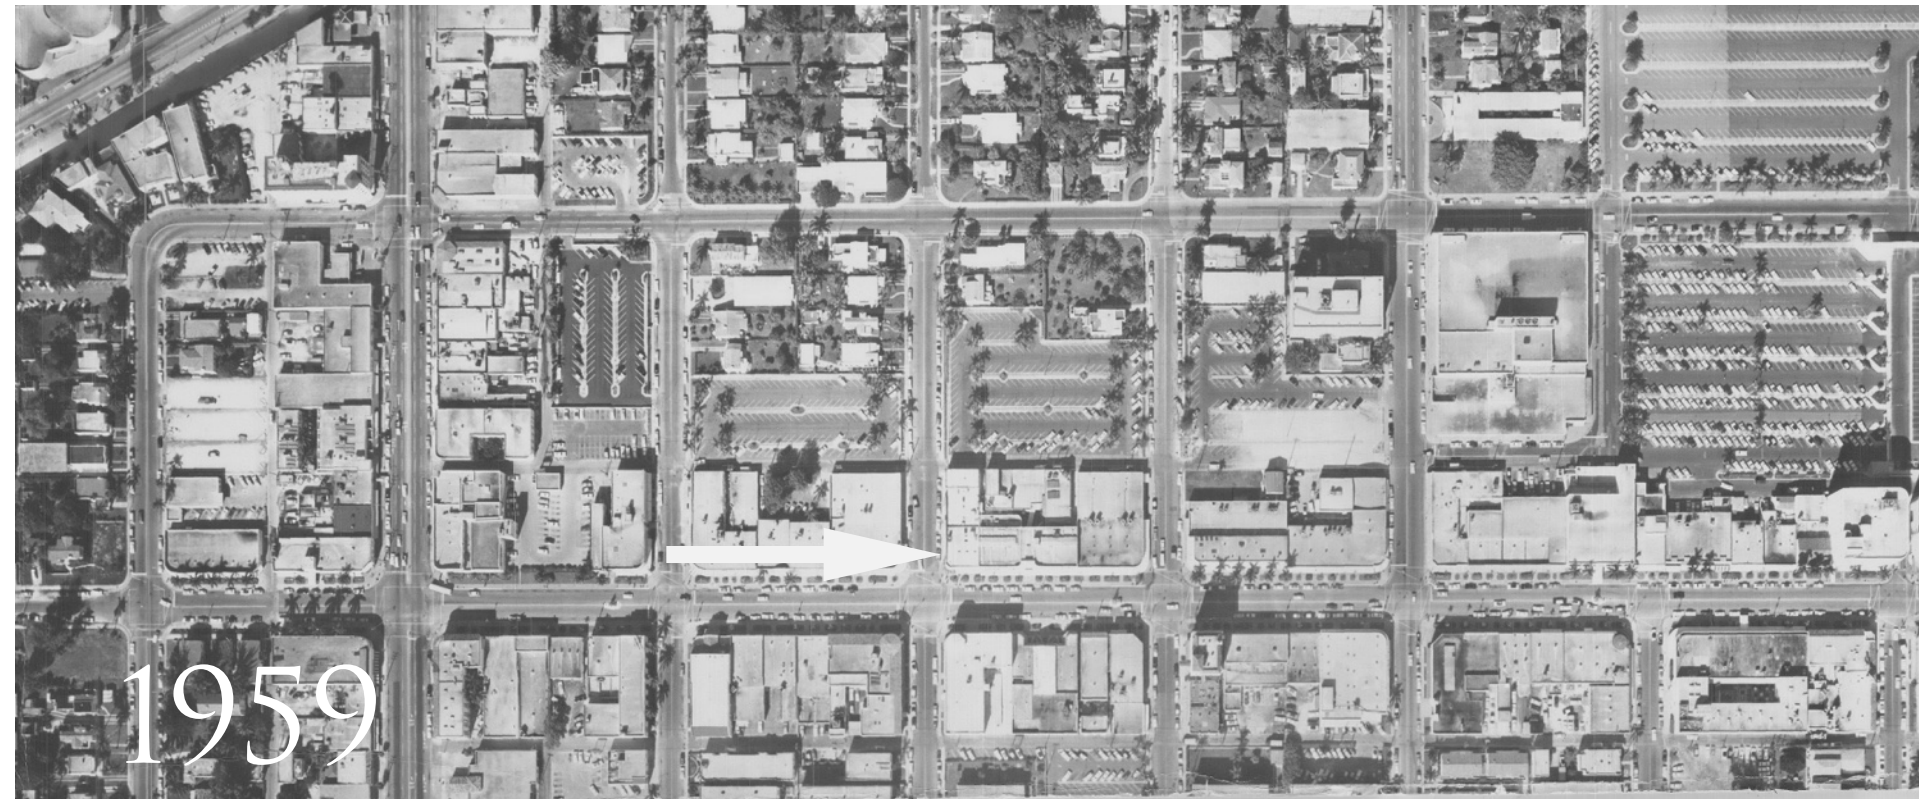
IN THESE AERIAL PHOTOGRAPHS COURTESY OF THE CITY OF MIAMI BEACH PUBLIC WORKS DEPARTMENT - THE EIGHT-SIDEED CUPULA CAN BE CLEARLY SEEN IN THE 1941 AND 1954 PHOTOGRAPHS. HOWEVER IT HAD BEEN REMOVED BY THE TIME OF THE 1959 PHOTO.

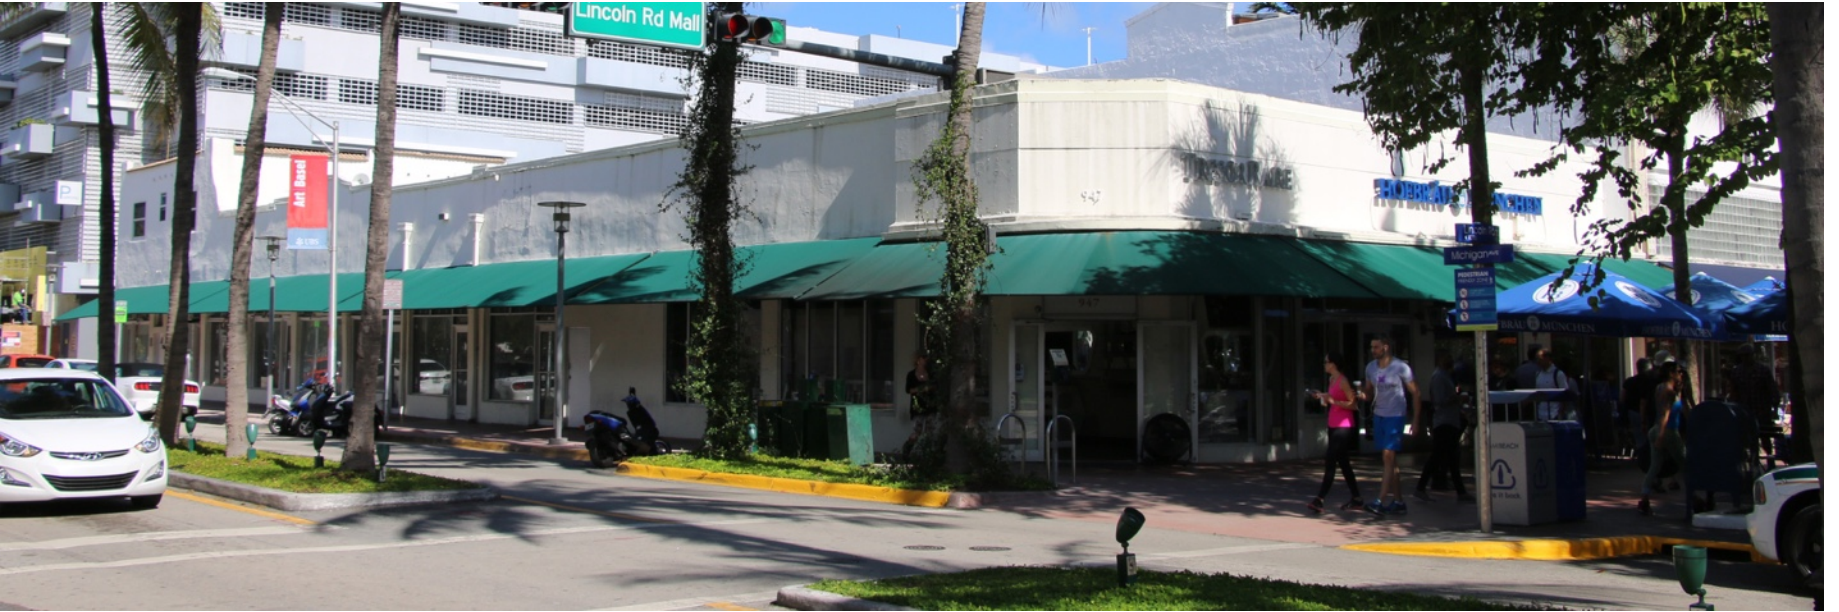
ABOVE: 2017 PHOTOGRAPH WITH SOUTH ELEVATION on LINCOLN ROAD AT RIGHT AND THE WEST ELEVATION (MICHIGAN AVENUE) AT RIGHT.

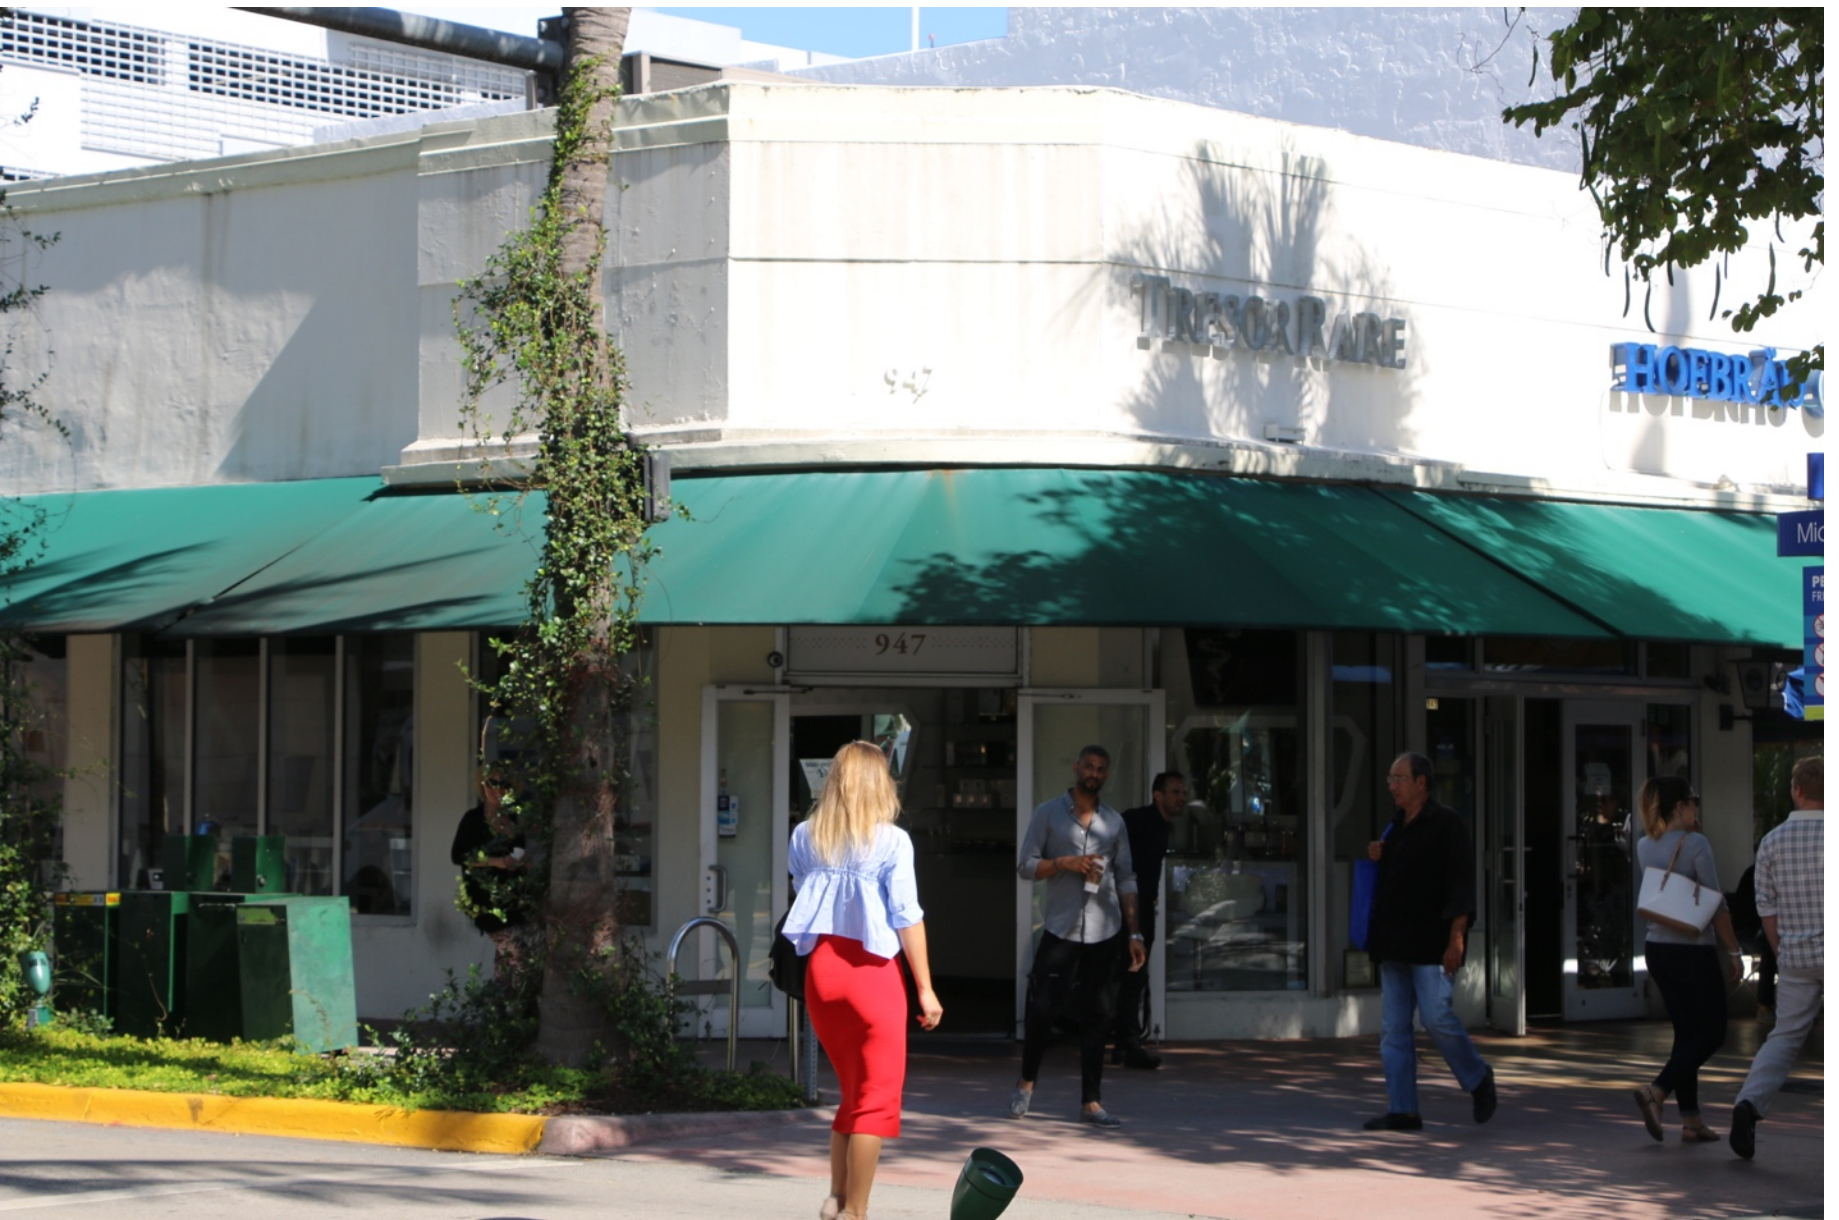
BELOW: 2017 PHOTOGRAPH SHOWS CORNER ENTRANCE WITH DIXON DESIGNED CLADDING WHICH ENDS NOT FAR ONTO MICHIGAN AVENUE

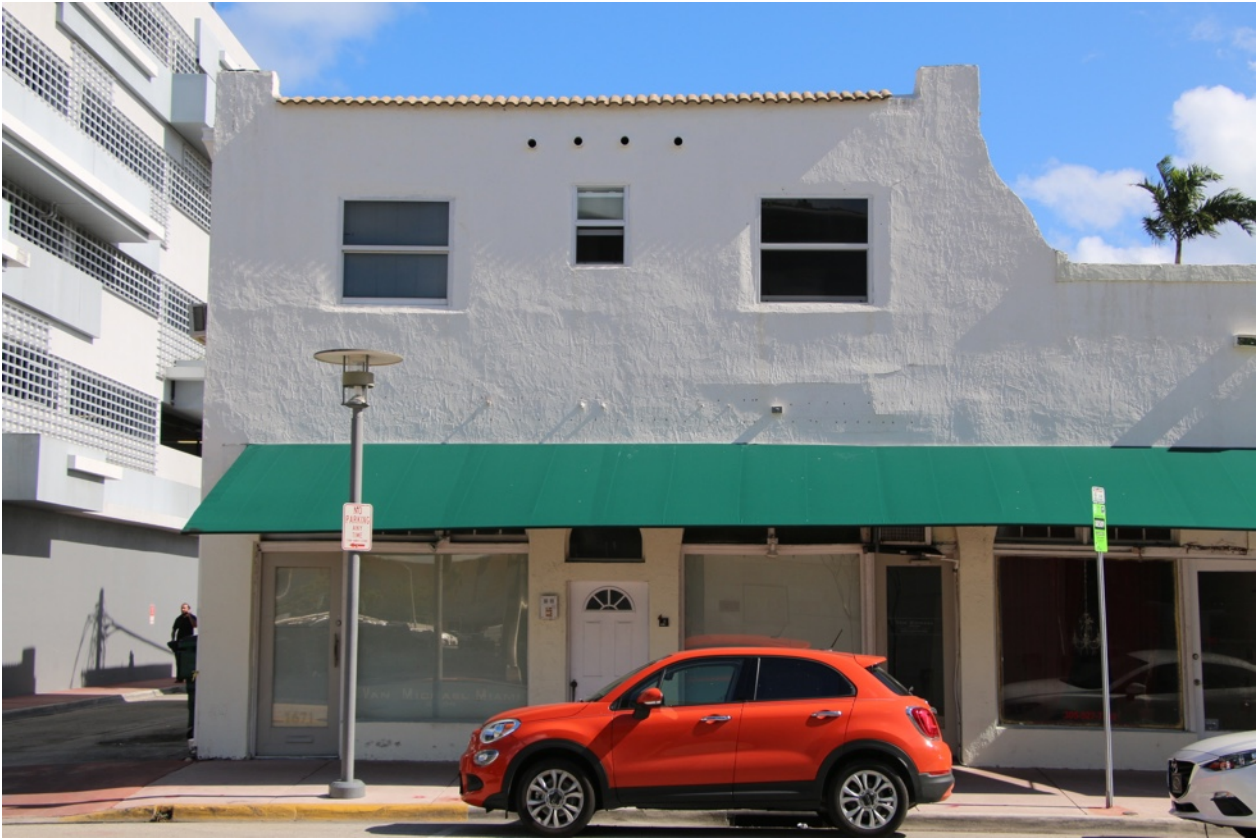
LEFT PHOTO: TWO STORY SECTION AT NORTHERN SIDE OF PROPERTY

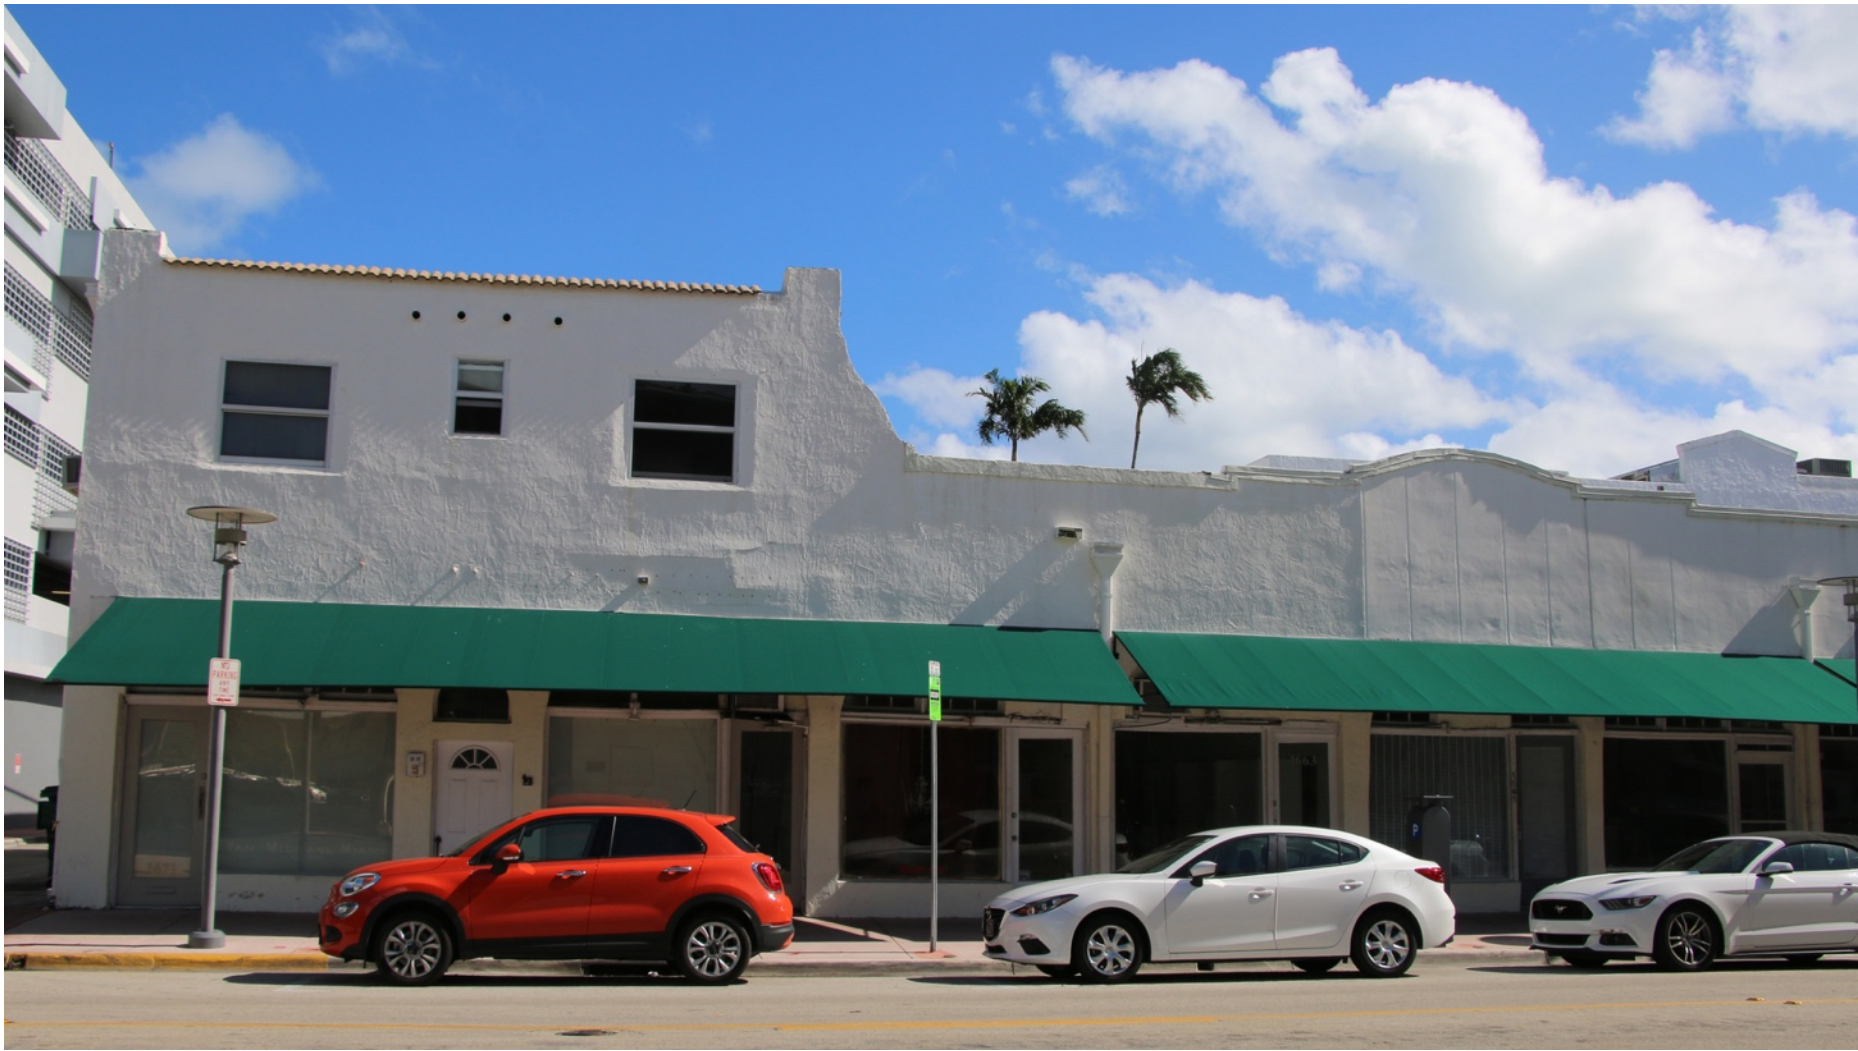
PHOTO BELOW: PARTIAL WEST ELEVATION FACING MICHIGAN AVENUE
