RENOVATION PROJECT
SHORING METHODOLOGY
FOR EXISTING FACADES

PREPARED BY
CHM STRUCTURAL ENGINEERS

RENOVATION PROJECT
7450 OCEAN TERRACE

STRUCTURAL CONCEPTUAL REPORT

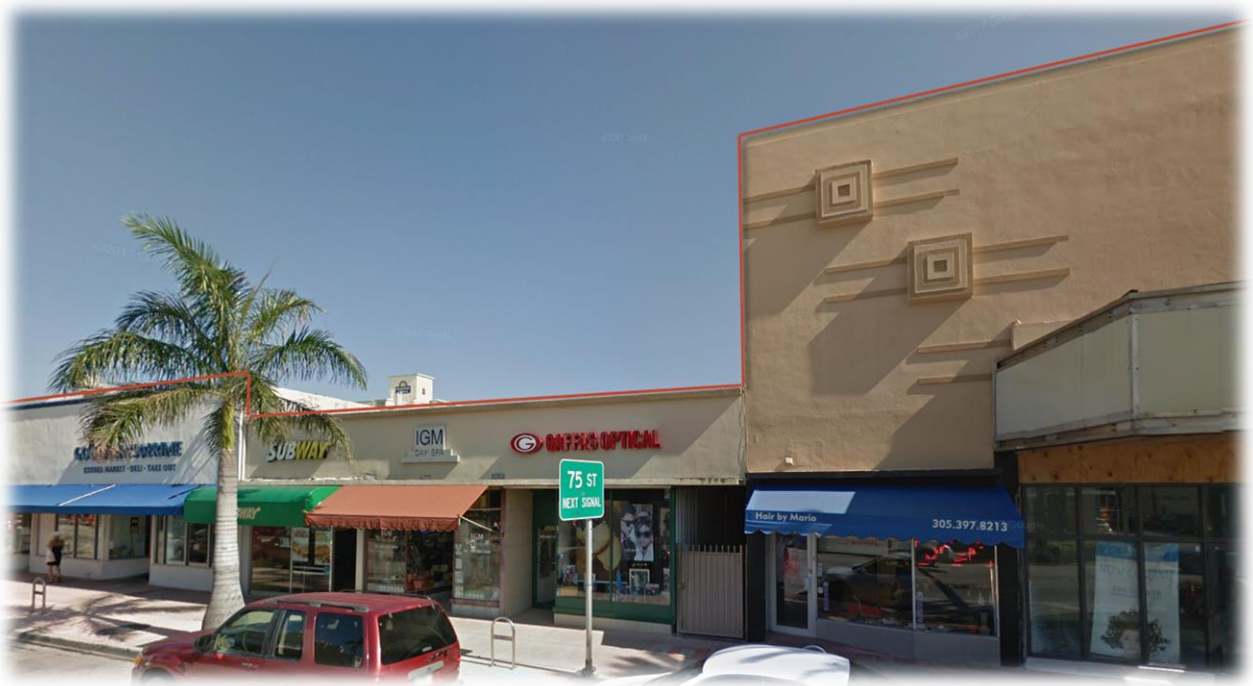
The general solution adopted, either for one, two or three-level buildings consists on vertical trusses distributed along the facades and connected to the existing beams at an approximate distance of 12'-0", as shown in the following drawing.

This shoring system will be installed towards the interior of the property, therefore not invading public spaces.

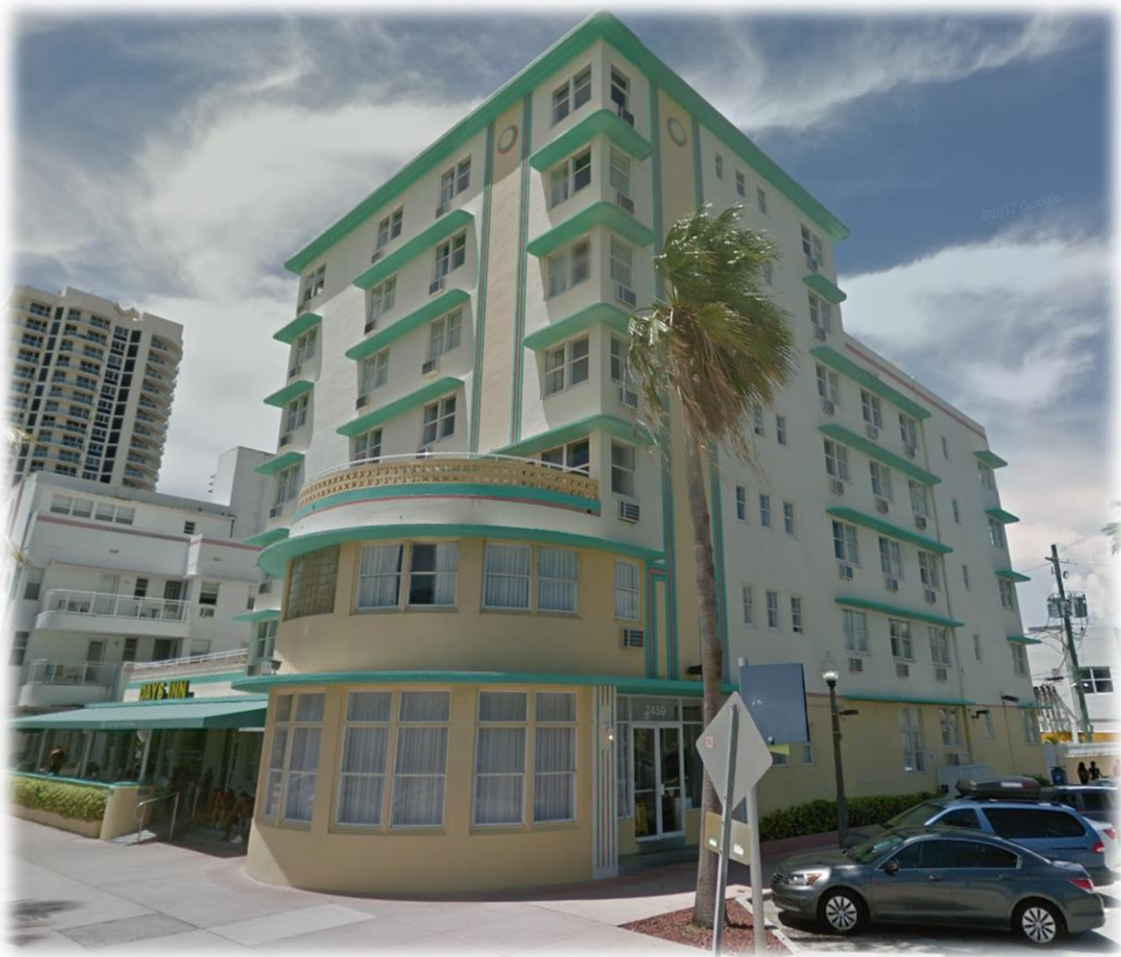
The structure of this seven-story building consists of concrete beams and columns, arranged in parallel frames with one-way ribbed slab spanning between them, and with exterior walls made of concrete masonry units, spanning vertically between perimeter beams that also serve as lintels for the windows.

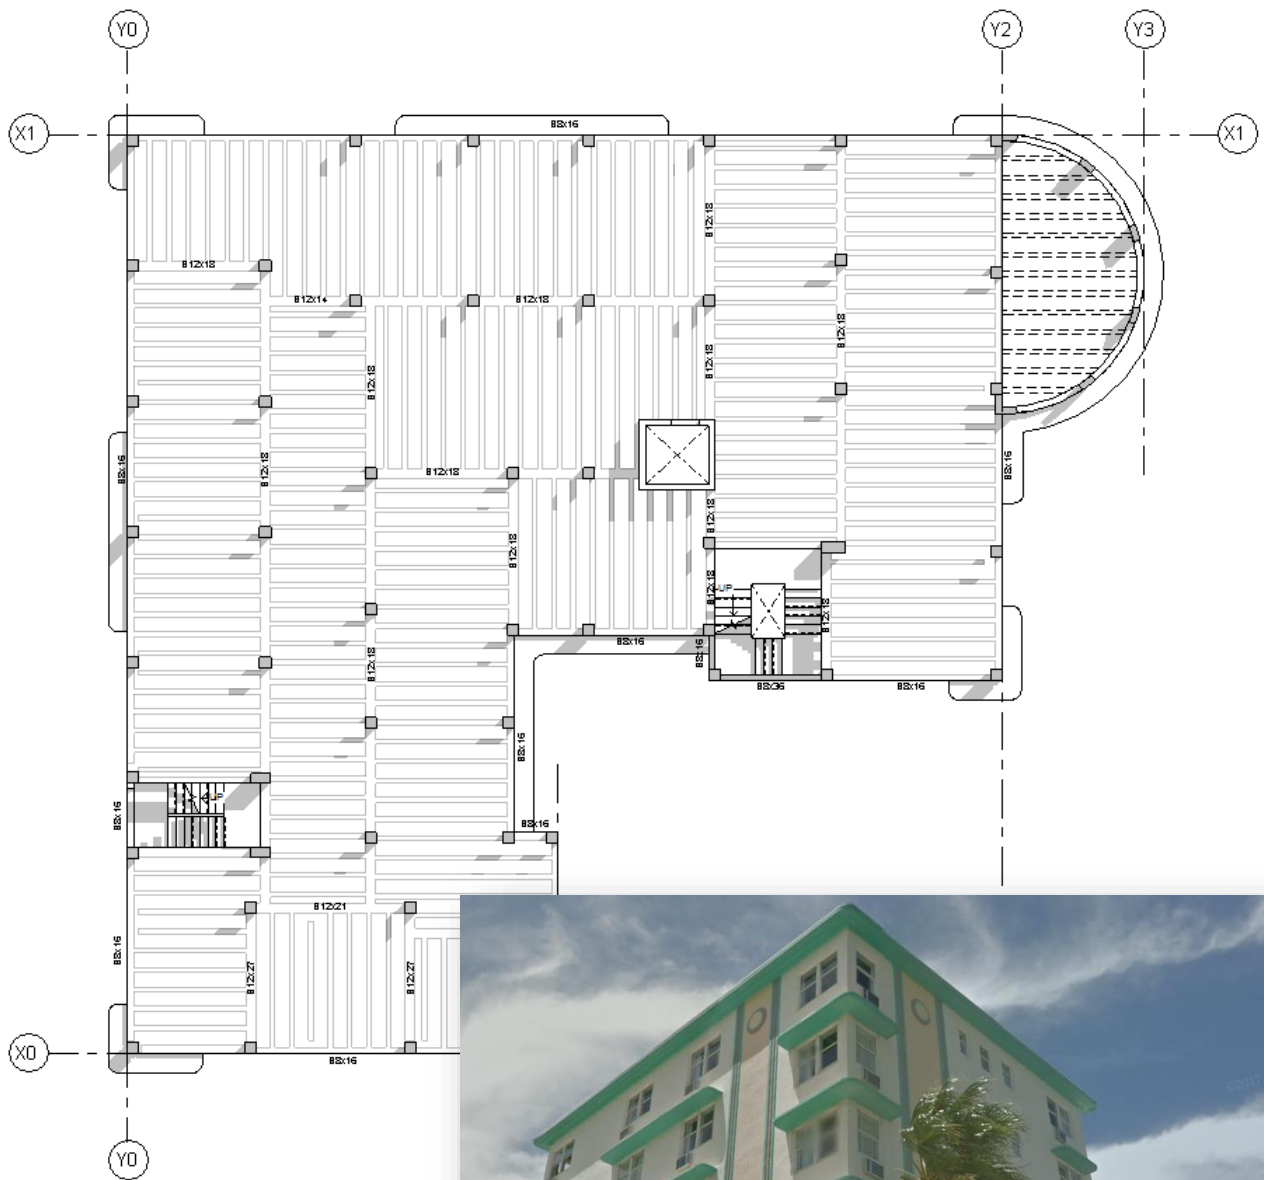
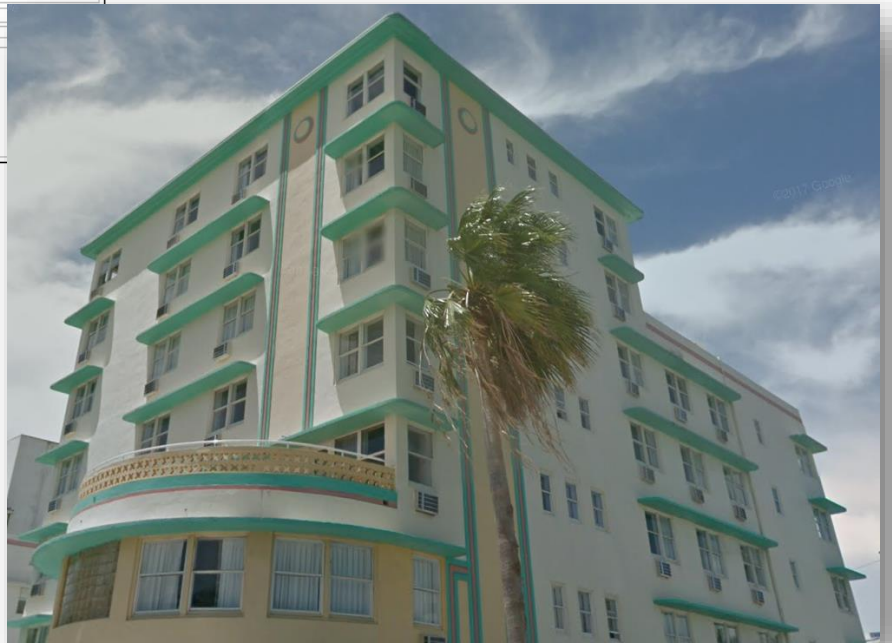
The plan layout shown below depicts the structural members of an elevated level.

Hotel room windows are protected by eyebrows aligned to the bottom of perimeter beams.

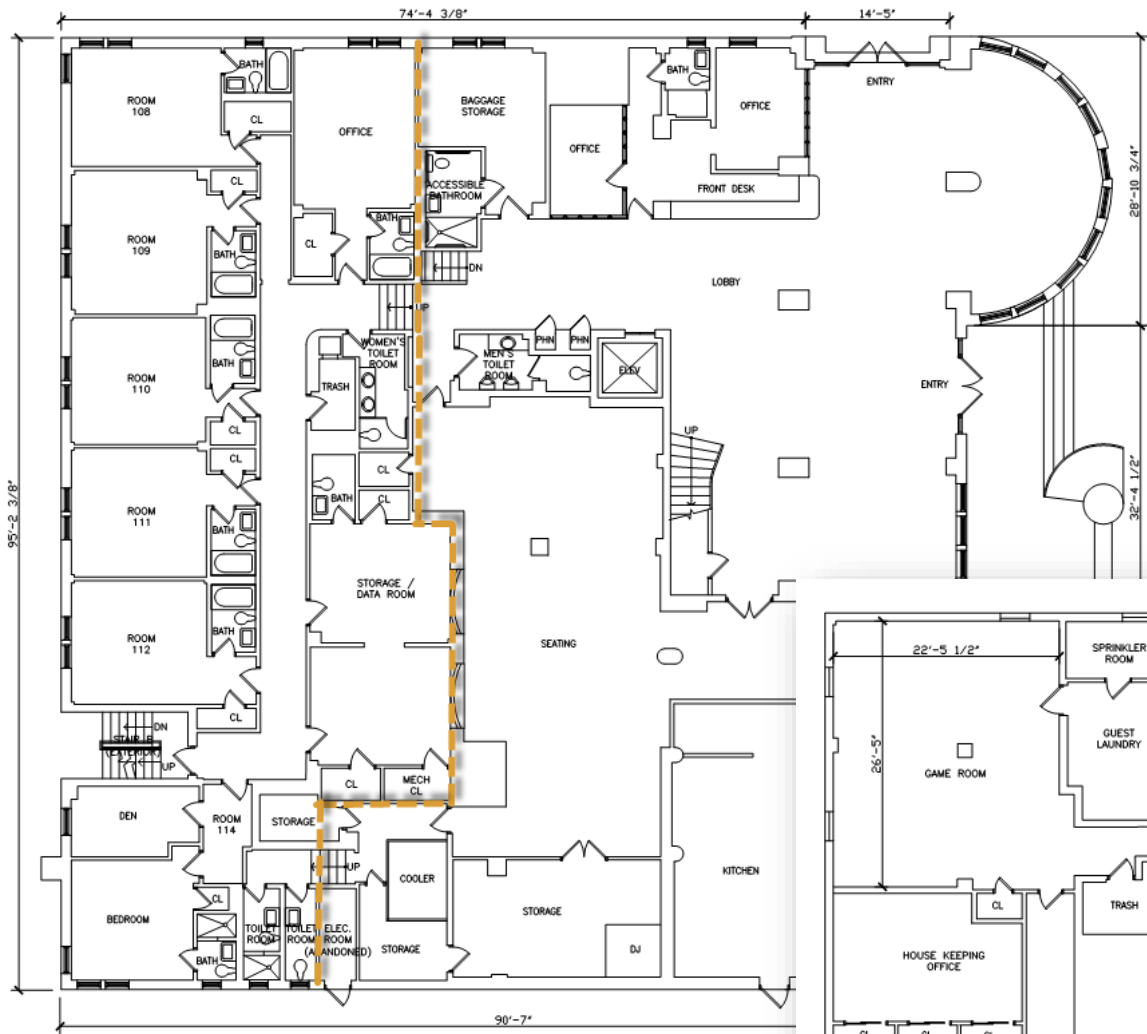
FIRST FLOOR / LOBBY LEVEL PLAN

The west portion of the lobby level is raised, coinciding with a half basement where service areas are located.

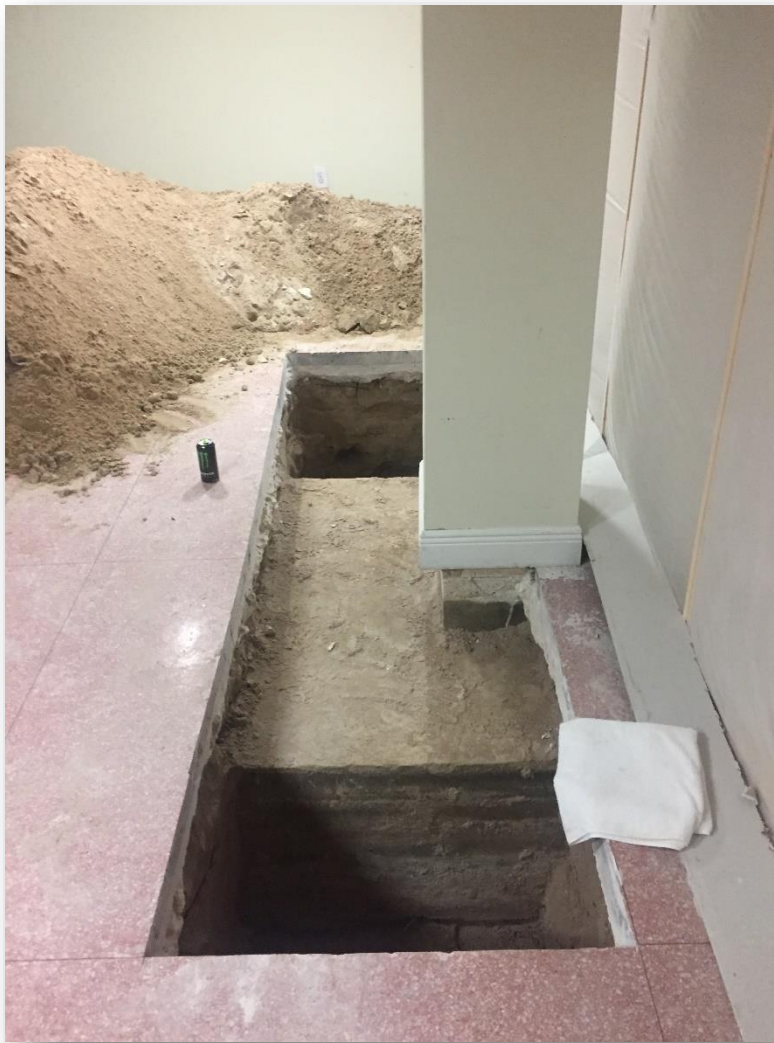
EXPLORATION OF EXISTING FOUNDATION
AT PARTIAL BASEMENT

In absence of reliable documentation, an exploratory demolition was performed to identify the following conditions:

1. The floor at the lobby area has a structural system similar to the elevated floors, with beams and ribbed slabs raised above the elevation of the pile caps defining a crawling space.
2. At the basement level, pile caps are poured directly below the slab on grade.

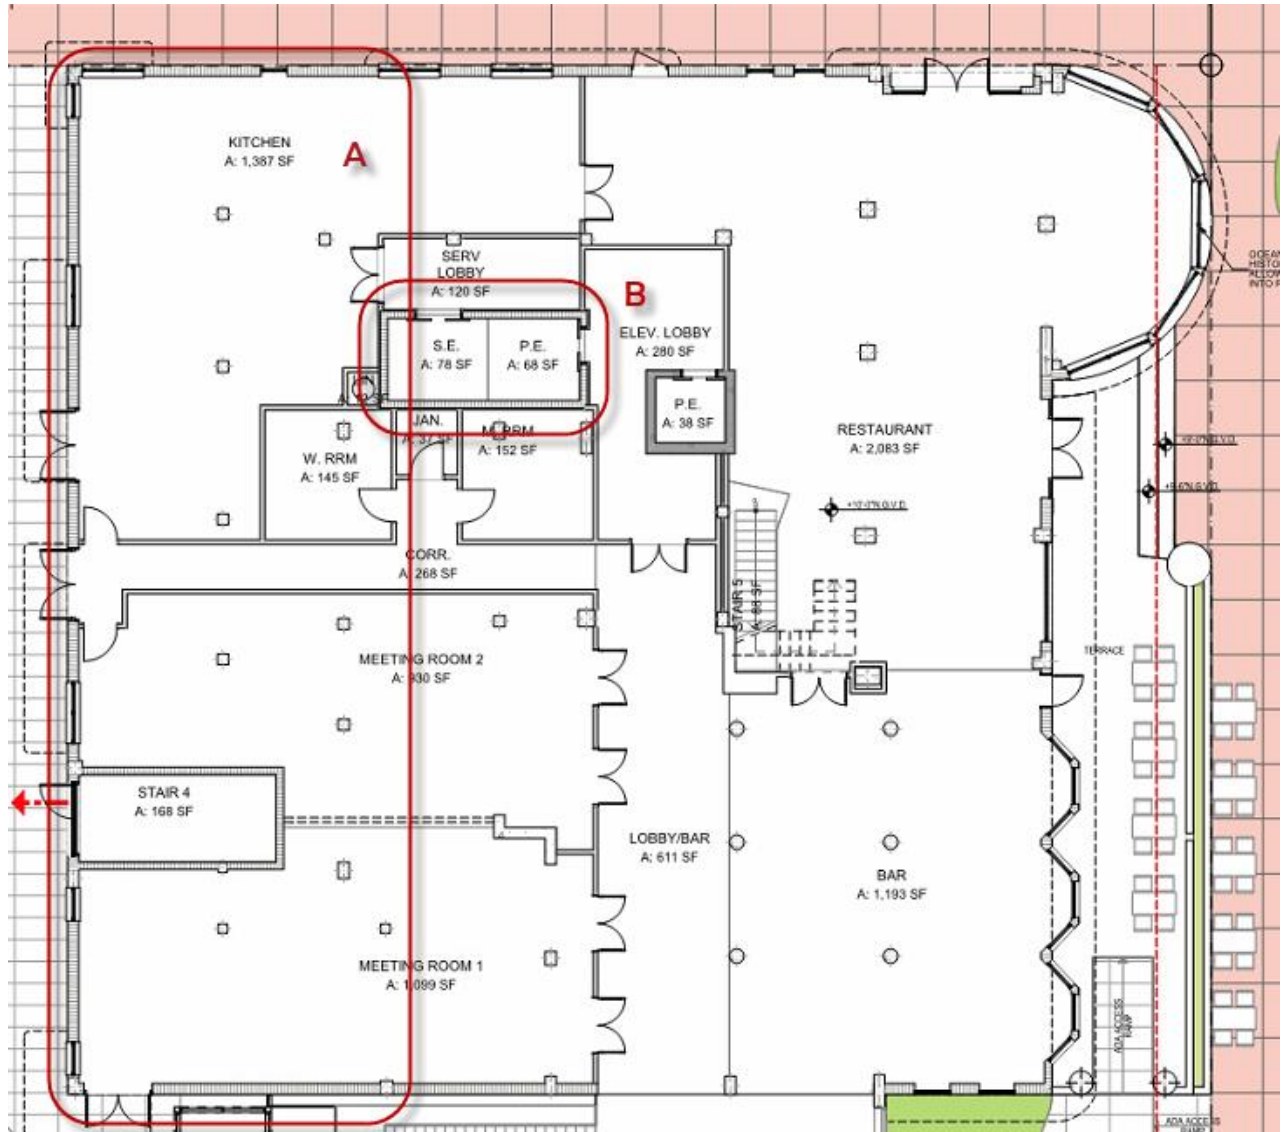
- A. Demolition of raised portion of lobby level and extension of slab at lobby elevation to the west edge of the building abandoning existing partial basement.
- B. Addition of a new passenger and service elevators to the NE of the existing one.
- C. Excavation and construction of an underground connection between the existing hotel and projected new service areas located to the west and outside of the footprint of the building.

A. Before the partial demolition of the raised, slab and columns will be strengthened by new concrete encasement as required by analysis taking into account their modified slenderness.

Retaining walls will also be evaluated and adequately retrofitted to consider the changed support configuration after the removal of the top boundary currently provided by the raised slab.

After strengthening provisions are implemented, demolition will be performed in steps by removing the ribbed slab panels first and framing beams afterwards.

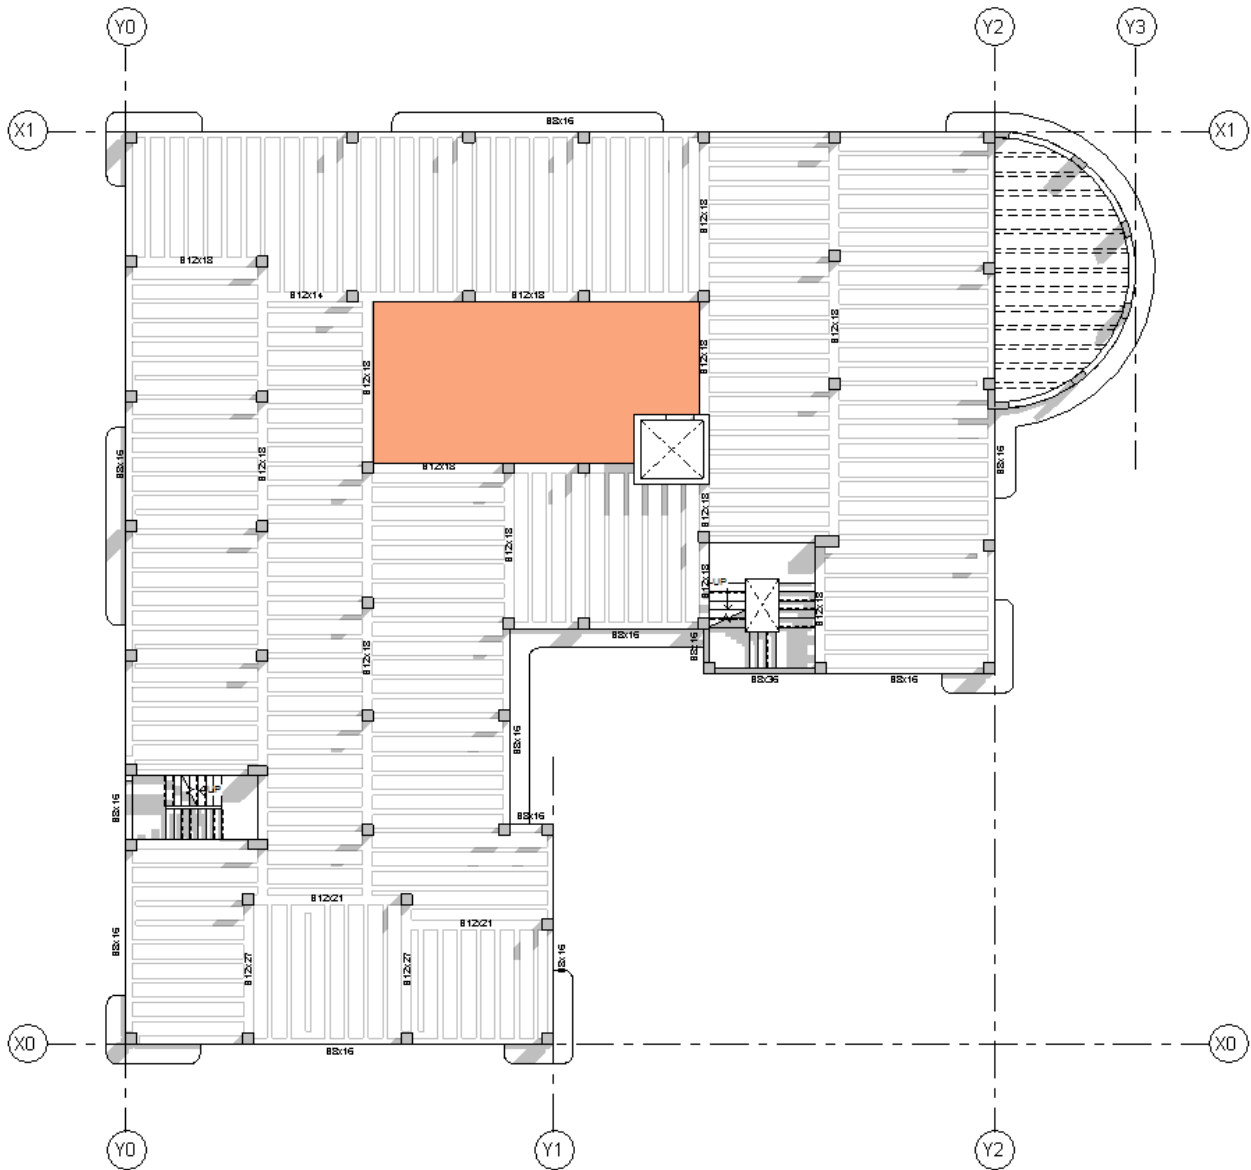
B. The location of the new elevator core has been proposed to cause the minimum possible impact to the existing structure, requiring only the removal of the ribbed system highlighted below throughout the building.

The removal of the above indicated area has no negative impact on the remaining beams, not requiring special shoring or strengthening provisions.

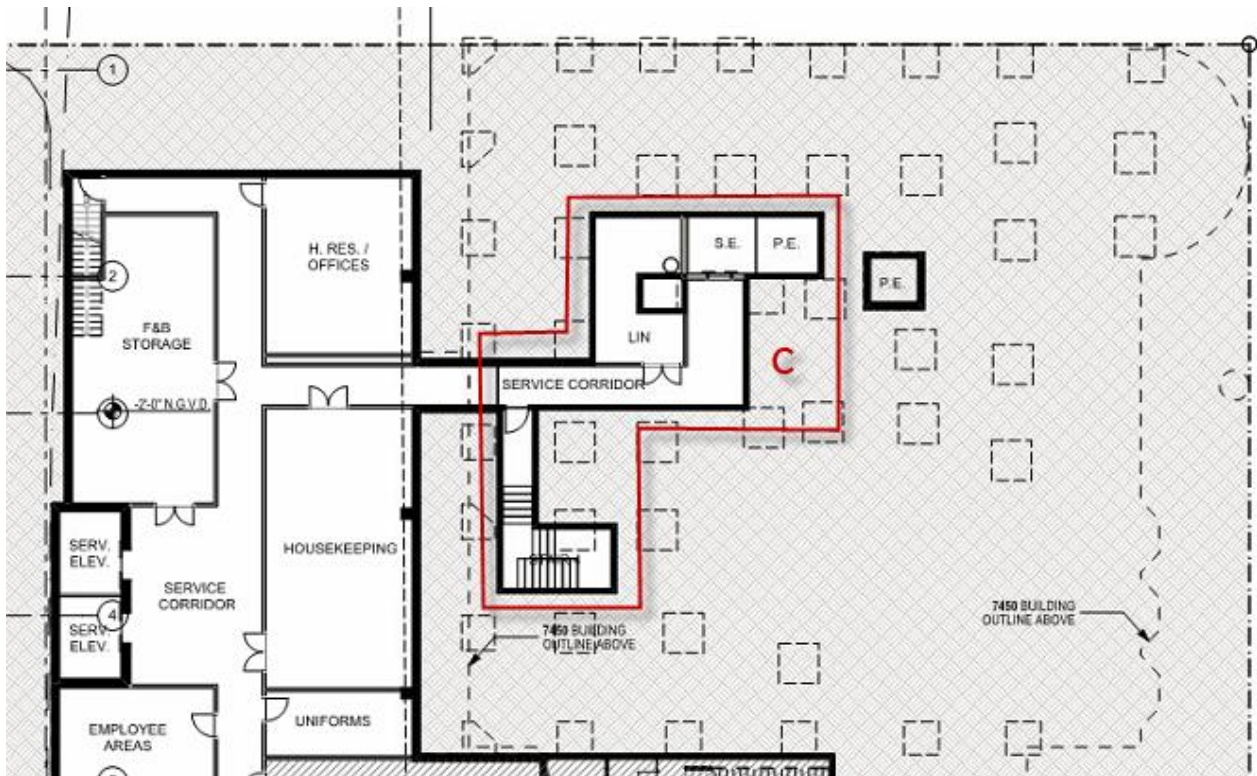
C. Finally, the underground connection between the hotel and the new service areas will require building a hydrostatic slab between the existing footings and at an elevation slightly below the bottom of the pile caps.

After having performed an accurate survey of the existing conditions, the final layout of the architectural intervention will be adjusted to work around the existing footings.

Pin piles will be driven to support the new slab and retaining walls designed to support hydrostatic loads. These new structural members will also be detailed and designed, connected to the existing adjacent pile caps, to confer the lateral stability that could otherwise be undermined by the removal of the excavated soil.
