As Palau is going through an emergency renovation, as such, we would like to address two major issues that create safety concerns.

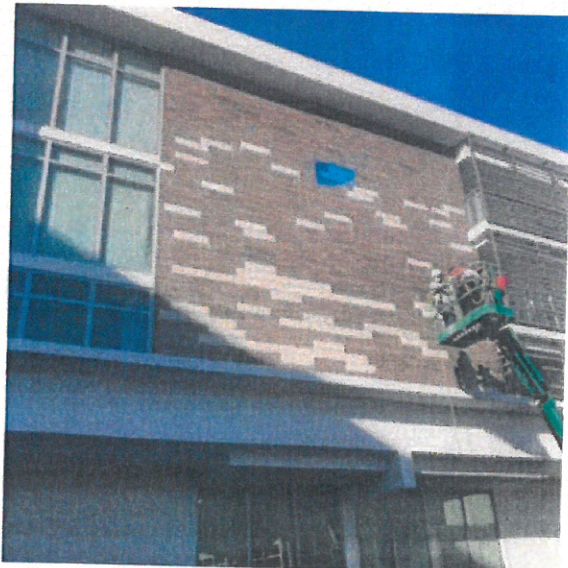
The picture on left: Repairs of a wall over an active parking lot on the south side of the building.

(1) **FAÇADE TILE CHANGE TO A SMOOTH DESIGNER CEMENT PLASTER (STUCCO):** We have been advised by our Engineer to replace all existing façade tiles due to safety and performance issue concerns. Where the original contractor installed the tiles with mortar over the cement plaster, the mortar has a surface showing many voids that do not meet industry standard requirements; as a result, the tiles have been buckling from the walls and delaminating from the substrate. This issue is a safety matter that the Association has been addressing on an "as needed" basis with emergency repairs as the buckling tiles are located over areas where pedestrians and automobiles pass. Our engineers confirmed that this situation would be ongoing due to the methods used to mount the tile and weather exposure. Due to the seriousness of this condition as a safety issue and the fact that we would like a permanent solution to avoid significant ongoing future expenses and injuries, we are proposing a more efficient remedy. Palau would like to replace the facade tiles with a smooth, concrete appearance, designer cement plaster with a fully integrated color. This solution will maintain the modern look and feel of the building, which is in line with similar classic treatments used throughout Miami Beach.

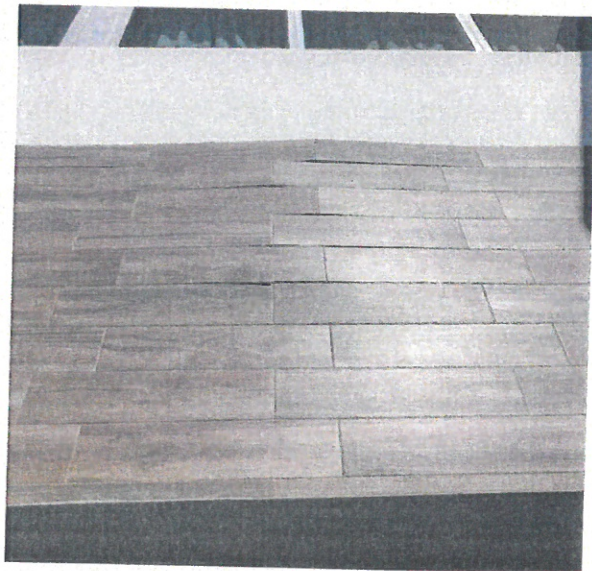
The picture on the right: Buckling of tiles over the busy garage entrance.

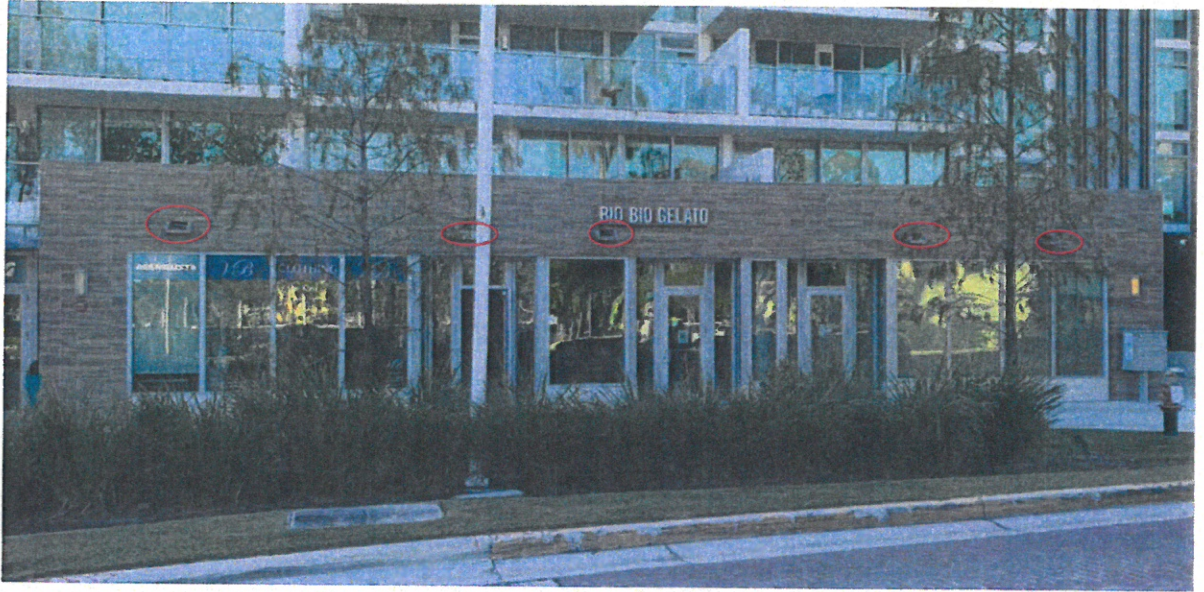
The picture above shows current scupper location

(2) **INSTALL ARCHITECTURAL GUTTERS OVER RETAIL:** We would like to install an architectural gutter over the retail units on the east side of Palau. Currently, five scuppers pour out water during rainfall, and every time a unit owner washes their balcony. The gutters sit above the retail units storefront, thus the water pours out on the shops' patrons and employees. We want to install painted aluminum gutters, which will be powder coated in a color that will match the adjacent painted stucco closely. There are two existing storm drains that will drain the water.
