BOUNDARY SURVEY  
of  
1688 MERIDIAN AVENUE, MIAMI BEACH,  
MIAMI-DADE COUNTY, FLORIDA 33139  
for  
IVY REALTY SERVICES & SHULMAN & ASSOCIATES

# LOCATION PLAN

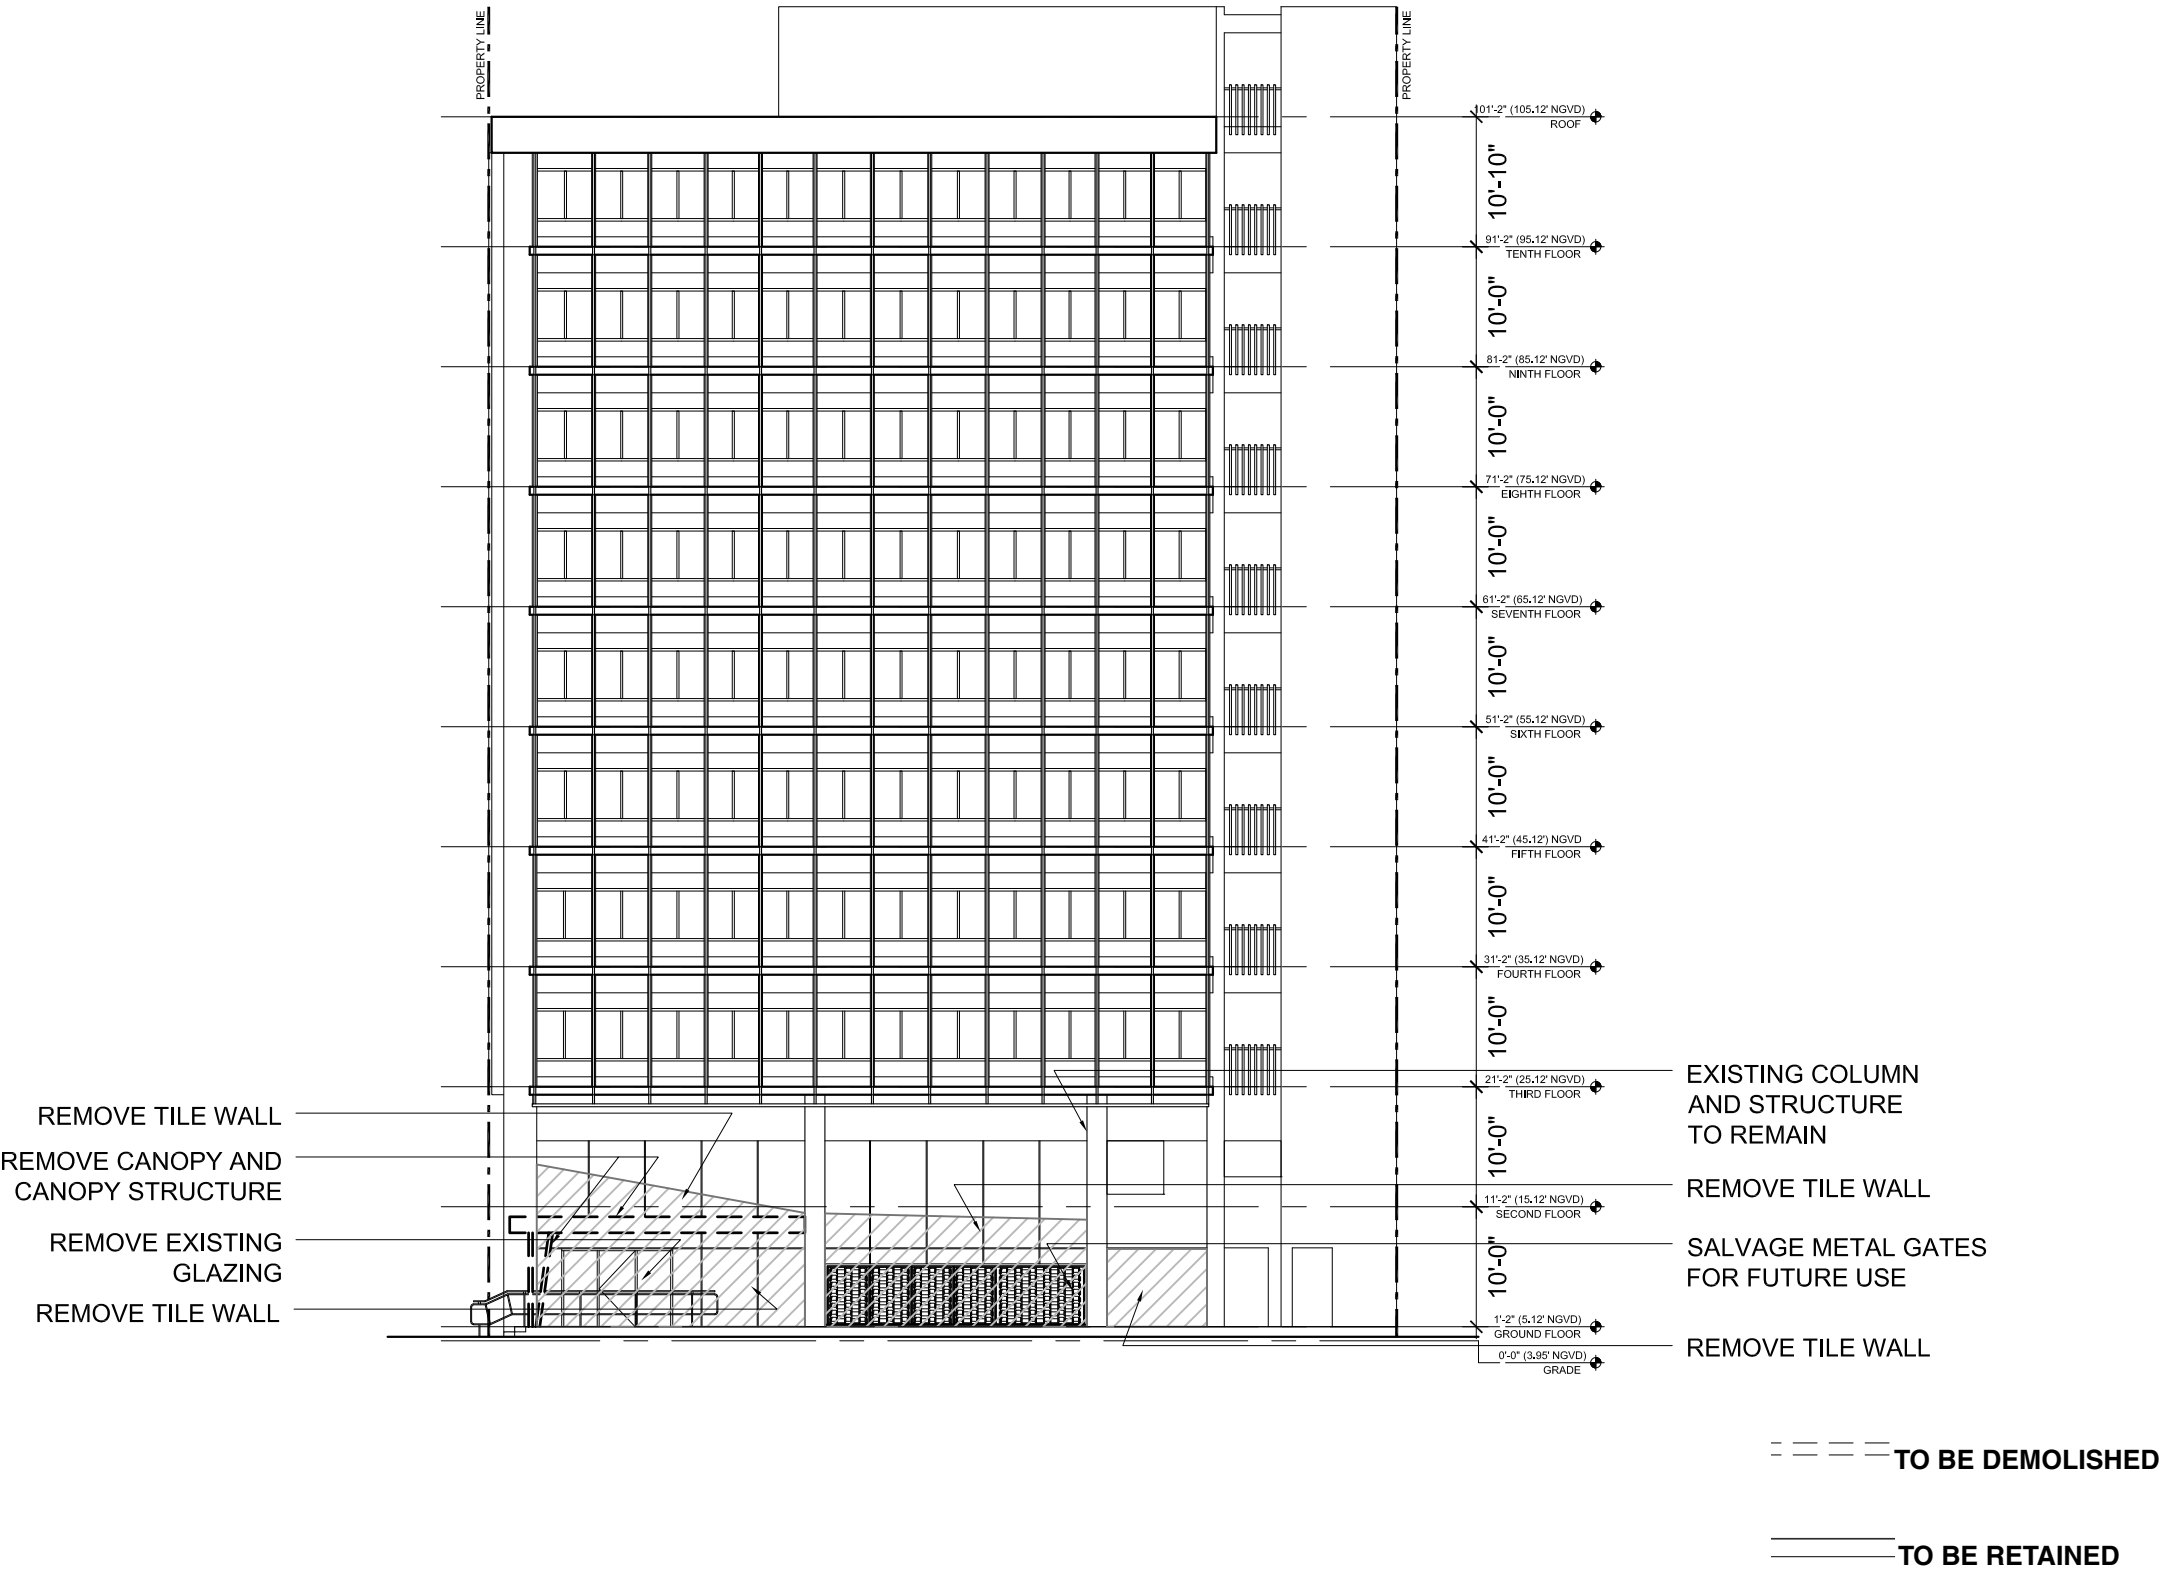
D-2.03

# DEMOLITION WEST ELEVATION
