Historic Property Resource Report – 2901-11 Indian Creek Drive.

### 2901-2911 INDIAN CREEK DRIVE HISTORIC BACKGROUND

STRUCTURAL CONDITION ASSESSMENT 2901 Indian Creek Miami Beach, Florida

STRUCTURAL CONDITION ASSESSMENT for 2901 Indian Creek Miami Beach, Florida

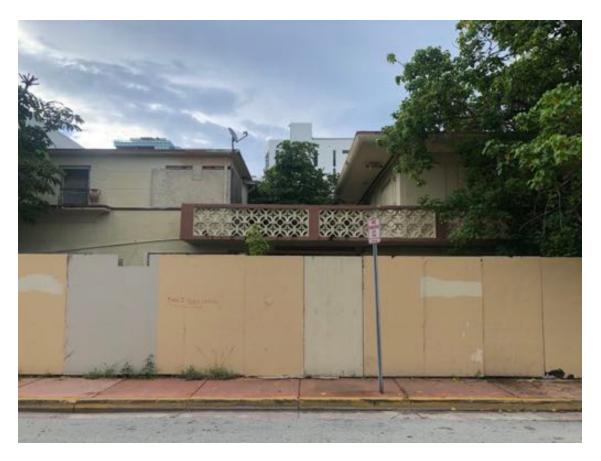
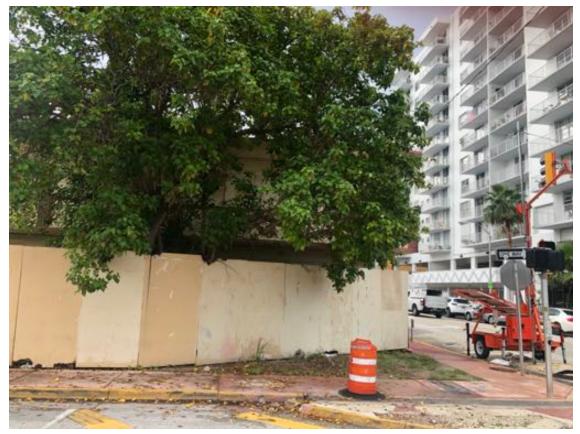
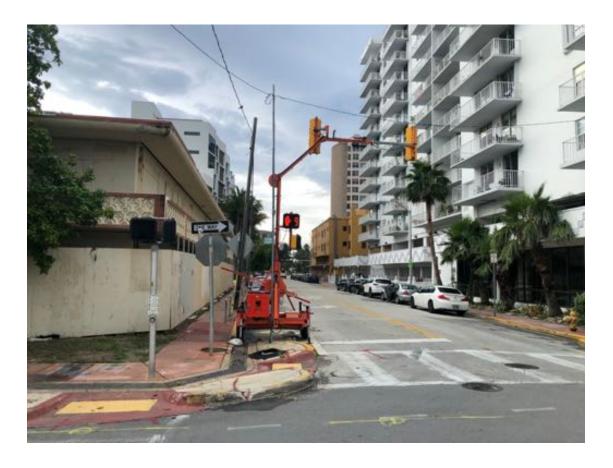
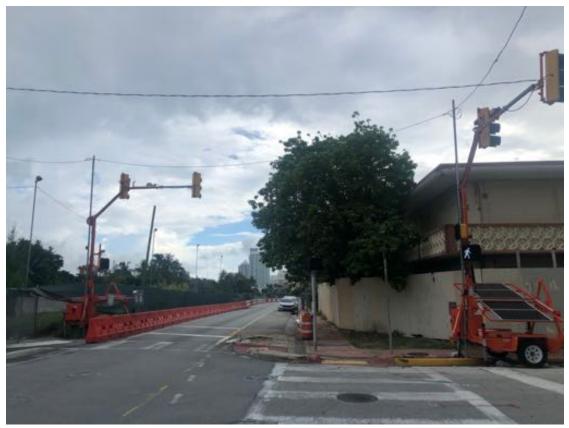
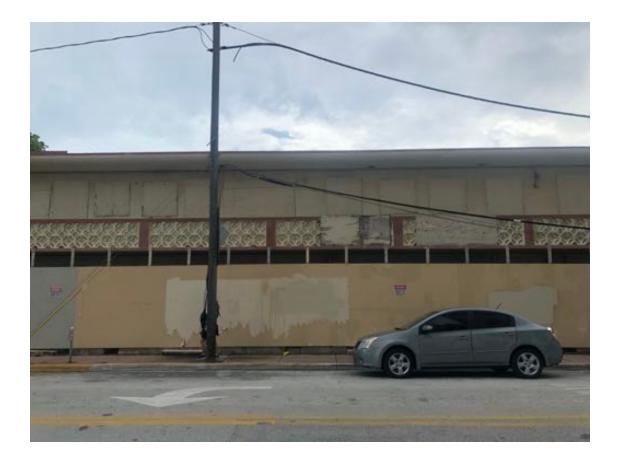
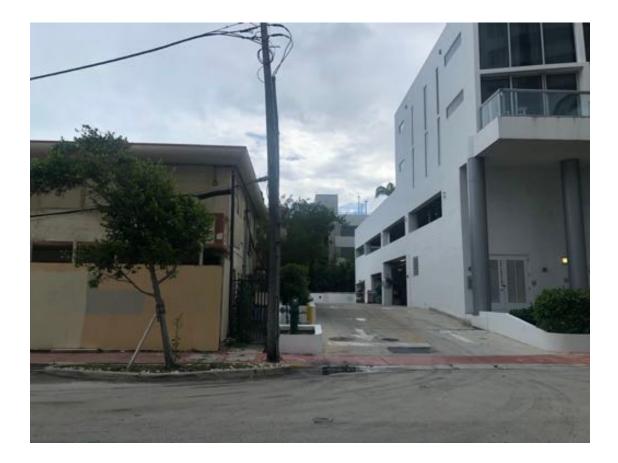
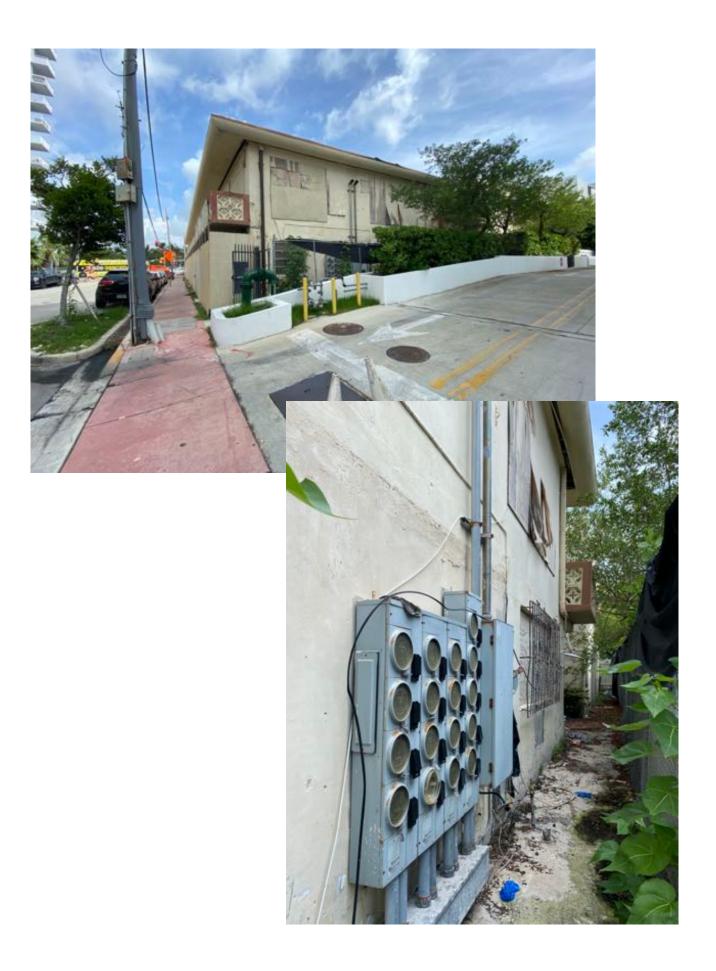
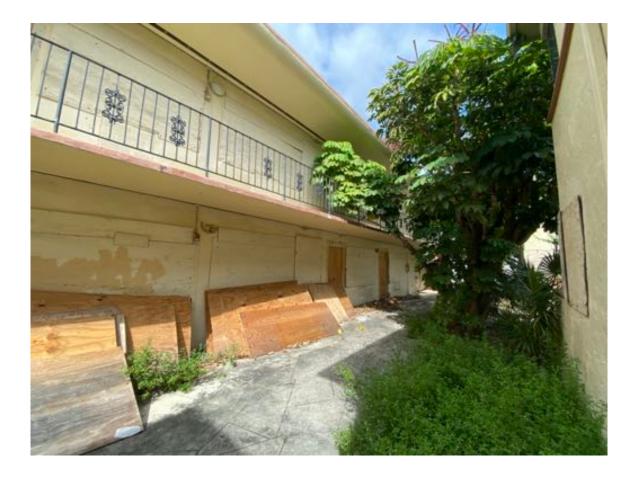
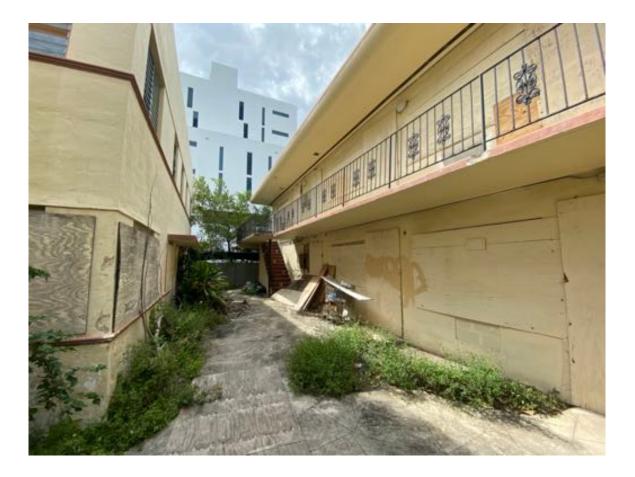
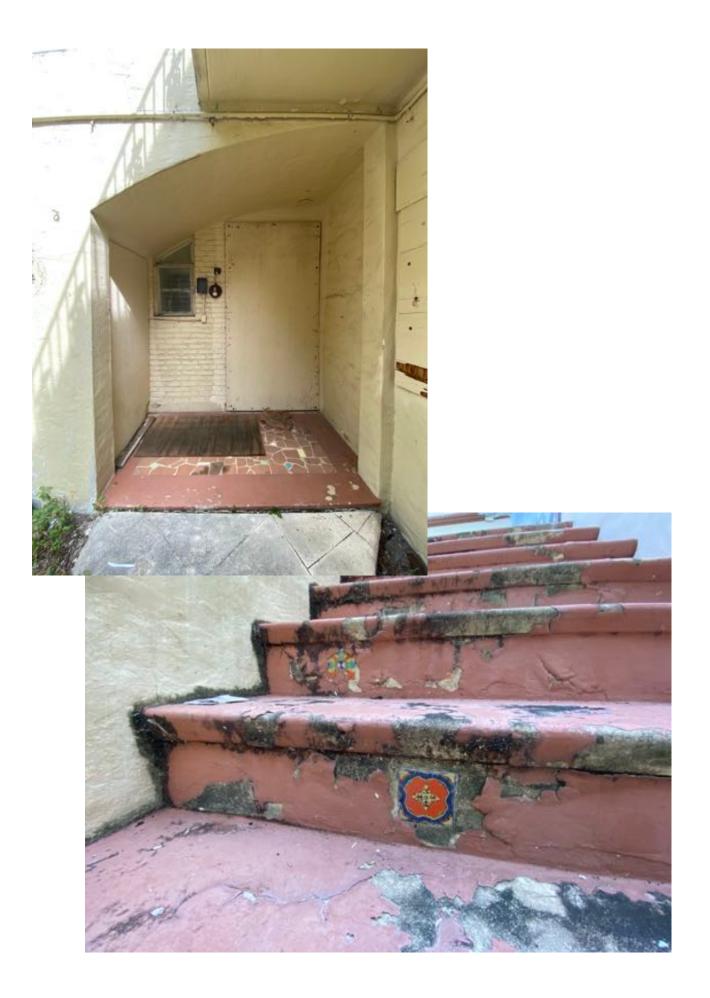
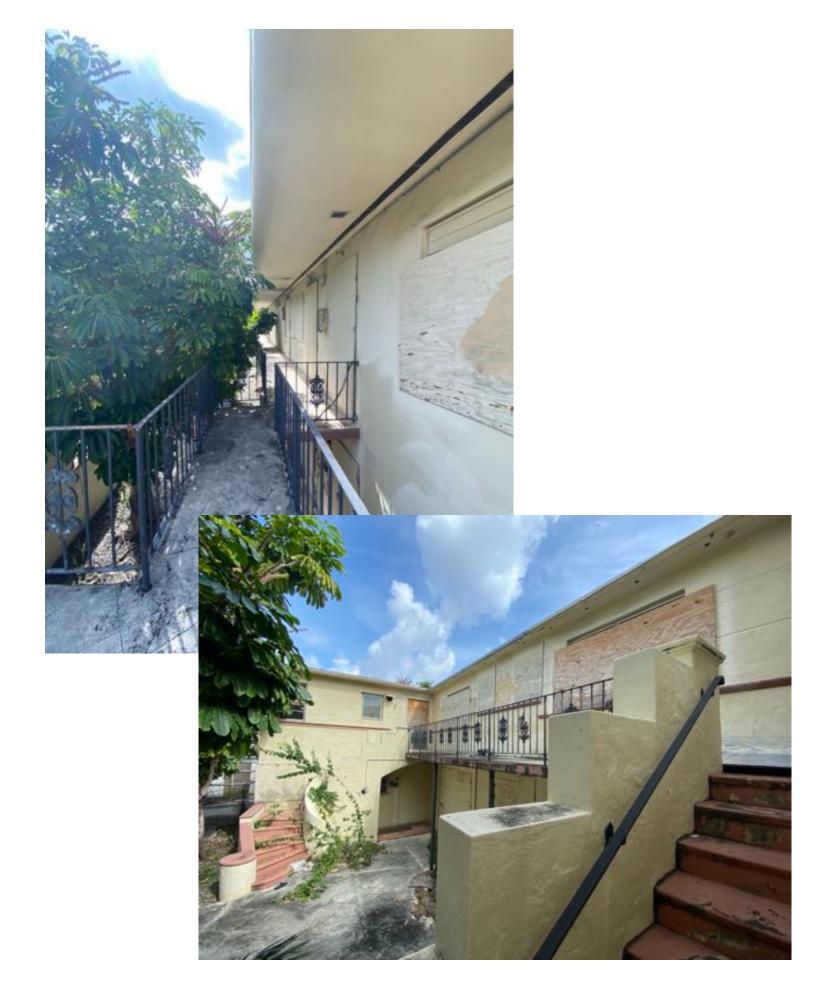
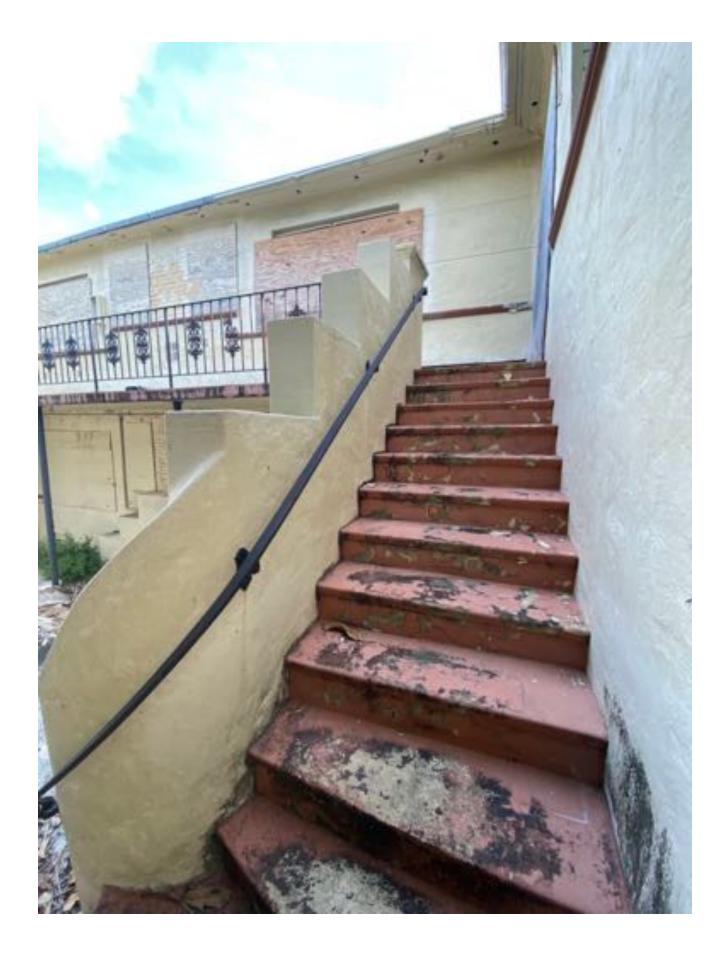
### 2020 Photos

The condition of the subject property and its environs have changed. Those changes are reflected in the photographs on this and following pages.

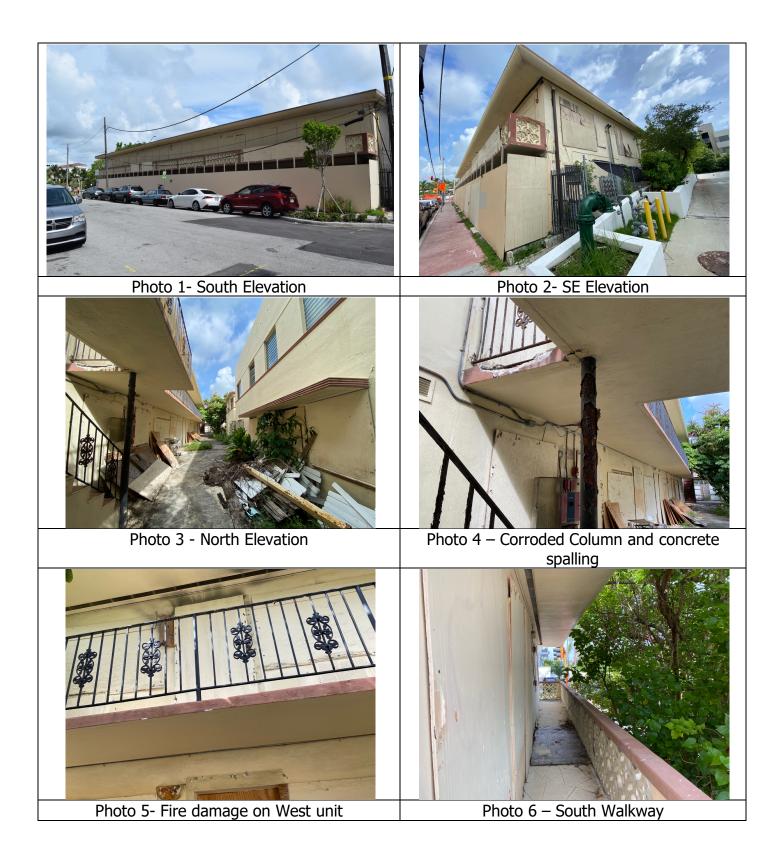
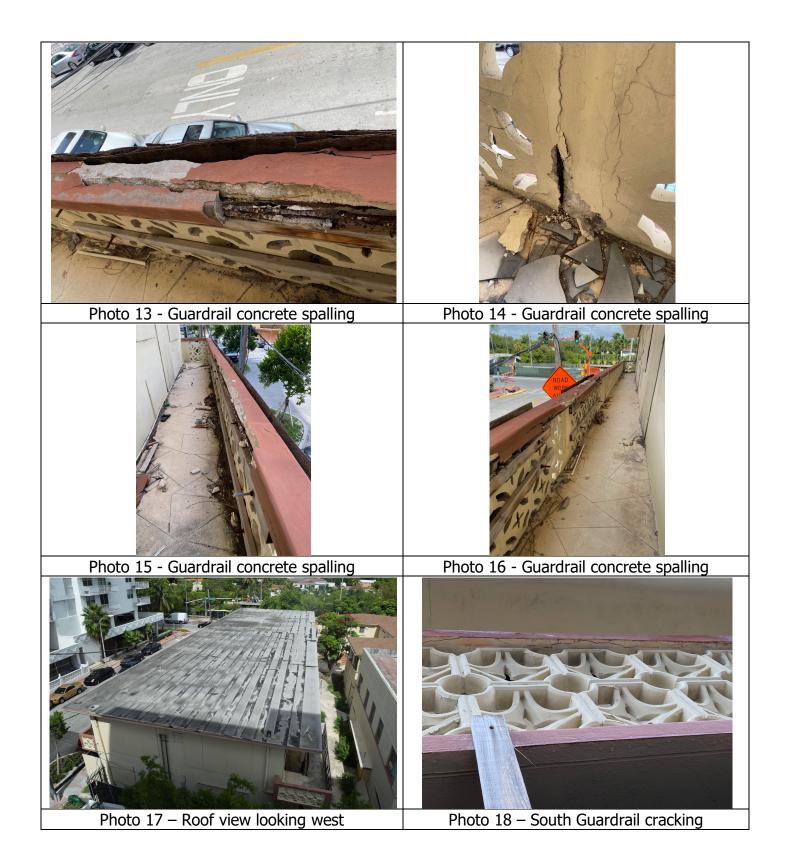
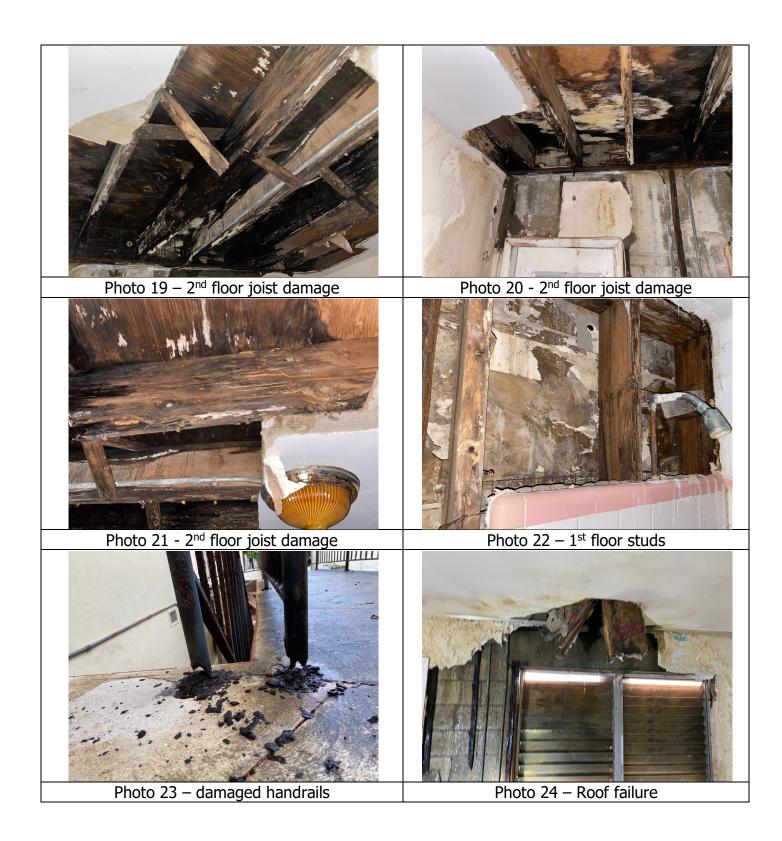
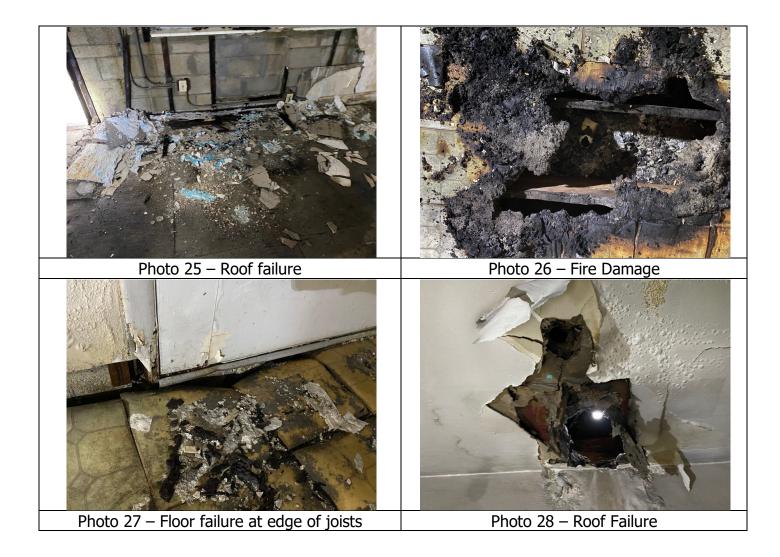
PHOTOS

Concrete members; which are the tie columns, tie beams, exterior stairs, and foundations have variable levels of deterioration. Some columns and beams exhibit concrete spalling, cracking, and deterioration (please see photos). The exterior concrete walkways on the second floor (South elevation), and their associated concrete stairs do exhibit extensive concrete deterioration, spalling, and cracking.

Wood members; The roof of the structure has failed in multiple locations, and the moisture intrusion had caused severe and extensive damage to all the wood members of the building (please see photos). There is moisture damage (rot) of wood, that has caused wood members to deflect, sag, fail, and total collapse. The wood members collapse in the building had created hazardous conditions within the building. The fact that the building had been vacant for some time now, and the moisture intrusion from the roof, door, and window openings had created an atmosphere for the wood to deteriorate severely.

Photo 7 – Guardrail concrete spalling	Photo 8 - Guardrail concrete spalling
Photo 9 - Guardrail concrete spalling	Photo 10 - Guardrail concrete cracking
Photo 11 - South Elevation, walkway slab	Photo 12 - South Elevation, walkway concrete
concrete spalling	spalling

Based on the site observations of the conditions of structural members of the building, and level III alteration required by the Florida Building Code, the structural members of this building need to be replaced rather than repaired. Hence, in order to do so, these structural members need to be demolished. APPENDIX A

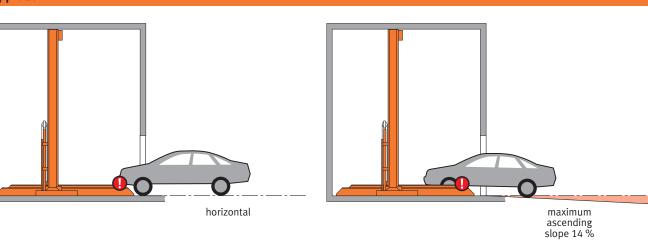
### Approach

The illustrated maximum approach angles must not be exceeded. Incorrect approach angles will cause serious maneouvring & positioning problems on the parking system for which the local agency of Klaus accepts no responsibility.

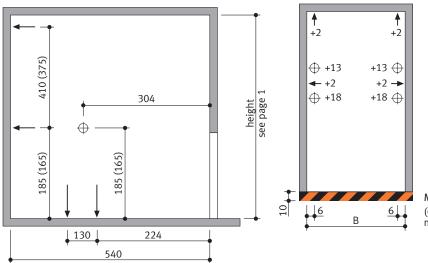
### Load plan

Forces in kN

Markings compliant to ISO 3864 (Colors used in this illustration are not ISO 3864 compliant)

Units are dowelled to the floor. Drilling depth: approx. 15 cm. Floor and walls are to be made of concrete (quality minimum C20/25)!

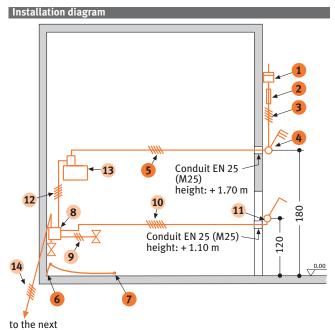
**Electrical installation**

Electrical data (te	o be performed by the	customer)
No. Qunatity	Description	Position

110.	Quinatity	Description	1031001	inequency
1	1	Electricity meter	in the supply line	
2	1	Main fuse: 3 x fuse 16 A (slow) or circuit breaker 3 x 16 A (trigger characteristic K or C)	in the supply line	1 per unit
3	1	Supply line 5 x 2.5 mm <sup>2</sup> (3 PH + N + PE) with marked wire and protective conductor	to main switch	1 per unit
4	1	Lockable main switch	defined at the plan evaluation	1 per unit
5	1	Supply line 5 x 2.5 mm <sup>2</sup> (3 PH + N + PE) with marked wire and protective conductor	from main switch to unit	1 per unit
6	every 10 m	Foundation earth connector	corner pit floor	
7	1	Equipotential bonding in accordance with DIN EN 60204 from foundation earth connector to the system		1 per system
