Shore Club Memorandum Re: Corner Glazing at Front Façade April 6, 2022 Prepared by Heritage Architectural Associates

This document was prepared in response to the comments made at the Historic Preservation Board (HPB) hearing on March 8, 2022 regarding the corner glazing at the Shore Club front façade. HPB member Kirk Pascal commented that the glazing formerly located at the corner windows within the vertical eyebrow was distinctive. He referred to it as "Flutex" glass. He speculated that this glazing was removed during the 1999-2001 renovation.

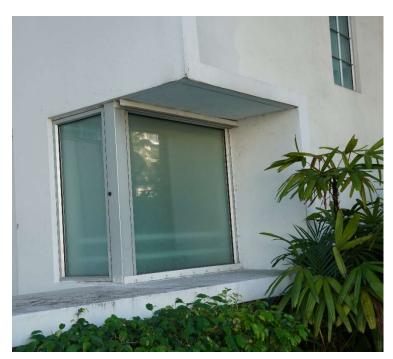
Five windows are located adjacent a staircase at the north corner of the westernmost plane of the front façade. The windows are recessed, and an undulating vertical eyebrow winds around the window openings. In addition to the location at the corner of the façade, each window has a corner within the recessed opening.

Figure 1. Detail of existing corner windows,

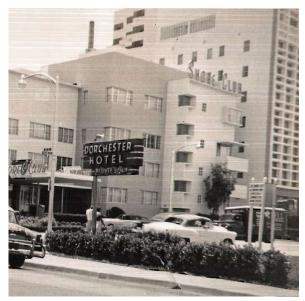
Historic photographs from the 1950s were examined. In addition, Debbie Tackett, Historic Preservation Officer for the City of Miami Beach, provided a color photograph of the Shore Club that was taken in 1989. Based upon review of this historic photographic documentation, it was determined that the type of glazing at the corner windows appeared to have a vertical ribbed pattern. In addition, it was determined that the current metal muntins appear to be wider than the original muntins.

Figure 3. View of corner windows at Shore Club, c. 1951.

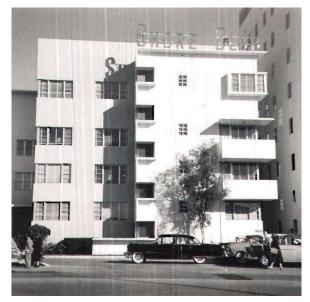
Figure 5. View of corner windows at Shore Club, c. 1956.

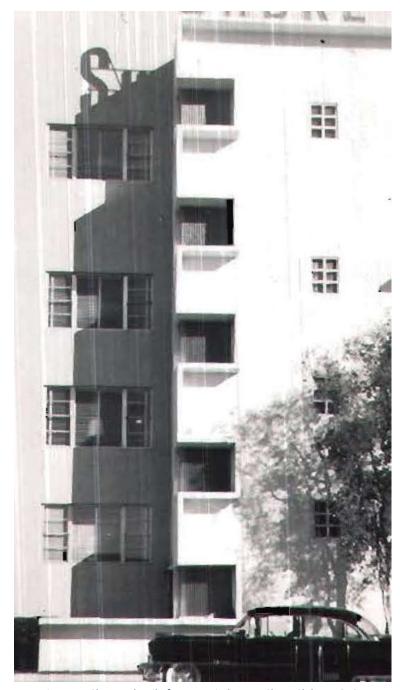
Figure 7. Closeup detail of corner windows at Shore Club, c. 1956.

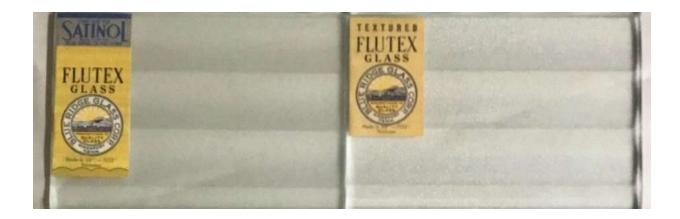
Figure 9. Samples of Flutex Glass in polished and Satinol finishes, date unknown.

Based upon the above referenced historic photographic documentation, research was conducted regarding Flutex glass. It was determined that this type of glass was in use in 1949. Flutex glass was manufactured by the Blue Ridge Glass Corporation and was marketed by Libbey-Owens-Ford Glass Company of Toledo, Ohio. Flutex was available with a ground and polished surface or a "Satinol" surface, which appears to have had a milky appearance.

It is our recommendation that the glazing located at the corner windows within the vertical eyebrow be restored to the era of significance based upon historic photographic documentation. The design intent is to replicate the appearance of the historic glass in this location. The product identified below, or another similar product, should be utilized in this location. Due to contemporary code requirements, glazing assemblies utilized must have a Notice of Acceptance from Miami-Dade County. Additionally, the metal muntins should be narrower than the existing to more closely match the historic appearance of the windows.

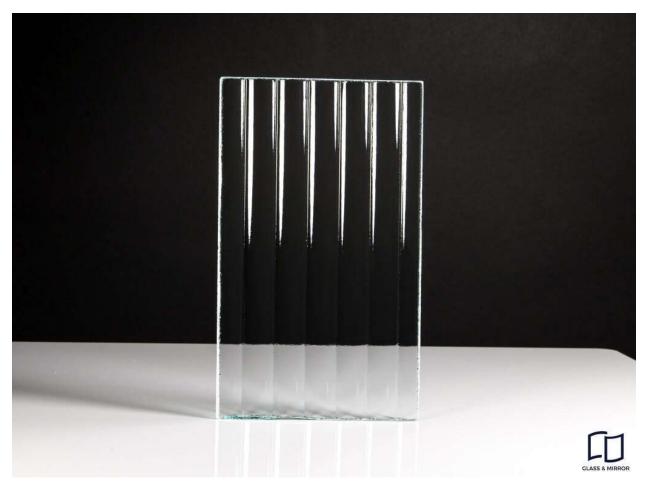
Product: Morue Flutex (3/4) https://glassupply.com/shop/morue-flutex-3-4/

Figure 10. Example of product similar to historic glass at corner windows.
