HPB23-0580

7410 Collins

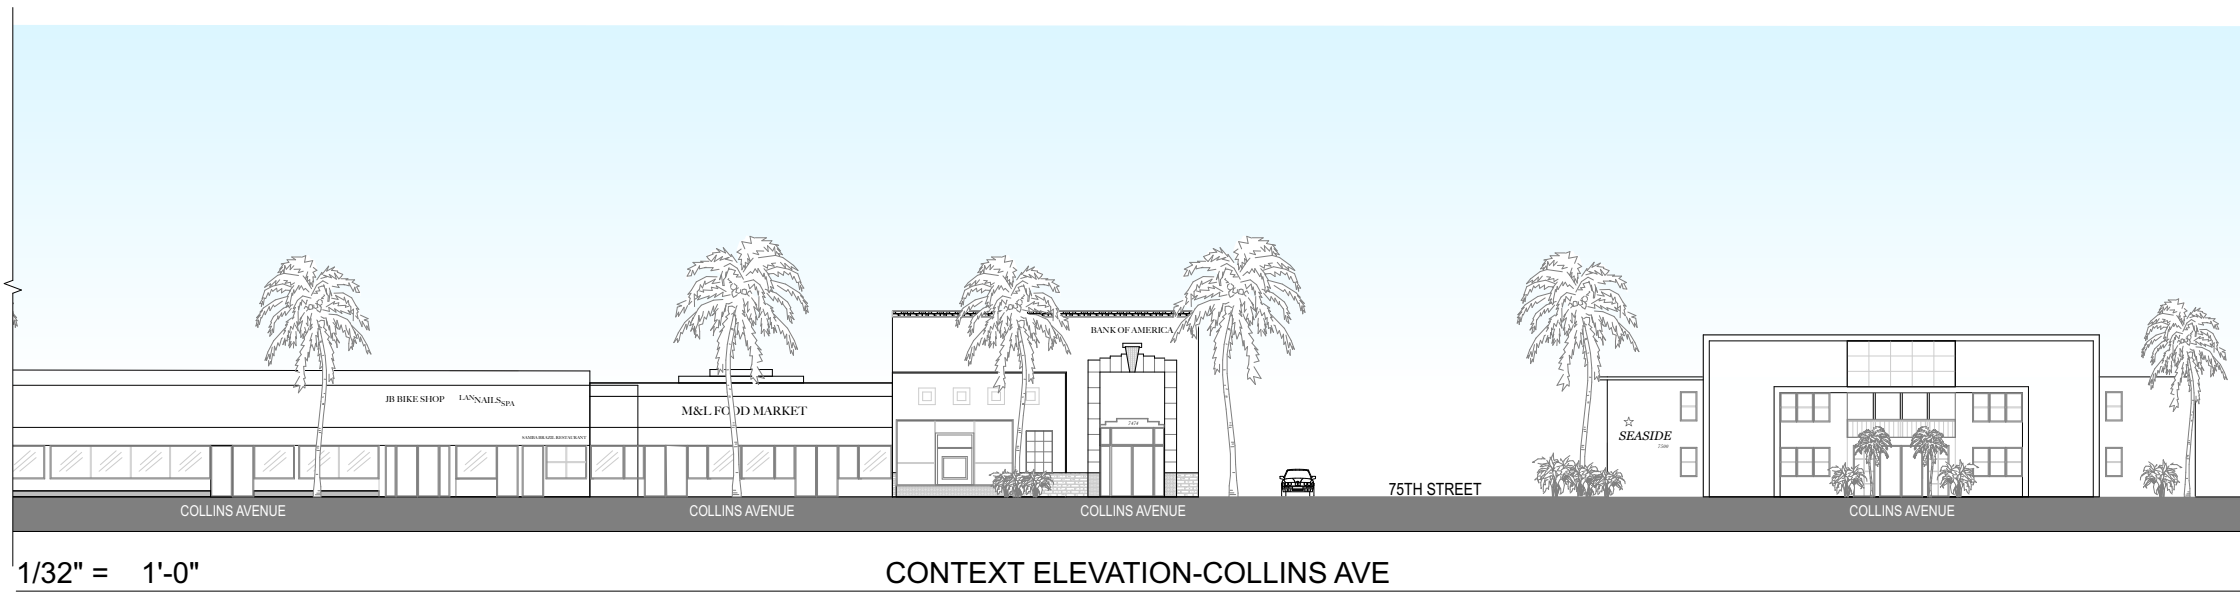
2

CONTEXT ELEVATION-COLLINS AVE

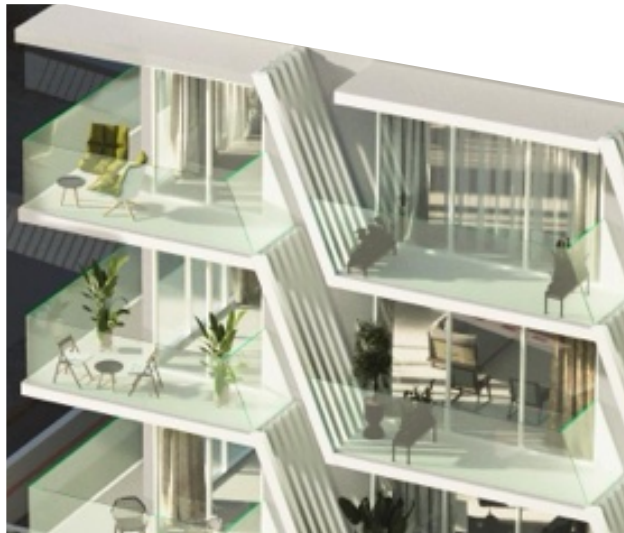
1/8" = 1'-0" BALCONY DETAIL

12 SLANTED ALUMINUM BALCONY LOUVERS

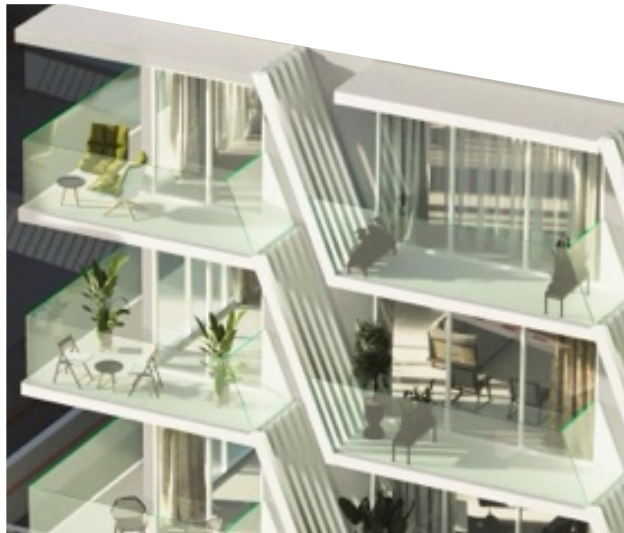
1/8" = 1'-0" BALCONY DETAIL

12 SLANTED ALUMINUM BALCONY LOUVERS
