Pedestrian-Bicycle-Micromobility Alleyways

Feasibility Analysis For:

Alton Court

Meridian Court

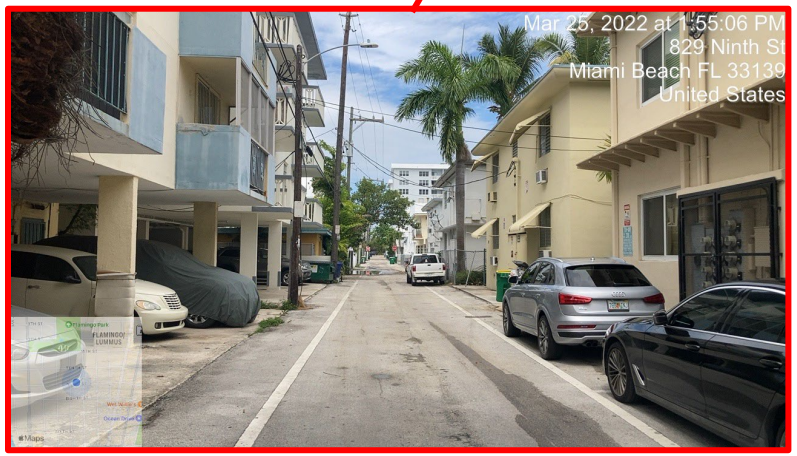
- Entrance is from Meridian Avenue through the South Shore Community Center parking lot which is the future site for Fire Station # 1
- Alley effective width is 12' so there is little to no room for a pedestrian or bicyclist to navigate around any large truck servicing the alley, including garbage trucks
- Little to no commercial activity which significantly reduces heavy vehicle traffic; however, many of the multi-family buildings have parking accessible only through the alley
