# Arborist Report

12 Star Island Drive  
Miami Beach

4/5/2019

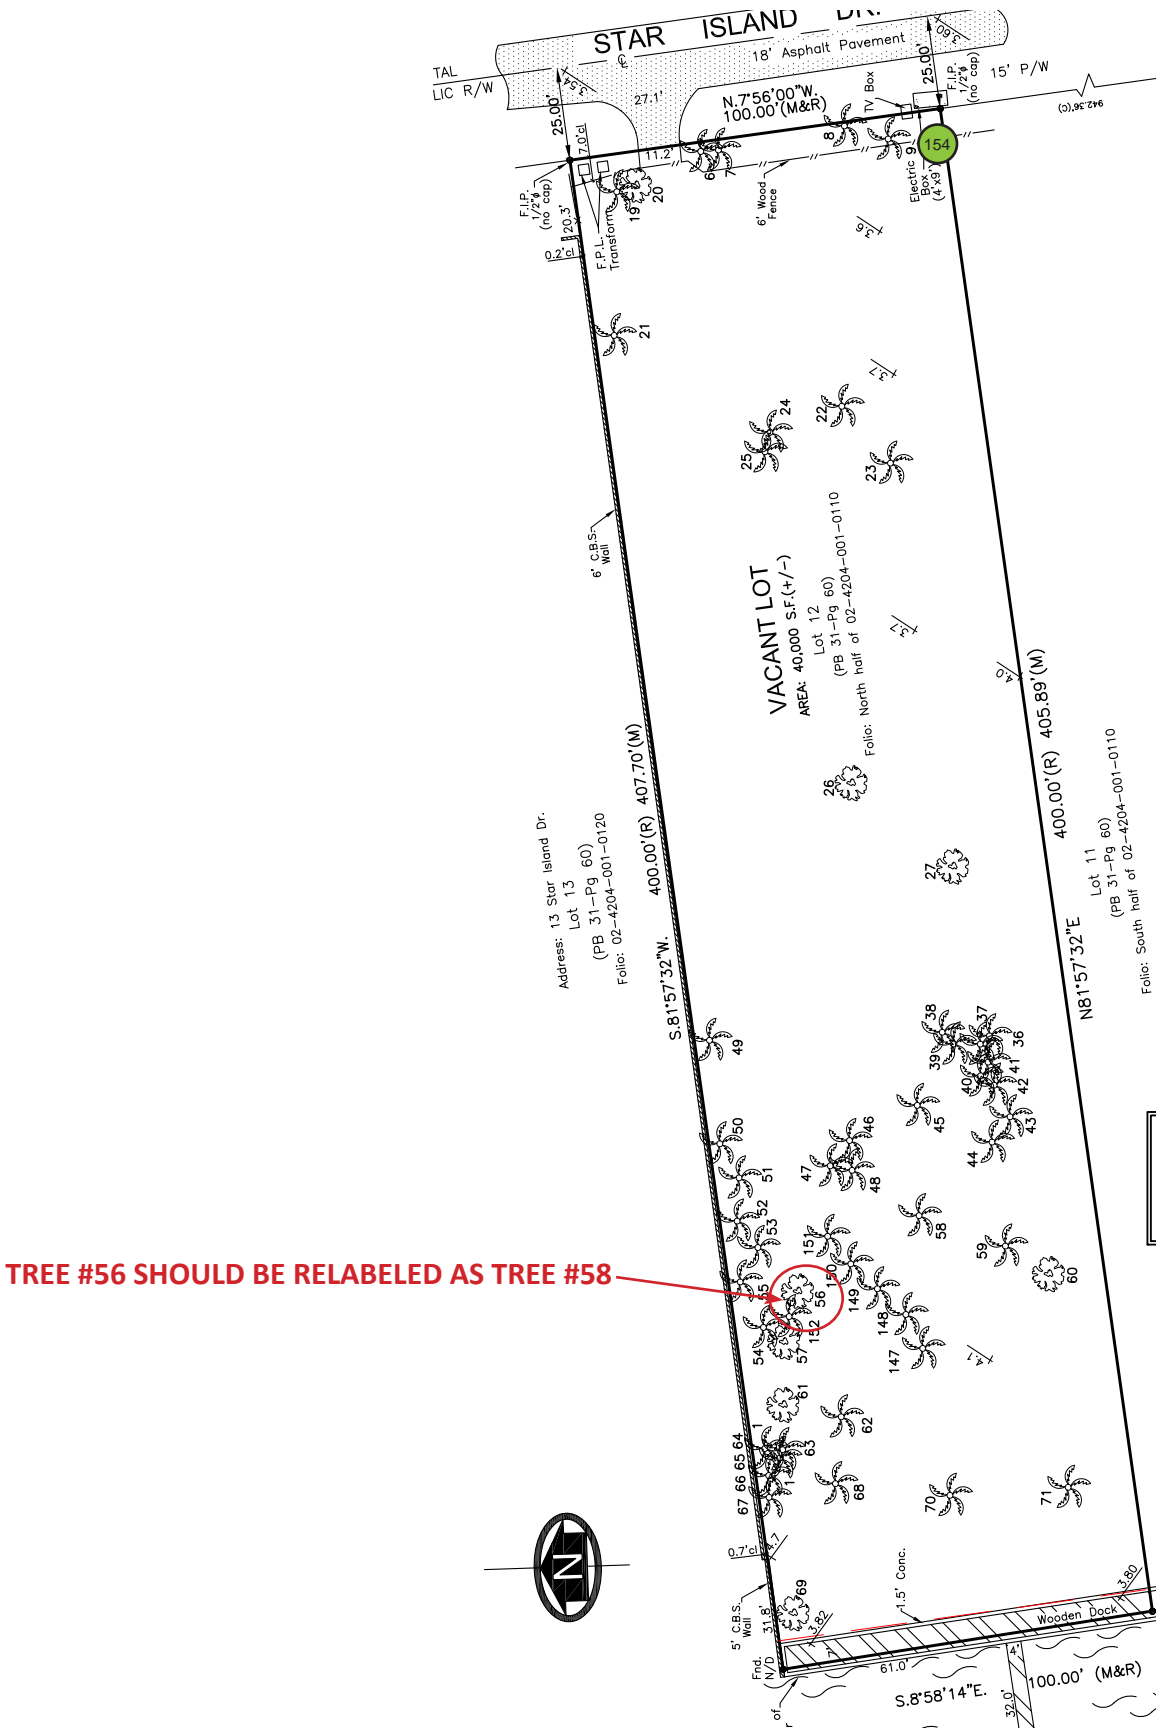
# Additional Existing Hardwood Tree

Tree #154 is a small Live Oak located at the front of the property. It is in good condition with a full, green canopy. Some of the lower branches can be removed and thinned to improve the tree's appearance. This tree's location is approximated in the diagram on the following page.
