RE: Certified Arborist Tree Risk and Viability Assessment
425-435 E Rivo Alto Drive, Miami Beach
NLE Project No. 15519001

PHOTO LOG

RE: Proposal for Certified Arborist Assessment and Tree Permitting Services
425-435 E Rivo Alto Drive, Miami Beach
NLE Project No. 15519001

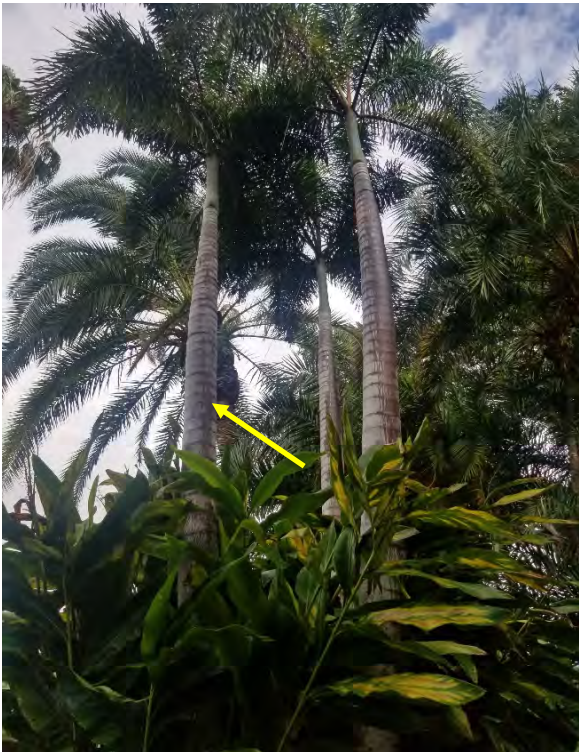
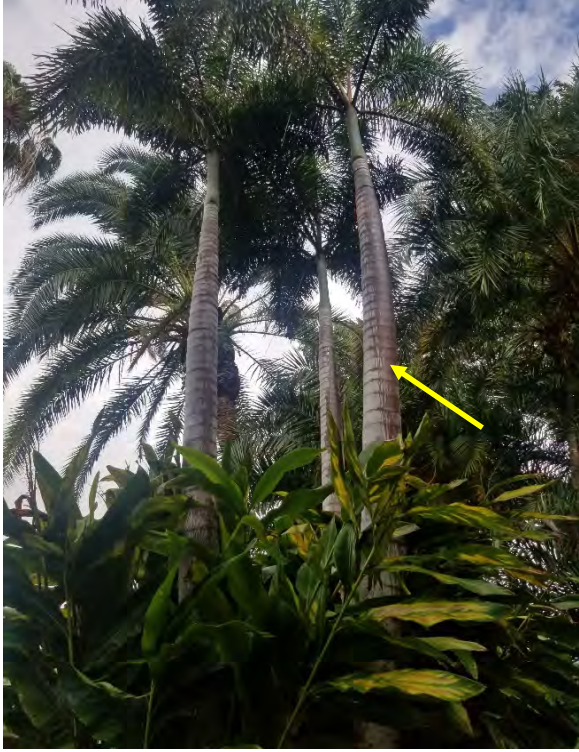
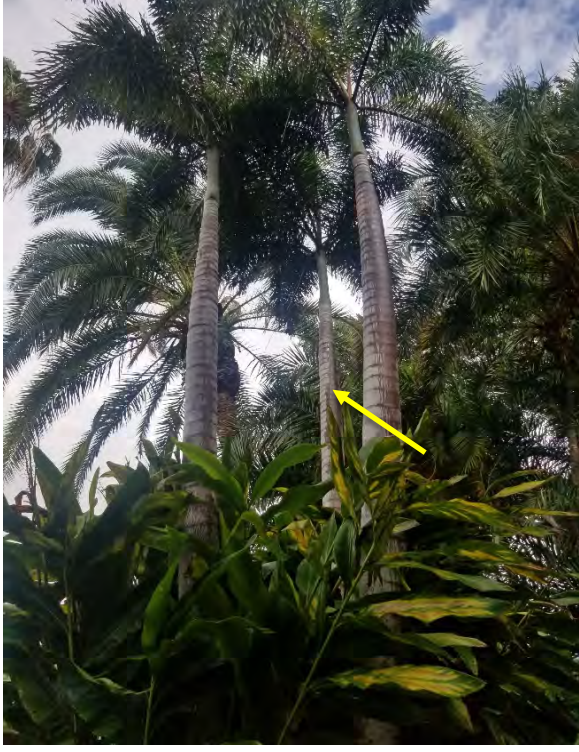
<p>Tree 1A foxtail palm (Wodyetia bifurcata) 10 inch DBH, Good condition 20 foot height, 10 foot spread</p>	<p>Tree 1B foxtail palm (Wodyetia bifurcata) 10 inch DBH Good condition 20 foot height, 10 foot spread</p>	<p>Tree 1C foxtail palm (Wodyetia bifurcata) 10 inch DBH Good condition 20 foot height, 10 foot spread</p>

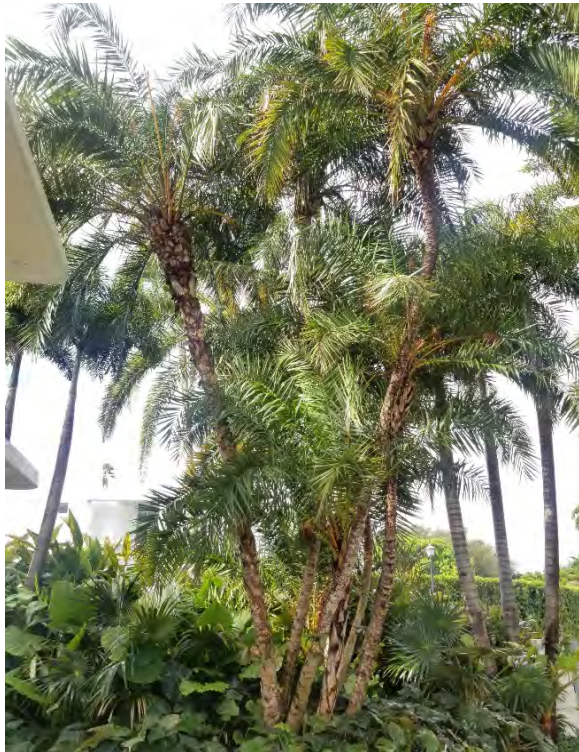
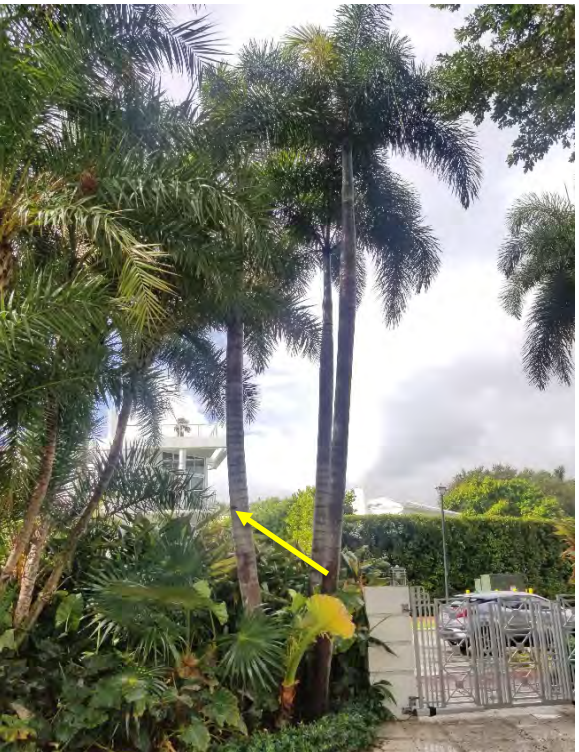
<p>Tree 2 Senegal date palm (Phoenix reclinata) cluster, Good condition 25 foot height, 20 foot spread</p>	<p>Tree 3A foxtail palm (Wodyetia bifurcata) 10 inch DBH Good condition 20 foot height, 10 foot spread</p>	<p>Tree 3B foxtail palm (Wodyetia bifurcata) 10 inch DBH Good condition 20 foot height, 10 foot spread</p>

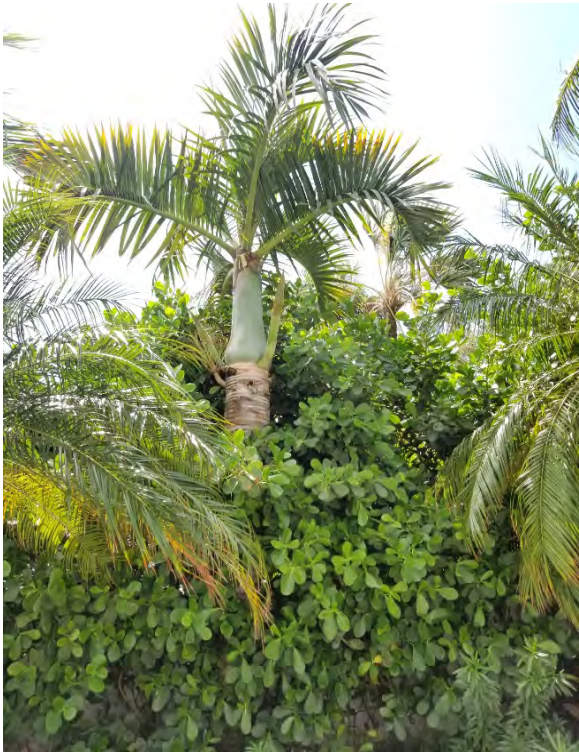
<p>Tree 48 spindle palm (<i>Hyophorbe verschaffeltii</i>) 11 inch DBH, Good condition 14 foot height, 9 foot spread</p>	<p>Tree 49 coconut palm (<i>Cocos nucifera</i>) 11 inch DBH Good condition 20 foot height, 20 foot spread</p>	<p>Tree 50 pygmy date palm (<i>Phoenix roebelinii</i>) cluster inch DBH Good condition 8 foot height, 10 foot spread</p>

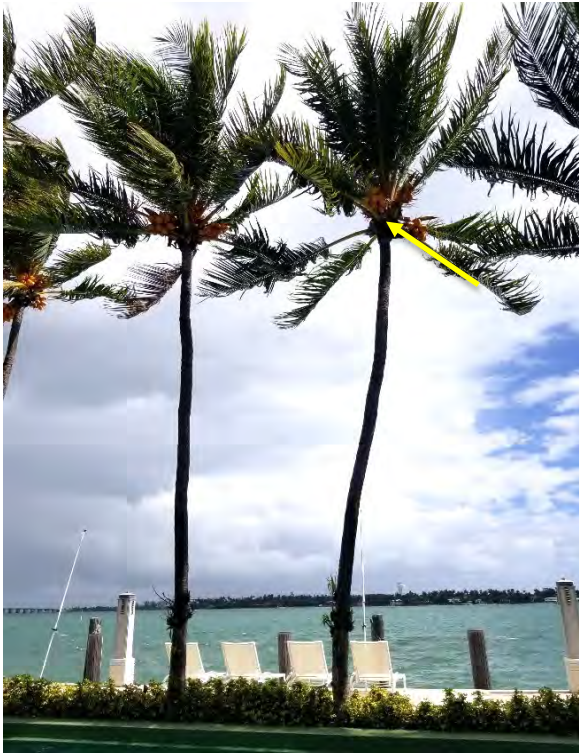
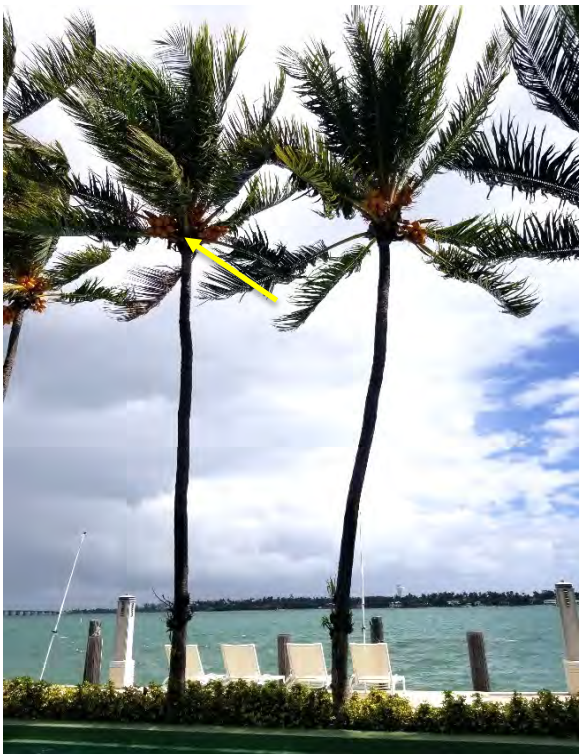
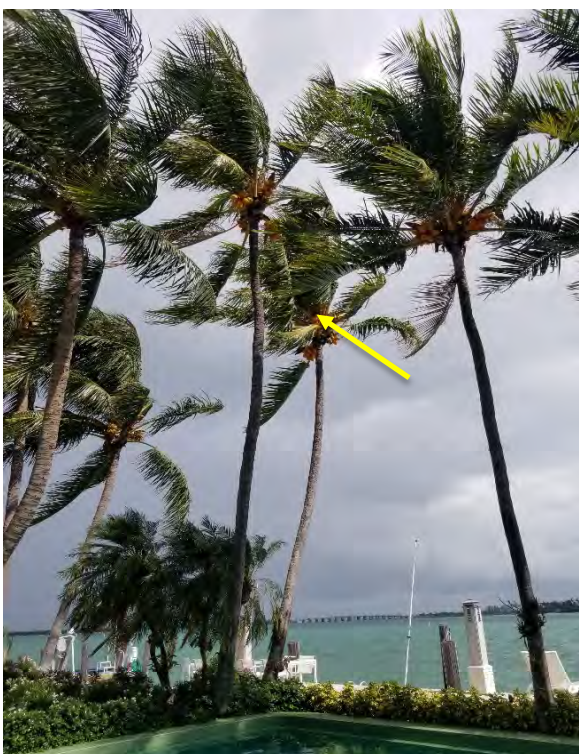
<p>Tree 54 coconut palm (Cocos nucifera) 10 inch DBH, Good condition 30 foot height, 20 foot spread</p>	<p>Tree 55 coconut palm (Cocos nucifera) 10 inch DBH Good condition 30 foot height, 20 foot spread</p>	<p>Tree 56 coconut palm (Cocos nucifera) 10 inch DBH Good condition 30 foot height, 20 foot spread</p>

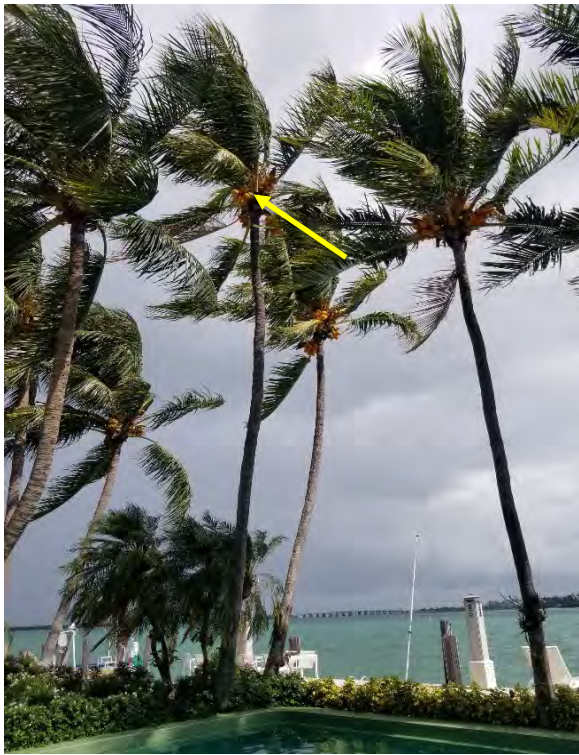
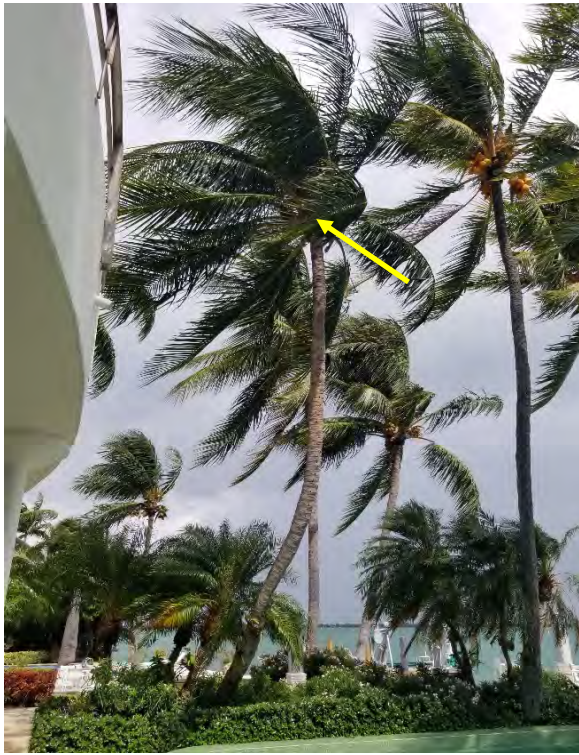
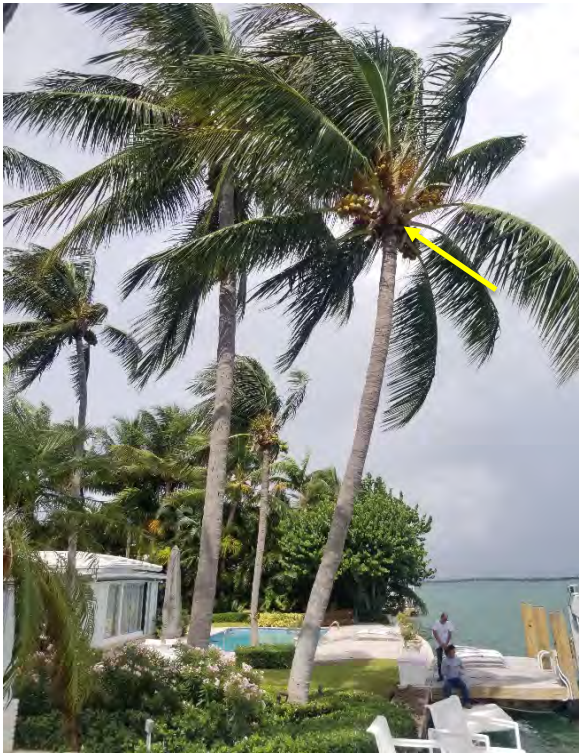
<p>Tree 57 coconut palm (Cocos nucifera) 11 inch DBH, Good condition 30 foot height, 20 foot spread</p>	<p>Tree 58 coconut palm (Cocos nucifera) 10 inch DBH Good condition 25 foot height, 20 foot spread</p>	<p>Tree 59 coconut palm (Cocos nucifera) 12 inch DBH Good condition 30 foot height, 20 foot spread</p>

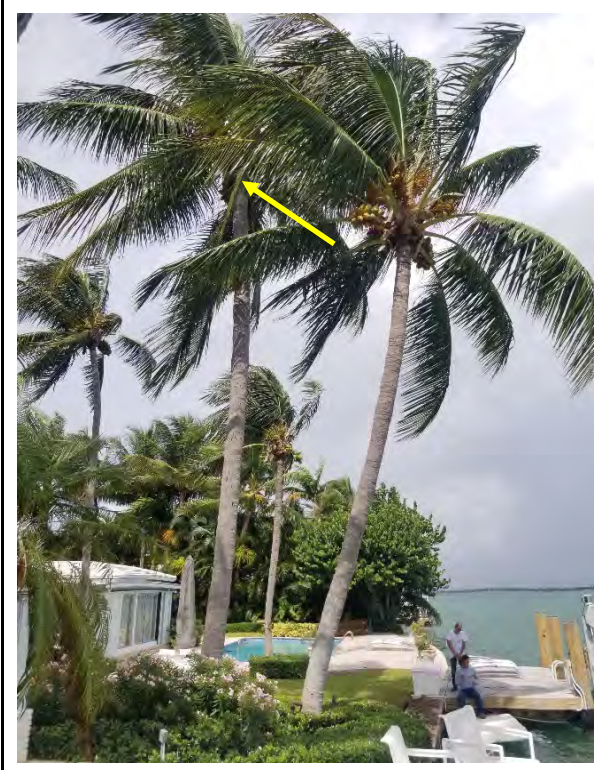
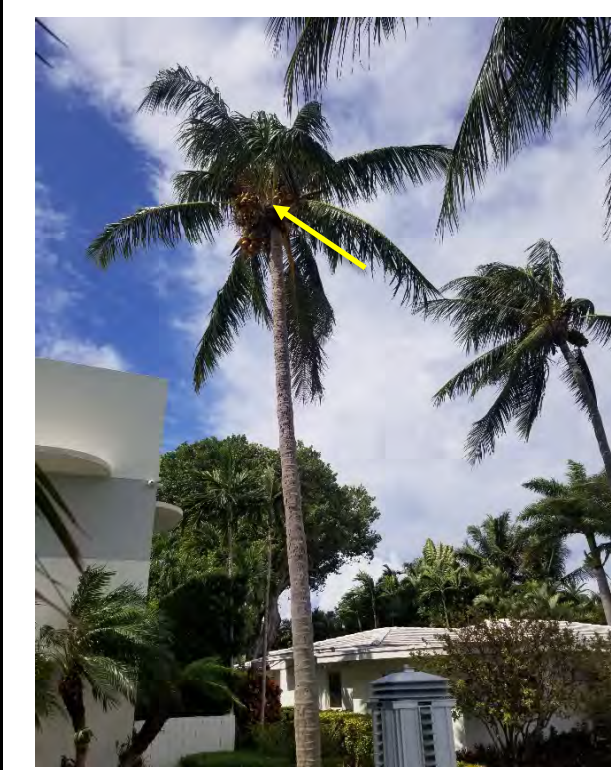
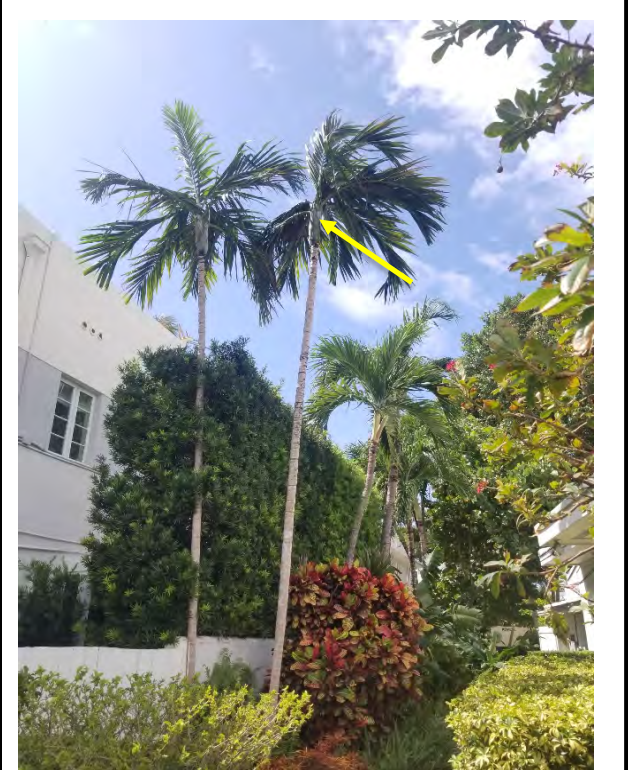
<p>Tree 60 coconut palm (Cocos nucifera) 12 inch DBH, Good condition 30 foot height, 20 foot spread</p>	<p>Tree 61 coconut palm (Cocos nucifera) 15 inch DBH Good condition 30 foot height, 20 foot spread</p>	<p>Tree 62 solitaire palm (Ptychosperma elegans) 3 inch DBH Good condition 20 foot height, 8 foot spread</p>

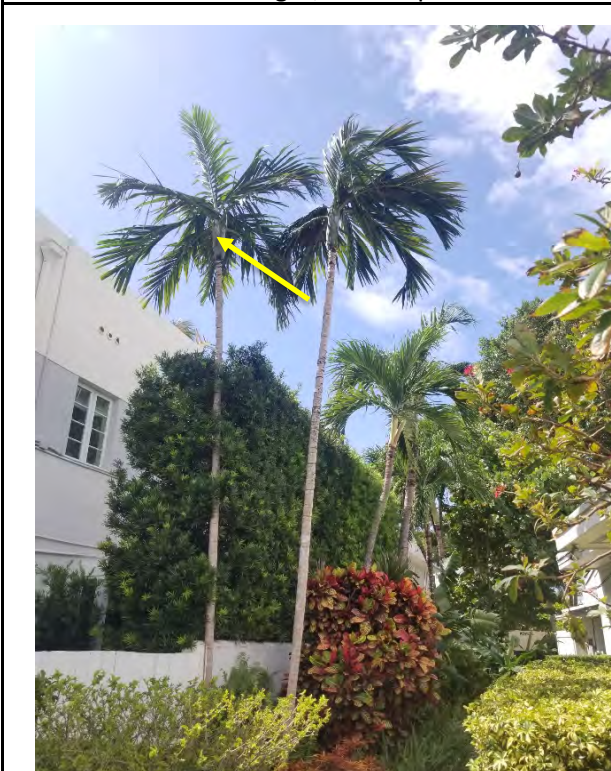
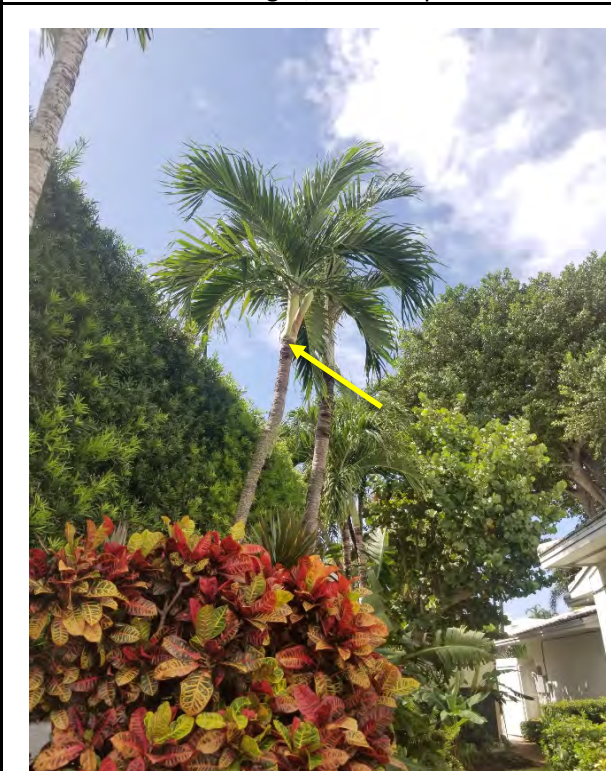
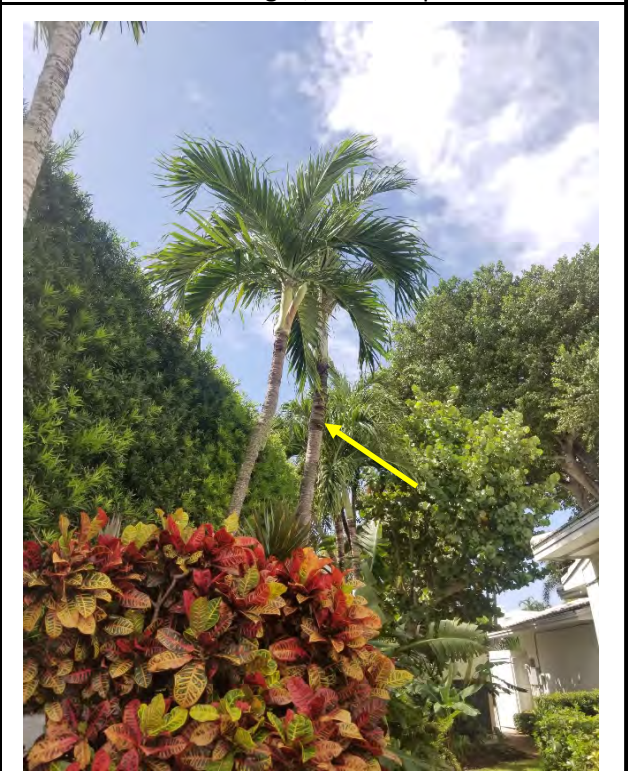
<p>below 6" DBH exemption threshold</p>
<p>Tree 63 solitaire palm (Ptychosperma elegans) 3 inch DBH, Good condition 20 foot height, 8 foot spread</p>	<p>Tree 64 Christmas palm (Adonidia merrellii) 5 inch DBH Good condition 18 foot height, 10 foot spread</p>	<p>Tree 65 Christmas palm (Adonidia merrellii) 5 inch DBH Good condition 18 foot height, 10 foot spread</p>

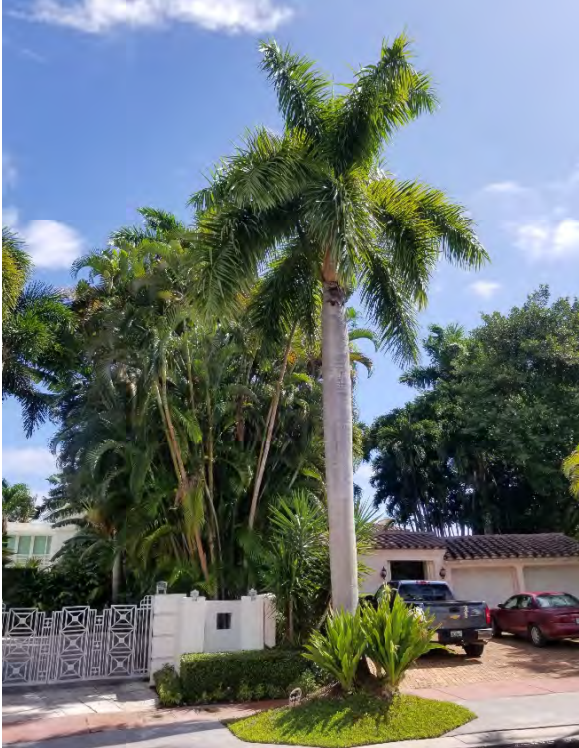
Tree 66 royal palm
(Roystonea regia)
18 inch DBH, Good condition
30 foot height, 20 foot spread
