# Arborist Report

98 La Gorce Circle  
Miami Beach

12/16/2019

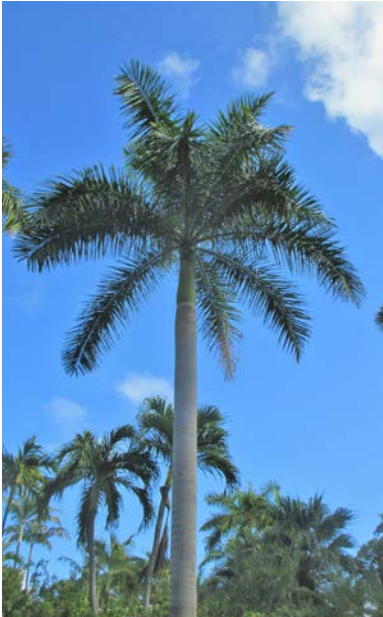
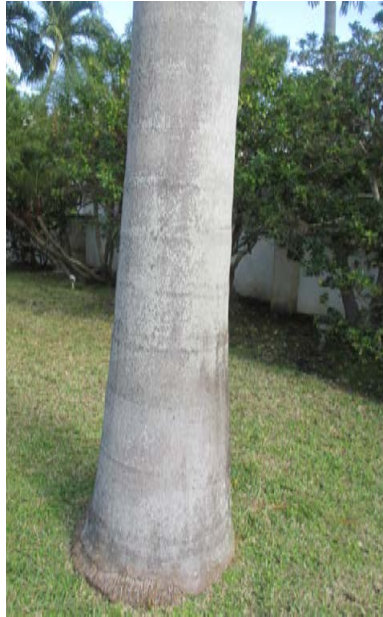
Tree #7 is a Royal Palm street tree located along La Gorce Circle. It is in good condition with a healthy green canopy. This tree has not been incorporated into the landscape plan and will therefore be removed.

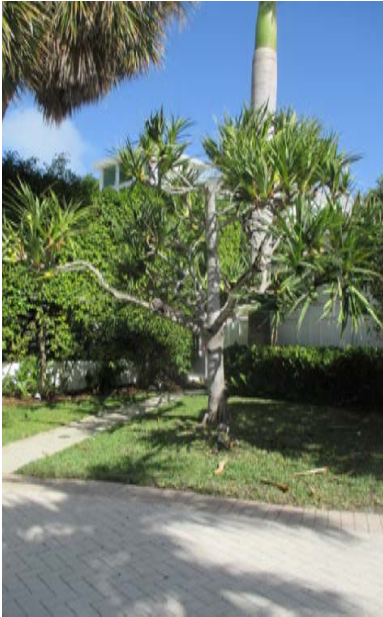
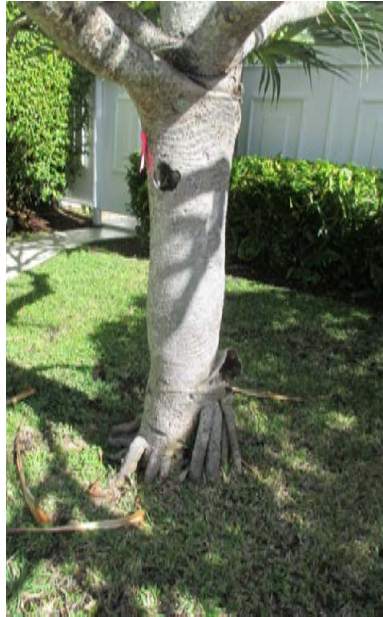
Tree #11 is a Screw-Pine located on the north side of the front of the property. It is in poor condition with decay on multiple main limbs. It is recommended that this tree be removed.  
This tree directly conflicts with the proposed construction.

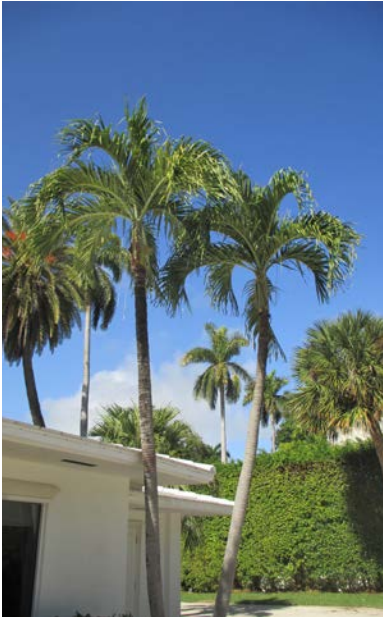
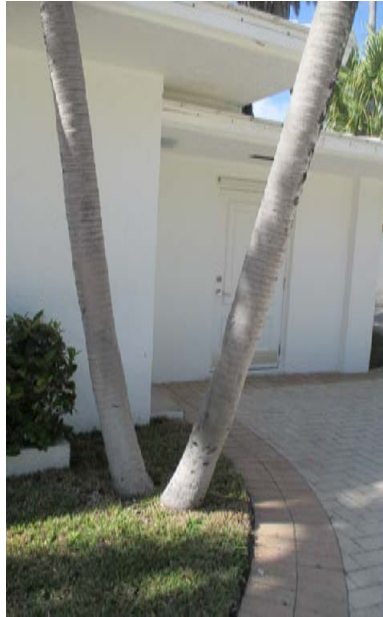
Tree #13 is a double Christmas Palm located at the front of the property. It is in good condition with a bright green canopy. This tree directly conflicts with the proposed construction and will be removed.

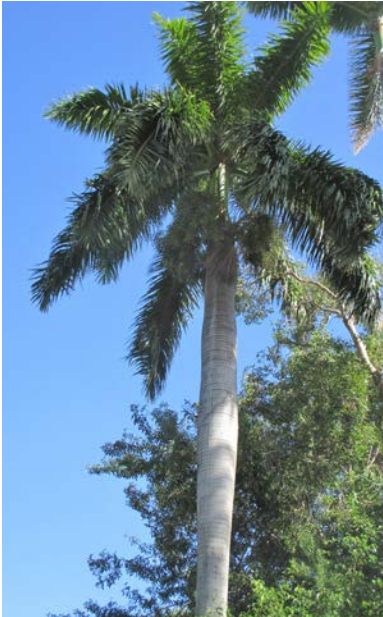
Tree #17 is a Royal Palm located on the south side of the front of the property. It is in good condition with a full, green canopy. This tree has not been incorporated into the landscape plan and will therefore be removed.

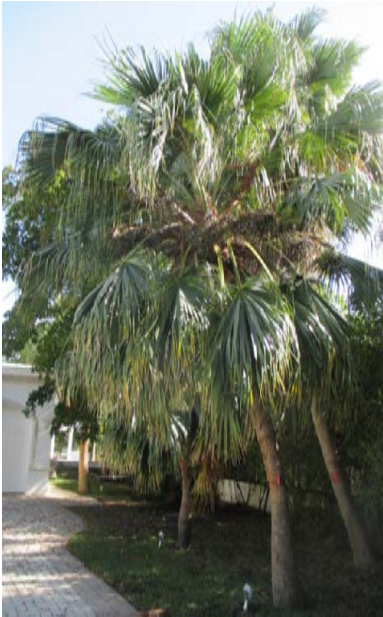
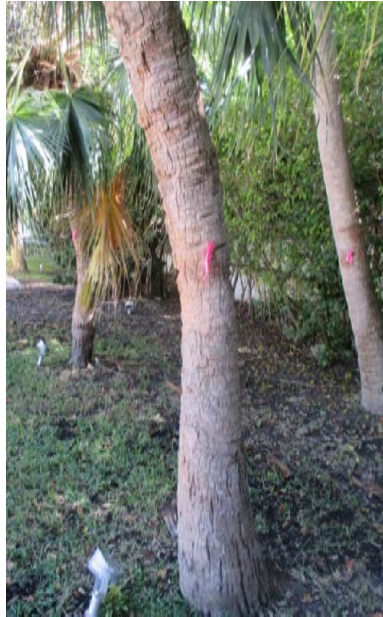
Tree #19 is a Chinese Fan Palm located on the south side of the property. It is in good condition with a full, green canopy. This tree directly conflicts with the proposed construction and will be removed.

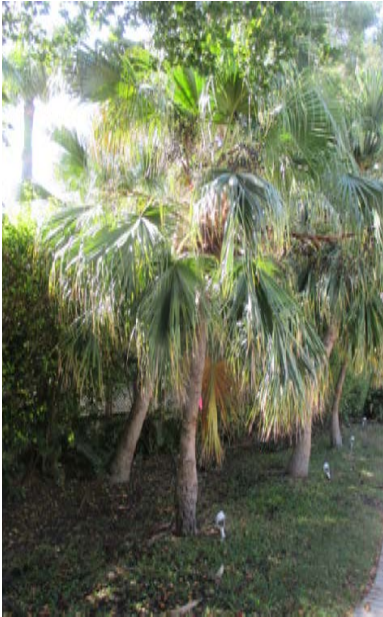
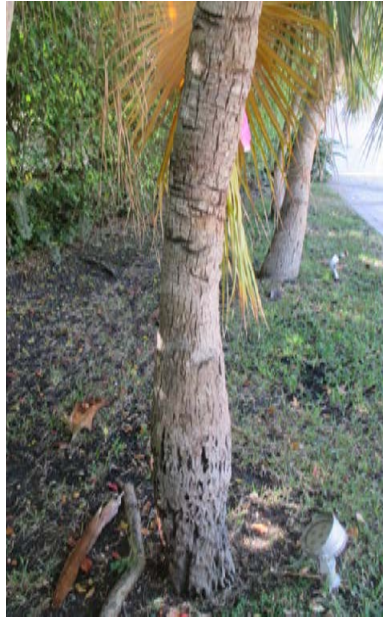
Tree #21 is a Chinese Fan Palm located on the south side of the property. It is in fair condition with some trunk abnormalities. This tree has not been incorporated into the landscape plan and will therefore be removed.

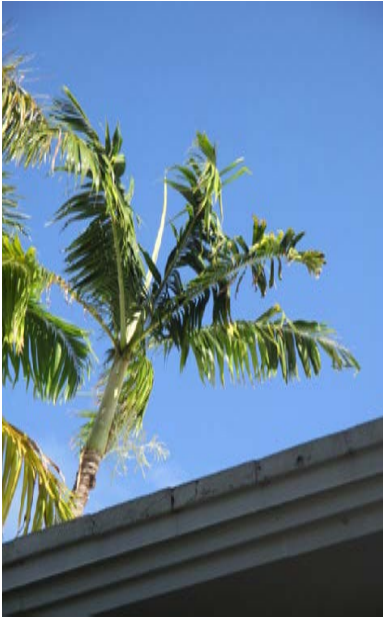
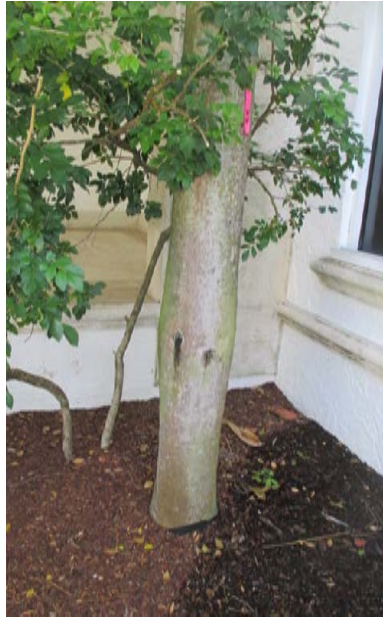
Tree #26 is a Montgomery Palm located at the front of the existing house. It is in poor condition with a small, distorted, and chlorotic canopy. This tree will need to be removed.  
This tree directly conflicts with the proposed construction.

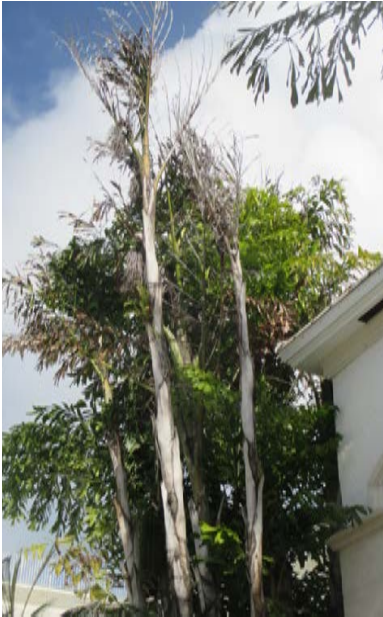
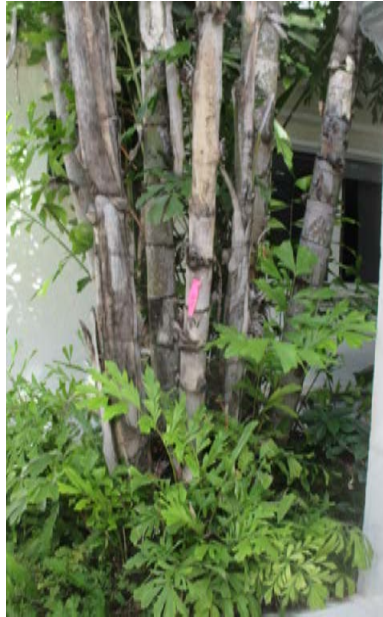
Tree #28 is a Fishtail Palm cluster located at the front of the existing house. It is in poor condition with chlorotic and necrotic foliage and dead trunks. It is recommended that this tree be removed. This tree directly conflicts with the proposed construction.

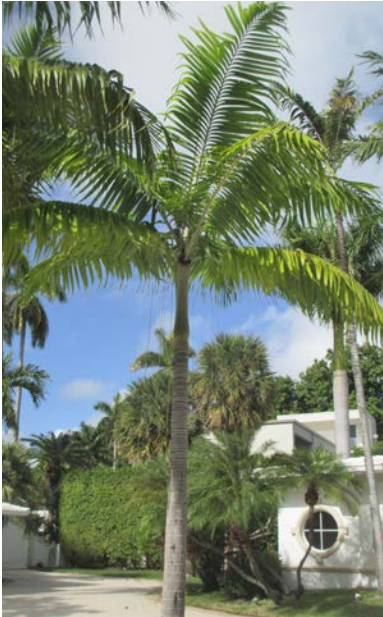
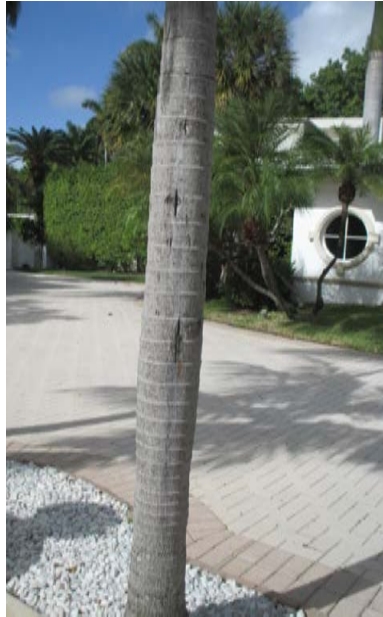
Tree #30 is a Montgomery Palm located around the front courtyard fountain. It is in poor condition with a chlorotic canopy and trunk splits. This tree will need to be removed.  
This tree directly conflicts with the proposed construction.

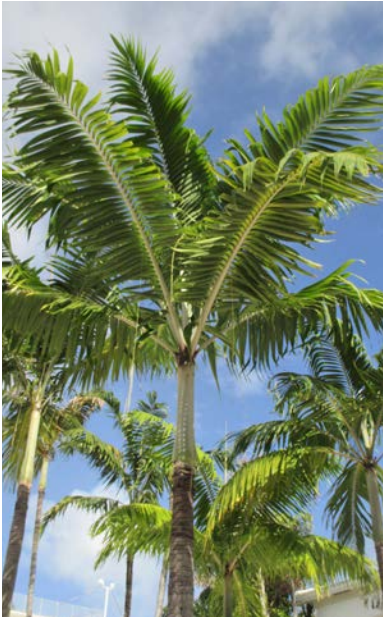
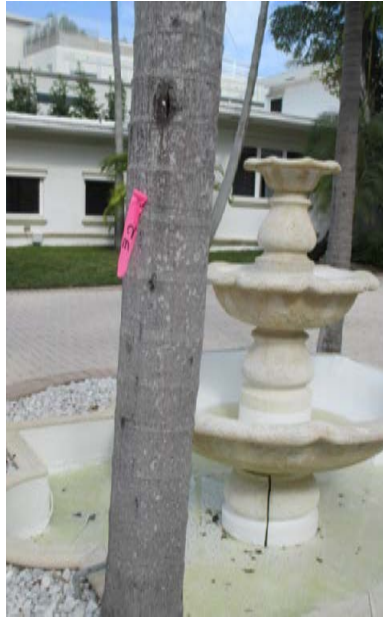
Tree #32 is a Montgomery Palm located around the front courtyard fountain. It is in poor condition with a chlorotic canopy and trunk splits. This tree will need to be removed.  
This tree directly conflicts with the proposed construction.

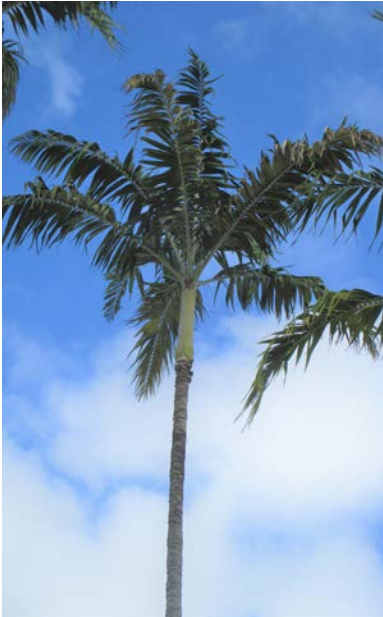
Tree #34 is a Montgomery Palm located in front of the existing house. It is in fair condition with the tips of the fronds brown. This tree directly conflicts with the proposed construction. If this tree is to be relocated, root pruning shall occur a minimum of 4-6 weeks prior to digging the palm and shall be performed or supervised by Certified Arborist. Minimum rootball measurement shall be based upon the most recent *Florida Grades & Standards for Nursery Plants*. Transplanting shall be performed or supervised by Certified Arborist. Prior to transplanting, the apical bud shall be protected by tying up palm fronds. Leaves shall be untied as soon as the palm is planted. When lifting the palm, a nylon sling with adequate padding shall be used and care shall be taken to not injure or compress the trunk. Plant at grade, with 2" of root initiation zone visible if applicable. Transplanting shall occur as soon as possible and no more than 24 hours after being dug for relocation. The backfill soil shall be irrigated during and following relocation. Wooden braces shall be installed to stabilize the tree.

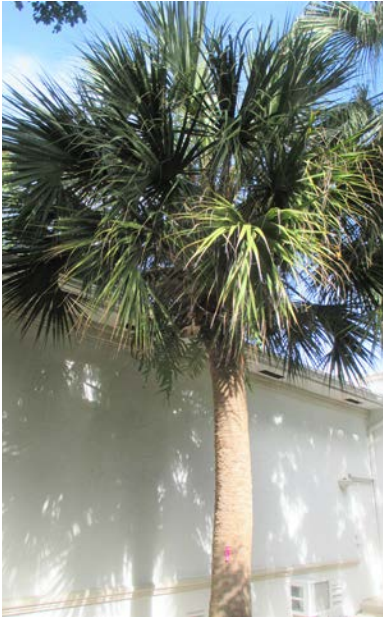
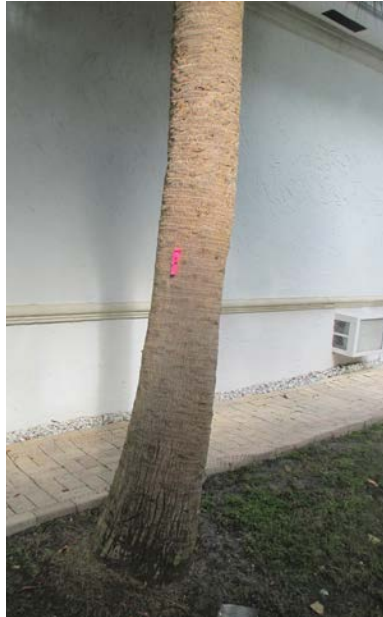
Tree #36 is a Sabal Palm located to the south of the existing house. It is in good condition with a full canopy. If this tree is to be relocated, root pruning shall occur a minimum of 4-6 weeks prior to digging the palm and shall be performed or supervised by Certified Arborist. Minimum rootball measurement shall be based upon the most recent *Florida Grades & Standards for Nursery Plants*. Transplanting shall be performed or supervised by Certified Arborist. Prior to transplanting, the apical bud shall be protected by tying up palm fronds. Leaves shall be untied as soon as the palm is planted. When lifting the palm, a nylon sling with adequate padding shall be used and care shall be taken to not injure or compress the trunk. Plant at grade, with 2" of root initiation zone visible if applicable. Transplanting shall occur as soon as possible and no more than 24 hours after being dug for relocation. The backfill soil shall be irrigated during and following relocation. Wooden braces shall be installed to stabilize the tree.

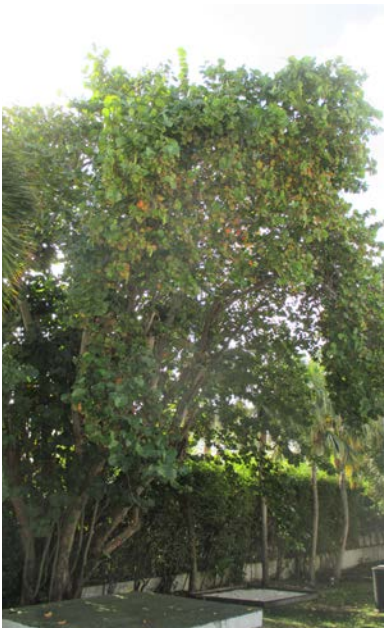
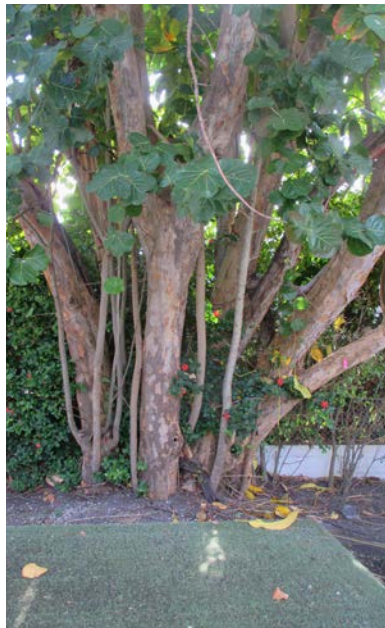
Tree #41 is a large Sea Grape located on the south side of the property. It is multi-trunked and has a dense canopy. There is large deadwood present which should be pruned out.

If this tree is to remain, protective barriers shall be placed 20ft from the tree trunk. Barriers shall be installed prior to the start of construction and demolition, and shall remain in place until development is completed and until the department authorizes their removal. Barriers shall be a minimum of 4ft high, and shall be constructed of continuous chain link fence with metal posts at 8ft spacing, or of 2x4 posts with three equally spaced 2x4 rails. Posts may be shifted to avoid roots. No materials shall be placed or disposed of within the TPZ. Natural grade shall be maintained within the TPZ.

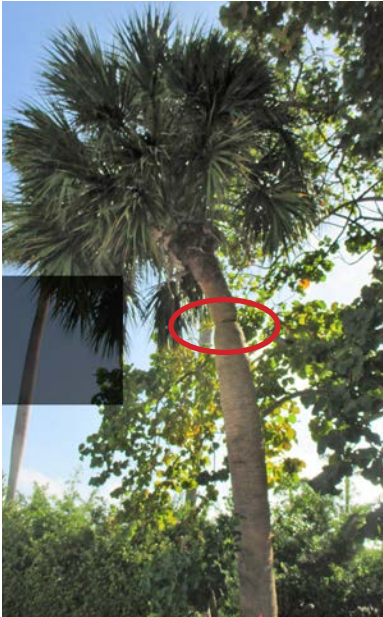
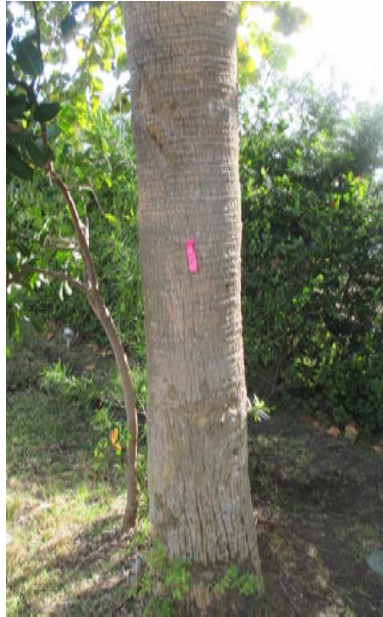
Tree #42 is a Sabal Palm located on the south side of the backyard. It is in fair condition and has a distinct trunk constriction (circled in red). If this tree is to be relocated, root pruning shall occur a minimum of 4-6 weeks prior to digging the palm and shall be performed or supervised by Certified Arborist. Minimum rootball measurement shall be based upon the most recent *Florida Grades & Standards for Nursery Plants*. Transplanting shall be performed or supervised by Certified Arborist. Prior to transplanting, the apical bud shall be protected by tying up palm fronds. Leaves shall be untied as soon as the palm is planted. When lifting the palm, a nylon sling with adequate padding shall be used and care shall be taken to not injure or compress the trunk. Plant at grade, with 2" of root initiation zone visible if applicable. Transplanting shall occur as soon as possible and no more than 24 hours after being dug for relocation. The backfill soil shall be irrigated during and following relocation. Wooden braces shall be installed to stabilize the tree.

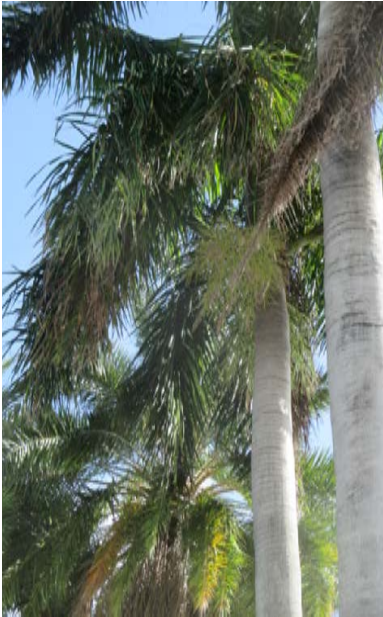
Tree #44 is a Royal Palm located on the south side of the backyard. The trunk appears to be collapsing in one area (circled in red) which may be indicative of Thielaviopsis Trunk Rot. It is recommended that this tree be removed.
