# FOUNTAINBLEAU SOUTH GARAGE & BALLROOM

## 4360-4370 Collins Avenue

Re: 4441 Collins Avenue Miami Beach, FL

I visited the above-mentioned property on Sunday, March 15, 2020 to evaluate 72 trees, verify condition and measurements, take photographs and note any significant defects.

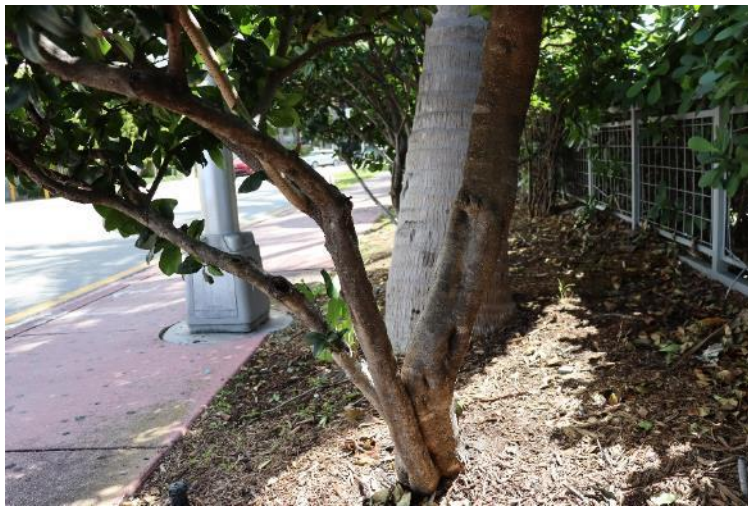
Tree Sixteen

Ligustrum (*Ligustrum japonicum*), facing west.

Note shaping and poor structure.

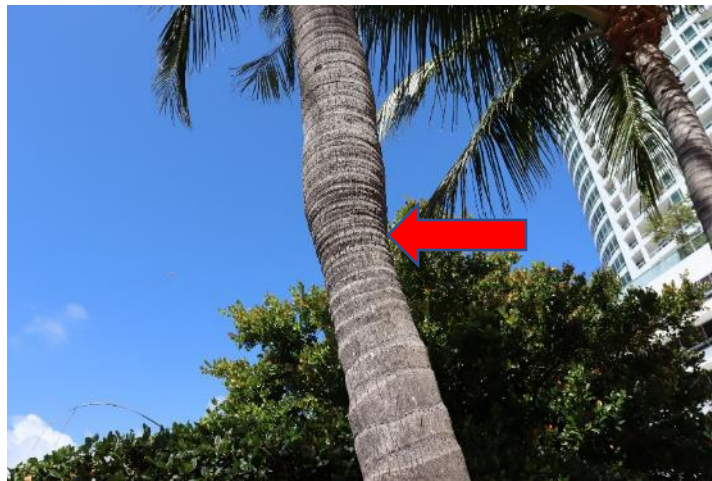
Tree Twenty-Two

Coconut Palm (*Cocos nucifera*), facing north.

Note significant pencilling (red arrow).
