# ILLUSION LANDSCAPE & DESIGN

Arborist report / Tree assessment:

Jan. 15, 2020

7835 Harding Ave. Miami Bch, Fl. 33141

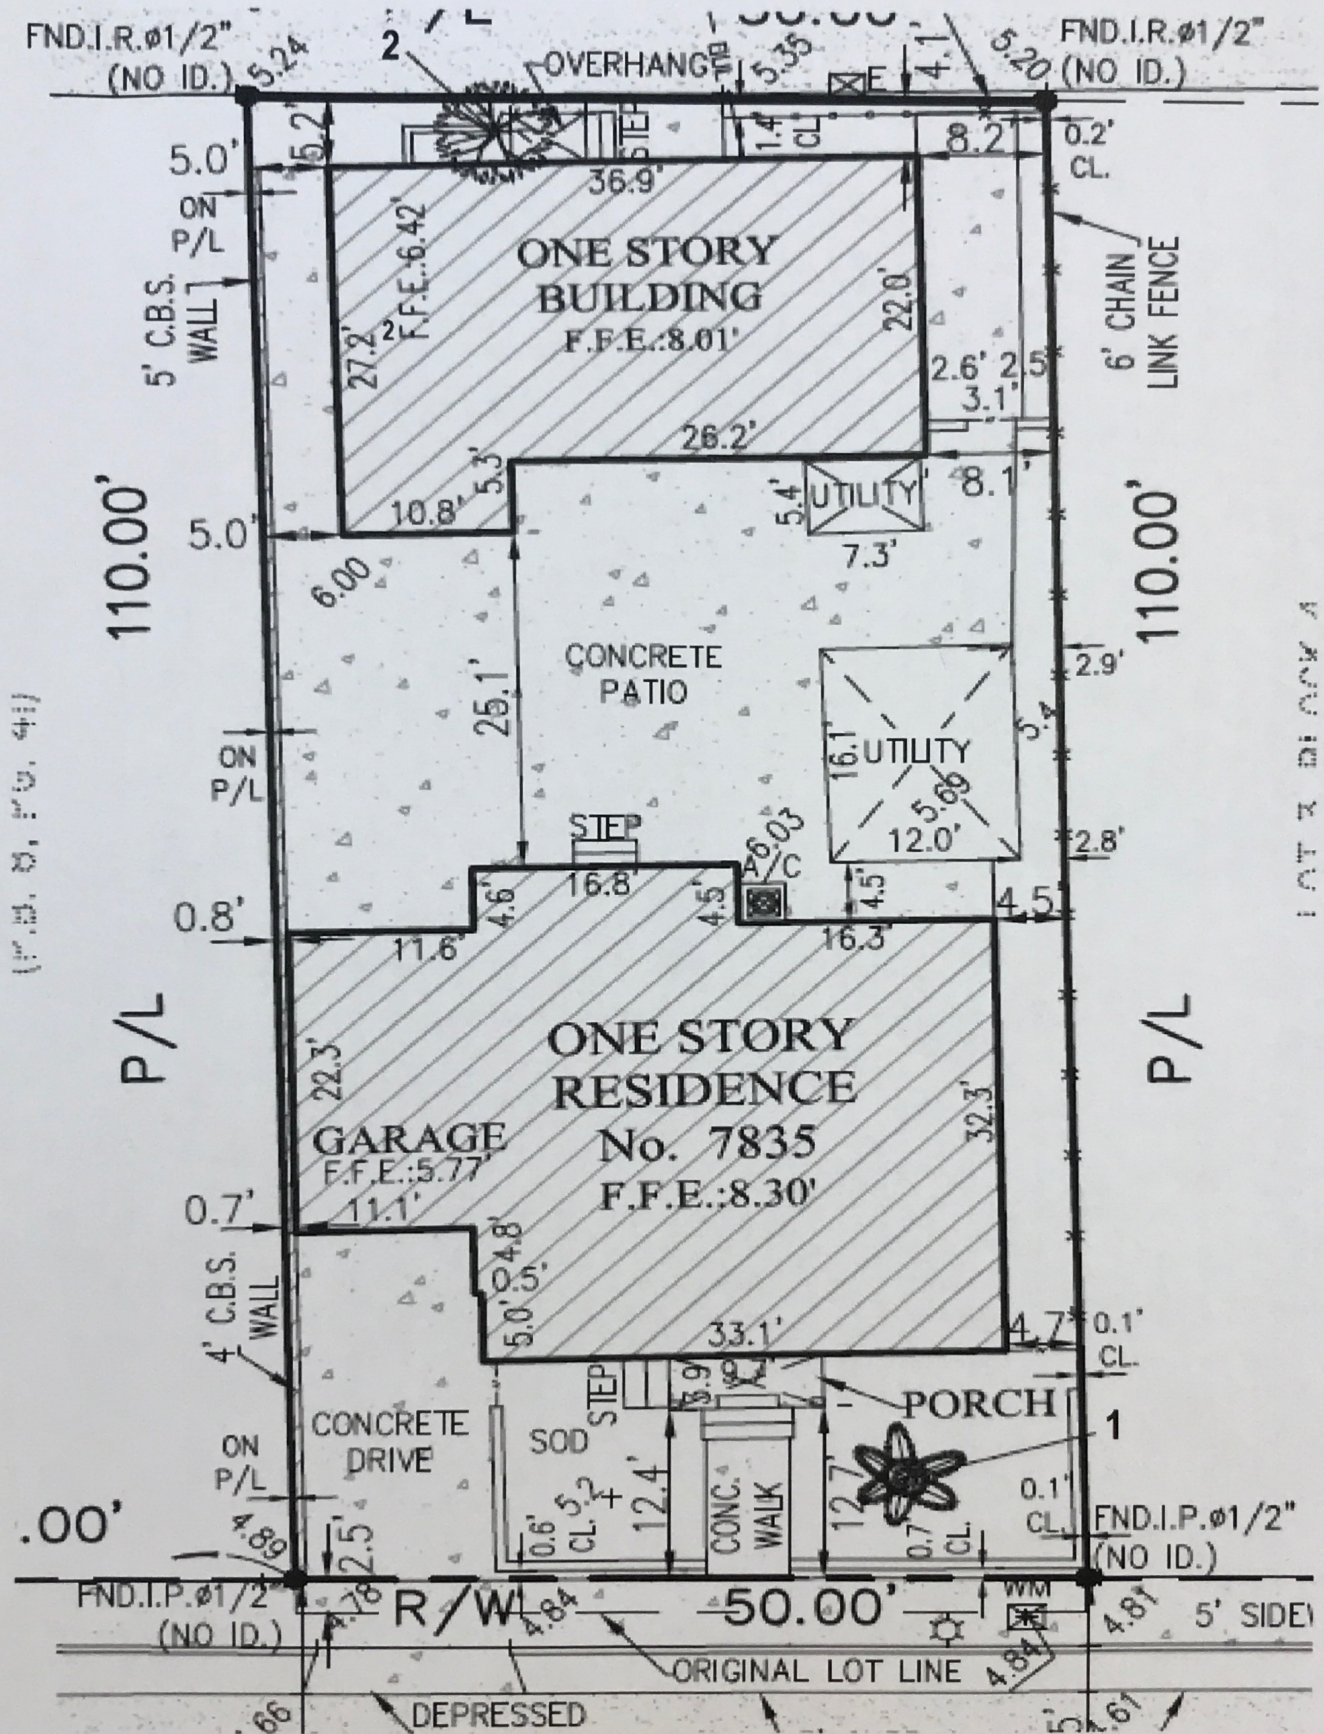
<u>Name</u>	<u>TPZ</u>	<u>Height</u>	<u>(DBH)</u>	<u>Spread</u>	<u>Status</u>
#1- Cocos nucifera	7'	28'	8"	15'	Remain
#2- Murraya paniculata	6'	29'	7"	12'	Remain
