Arborist Report

6342-6360 North Bay Road
Miami Beach

11/9/2020

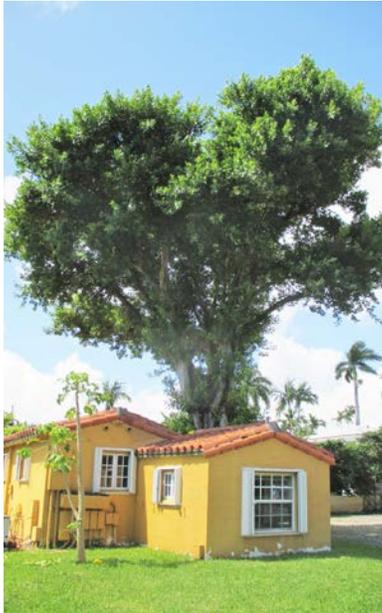
Condition -
Good

Tree #1 is a large Chinese Banyan located next to the guest house at the front of the property. It is in good condition with a dense, symmetrical canopy. The root flare is clearly visible. The canopy has been reduction pruned and raised recently, and new vigorous shoot growth is occurring from these cuts and along the main limbs and trunk. There is little deadwood and few aerial roots. This tree is to be relocated and root pruning shall occur a minimum of 8 weeks prior to digging the tree and shall be performed or supervised by Certified Arborist. Minimum rootball measurement shall be based upon the most recent *Florida Grades & Standards for Nursery Plants*. Transplanting shall be performed or supervised by Certified Arborist. Prior to transplanting, only branches that are dead or broken are to be removed; no live foliage is to be pruned off. When lifting the tree, ensure that the trunk is not damaged. The diameter of the planting hole shall be twice the root ball diameter. Plant at grade, with the trunk flare visible. Transplanting shall occur as soon as possible and no more than 24 hours after being dug for relocation. Proper irrigation shall be provided during and after transplanting. Following relocation, a 20ft radius TPZ shall be erected.

Disposition -
Relocate - 20ft radius TPZ

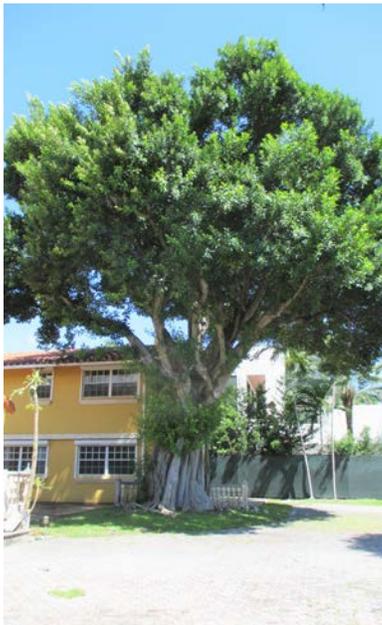
Condition -
Good

Tree #2 is a large Chinese Banyan located in front of the main house. It is in good condition with a dense, symmetrical canopy. The root flare is clearly visible. The canopy has been reduction pruned and raised recently, and new vigorous shoot growth is occurring from these cuts and along the main limbs and trunk. There is little deadwood and few aerial roots. This tree is to be relocated and root pruning shall occur a minimum of 8 weeks prior to digging the tree and shall be performed or supervised by Certified Arborist. Minimum rootball measurement shall be based upon the most recent *Florida Grades & Standards for Nursery Plants*. Transplanting shall be performed or supervised by Certified Arborist. Prior to transplanting, only branches that are dead or broken are to be removed; no live foliage is to be pruned off. When lifting the tree, ensure that the trunk is not damaged. The diameter of the planting hole shall be twice the root ball diameter. Plant at grade, with the trunk flare visible. Transplanting shall occur as soon as possible and no more than 24 hours after being dug for relocation. Proper irrigation shall be provided during and after transplanting. Following relocation, a 25ft radius TPZ shall be erected.

Disposition -
Relocate - 25ft radius TPZ

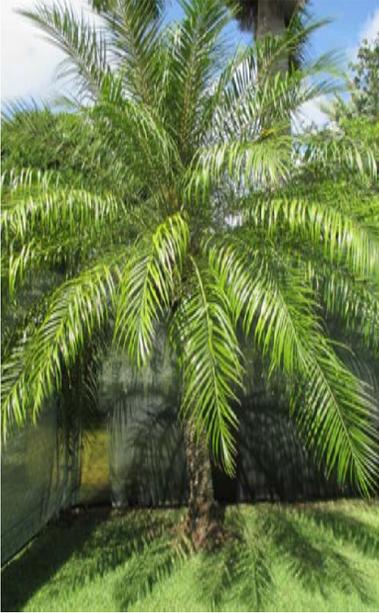
Tree #3 is a Pygmy Date Palm street tree located along North Bay Road. Overhead wires are above. It is in good condition with a healthy green canopy. This tree has not been incorporated into the landscape plan and will therefore be removed.

Disposition -
Remove

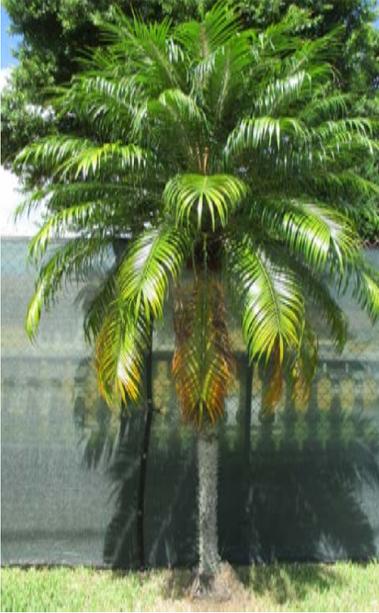
Tree #5 is a Pygmy Date Palm street tree located along North Bay Road. Overhead wires are above. It is in fair condition with some lower dead fronds. This tree has not been incorporated into the landscape plan and will therefore be removed.

Disposition -
Remove

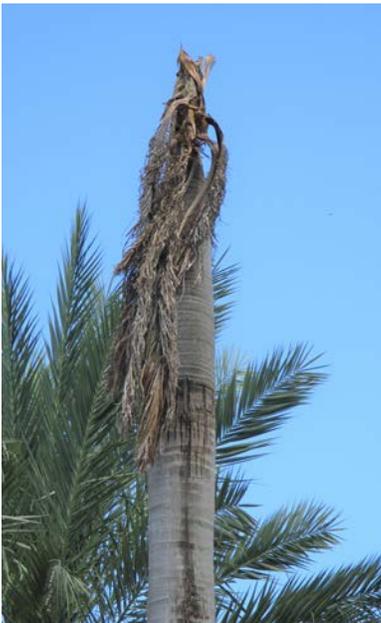
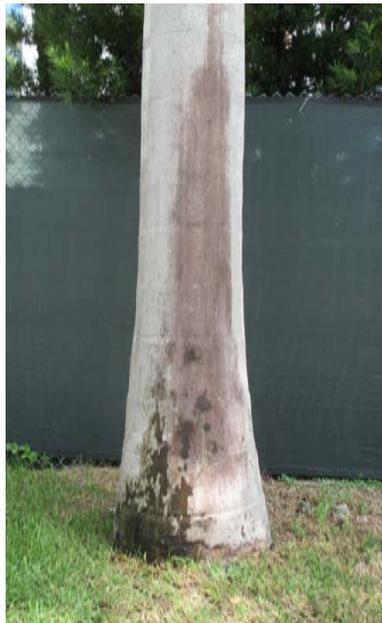
Condition -
Dead

Tree #8 is dead Royal Palm located on the east side of the front yard. This tree is dead and will need to be removed.

Disposition -
Remove

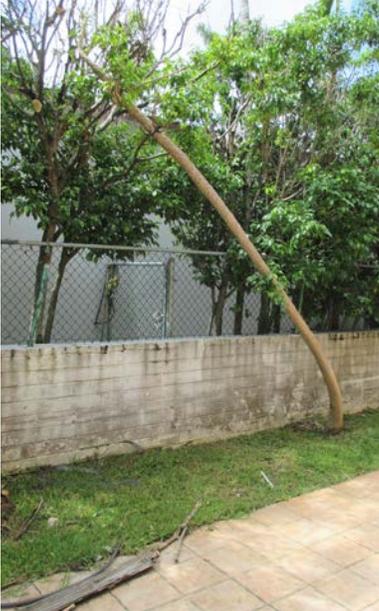
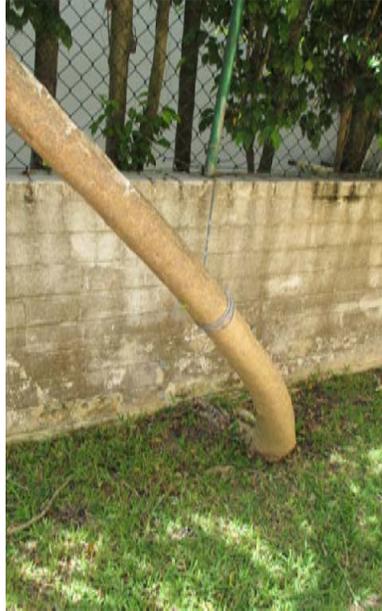
Condition -
Poor

Tree #13 is a Papaya located on the west side of the property. It is growing at a sharp angle and there is basically no foliage left. This tree has not been incorporated into the landscape plan and will therefore be removed.

Disposition -
Remove

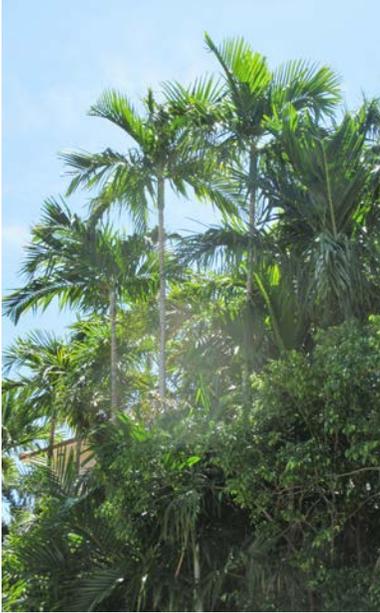
Tree #15 is a cluster of seven Solitaire Palms located on the west side of the backyard. They are in good condition with mostly green foliage. This tree has not been incorporated into the landscape plan and will therefore be removed.

Disposition -
Remove

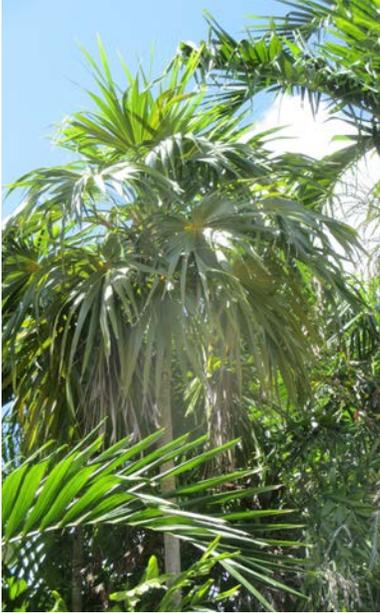
Tree #17 is a Florida Thatch Palm located on the west side of the backyard. It is in fair condition with a chlorotic canopy. This tree has not been incorporated into the landscape plan and will therefore be removed.

Disposition -
Remove

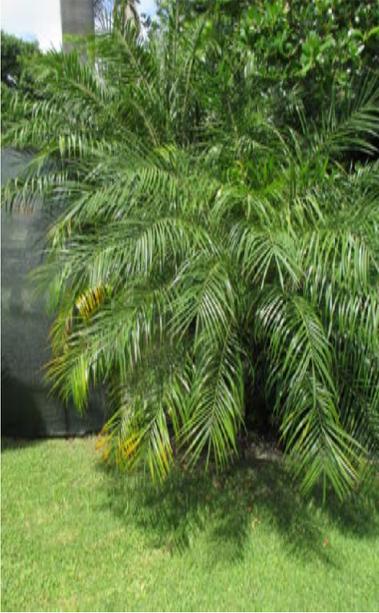
Tree #21 is a double Pygmy Date Palm street tree located along North Bay Road. Overhead wires are above. It is in good condition with a mostly green canopy. This tree has not been incorporated into the landscape plan and will therefore be removed.

Disposition -
Remove

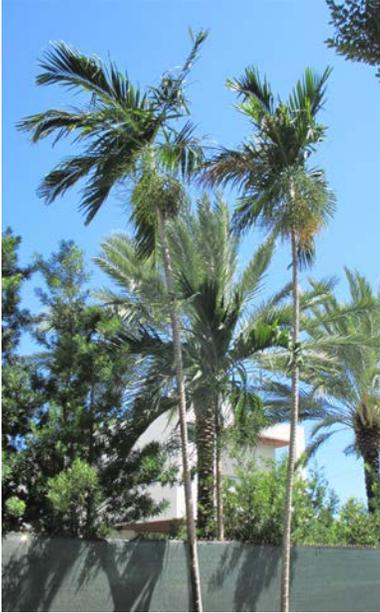
Condition -
Fair

Tree #23 is two Solitaire Palms located on the east side of the front yard. They are in fair condition with some tattered fronds.

Disposition -
Remove

This tree has not been incorporated into the landscape plan and will therefore be removed.

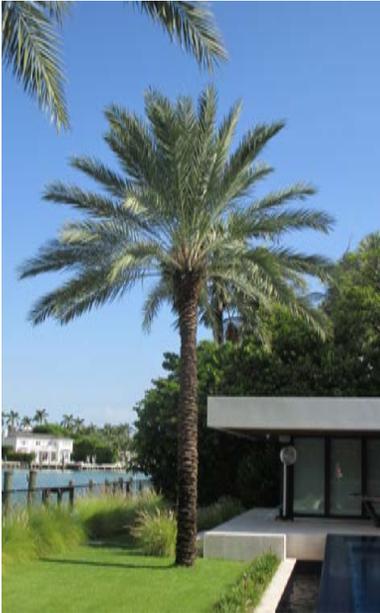
Tree #25 is a Date Palm located at the rear of the property. It is in good condition with a healthy green canopy.

Disposition -
Remain - 10ft radius TPZ

This tree is to remain and protective barriers shall be placed 10ft from the tree trunk. Barriers shall be installed prior to the start of construction, and shall remain in place until development is completed and the department authorizes their removal. Barriers shall be a minimum of 4ft high, and shall be constructed of continuous chain link fence with metal posts at 8ft spacing, or of 2x4 posts with three equally spaced 2x4 rails. Posts may be shifted to avoid roots. No materials shall be placed or disposed of within the TPZ. Natural grade shall be maintained within the TPZ.

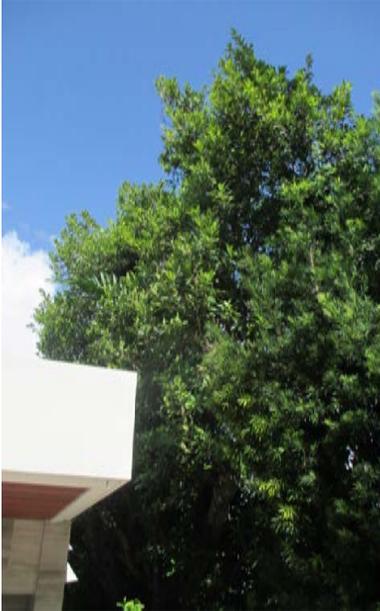
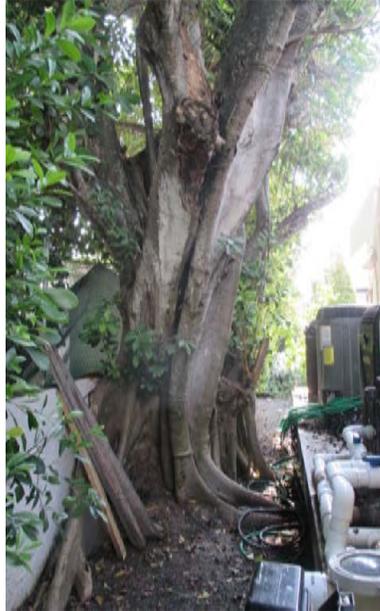
Condition -
Fair

Tree #27 is a Strangler Fig located at the rear of the property behind the cabana. It is in fair condition - a number of large diameter limbs have been cut to provide clearance to the cabana and the canopy is asymmetrical. There is some branch dieback at the top of the tree. The trunk is growing on the propertyline wall. There are a number of older pruning cuts with decay. Prune to remove deadwood.

Disposition -
Remain - 17.5ft radius TPZ

This tree is to remain and protective barriers shall be placed 17.5ft from the tree trunk. Barriers shall be installed prior to the start of construction, and shall remain in place until development is completed and the department authorizes their removal. Barriers shall be a minimum of 4ft high, and shall be constructed of continuous chain link fence with metal posts at 8ft spacing, or of 2x4 posts with three equally spaced 2x4 rails. Posts may be shifted to avoid roots. No materials shall be placed or disposed of within the TPZ. Natural grade shall be maintained within the TPZ.

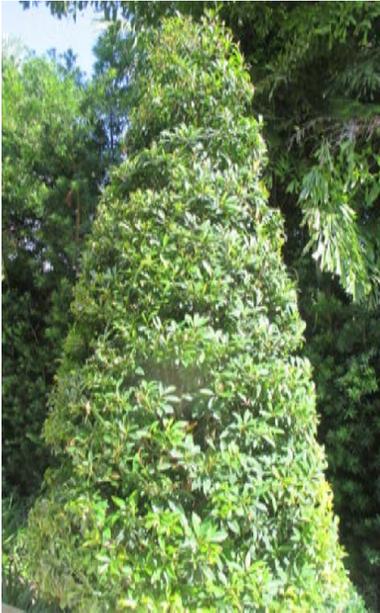
Tree #29 is a Japanese Blueberry located on the eastern side of the house. It is in good condition with a dense green canopy.

Disposition -
Remain - 10ft radius TPZ

This tree is to remain and protective barriers shall be placed 10ft from the tree trunk. Barriers shall be installed prior to the start of construction, and shall remain in place until development is completed and the department authorizes their removal. Barriers shall be a minimum of 4ft high, and shall be constructed of continuous chain link fence with metal posts at 8ft spacing, or of 2x4 posts with three equally spaced 2x4 rails. Posts may be shifted to avoid roots. No materials shall be placed or disposed of within the TPZ. Natural grade shall be maintained within the TPZ.

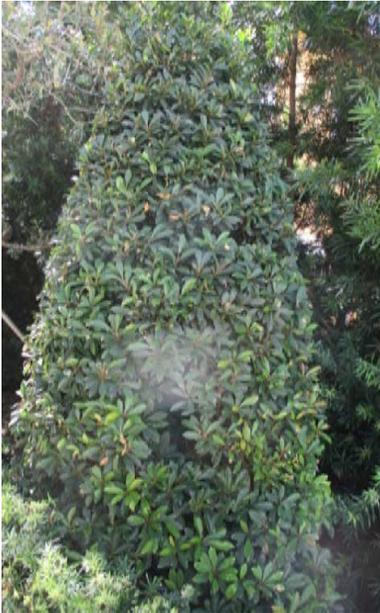
Tree #31 is a Japanese Blueberry located on the west side of the property. It is in good condition with a dense green canopy. This tree is to be relocated and root pruning shall occur a minimum of 8 weeks prior to digging the tree and shall be performed or supervised by Certified Arborist. Minimum rootball measurement shall be based upon the most recent *Florida Grades & Standards for Nursery Plants*. Transplanting shall be performed or supervised by Certified Arborist. Prior to transplanting, only branches that are dead or broken are to be removed; no live foliage is to be pruned off. When lifting the tree, ensure that the trunk is not damaged. The diameter of the planting hole shall be twice the root ball diameter. Plant at grade, with the trunk flare visible. Transplanting shall occur as soon as possible and no more than 24 hours after being dug for relocation. Proper irrigation shall be provided during and after transplanting. Following relocation, a 3ft radius TPZ shall be erected.

Disposition -
Relocate - 3ft radius TPZ

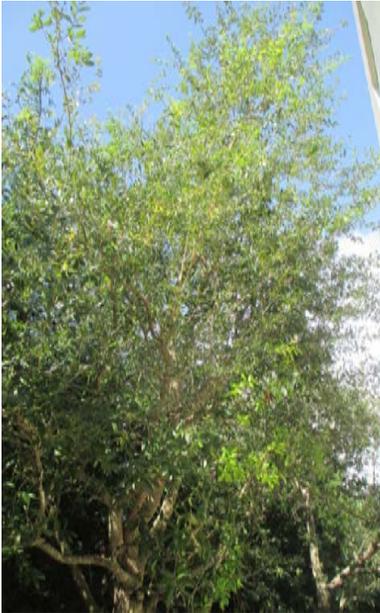
Tree #33 is a Live Oak located on the west side of the house. It is in good condition. There is a lot of sucker growth along the limbs and branches. Remove the stakes before they girdle the tree. This tree is to be relocated and root pruning shall occur a minimum of 8 weeks prior to digging the tree and shall be performed or supervised by Certified Arborist. Minimum rootball measurement shall be based upon the most recent *Florida Grades & Standards for Nursery Plants*. Transplanting shall be performed or supervised by Certified Arborist. Prior to transplanting, only branches that are dead or broken are to be removed; no live foliage is to be pruned off. When lifting the tree, ensure that the trunk is not damaged. The diameter of the planting hole shall be twice the root ball diameter. Plant at grade, with the trunk flare visible. Transplanting shall occur as soon as possible and no more than 24 hours after being dug for relocation. Proper irrigation shall be provided during and after transplanting. Following relocation, a 10ft radius TPZ shall be erected.

Disposition -
Relocate - 10ft radius TPZ

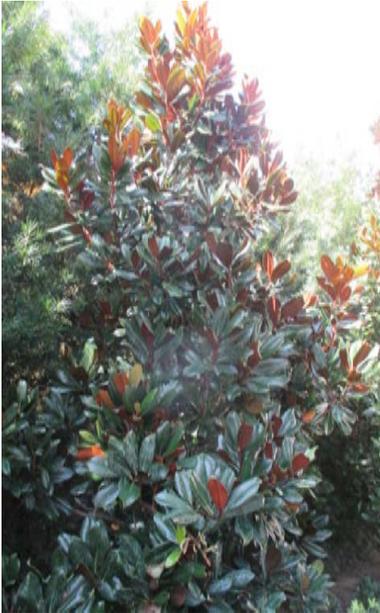
Tree #35 is a Southern Magnolia located on the west side of the house. It is in good condition with a dense, healthy canopy. This tree is to be relocated and root pruning shall occur a minimum of 8 weeks prior to digging the tree and shall be performed or supervised by Certified Arborist. Minimum rootball measurement shall be based upon the most recent *Florida Grades & Standards for Nursery Plants*. Transplanting shall be performed or supervised by Certified Arborist. Prior to transplanting, only branches that are dead or broken are to be removed; no live foliage is to be pruned off. When lifting the tree, ensure that the trunk is not damaged. The diameter of the planting hole shall be twice the root ball diameter. Plant at grade, with the trunk flare visible. Transplanting shall occur as soon as possible and no more than 24 hours after being dug for relocation. Proper irrigation shall be provided during and after transplanting. Following relocation, a 4ft radius TPZ shall be erected.

Disposition -
Relocate - 4ft radius TPZ

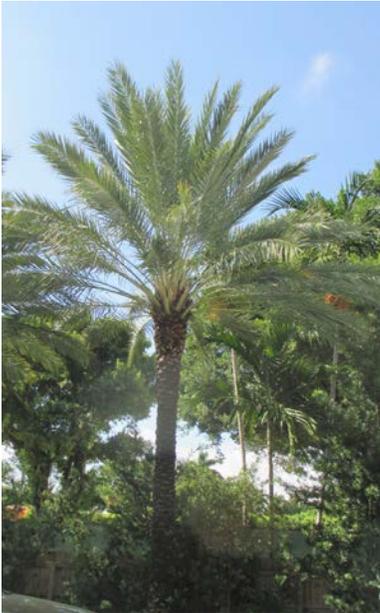
Tree #37 is a Date Palm located to the west of the driveway. It is in good condition with a healthy green canopy. This tree is to be relocated and root pruning shall occur a minimum of 4-6 weeks prior to digging the palm and shall be performed or supervised by Certified Arborist. Minimum rootball measurement shall be based upon the most recent *Florida Grades & Standards for Nursery Plants*. Prior to transplanting, the apical bud shall be protected by tying up palm fronds. Leaves shall be untied as soon as the palm is planted. When lifting the palm, a nylon sling with adequate padding shall be used and care shall be taken to not injure or compress the trunk. Plant at grade, with 2" of root initiation zone visible if applicable. Transplanting shall occur as soon as possible and no more than 24 hours after being dug for relocation. The backfill soil shall be irrigated during and following relocation. Wooden braces shall be installed to stabilize the tree. Following relocation, a 7.5ft radius TPZ shall be erected.

Disposition -
Relocate - 7.5ft radius TPZ

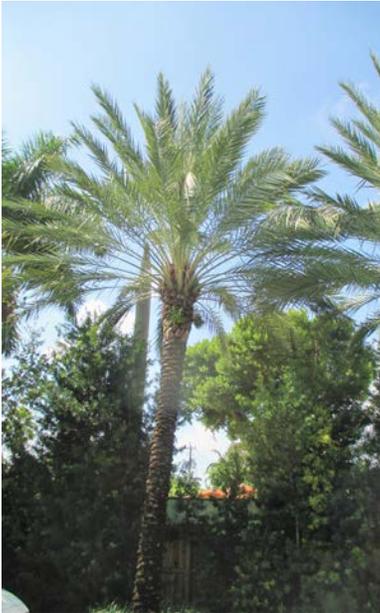
Tree #39 is a Date Palm located to the west of the driveway. It is in good condition with a healthy green canopy. This tree is to be relocated and root pruning shall occur a minimum of 4-6 weeks prior to digging the palm and shall be performed or supervised by Certified Arborist. Minimum rootball measurement shall be based upon the most recent *Florida Grades & Standards for Nursery Plants*. Prior to transplanting, the apical bud shall be protected by tying up palm fronds. Leaves shall be untied as soon as the palm is planted. When lifting the palm, a nylon sling with adequate padding shall be used and care shall be taken to not injure or compress the trunk. Plant at grade, with 2" of root initiation zone visible if applicable. Transplanting shall occur as soon as possible and no more than 24 hours after being dug for relocation. The backfill soil shall be irrigated during and following relocation. Wooden braces shall be installed to stabilize the tree. Following relocation, a 7.5ft radius TPZ shall be erected.

Disposition -
Relocate - 7.5ft radius TPZ

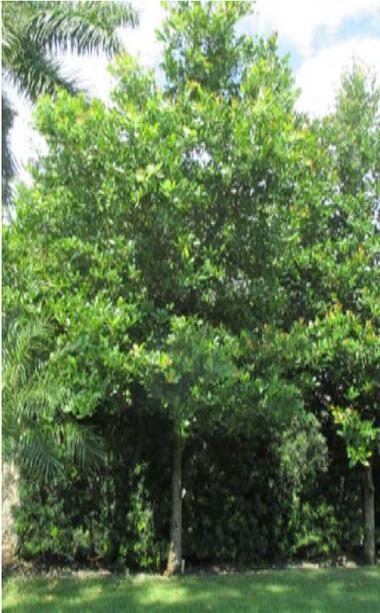
Tree #43 is a Brazilian Beautyleaf street tree located along North Bay Road. It is in good condition with a healthy green canopy and is growing vigorously. This tree is to be relocated and root pruning shall occur a minimum of 8 weeks prior to digging the tree and shall be performed or supervised by Certified Arborist. Minimum rootball measurement shall be based upon the most recent *Florida Grades & Standards for Nursery Plants*. Transplanting shall be performed or supervised by Certified Arborist. Prior to transplanting, only branches that are dead or broken are to be removed; no live foliage is to be pruned off. When lifting the tree, ensure that the trunk is not damaged. The diameter of the planting hole shall be twice the root ball diameter. Plant at grade, with the trunk flare visible. Transplanting shall occur as soon as possible and no more than 24 hours after being dug for relocation. Proper irrigation shall be provided during and after transplanting. Following relocation, a 5ft radius TPZ shall be erected.

Disposition -
Relocate - 5ft radius TPZ

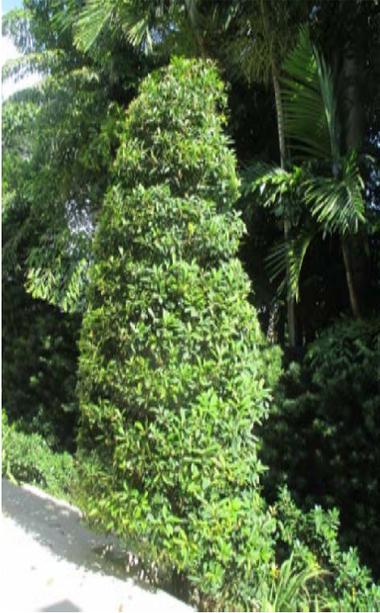
Tree #53 is a Japanese Blueberry located on the eastern side of the house. It is in good condition with a dense green canopy.

Disposition -
Remain - 10ft radius TPZ

This tree is to remain and protective barriers shall be placed 10ft from the tree trunk. Barriers shall be installed prior to the start of construction, and shall remain in place until development is completed and the department authorizes their removal. Barriers shall be a minimum of 4ft high, and shall be constructed of continuous chain link fence with metal posts at 8ft spacing, or of 2x4 posts with three equally spaced 2x4 rails. Posts may be shifted to avoid roots. No materials shall be placed or disposed of within the TPZ. Natural grade shall be maintained within the TPZ.

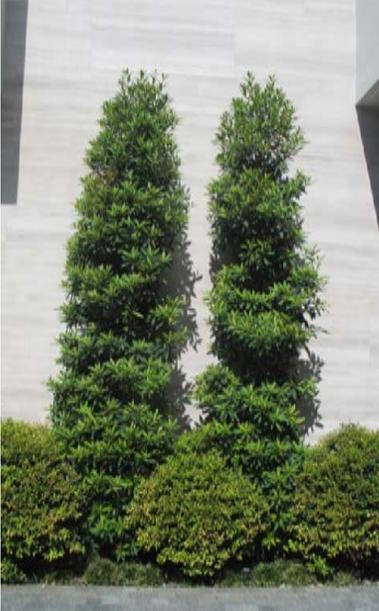
Condition -
Good

Trees #55 - 56 are two Japanese Blueberry trees located at the front of the house. They are in good condition with dense green canopies.

Disposition -
Remain - 10ft radius TPZ

These trees are to remain and protective barriers shall be placed 10ft from the tree trunks. Barriers shall be installed prior to the start of construction, and shall remain in place until development is completed and the department authorizes their removal. Barriers shall be a minimum of 4ft high, and shall be constructed of continuous chain link fence with metal posts at 8ft spacing, or of 2x4 posts with three equally spaced 2x4 rails. Posts may be shifted to avoid roots. No materials shall be placed or disposed of within the TPZ. Natural grade shall be maintained within the TPZ.
