PUBLIC WORKS DEPT Flooding from Stormwater Grates

Roy Coley, Public Works Director April 29, 2021 Land Use and Sustainability Committee

Flooding from Stormwater Grates

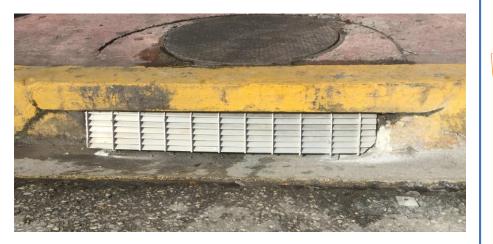
Stop Ocean Pollution Grates

Shortly after installation, a rain event caused flooding on Ocean Drive due to debris clogging the grates. A similar situation was observed at all locations where grates were installed.

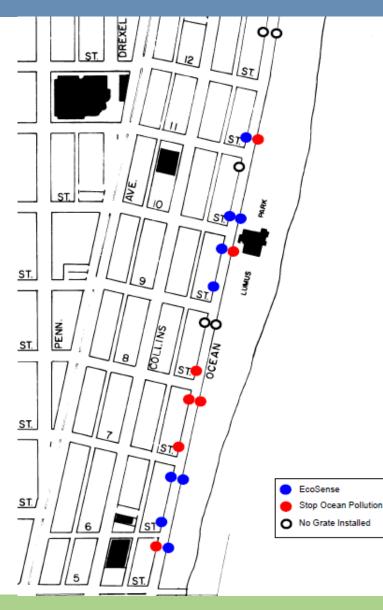
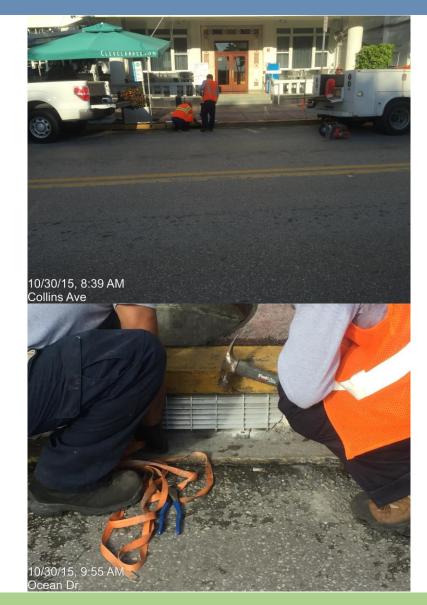
Installation Locations on Ocean Drive

Seven Stop Ocean Pollution and nine EcoSense grates were installed along Ocean Drive from 5th Street to 12th Street.
