RE: 940 71 St, Miami Beach, FL 33141

Enclosed please find the Certified Arborist Report for the property located at 940 71 St. in Miami Beach conducted on March 29, 2021 by Treage LLC.

ARBORIST REPORT

940 71 St.
Miami Beach, FL 33141

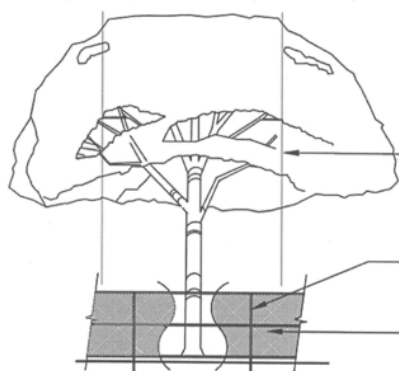
TREE / PALM PROTECTION FENCES SHALL BE CONSTRUCTED PRIOR TO ANY CONSTRUCTION ACTIVITY INCLUDING GRUBBING FOR ALL TREES / PALMS THAT ARE 'TO REMAIN, BE PROTECTED, or BE RELOCATED'

NO ACTIVITY OR DISTURBANCE SHOULD OCCUR WITHIN THE FENCED AREAS, INCLUDING VEHICLE USE, STORAGE OF MATERIALS, DUMPING OF LIQUIDS OR MATERIALS, GRADE CHANGES, GRUBBING, AND MECHANICAL TRENCHING FOR IRRIGATION, ELECTRICAL, LIGHTING, ETC.

In no case shall the fence be installed less than ten feet from the trunk

Tree + Palm protection barriers to extend beyond the 'dripline' or to the 'critical root zone area' of all trees/palms to be protected. Extend where necessary to protect tree canopy roots
