## Flooding and Drainage Issues

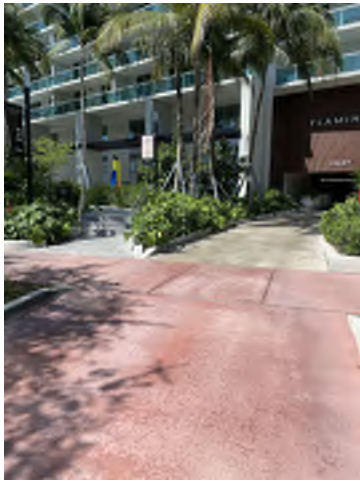
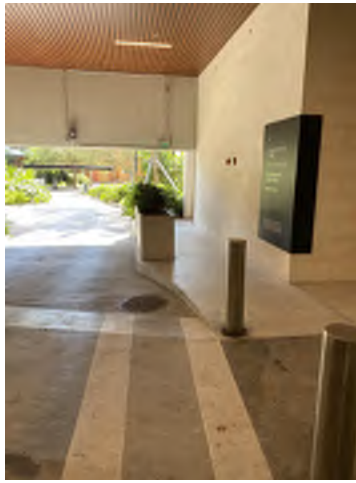
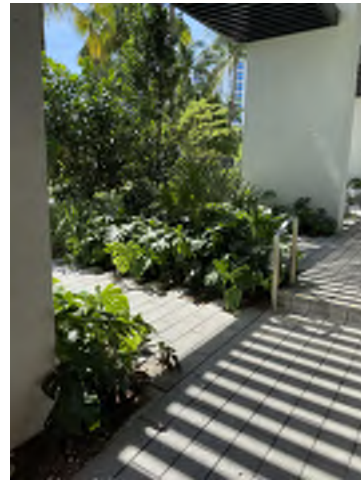
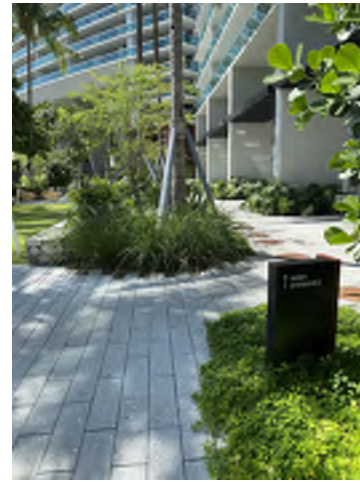
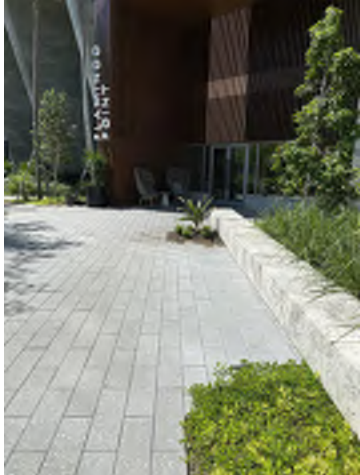
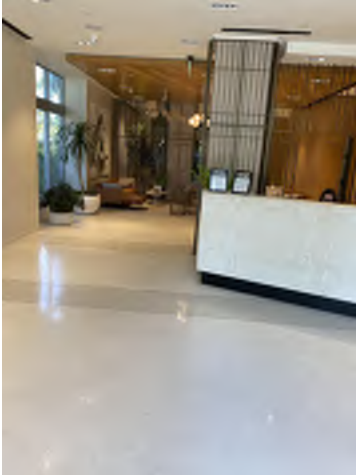
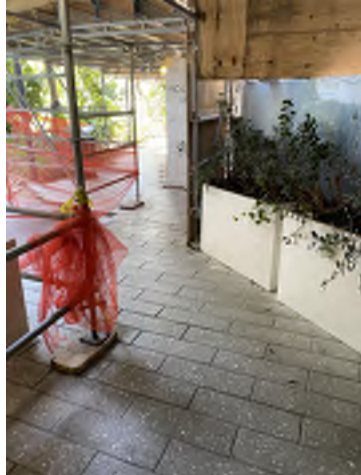
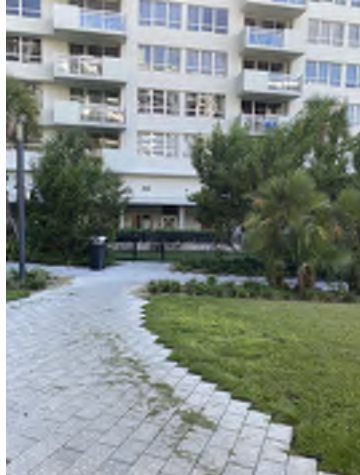
**Option 4:  
Must enter into  
valet drop off  
zone for  
wheeled  
access and  
double back to  
main pathway  
to main  
entrance. Note  
steps blocking  
path.**
