Byron Carlyle Theater

**500 71st Street
Miami Beach, Florida 33141**

CONDITIONS ASSESSMENT AND RECOMMENDATIONS

05-11-2021

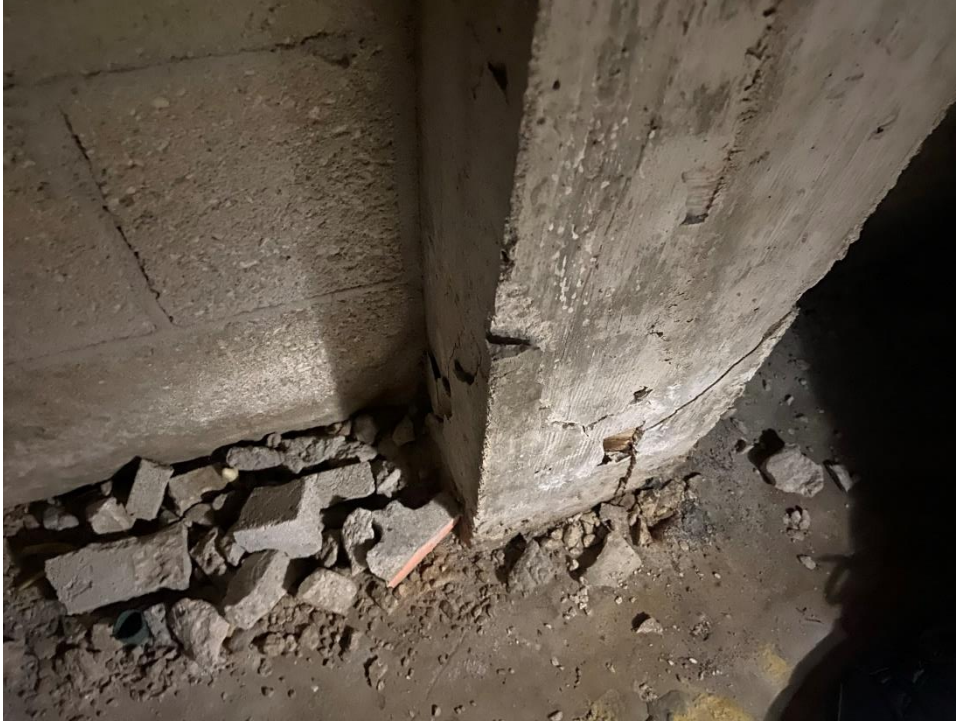
Photograph No. 1

1) Concrete column located in hallway adjacent to the underground restrooms (at the west side) is spalled at the base (refer to Photograph No. 1).

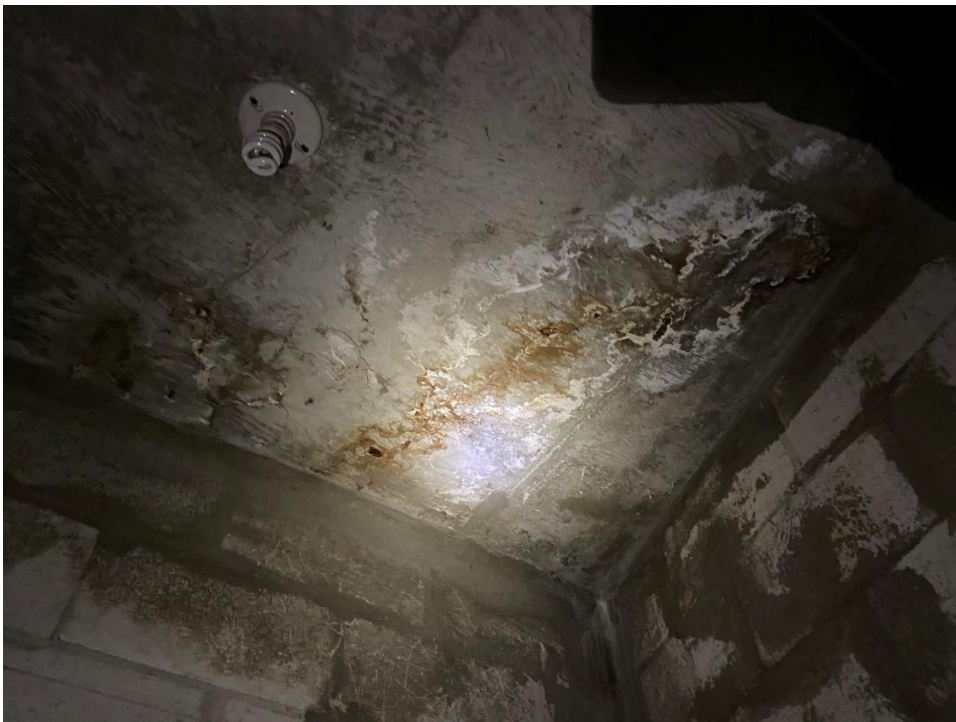
Photograph No. 2

2) Concrete slab above the electrical room at the ground floor (at corner of room, towards South facade) in between the east and west sides of the buildings is spalled (see Photograph No. 2).

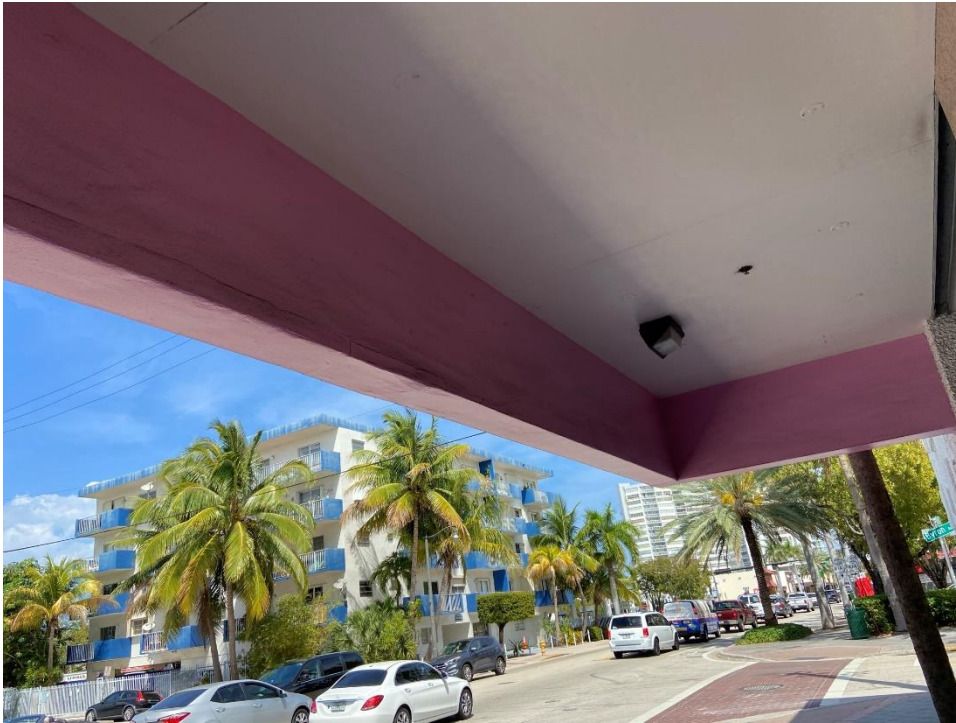
Photograph No. 3

3) Exterior concrete beams at the north facade of the building are spalled at the bottom (see Photographs No. 3 through 5).

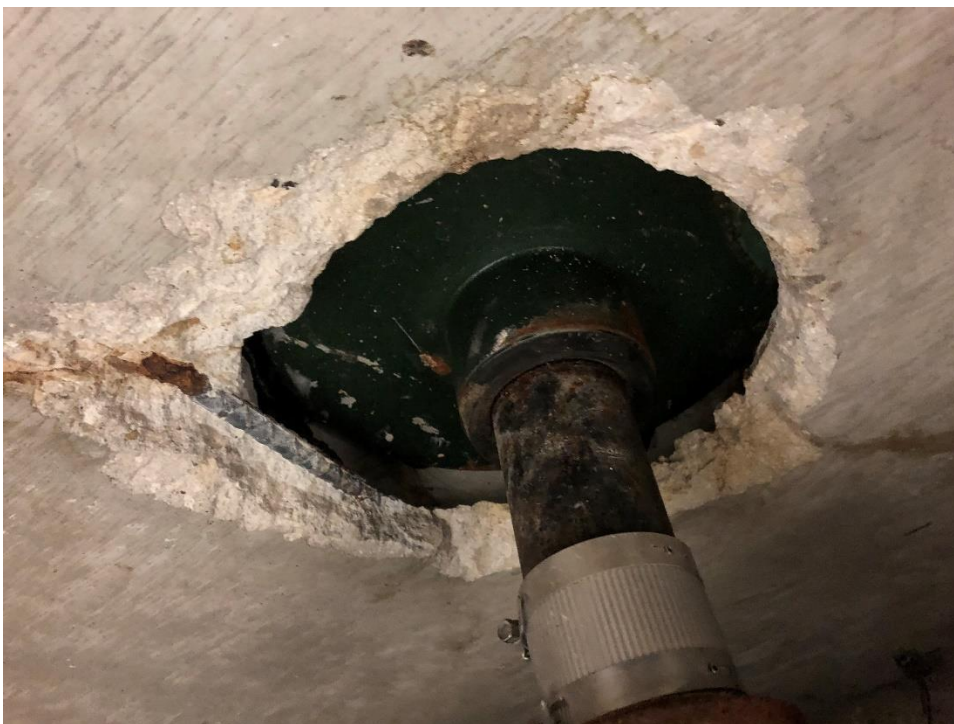
Photograph No. 6

4) Second level concrete slab in the south façade of the building (towards the center, above the men's restroom) has a large opening (about 9" in diameter) (refer to Photographs No. 6 and 7). Exposed reinforcement is observed at the perimeter of the opening as well as perpendicular narrow cracks. Additionally, a water tank seems to be bearing above this opening.

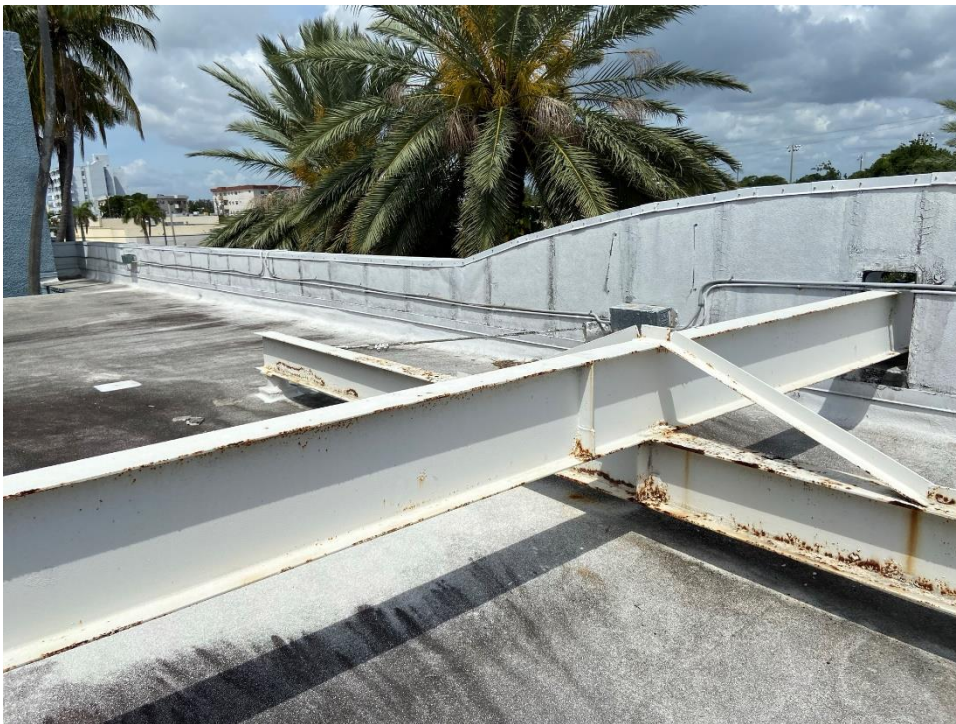
Photograph No. 8

5) The structural steel supporting the theater sign (located at low roof near north façade) is mildly corroded (see Photographs No. 8 and 9).

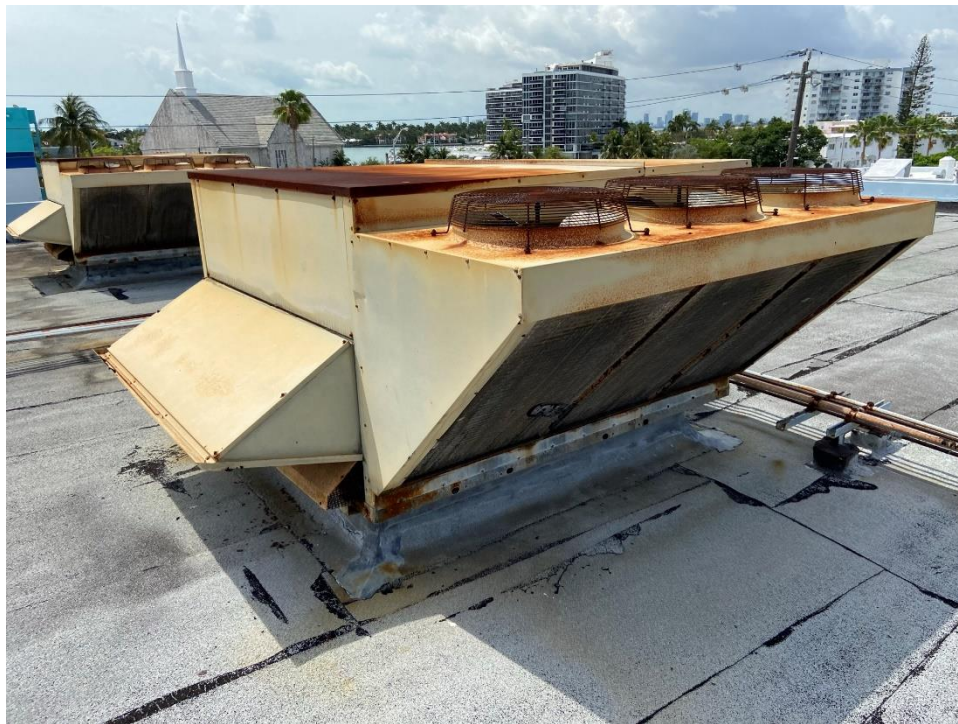
Photograph No. 10

6) Rooftop A/C package units at western upper roof are mildly corroded (see Photographs No. 10 and 11).

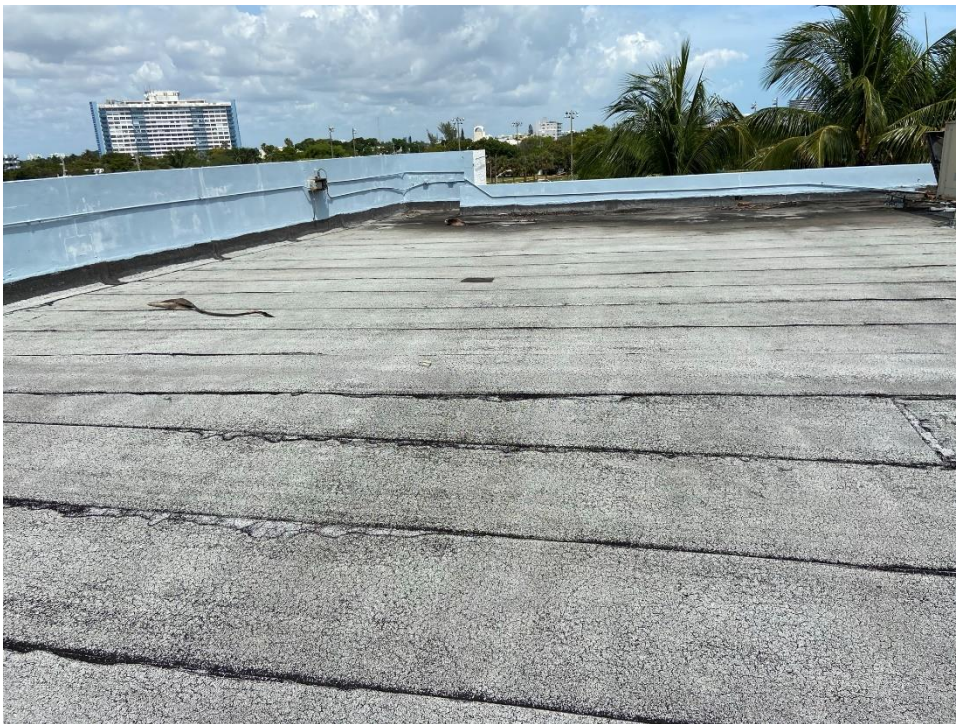
Photograph No. 12

7) The roofing systems over all upper roofs and lower roofs are old and the granules have worn away (refer to Photographs No. 12 through 16).

A Roof Report was not received for this Study. All roofing, terminations, caps, curbs and accessories are recommended for a complete replacement. The roof consists of nine separate flat roof areas with built-up roofing membranes supported by either a concrete deck, or steel deck and lightweight concrete on prefabricated steel bar joists. Over the theaters, the top chord of the joists is sloped slightly to assist drainage slope. Future re-roofing over theater areas should take acoustics into consideration. Based on record documents received, the existing roofing over the east portion of the building is 19-20 years old, and the roofing over the west portion is 25-30 years old. All roof areas were worn, cracking was noted, and the low parapet walls had no caps. For added protection, a future project could consider bringing the roofing up an over the parapet and covering with a new cap. Any new cap locations should be carefully coordinated with the existing architecture. The existing rooftop HVAC equipment and exhaust fans were corroded and not functional and must be replaced, along with new curbs. In at least one location, the equipment was close to the roof edge, where a guardrail is required by current code and was not present. Depending on future design, some existing roof openings will need to be structurally closed, and / or new openings created.

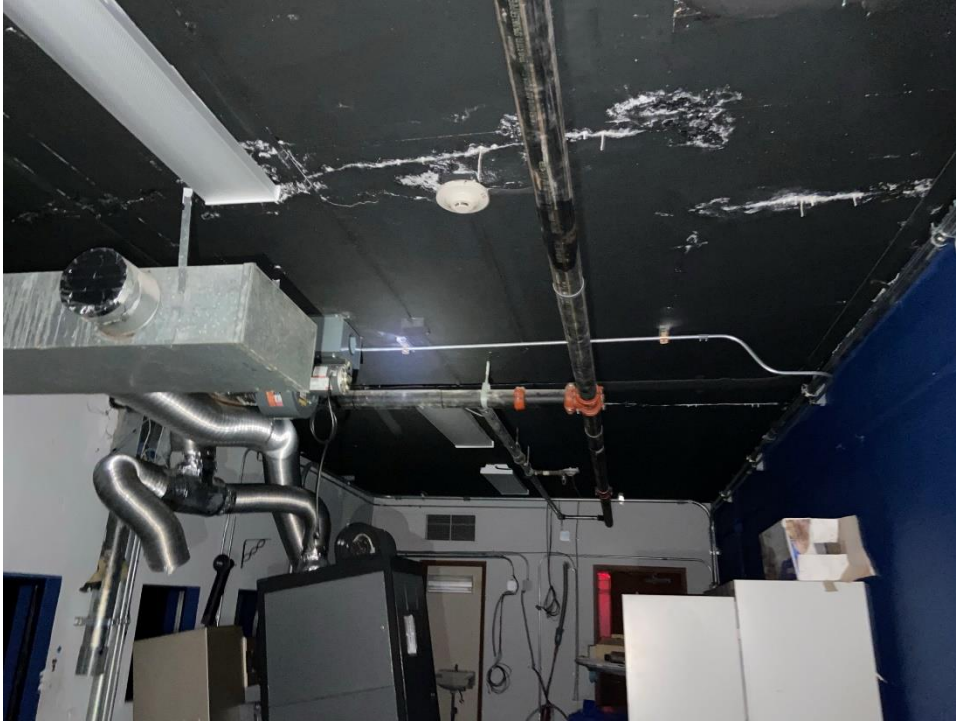
Photograph No. 17

8) Efflorescence was observed below the low roof slab located above projection room of cinema theater in the eastern portion of the building through cracks in the slab (refer to Photograph No. 17). This is likely the consequence of roof leakage. This may have been a previous leak.

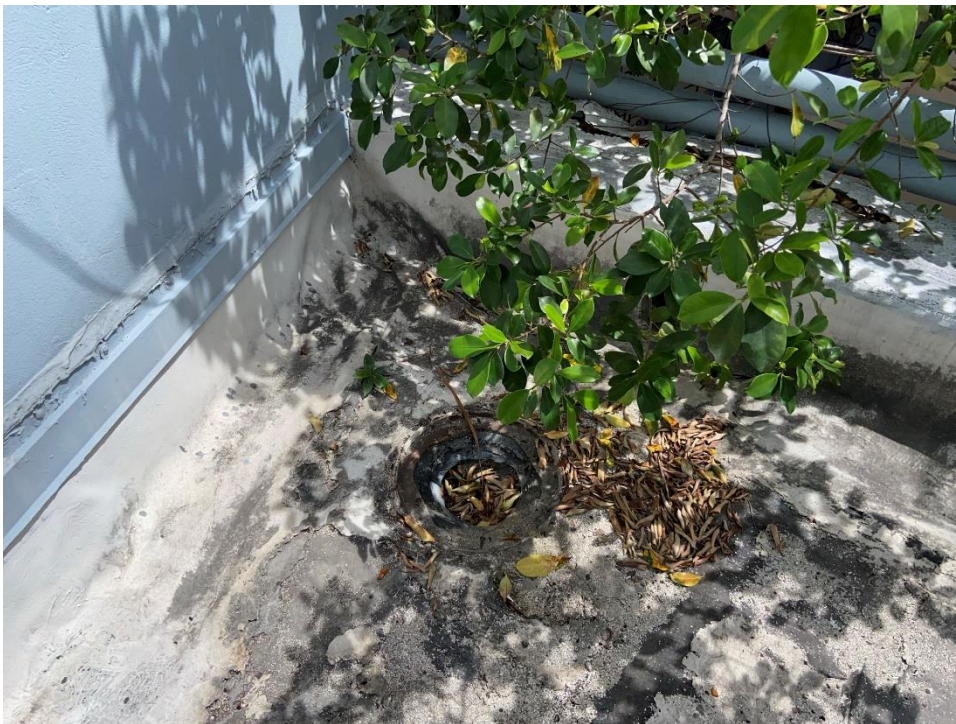
Photograph No. 18

9) Drain of low roof at 2nd floor is missing protective cover. Debris and leaves are presently obstructing the drain (refer to Photograph No. 18).

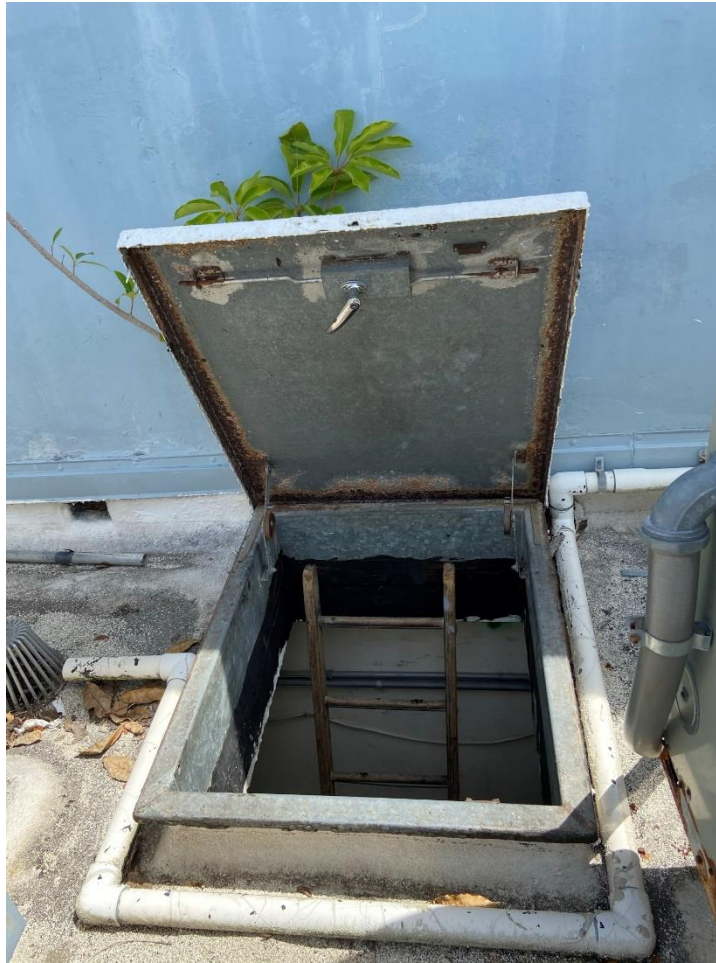
Photograph No. 19

10) Access roof hatch located at the east low roof is mildly corroded (refer to Photograph No. 19).

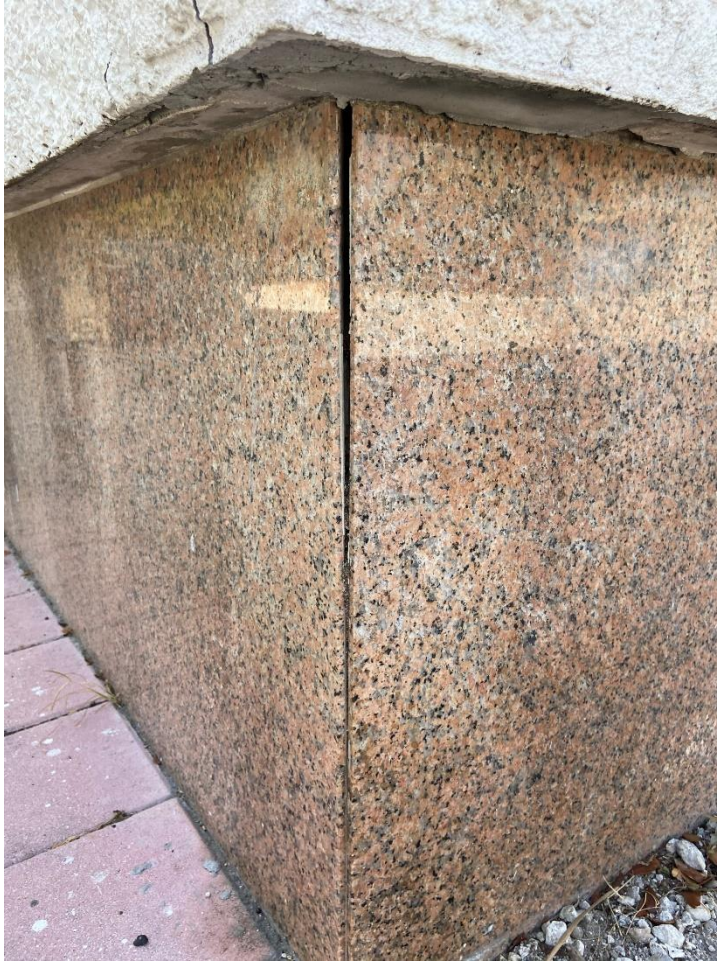
Photograph No. 20

11) There is a small gap between the exterior adjoining stone tile at the northeast corner that might allow moisture ingress and therefore potential deterioration of structure behind (see Photograph 20).

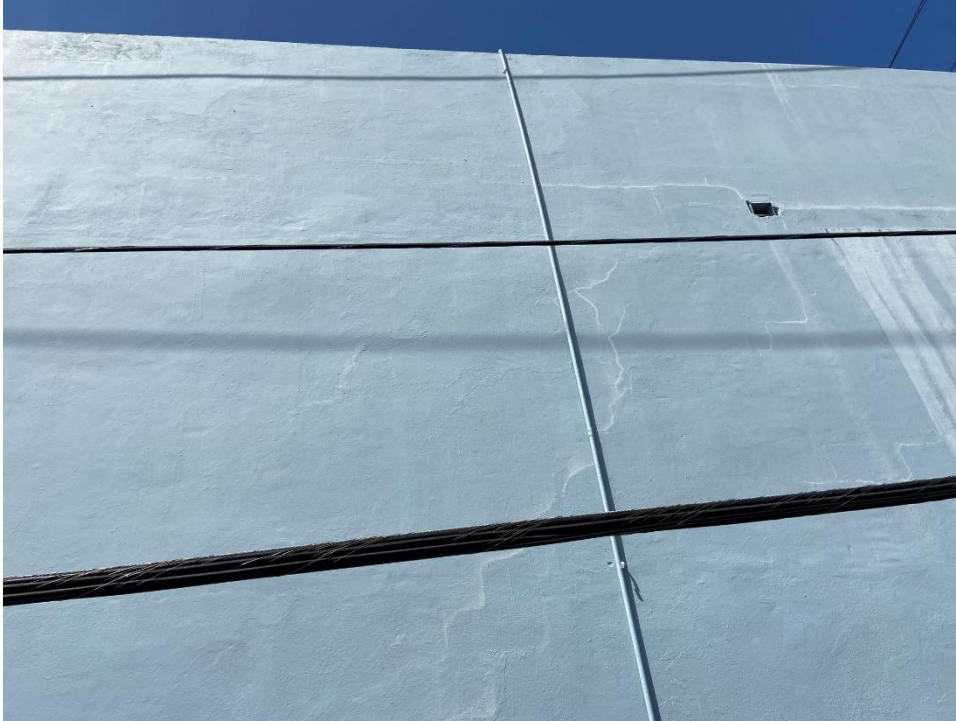
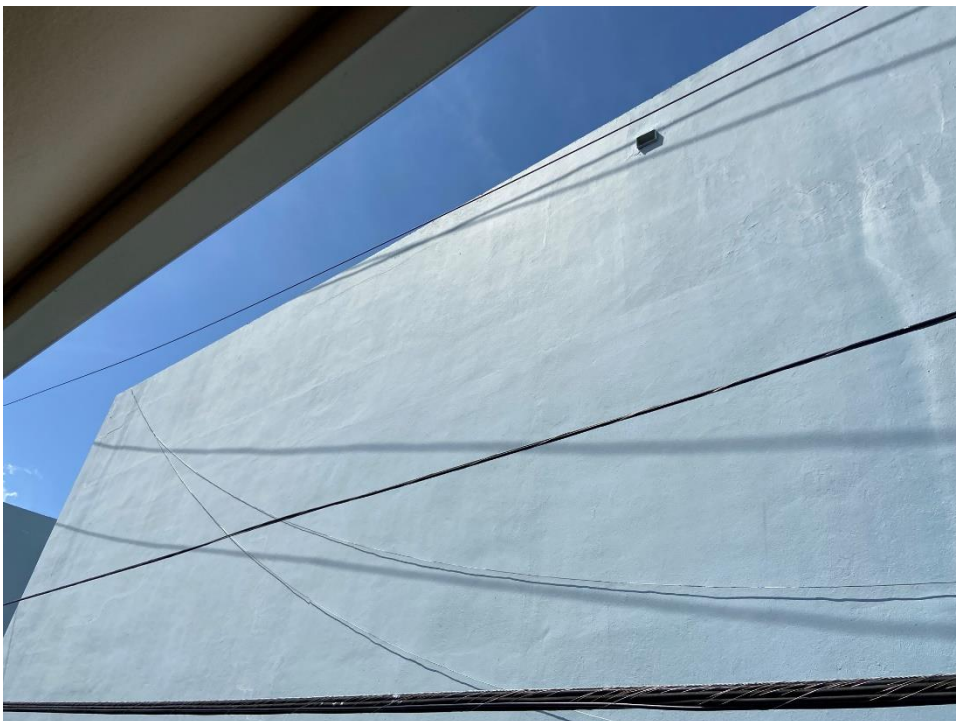
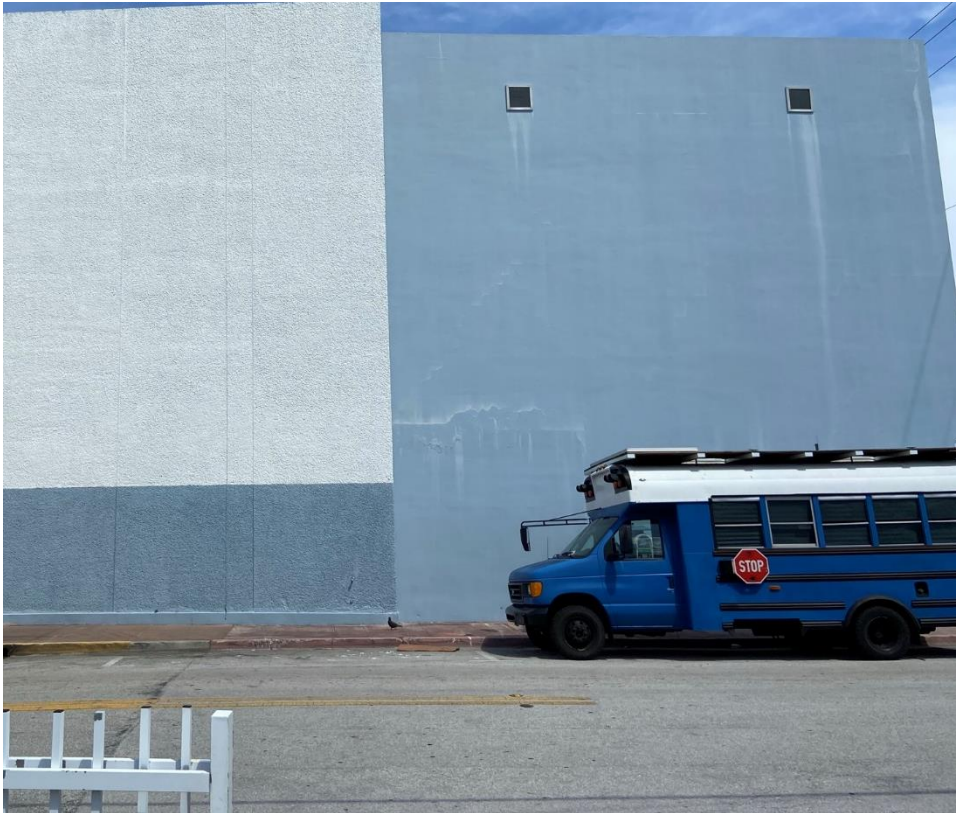
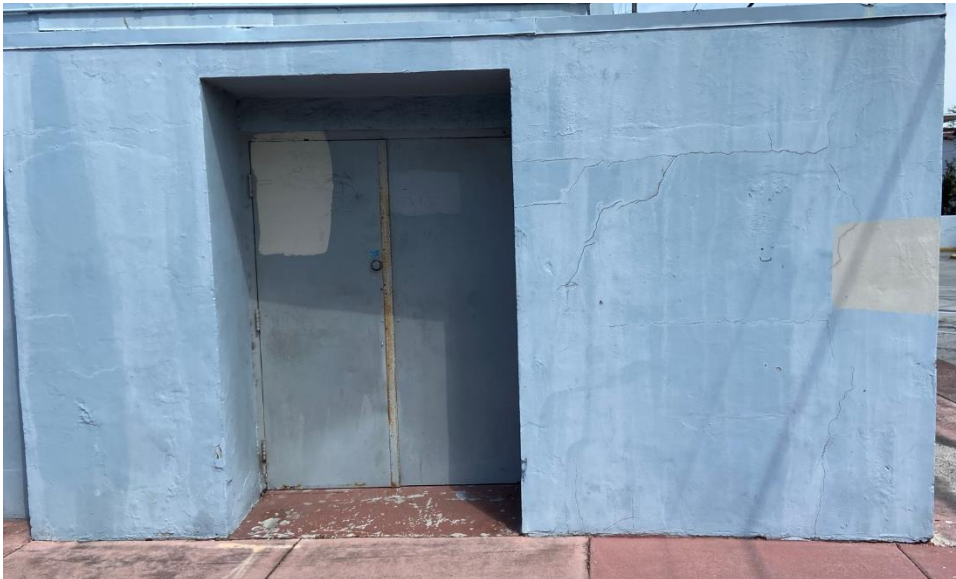
12) There are a few cracks on the exterior stucco finish of the C.M.U. walls throughout the south and east facades (refer to Photographs No. 21 through 24).

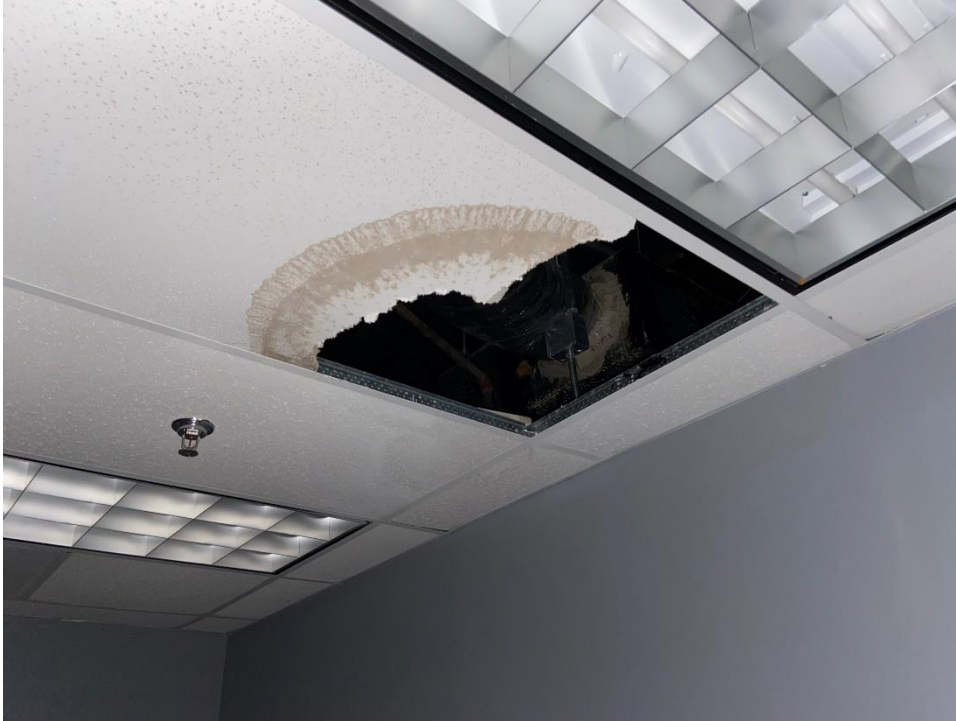
Photograph No. 26

14) The ceiling failed and there were moisture stains in a location of the ceiling over first-floor office area (towards the north façade) (see Photograph 26). The portions closer to the failure

exhibited moisture stains. This is likely related to water intrusion from the low roof at the north façade. Refer to Photograph 27 for a view of the underside of the structural framing at this location.

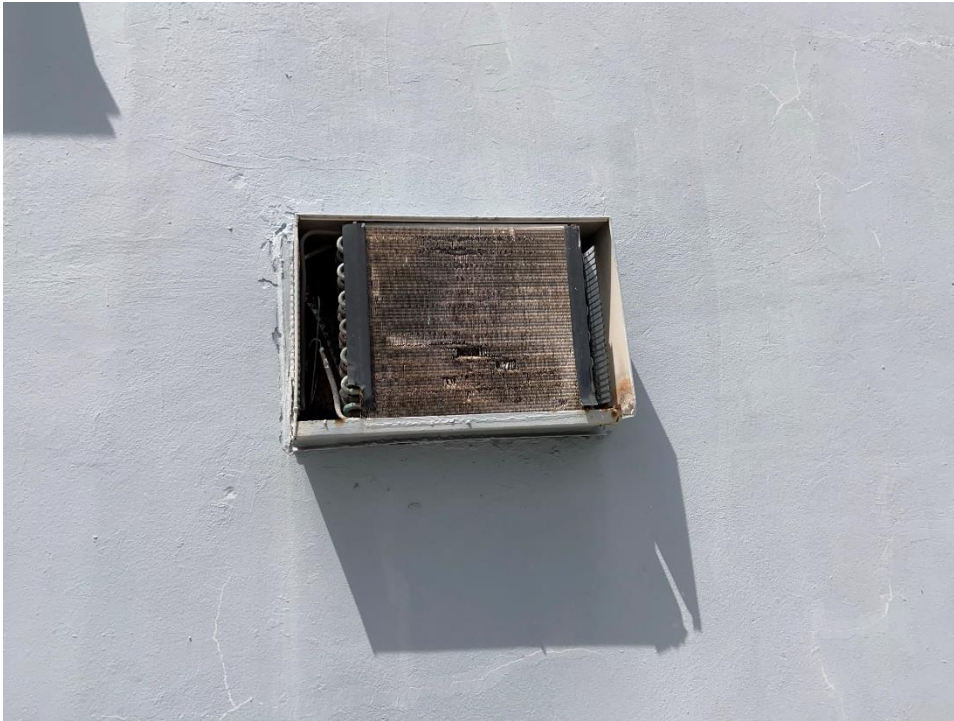
Photograph No. 28

15) Air conditioning unit in 2nd floor room at south end of the building, in between the east and west theaters, lacks exterior cover (see Photograph 28). This can potentially allow water intrusion and accelerate deterioration of adjacent concrete members (i.e. concrete spalling and corrosion).
