Flooding from Stormwater Grates

On October 2015, the City initiated a pilot program for inlet grates. Two types of grates were chosen from two different vendors, Stop Ocean Pollution and EcoSense.

Seven Stop Ocean Pollution and nine EcoSense grates were installed along Ocean Drive from 5th Street to 12th Street.

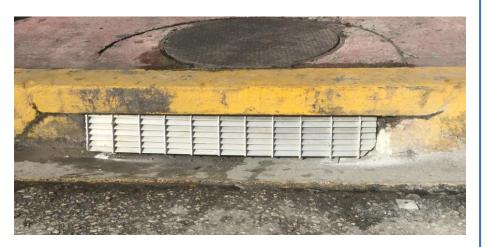
Stop Ocean Pollution Grates

Shortly after installation, a rain event caused flooding on Ocean Drive due to debris clogging the grates. A similar situation was observed at all locations where grates were installed.

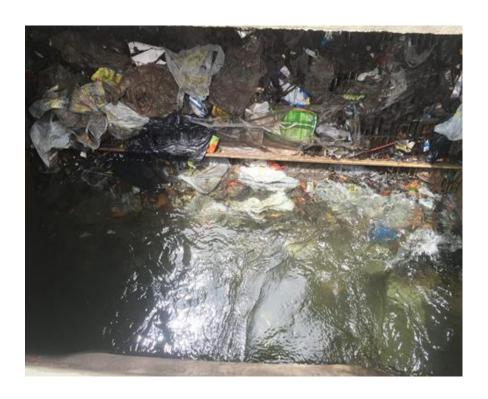
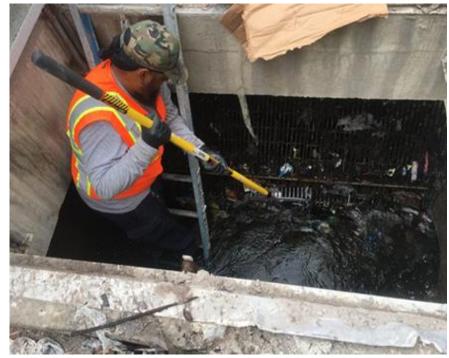
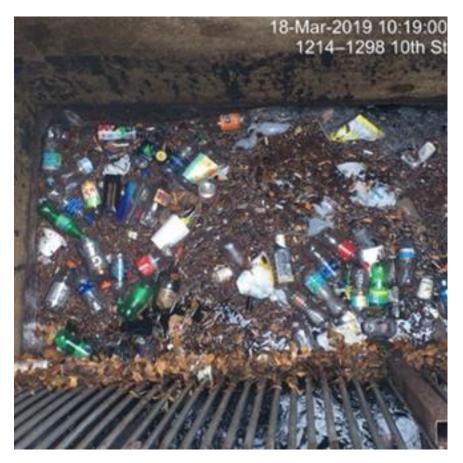
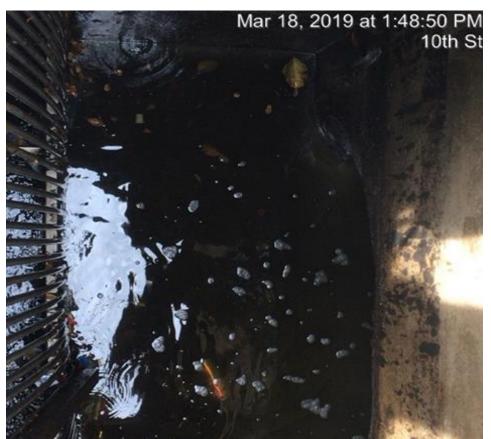
Cleaning at Screen/Trash Rack Structure

The process is extremely labor intensive. The daily inspections cleaning of the city's 4100 storm inlets is cost prohibitive. Less impact to collect the trash at the pump stations collection systems
