GENERAL CONDITIONS ASSESSMENT REPORT

EXISTING STRUCTURAL SYSTEMS

EXISTING RESIDENTIAL APARTMENT BUILDING

1158 MARSEILLE DRIVE
MIAMI BEACH, FLORIDA

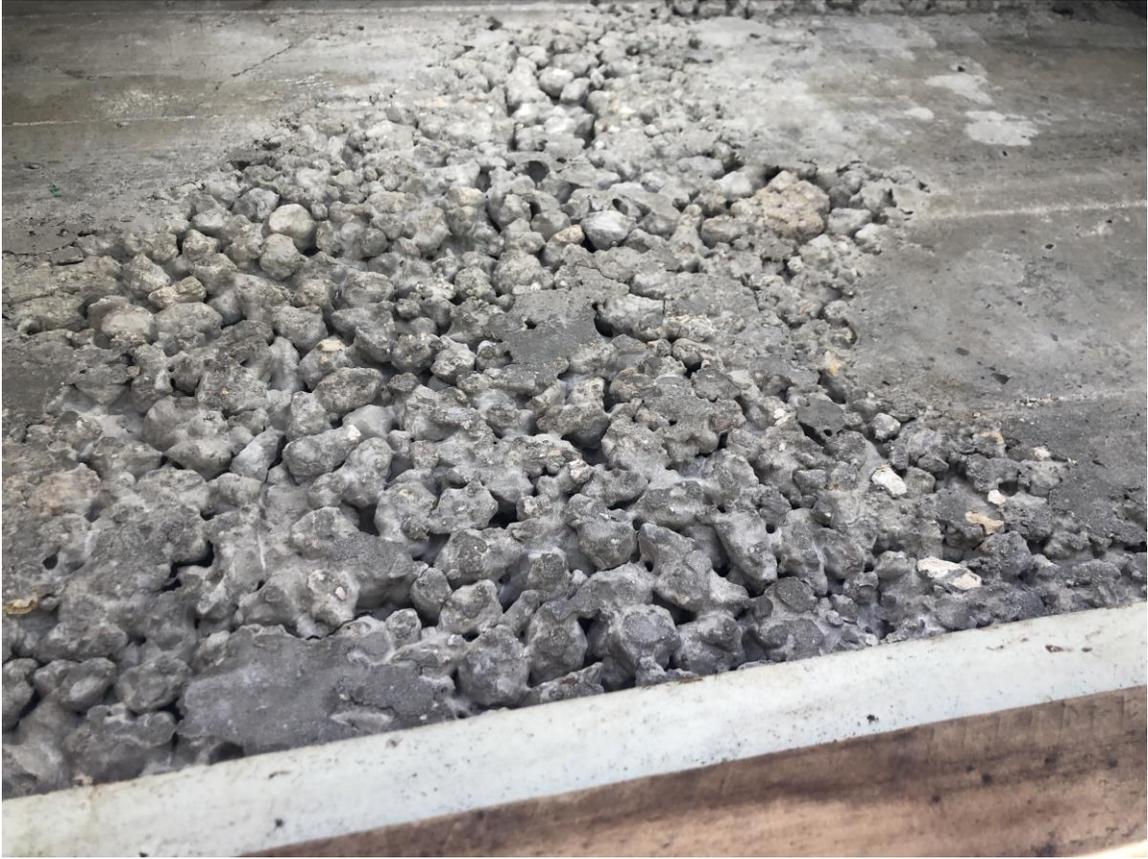
PHOTOGRAPH NO. 41

6. The roofs of the storage closets are thin concrete slabs. There are several locations of spalled concrete (detected by “sounding”) and cracked concrete (refer to Photograph No. 37) in these slabs. There is a location of “honeycombed” concrete on the bottom of these slabs (refer to Photograph No. 41). This condition is from the original construction. This condition hastens deterioration of the concrete member.
