# ARBORIST REPORT

## 5860 La Gorce Drive

## Miami Beach, FL 33140

Treage LLC ~ Tree and Garden Experts  
www.treage.com ~ info@treage.com ~ 786.525.7883

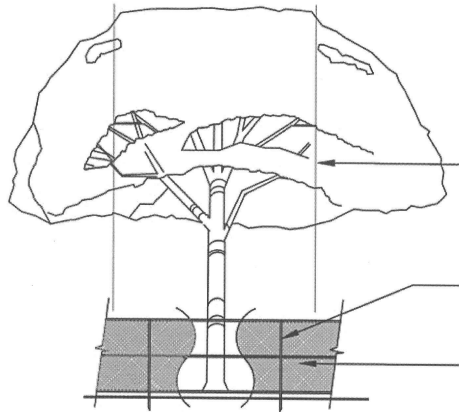
TREE / PALM PROTECTION FENCES SHALL BE CONSTRUCTED PRIOR TO ANY CONSTRUCTION ACTIVITY INCLUDING GRUBBING FOR ALL TREES / PALMS THAT ARE 'TO REMAIN, BE PROTECTED, or BE RELOCATED'

NO ACTIVITY OR DISTURBANCE SHOULD OCCUR WITHIN THE FENCED AREAS, INCLUDING VEHICLE USE, STORAGE OF MATERIALS, DUMPING OF LIQUIDS OR MATERIALS, GRADE CHANGES, GRUBBING, AND MECHANICAL TRENCHING FOR IRRIGATION, ELECTRICAL, LIGHTING, ETC.

In no case shall the fence be installed less than ten feet from the trunk

Tree + Palm protection barriers to extend beyond the 'dripline' or to the 'critical root zone area' of all trees/palms to be protected. Extend where necessary to protect tree canopy roots

Protection measures for this project include: 1) establishing Tree Protection Zones (TPZ) with proper fencing and signage (see Tree Protection Detail below) 2) protecting the Critical Root Zone (CRZ) with a temporary application of 6" of mulch to reduce soil compaction and potential root damage, 3) avoiding cutting any roots within 15-30 cm of the root initiation zone and 4) ensuring that no grade changes or storage or disposal of harmful substances occur in the Tree Protection Zone.

Additional details on protection during construction can be found in the ANSI A-300 standards referenced above, or by further consultation and oversight of construction activities by a certified arborist. See Tree Protection Detail on following page.
