Deauville Beach Resort - Structural Condition Assessment
Anesta Consulting File Number: 21-04005
Report Issued December 15, 2021

Structural Condition Assessment

Building: Deauville Beach Resort

Location: 6701 Collins Avenue, Miami Beach, Florida 33141

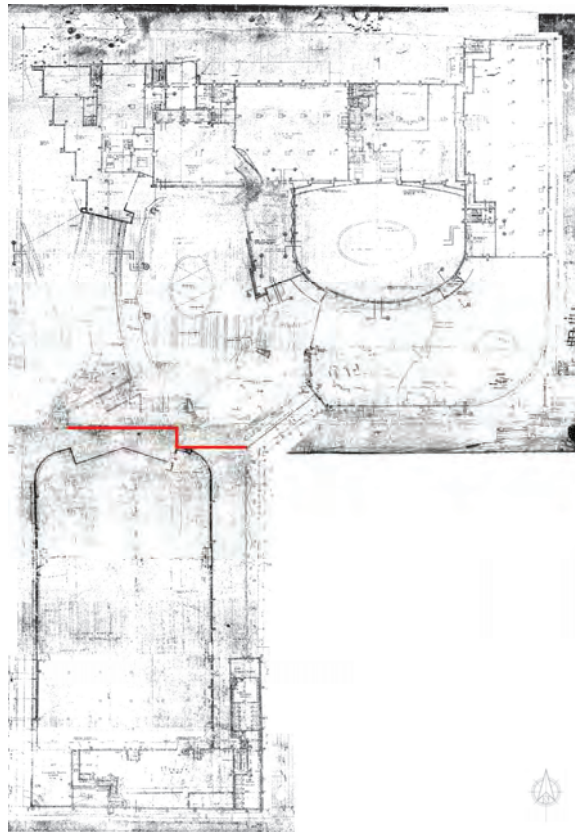
We identified one isolation joint within the Deauville during our scope of work, located as shown in Image 15. There were no isolation joints present between the Hotel portion and Lobby/east ballroom portions of the Deauville. The structure below the Low Roof was continuous below the 4th elevated slab of the Hotel portion of the Deauville, as shown in Image 16.

Image 15: Location of Isolation Joint below Low Roof Level (red line). Note that there was no Isolation Joint along the Hotel interface with the Lobby Level.

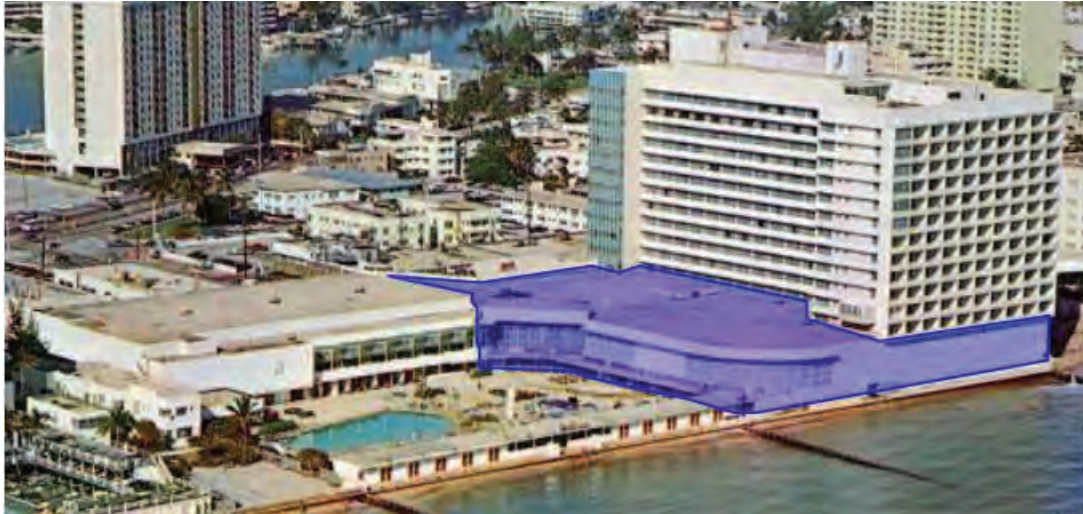
The most substantial transfer slab we identified within the Deauville was located at the 4th Elevated Level below Hotel Portion of Structure, and was continuous with Low Roof Structure (Image 16 and 17). Essentially, the columns along the hallways in the Hotel portion of the structure were transferred by cantilever beams within the transfer slab to the column locations in the Ground, Lobby, and 3rd Floor levels of the structure below (Image 18). The transferred columns in this area were part of both the vertical and lateral systems of the Deauville.

Image 16: Graphic Depiction of Continuous Structure with Hotel Portion (blue shaded area) based on Isolation Joint Location.

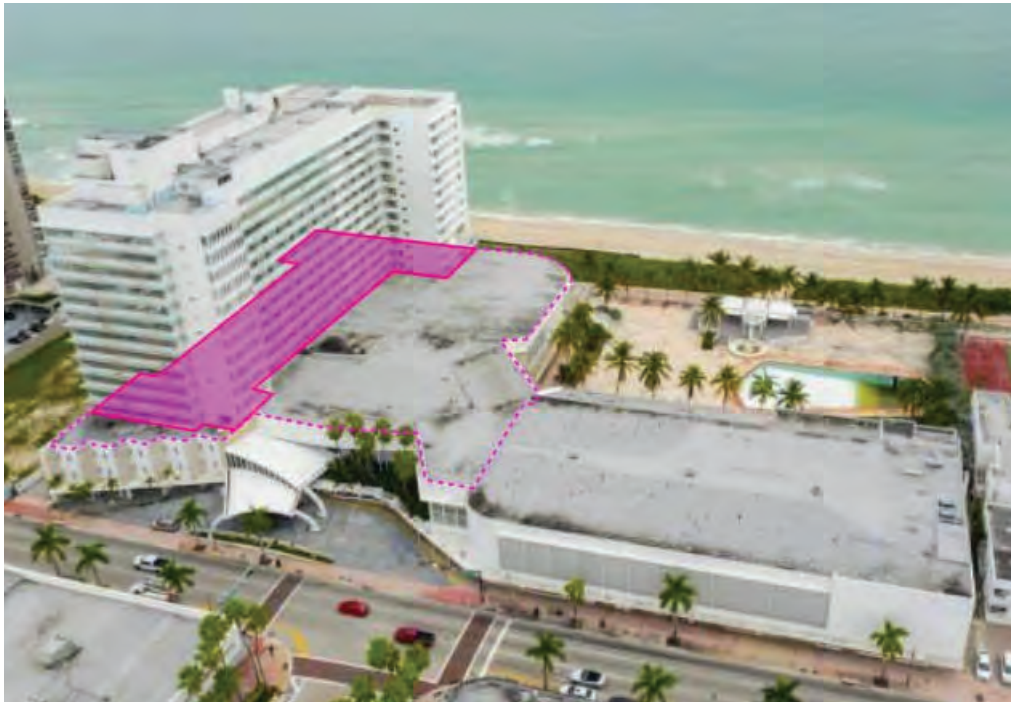
Image 17: Location of the Transfer Slab at 4th Elevated Level below Hotel Portion of Structure, Continuous with Low Roof Structure.

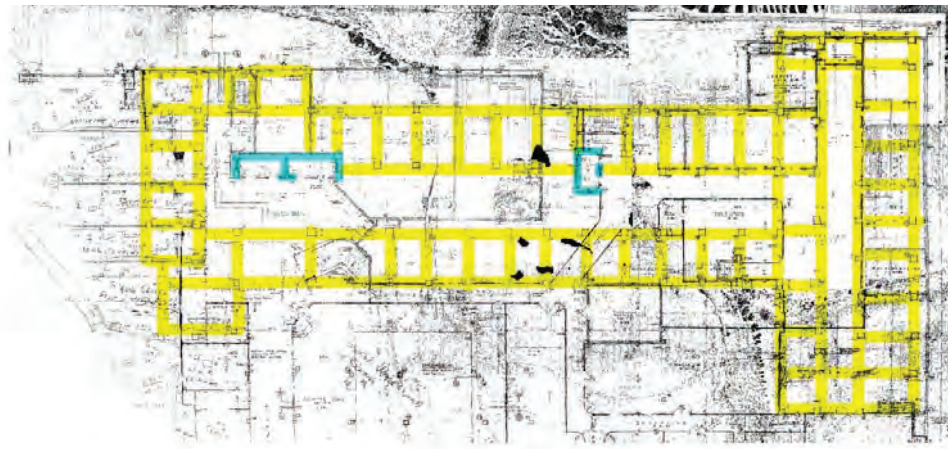
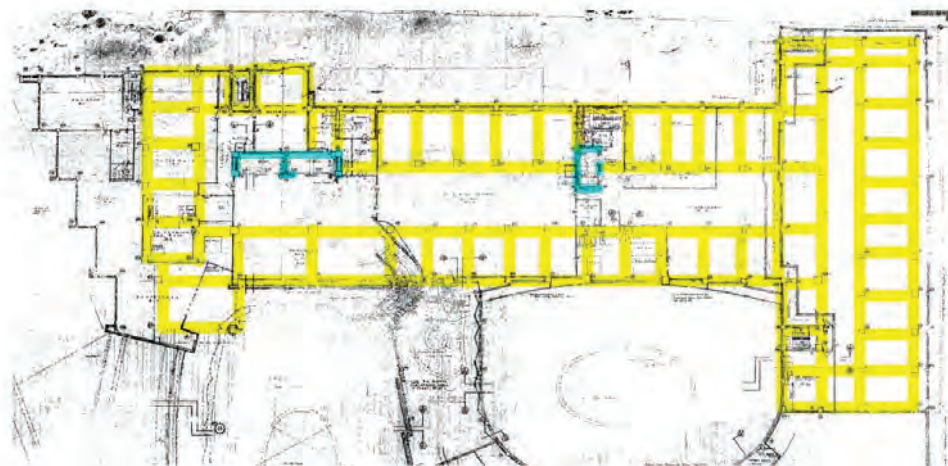
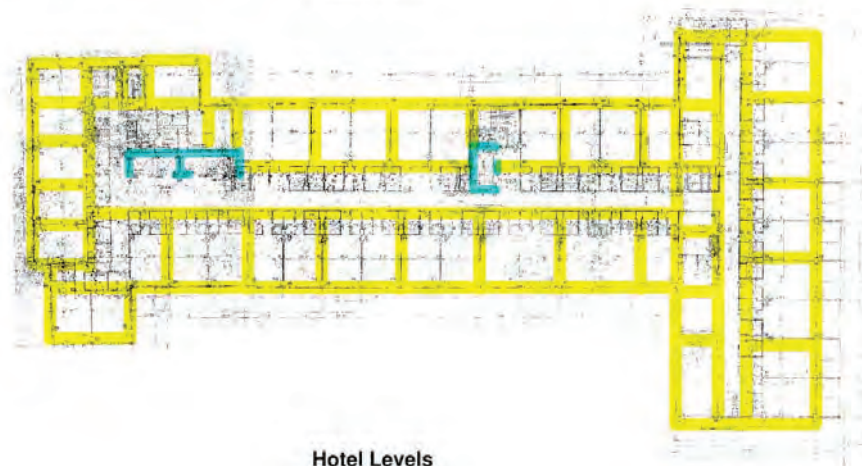
The lateral system of the Deauville appeared to primarily consist of reinforced concrete frames located along its perimeter walls. We observed few, if any, shear walls while on site or within the record set of plans. There was one apparent shear wall which ran north-south within the center of the main elevator shaft (nearest the lobby). The remainder of the system whether within the Hotel portion or throughout the Lobby and Ballroom areas were frame systems along the perimeter walls. The frames within the Hotel portion featured smaller cross-sections and larger on-center spacings on the main roof level than on the ground level, as depicted in Image 18. For example, the columns on the ground level ranged from 28"-48" square with frames along every bay, while the main roof level columns ranged from 14"-20" square with frames along every other bay.

Image 18: Apparent Lateral System Layout of Deauville within Hotel Portion of Structure

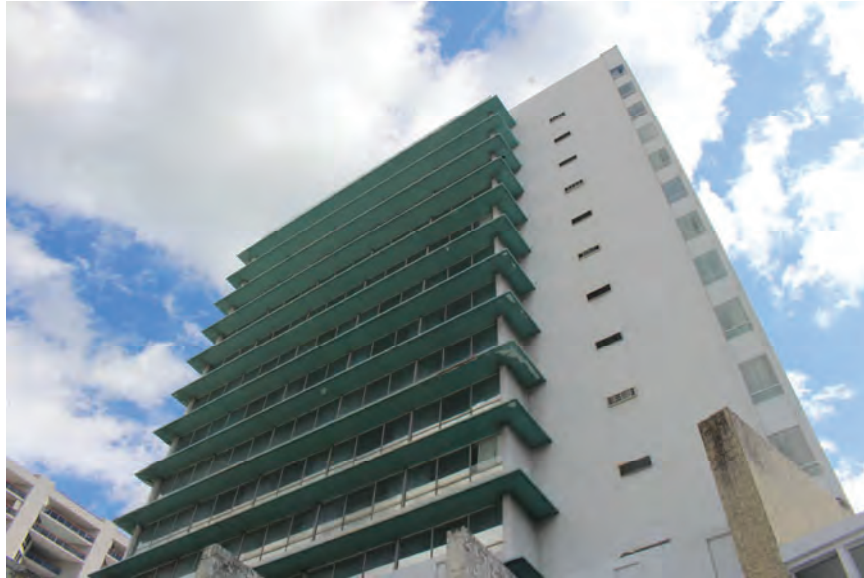
Image 20: View of the exterior condition of the west wall of the Hotel.

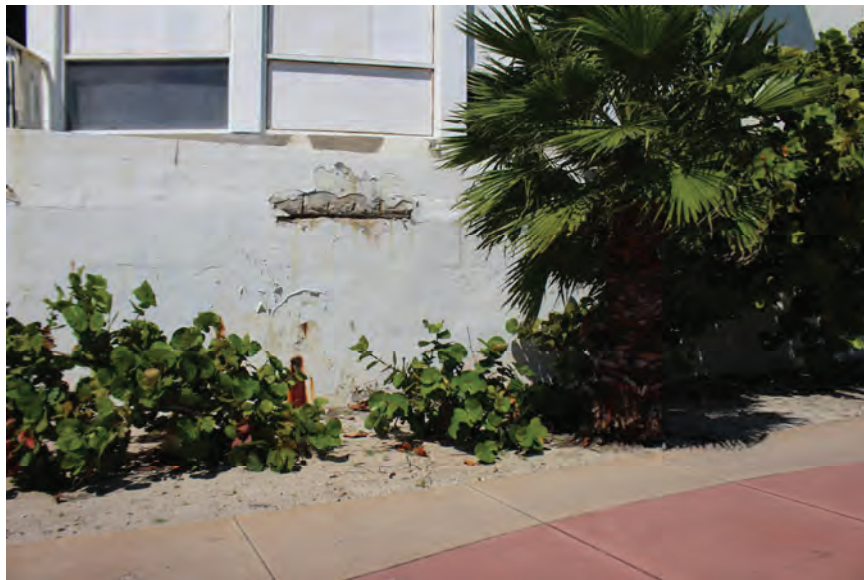
Image 33: View of the condition of the support wall below the east ballroom.

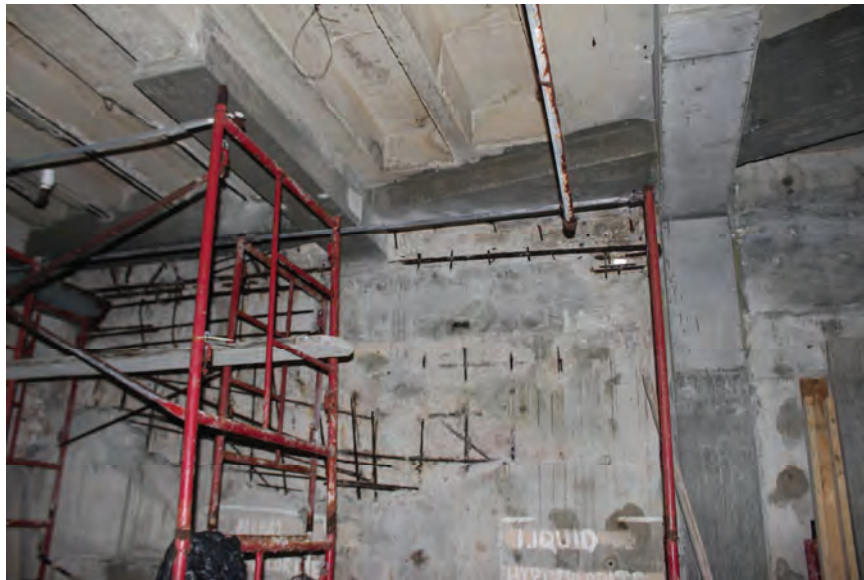
Image 35: View of the condition of the east support wall below east ballroom, from within the pool equipment room.

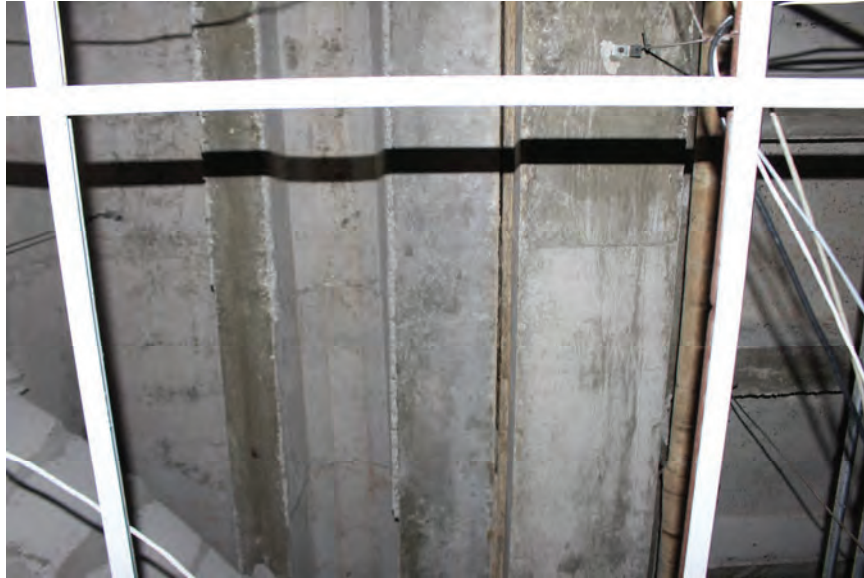
Image 44: View of the isolation joint between the north and south portions of the structure, shown in Image 15.

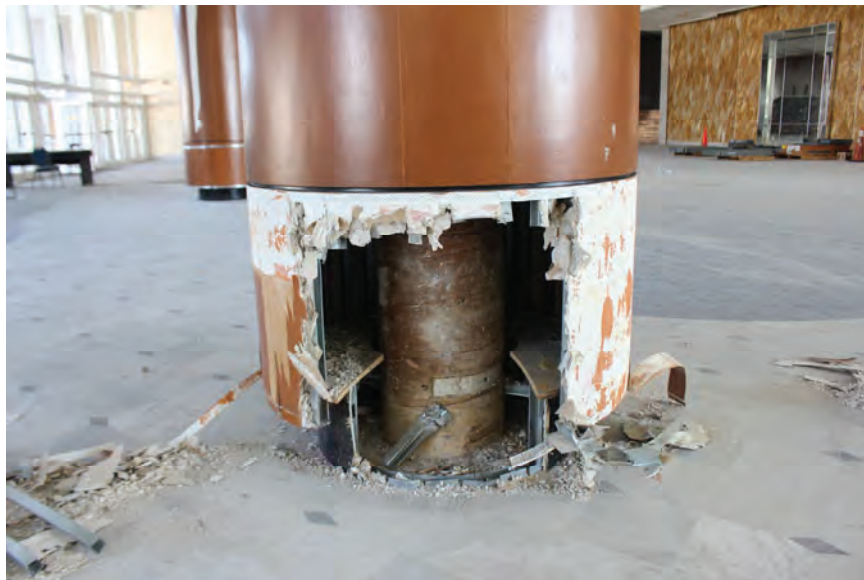
Image 51: Typical sonotube column within Lobby. Note that the column's sonotube paper was encasing the column.

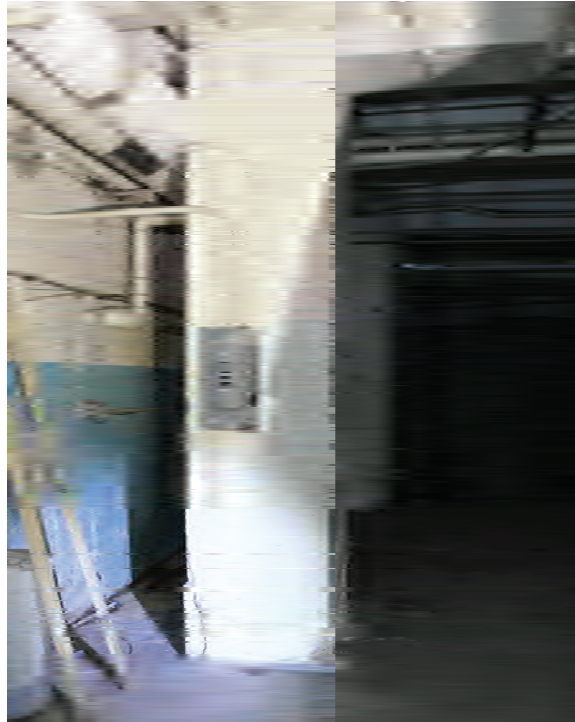
Image 52: Typical condition of Ground Level column, below Hotel, within the interior of the building. Note corrosion as well as honeycombed concrete.

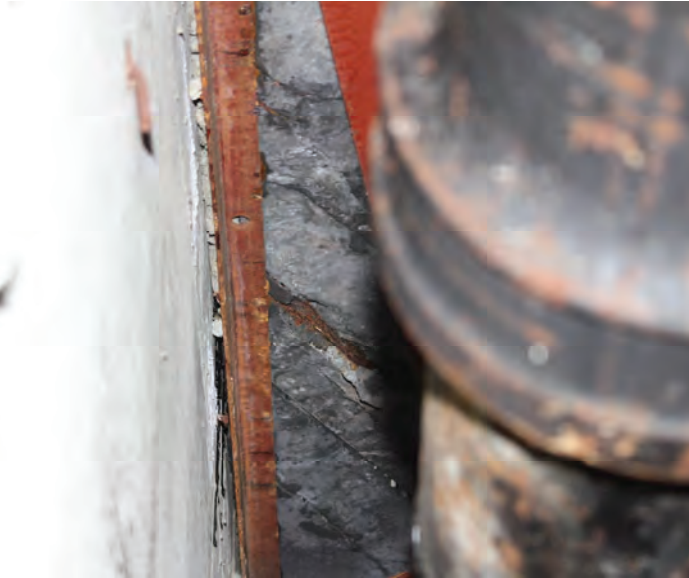
Image 56: Typical condition of corroded plank slab system above the steel truss framed roofs above the Lobby and Ballrooms

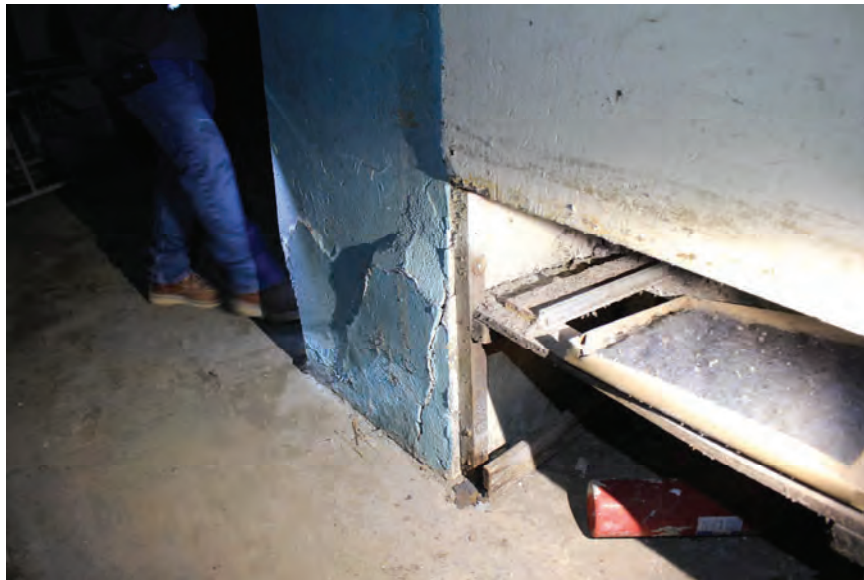
Image 59: Typical condition of Ground Level column within and along Boiler Room, below Hotel.

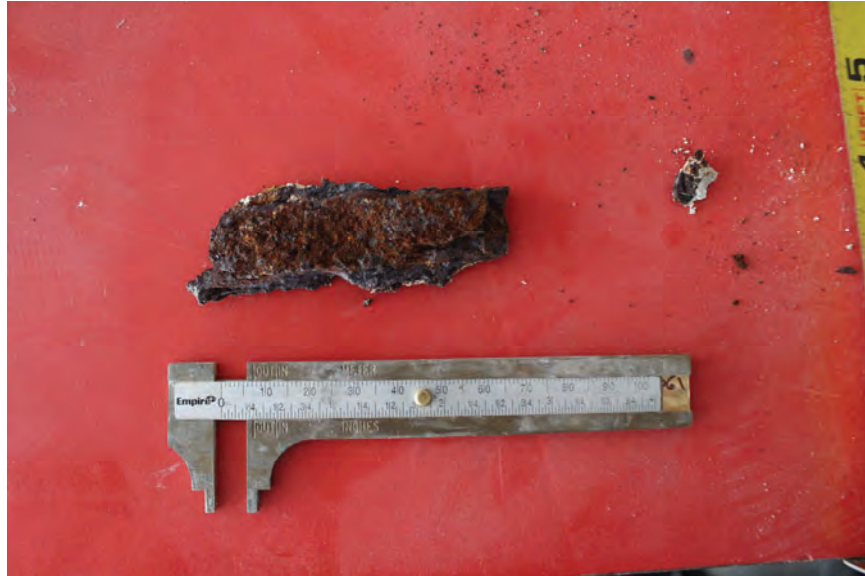
Image 72: Use of caliper to measure thickness of flaked reinforcement steel due to corrosion. This particular photograph exemplifies a typical condition of flakes ranging between 3/16 – 5/16" from #11 bars in Frame Columns.

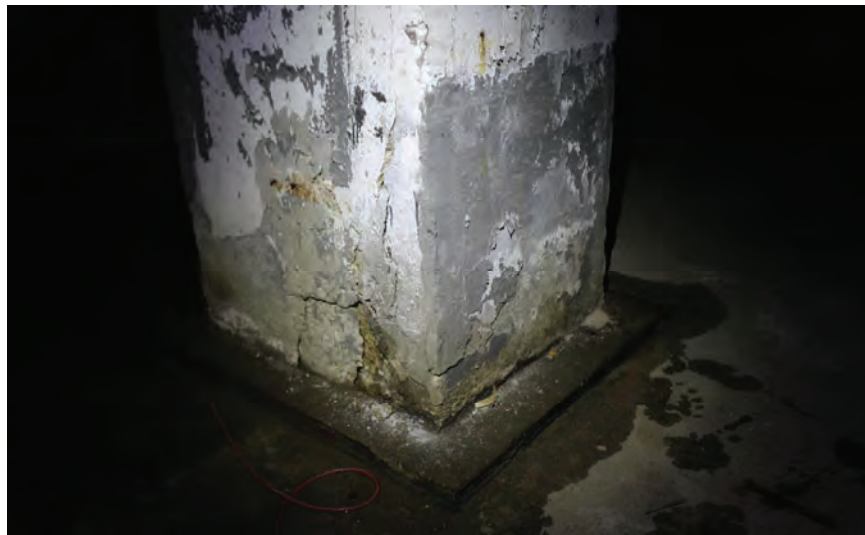
Image 73: Typical condition of Ground Level Hotel frame column with previous patch repairs.

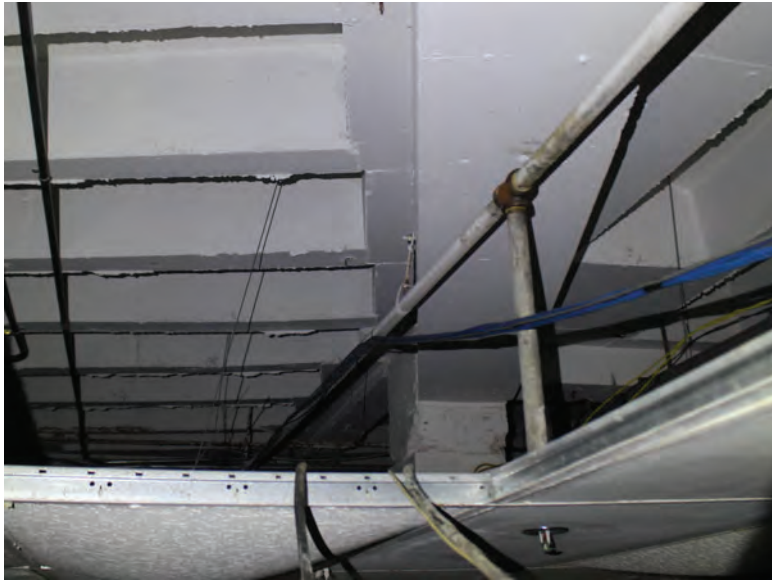
Image 80: Typical condition of congested beam-column frame joint. Note honeycombed concrete and poor horizontal joint within column.

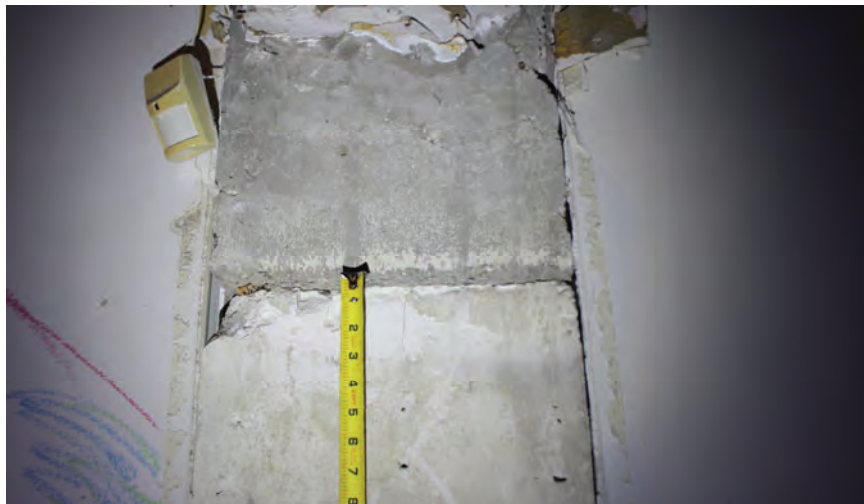
Image 87: Typical horizontal joint within frame column in conjunction with poor mix and concrete quality. Note that the lower portion of the column was a powder-like consistency, able to be removed in large pieces by hand, and the upper portion of the column was a grainy consistency which was able to be scraped away by hand. (Label 3)

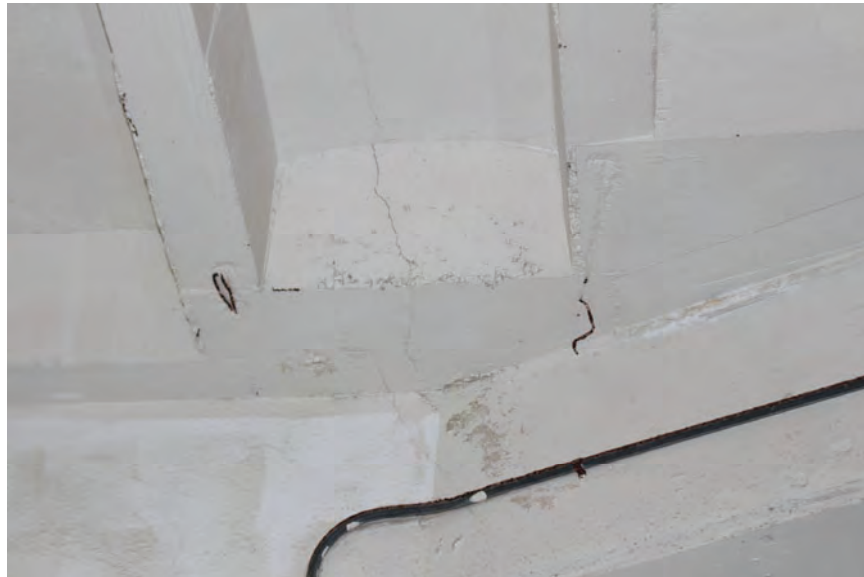
Image 91: Close up view of structural crack in previous image. Note the continuation of the crack through several elements. Note the honeycomb in the slab.

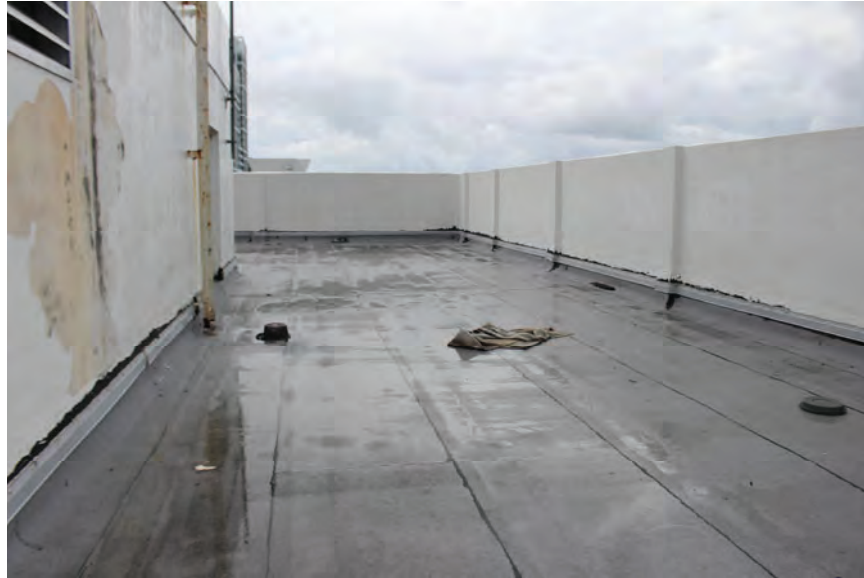
Image 92: Typical condition of main roof and parapets.

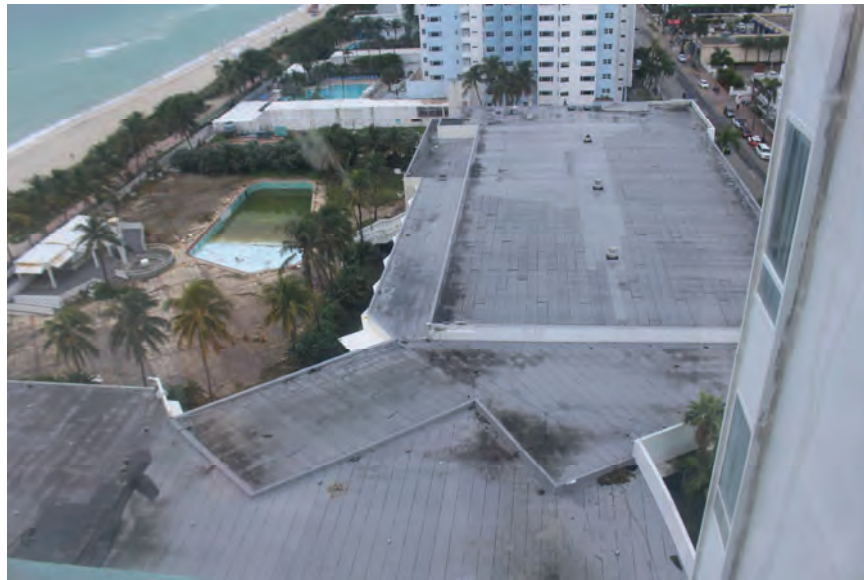
Image 93: Typical condition of low roof and parapets.

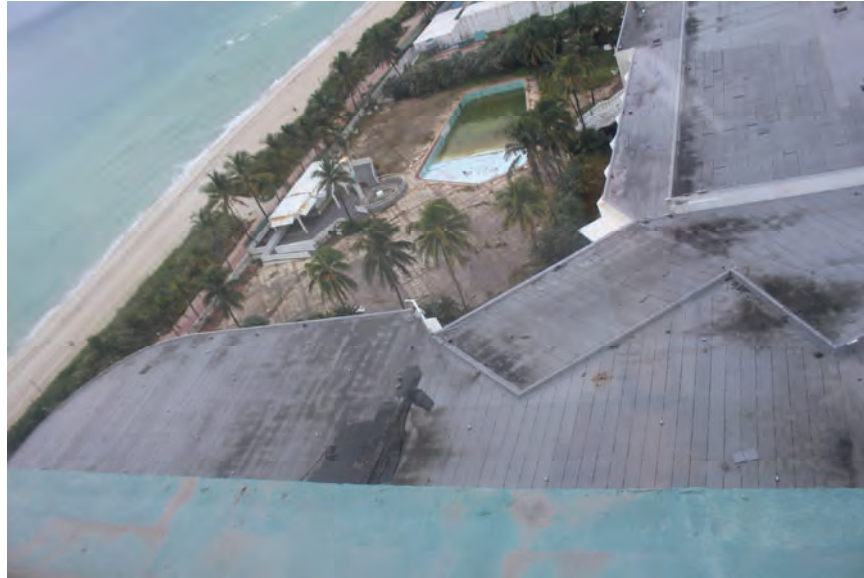
Image 94: Typical condition of low roof and parapets.

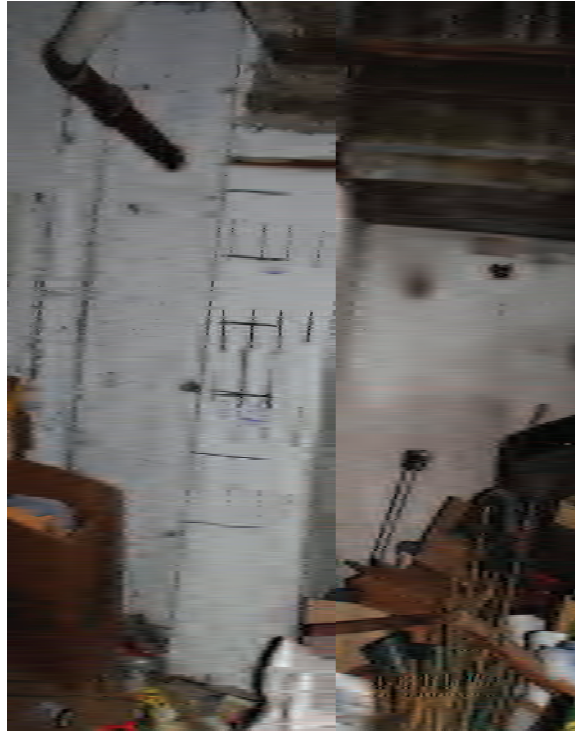
- Column Label 7 is of particular concern, as it is the southeast frame column of the Hotel portion of the building, and was not able to be core tested due to the column presenting as “plaster” during core-drill operations. We have included Images 97 and 98 of Column 7, the core location, and the condition of the frame beams and slab system above.

Image 97: Condition of Column Label 7, facing south. See Image 96 for location of Column 7 in plan view.

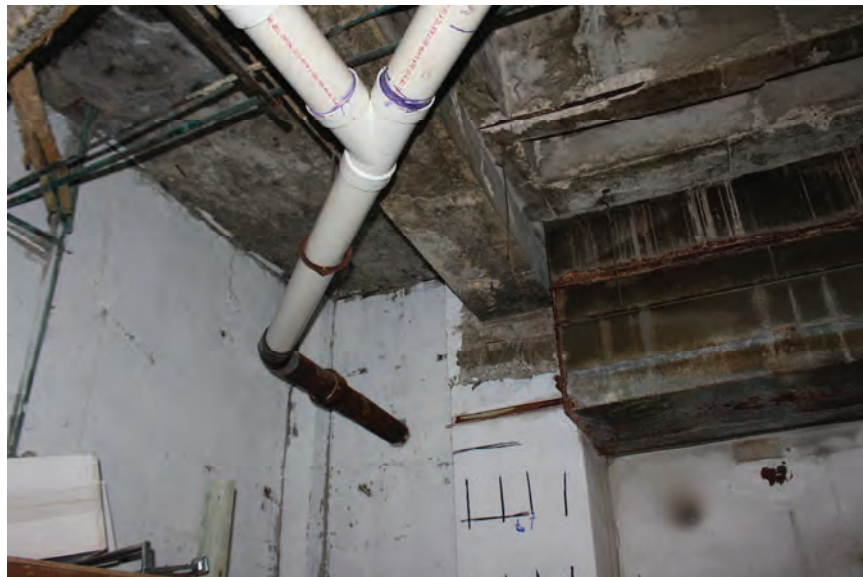
Image 98: Condition of the frame beams and slab system above Column Label 7, facing southeast. See Image 96 for location of Column 7 in plan view.

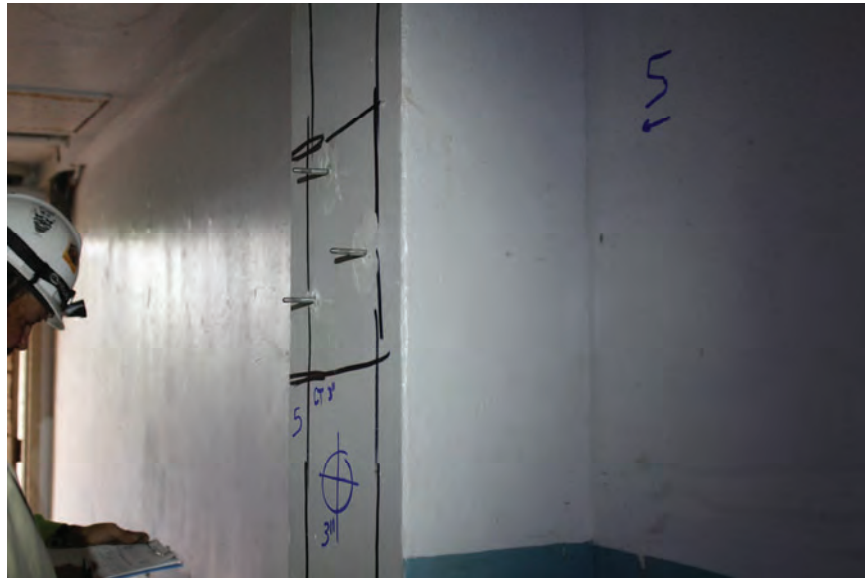
- While not effective for determining compressive strength, the Windsor Probe was effective in identifying the extent of voids and/or accumulations of paste within the concrete columns which were not apparent upon visual inspection. In such cases, the probes would blow out of the concrete (see Images 99 – 101).

Image 99: Typical condition of the 3 probes installed for the Windsor Probe Test. (Column Label 5)

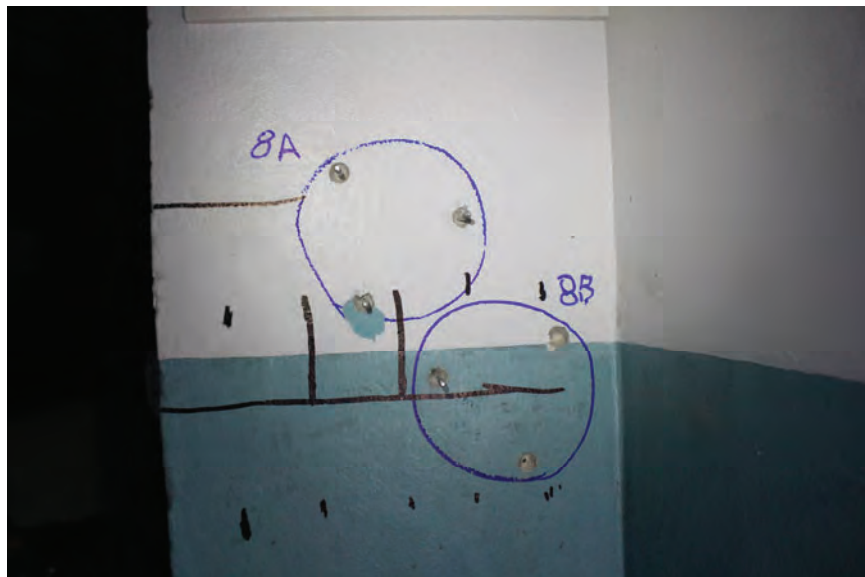
Image 100: Condition of the completed Windsor Probe installation for location 8A, and the "blow out" condition of attempt to test at location 8B.

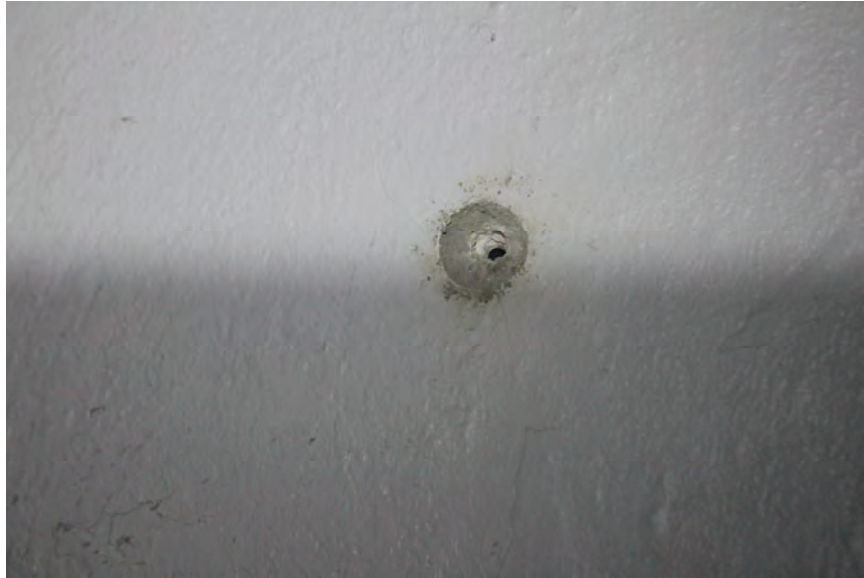
Image 101: Typical condition of a “blow out” location of a Windsor Probe which exposed interior voids within the concrete columns.

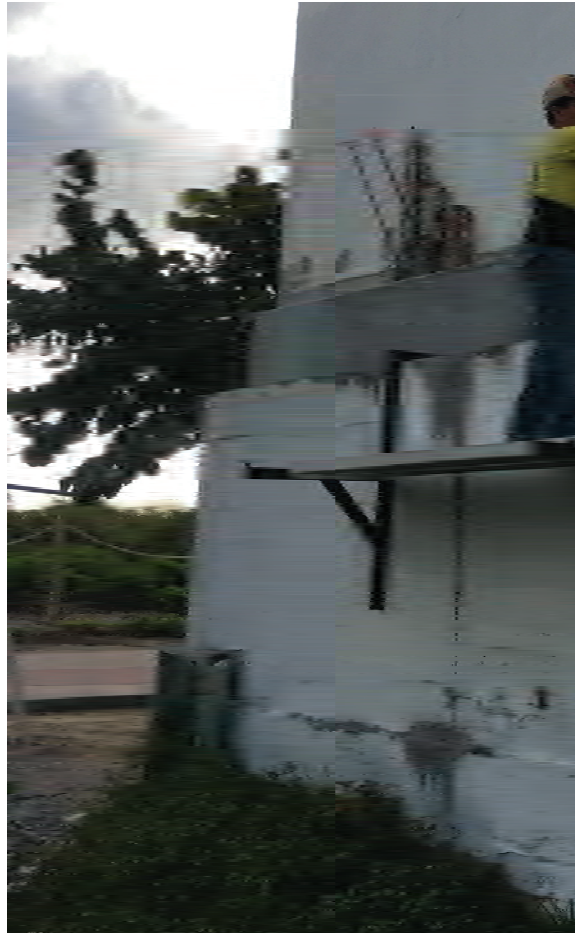
Image 125: Hotel North Wall Column
