Arborist Report

205 E San Marino Drive
Miami Beach

2/27/2020

Property Location -
205 E San Marino Drive
Miami Beach, FL 33139

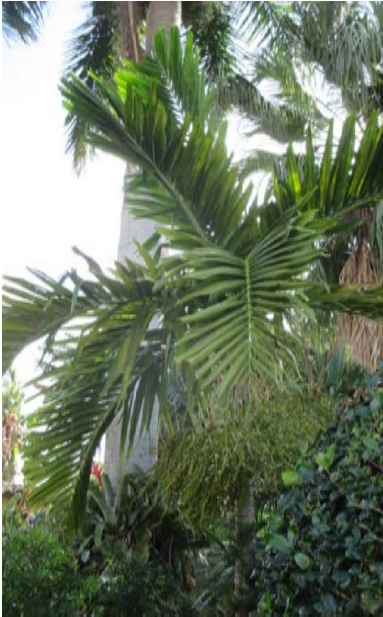
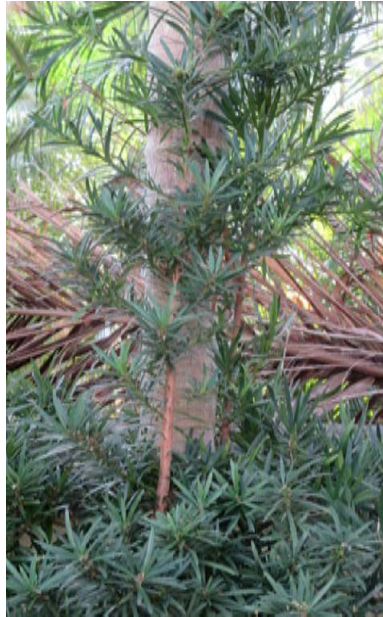
Tree #7 is an Alexander Palm located in the front swale along E San Marino Drive. It is in fair condition with chlorotic foliage. This tree has not been incorporated into the landscape plan and will therefore be removed.

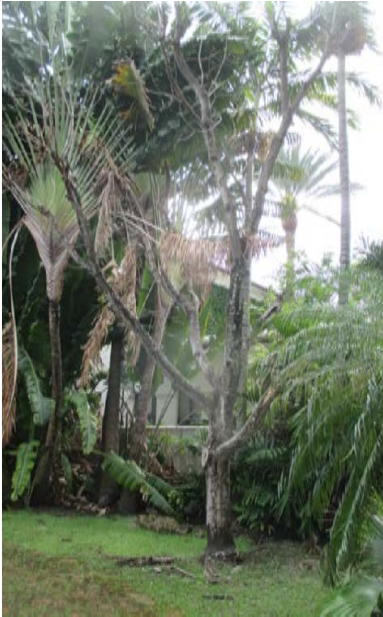
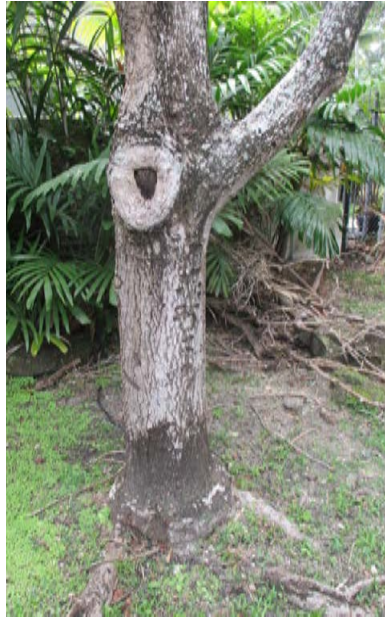
Tree #18 is a Mango located towards the front southern side of the property. It is dead and will need to be removed.

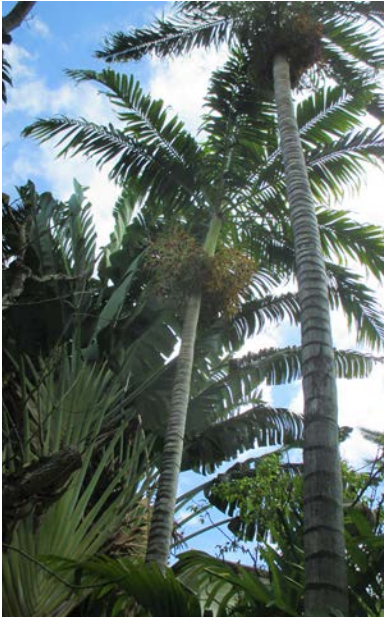
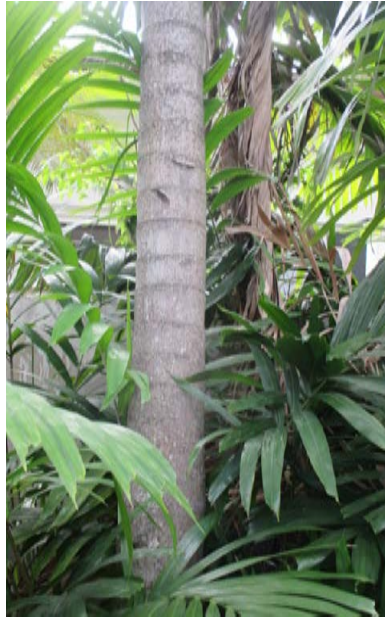
Tree #20 is a Montgomery Palm located on the front southern side of the property. It is in good condition with a healthy, green canopy. This tree has not been incorporated into the landscape plan and will therefore be removed.

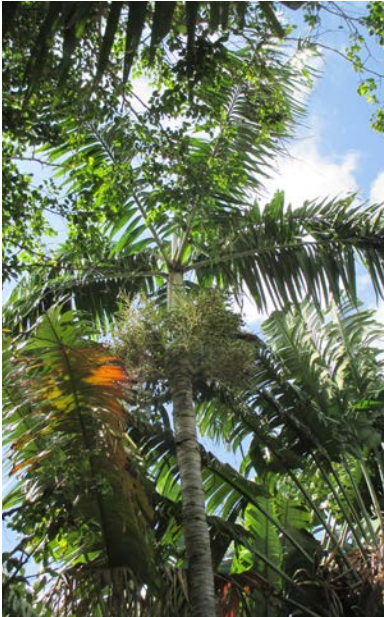
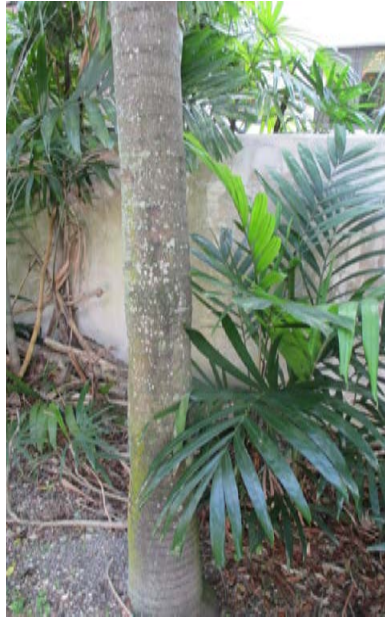
Tree #34 is a Montgomery Palm located on the south side of the front yard. It is in good condition with a healthy, green canopy. This tree has not been incorporated into the landscape plan and will therefore be removed.

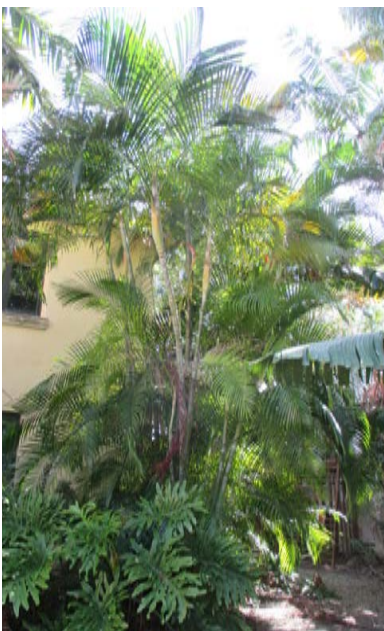
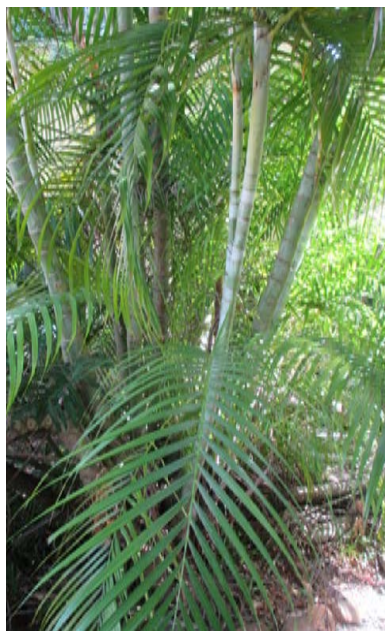
Tree #35 is a Cabada Palm cluster located at the front of the existing house. It is in good condition with some yellowing of the foliage. This tree has not been incorporated into the landscape plan and will therefore be removed.

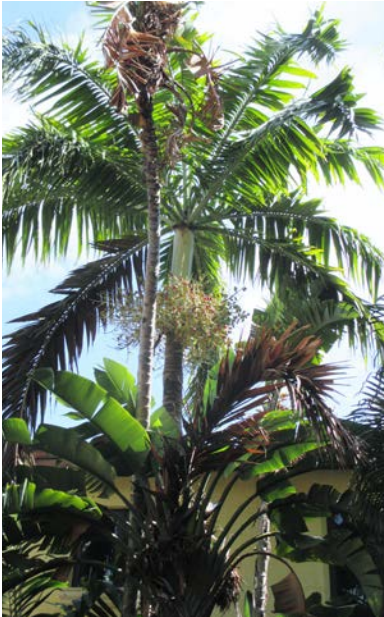
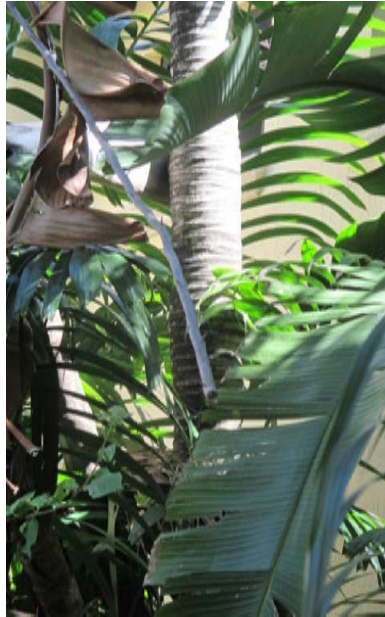
Tree #36 is a Princess Palm located at the front of the existing house. It is in good condition with a healthy, green canopy. This tree has not been incorporated into the landscape plan and will therefore be removed.

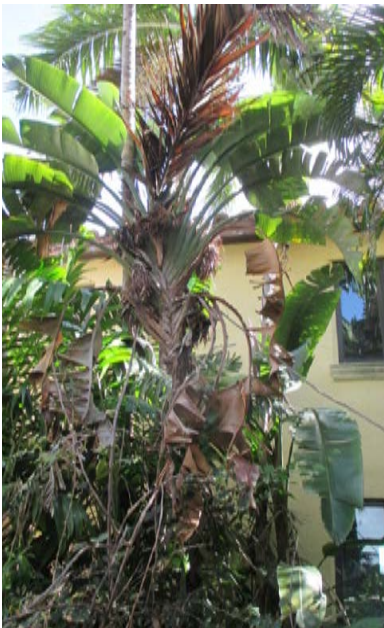
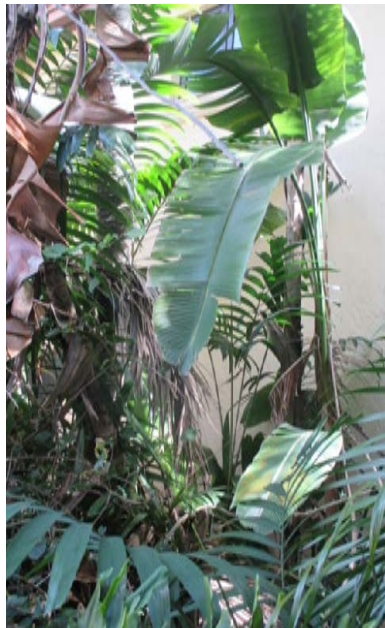
Trees #37 - 38 is a White Bird-of-Paradise cluster located at the front of the existing house. It is in fair condition with some tattered fronds and lower dead fronds. This plant has not been incorporated into the landscape plan and will therefore be removed.

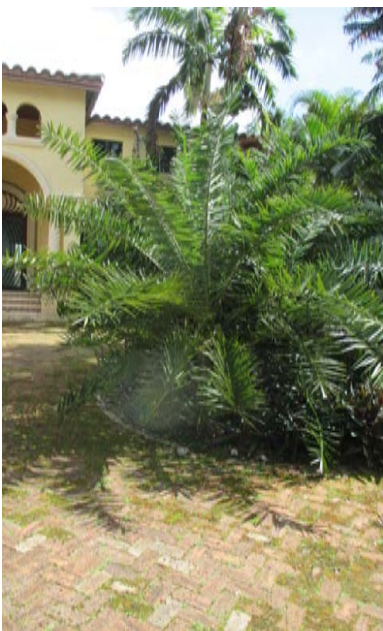
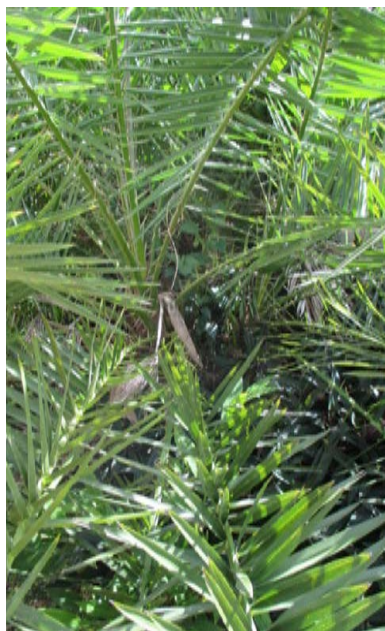
Tree #40 is a small Sylvester Palm located in the front driveway circle. It is in good condition with healthy, green foliage. It is small and no trunk has formed yet. This tree has not been incorporated into the landscape plan and will therefore be removed.

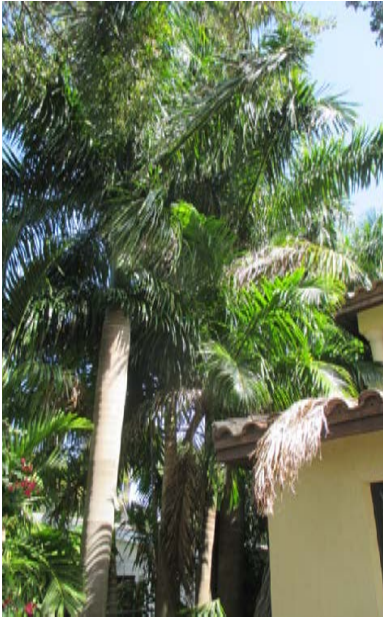
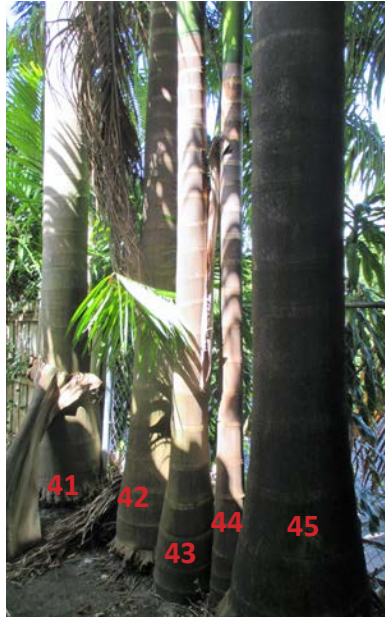
Trees #41 - 45 are five Royal Palms located on the north side of the existing house. Overall, they are in good condition with full, green canopies and no major trunk injuries observed.

This tree has not been incorporated into the landscape plan and will therefore be removed.

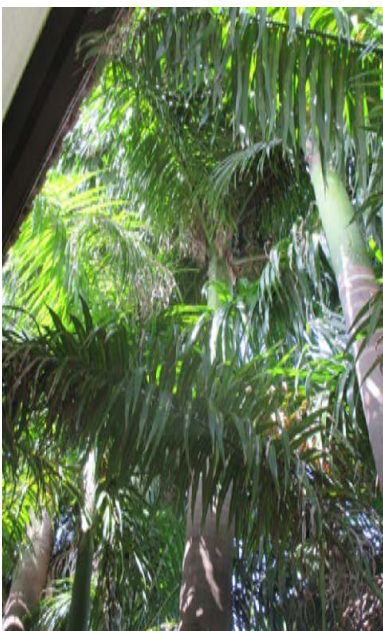
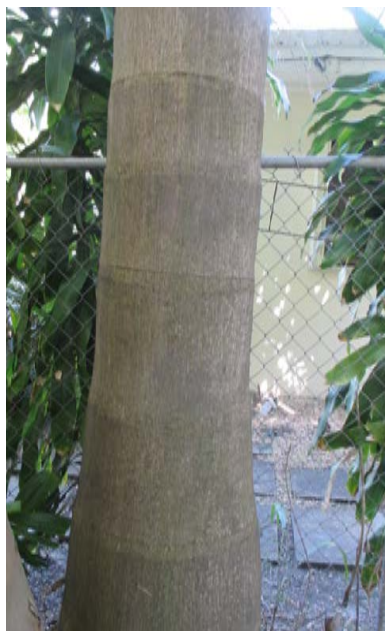
Tree #46 is a Royal Palm located on the north side of the existing house. It is in good condition with a full, green canopy and no major trunk injuries observed.

This tree has not been incorporated into the landscape plan and will therefore be removed.

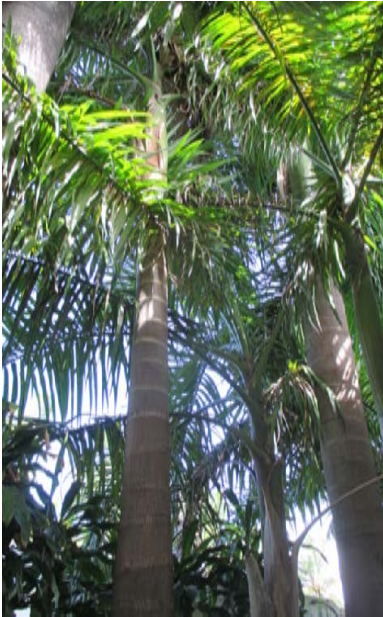
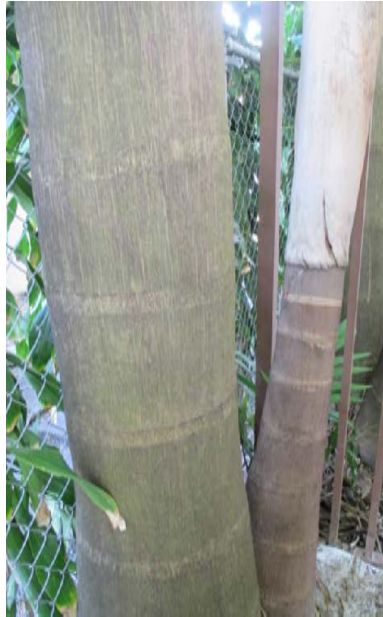
Tree #47 is a double Royal Palm located on the north side of the existing house. It is in good condition with a healthy green canopy and no major trunk injuries observed. This tree has not been incorporated into the landscape plan and will therefore be removed.

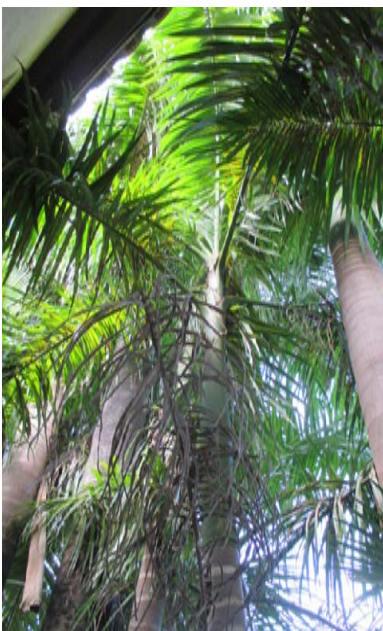
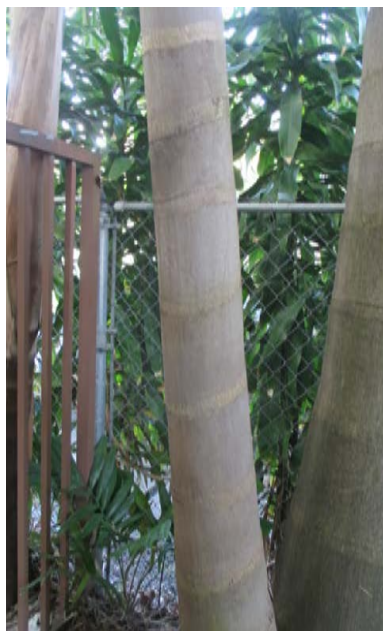
Tree #48 is a Royal Palm located on the north side of the existing house. It is in good condition with a healthy green canopy and no major trunk injuries observed. This tree has not been incorporated into the landscape plan and will therefore be removed.

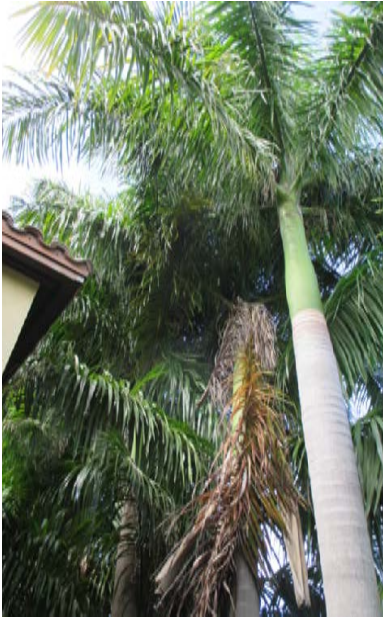
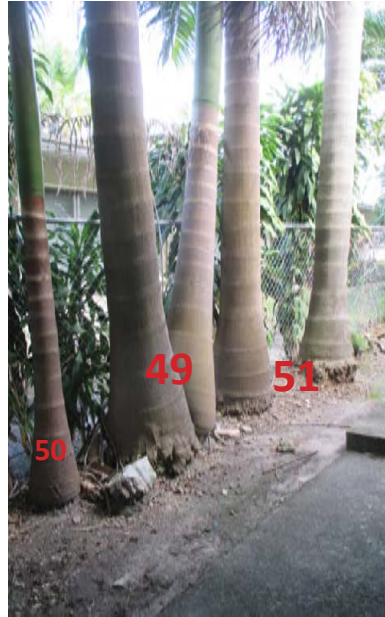
Tree #49 - 51

Trees #49 - 51 are three Royal Palms located on the north side of the existing house. Trees #49 and #51 are double-trunked. These trees are in good condition with healthy green canopies and no major trunk injuries observed.

This tree has not been incorporated into the landscape plan and will therefore be removed.

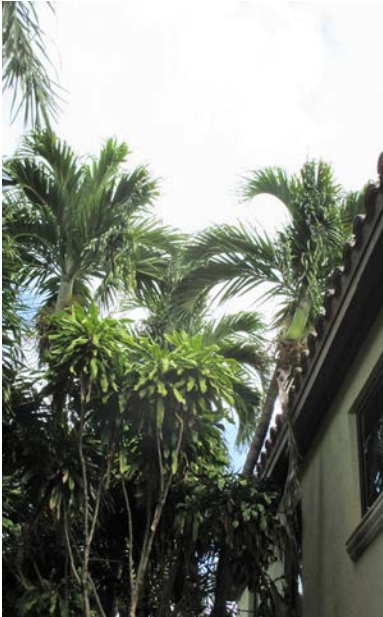
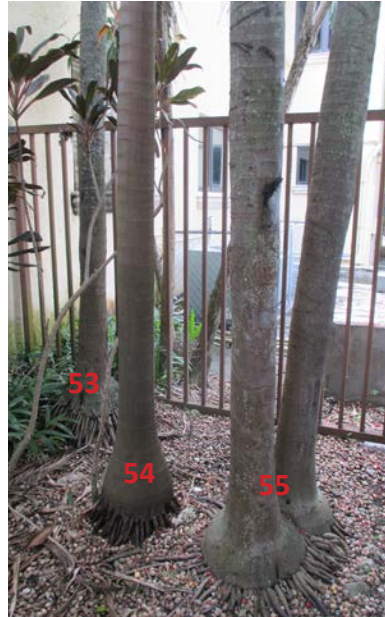
Trees #53 - 55 are three Christmas Palms located to the north of the existing house. Tree #55 is double-trunked. These trees are in good condition with full, green canopies.

This tree has not been incorporated into the landscape plan and will therefore be removed.

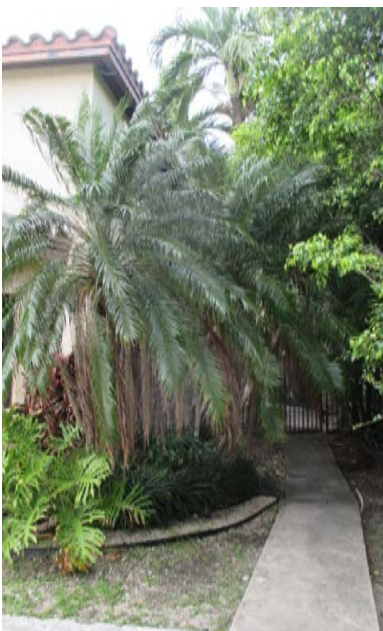
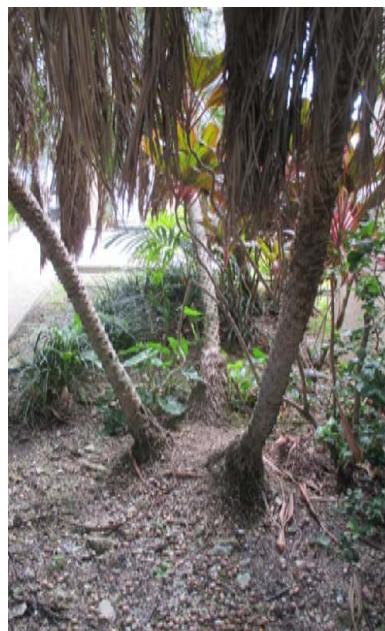
Tree #56 is a cluster of four Pygmy Date Palms located on the north side of the existing house. These trees are in good condition with some lower dead fronds.

This tree has not been incorporated into the landscape plan and will therefore be removed.

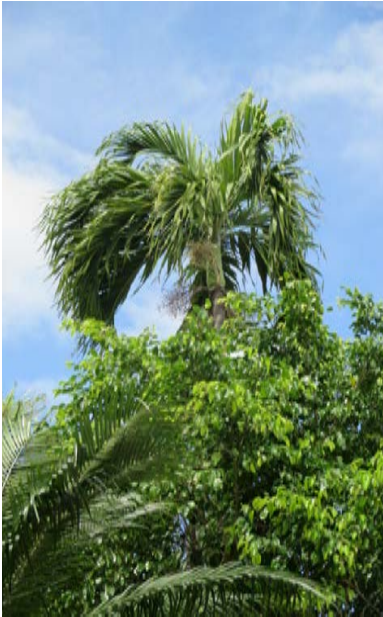
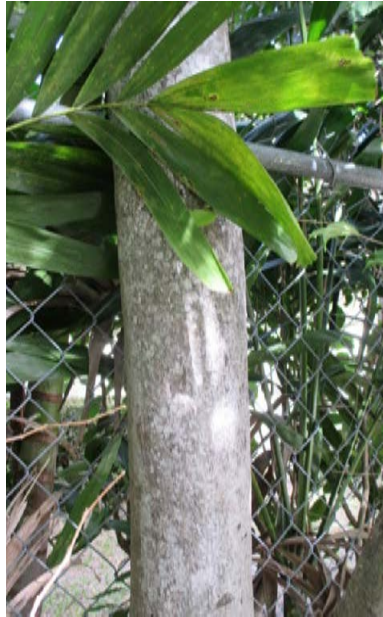
Tree #57 is a Christmas Palm located on the north side of the backyard. It is in fair condition with some chlorosis. This tree has not been incorporated into the landscape plan and will therefore be removed.

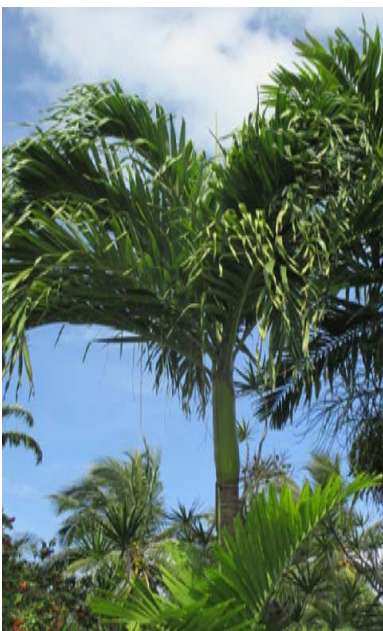
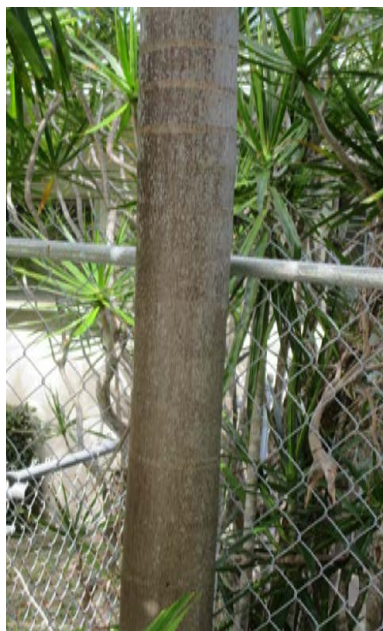
Tree #58 is a Christmas Palm located on the north side of the backyard. It is in fair condition with some chlorosis. This tree has not been incorporated into the landscape plan and will therefore be removed.

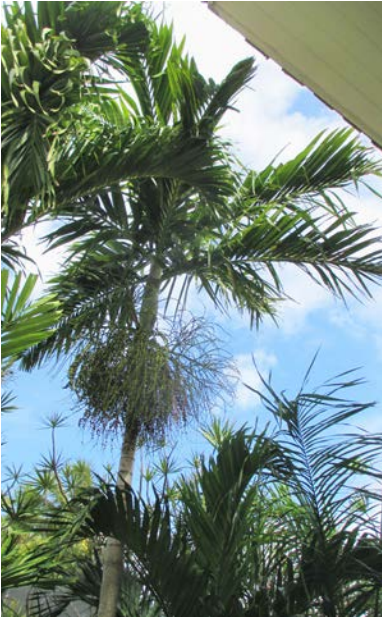
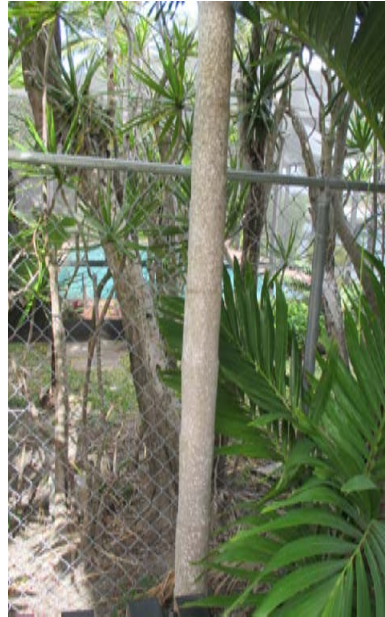
Tree #59 is an Alexander Palm located on the north side of the backyard. It is in fair condition with some chlorosis. This tree has not been incorporated into the landscape plan and will therefore be removed.

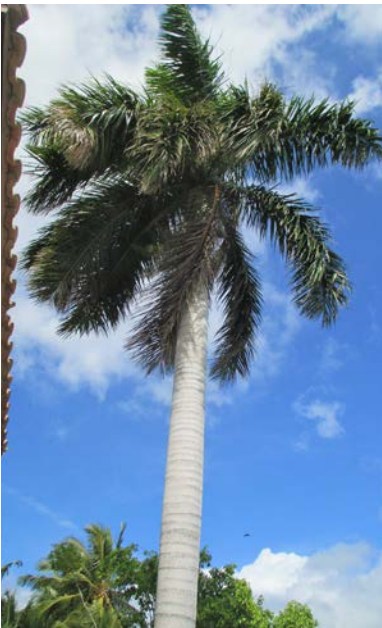
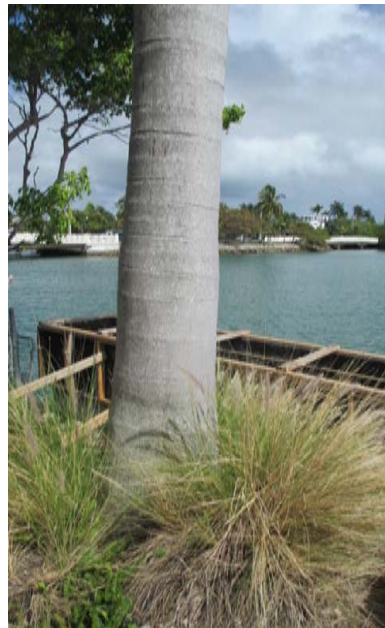
Tree #60 is a Royal Palm located at the rear of the backyard. It is in good condition with a full, green canopy and no trunk injuries observed. Some of the foliage is slightly frizzled. This tree has not been incorporated into the landscape plan and will therefore be removed.

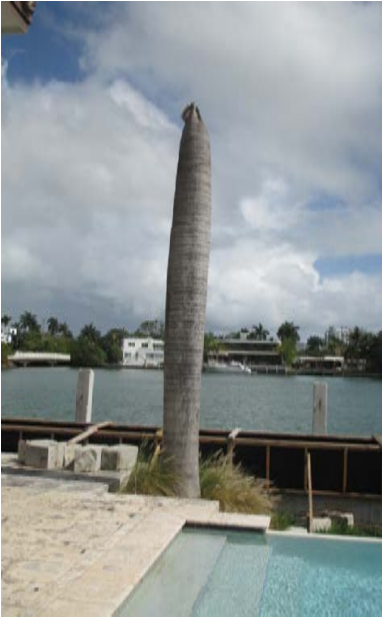
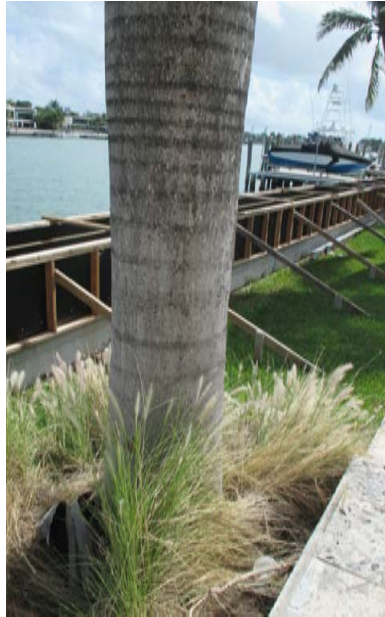
Tree #61 is a dead Royal Palm located at the rear of the property. It is dead and will need to be removed.

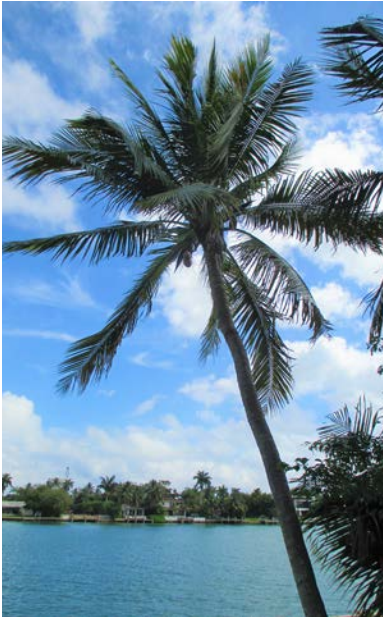
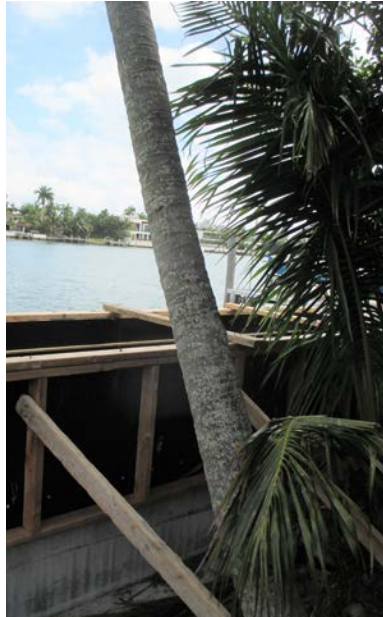
Tree #63 is a Coconut Palm located in the rear southeast corner of the property. It is in fair condition with yellowing on the foliage. This tree has not been incorporated into the landscape plan and will therefore be removed.

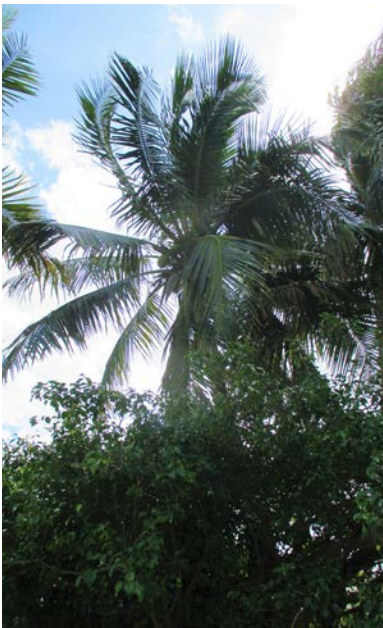
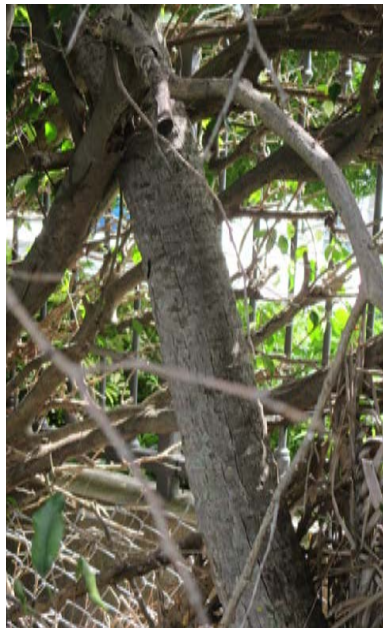
Tree #64 is a Coconut Palm located in the rear southeast corner of the property. It is in good condition with a healthy, green canopy. This tree has not been incorporated into the landscape plan and will therefore be removed.

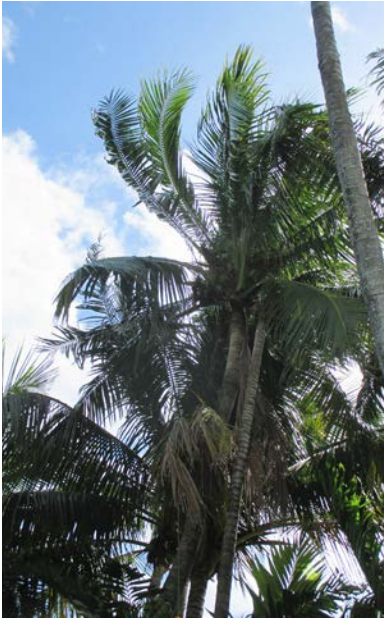
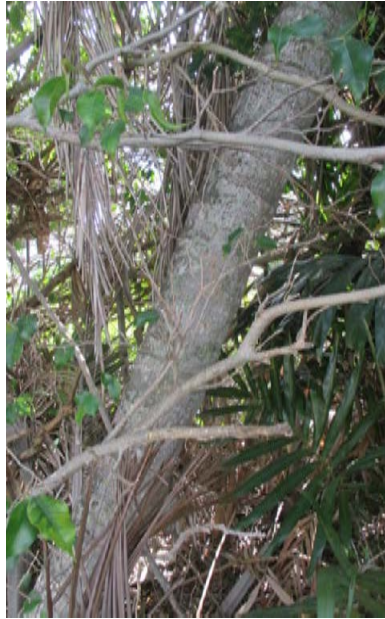
Tree #65 is a Coconut Palm located in the rear southeast corner of the property. It is in good condition with a healthy, green canopy. This tree has not been incorporated into the landscape plan and will therefore be removed.

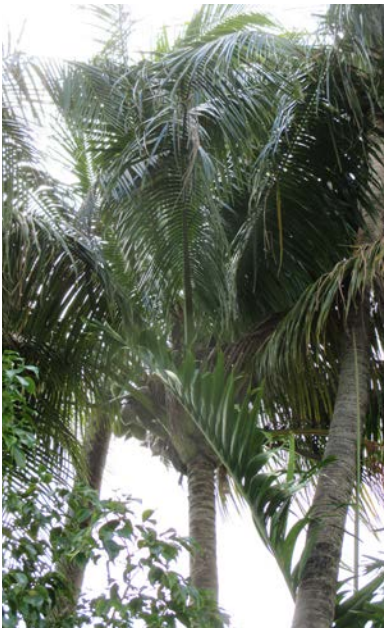
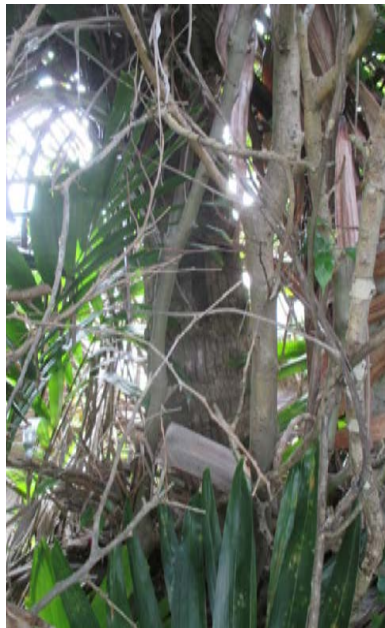
Tree #66 is a Coconut Palm located in the rear southeast corner of the property. It is in good condition with a healthy, green canopy. This tree has not been incorporated into the landscape plan and will therefore be removed.

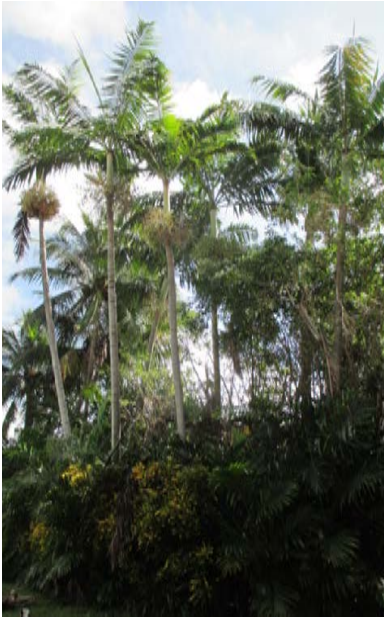
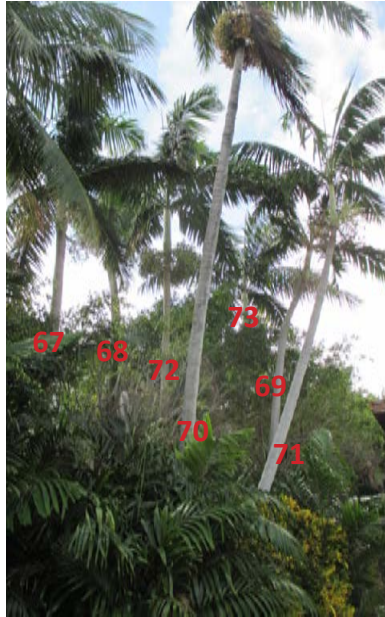
Trees #67 - 73 are seven Montgomery Palms located in the rear, southeast corner of the property. Overall, they are in good condition with healthy, green foliage. These trees have not been incorporated into the landscape plan and will therefore be removed.

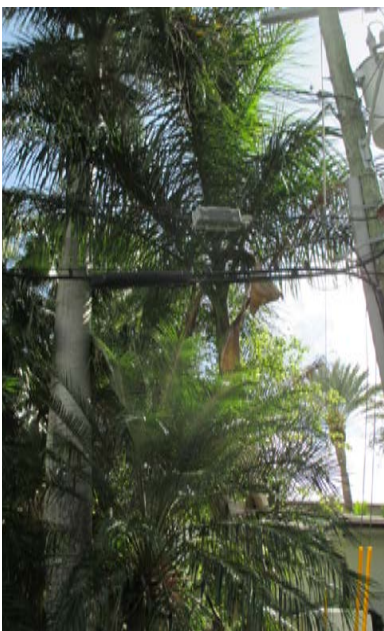
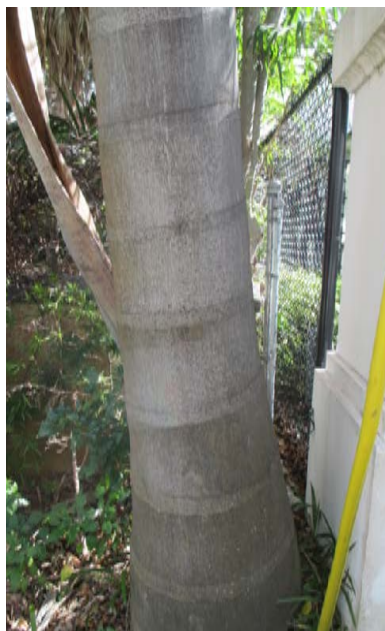
Tree #74 is a Royal Palm located in the front southwest corner of the property. Overhead wires are above. This tree is in good condition with a healthy, green canopy and no major trunk injuries observed.

If this tree is to remain, protective barriers shall be placed 10ft from the tree trunk. Barriers shall be installed prior to the start of construction and demolition, and shall remain in place until development is completed and until the department authorizes their removal. Barriers shall be a minimum of 4ft high, and shall be constructed of continuous chain link fence with metal posts at 8ft spacing, or of 2x4 posts with three equally spaced 2x4 rails. Posts may be shifted to avoid roots. No materials shall be placed or disposed of within the TPZ. Natural grade shall be maintained within the TPZ.
