PROPOSED REMODELING/ADDITIONS:

5446 N. BAY RD

Subject: Building Forensic Test Report

Subject: Building Envelope Visual Assessment Report

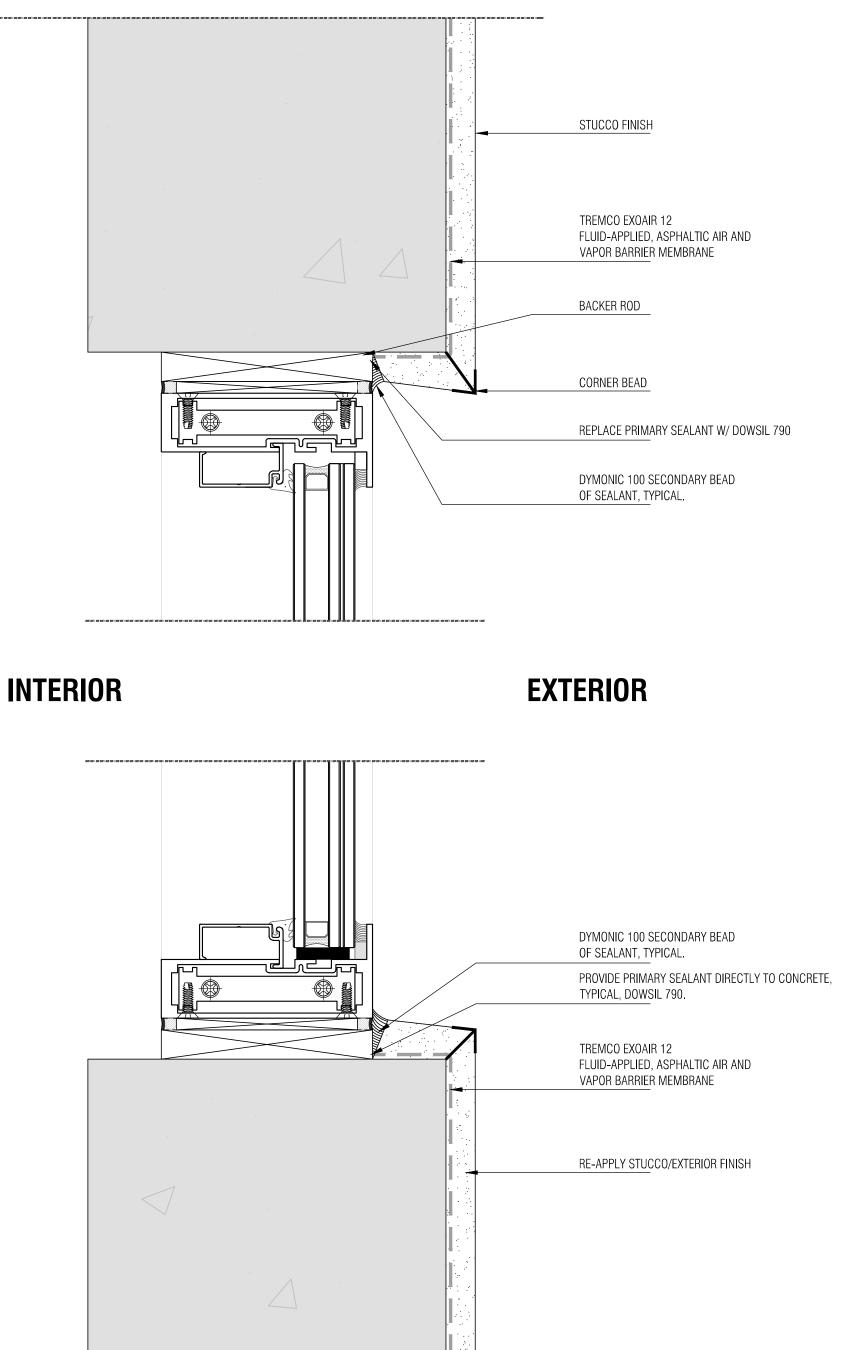
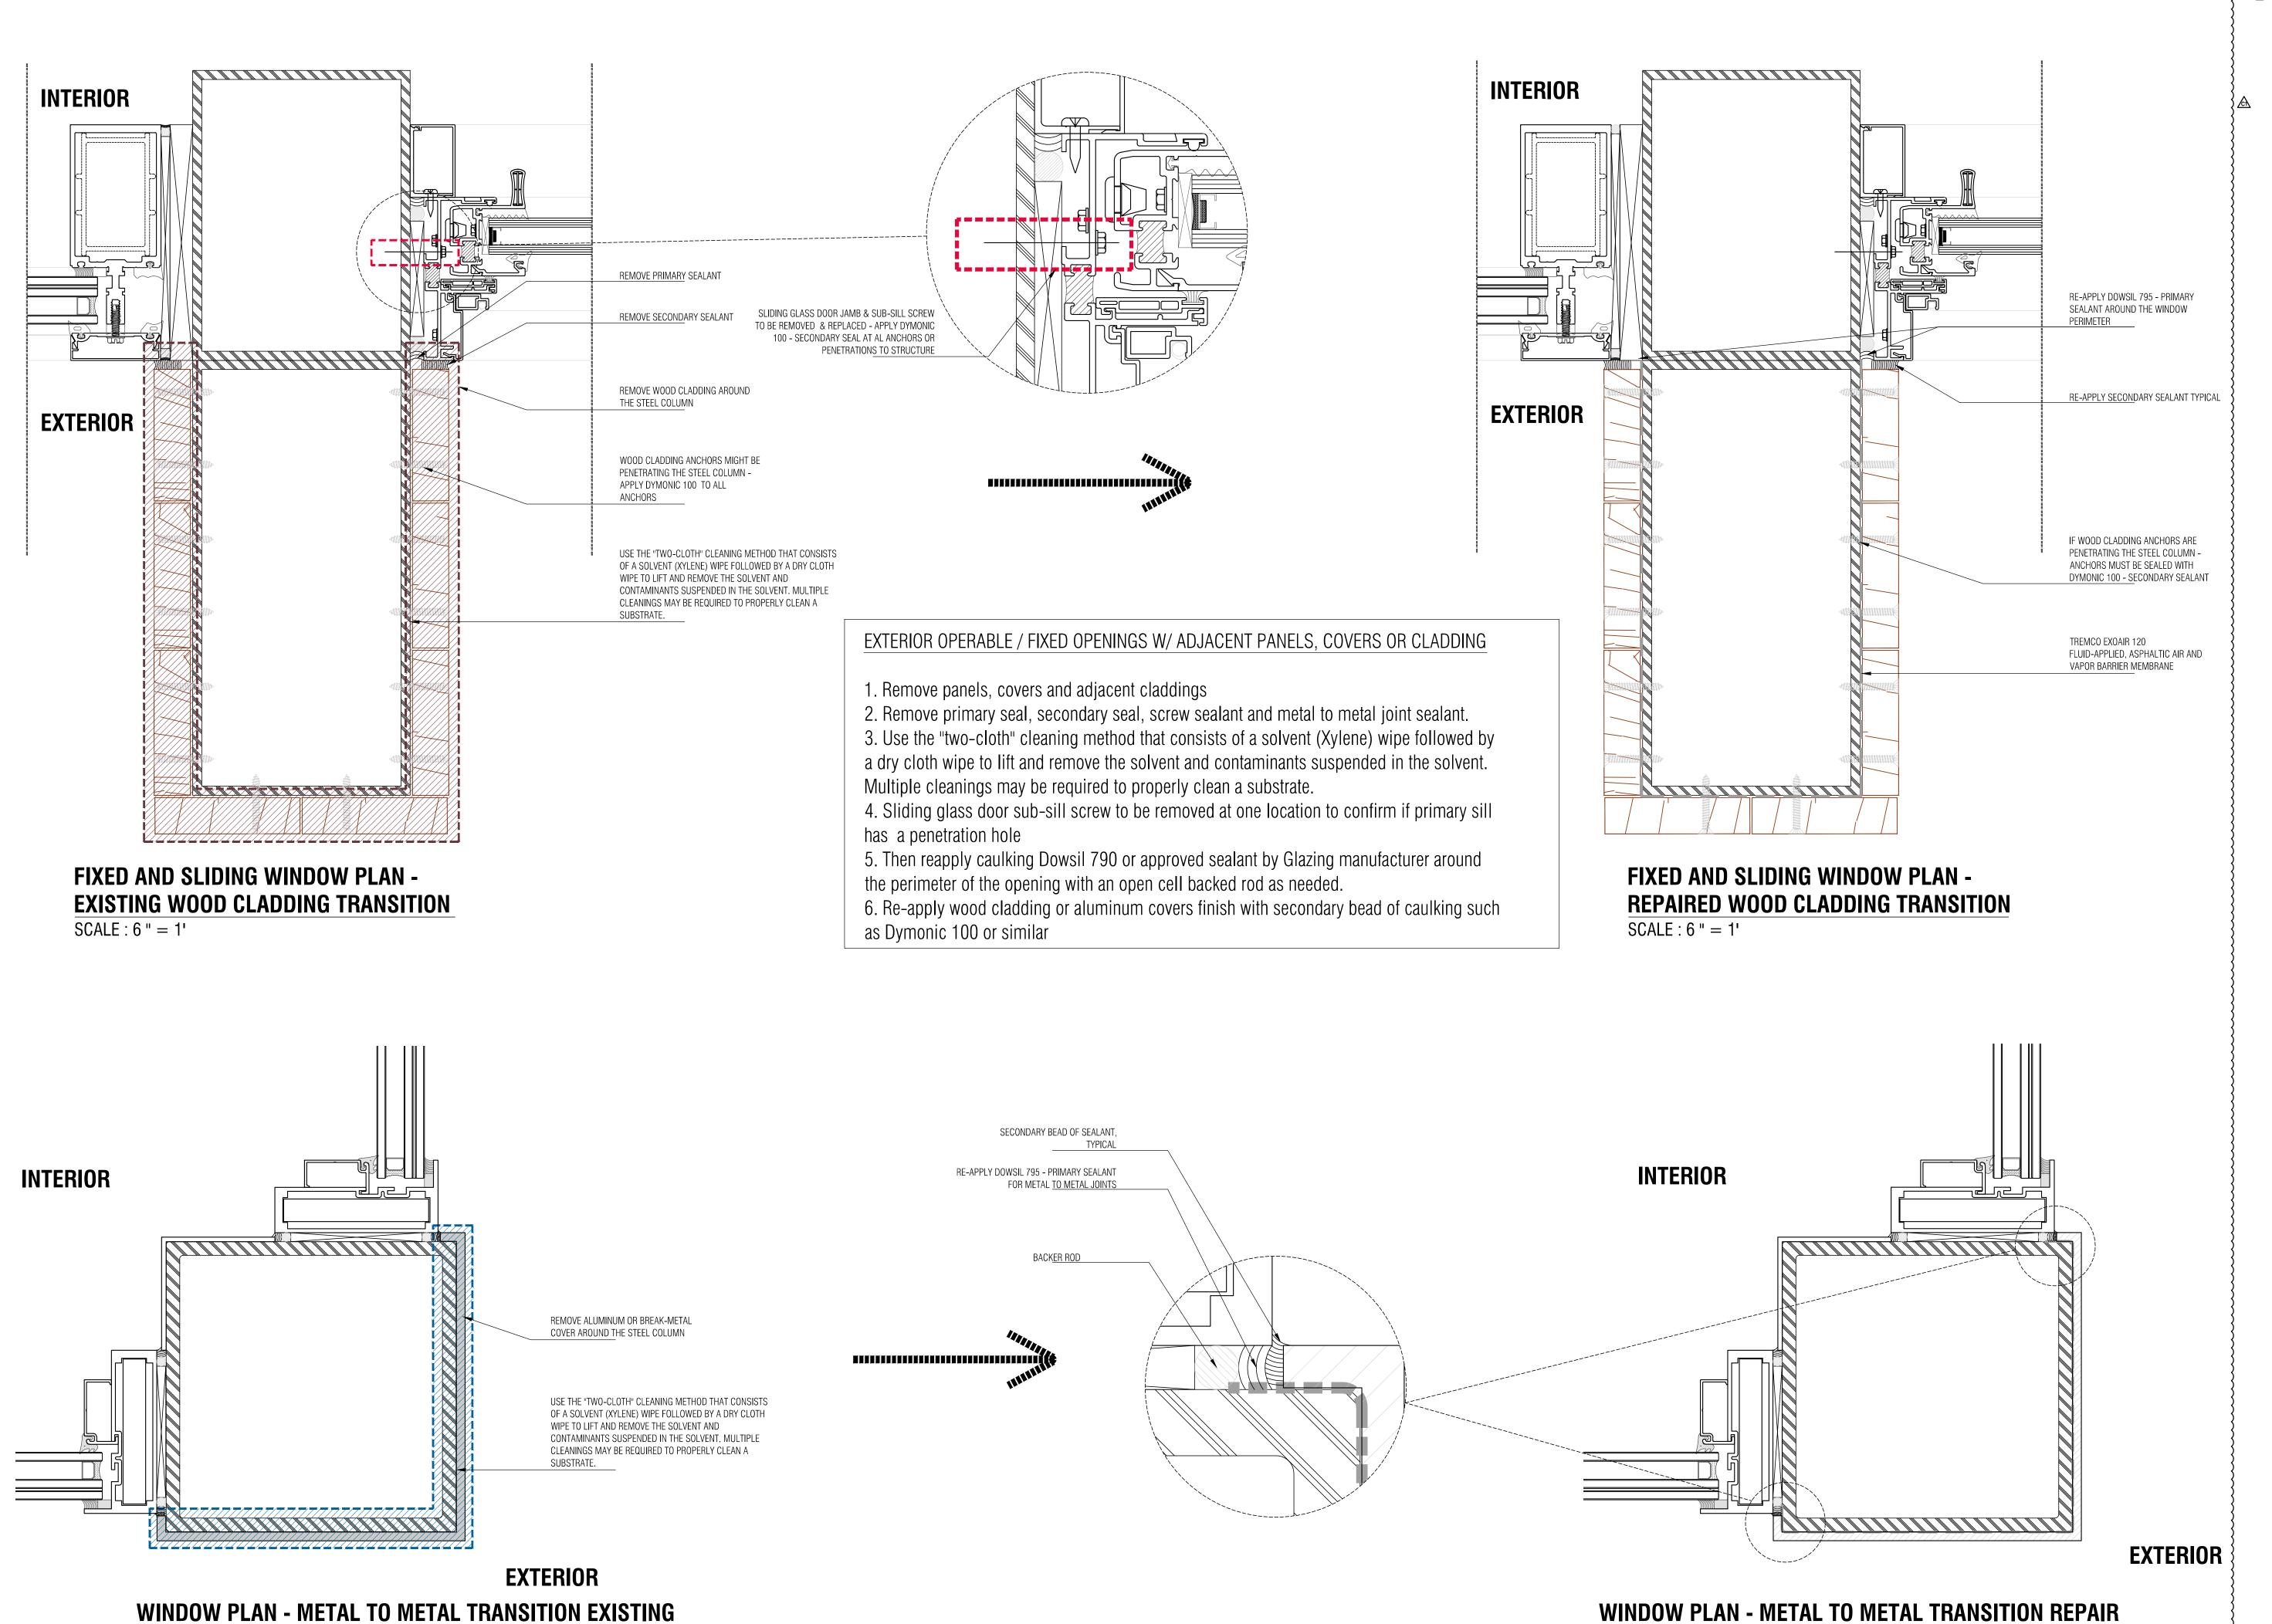
WINDOW JAMB - EXISTING AND REPAIR

STUCCO W/ CRACKS AND DELAMINATION TO BE TREATED AS FOLLOWS:

- 1. STUCCO CRACK OR DELAMINTAION MUST BE MARKED WITH A SQUARE SHAPE
- 2. USE A SMALL DRILL INO THE STUCCO TO DETERMINE THE THICKNESS. 3. CUT STUCCO TO THE DIMENSION NOT TO JEOPARDIZE MIN SUBSTRATE IN A SQUARE SHAPE FASHION.
- 4. THIS WILL BE FOLLOWED BY A SERIES OF VERTICAL CUT TO FACILITATE STUCCO REMOVAL AND NOT TRANSMIT PRESSURE TO THE ADJACENT SOUND STUCCO. 5. EXPOSE THE MAIN SUBSTRATE.
- 6. APPLY "STO POWERWALL STUCCO PREBLEND 102" UP TO FINISH LEVEL AS PER MANUFACTURER RECOMMENDATIONS.
