GENERAL ASSESSMENT REPORT

EXISTING STRUCTURAL SYSTEMS

803 2ND STREET MIAMI BEACH, FLORIDA

APRIL 5, 2021

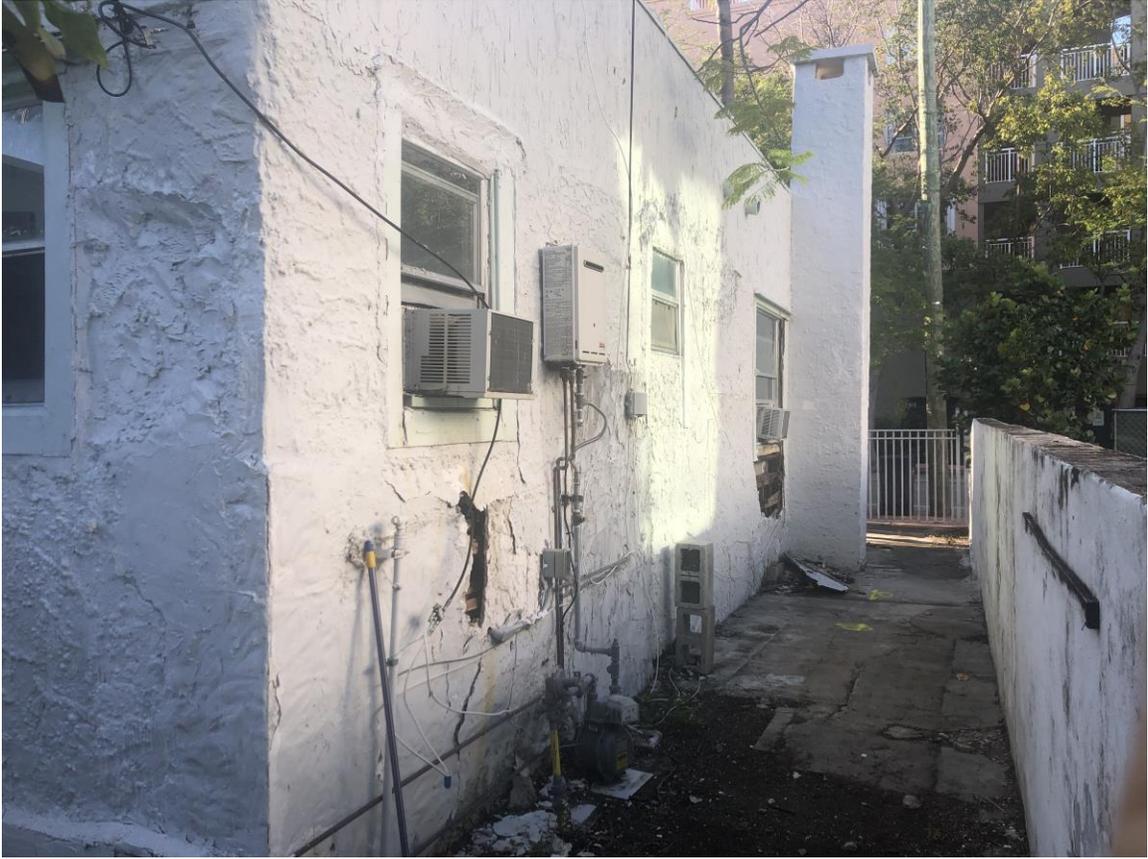
PHOTOGRAPH NO. 6

The exterior chimney/flue on the west side of the building is constructed of masonry. Refer to Photograph No. 6.

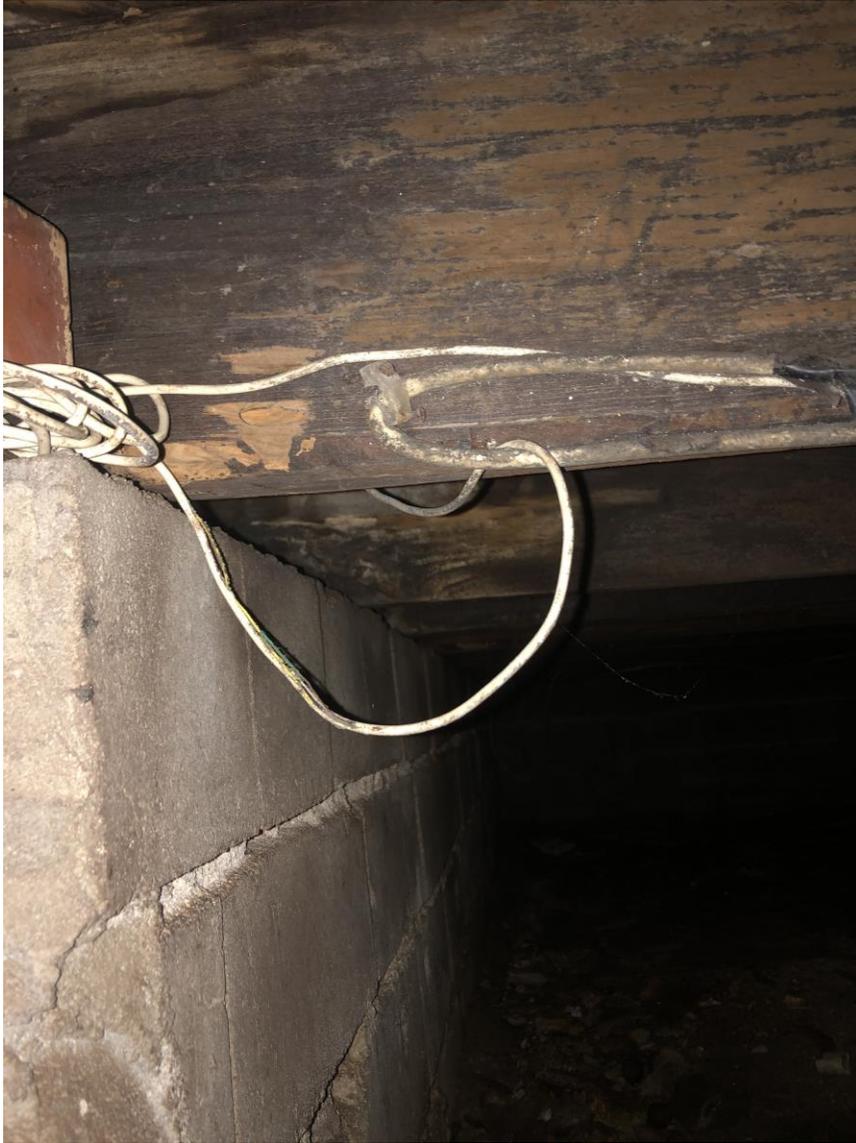
PHOTOGRAPH NO. 97

The exterior stem-walls, on which the floor joists bear, are constructed of concrete block. Refer to Photograph No. 97.

Direct observation of the floor structure was limited to one vent/access opening on the east side of the building. The original floors generally consist of wood board sheathing over wood joists. The joists generally bear on the exterior concrete block stem-wall (refer to Photograph No. 97) and on interior wood beams, which bear on wood shims on concrete blocks on concrete pads. Refer to Photographs Nos. 96 and 99.

5. In the area under the floor that was visible, there is insect damage in some of the wood joists and sheathing. Refer to Photographs Nos. 96, 97 and 98.
