ALVEY TREE CONSULTING LLC

## Arborist Report

1420 22nd Street

Miami Beach

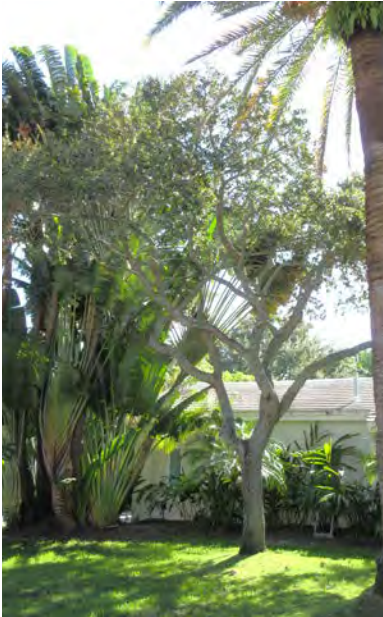
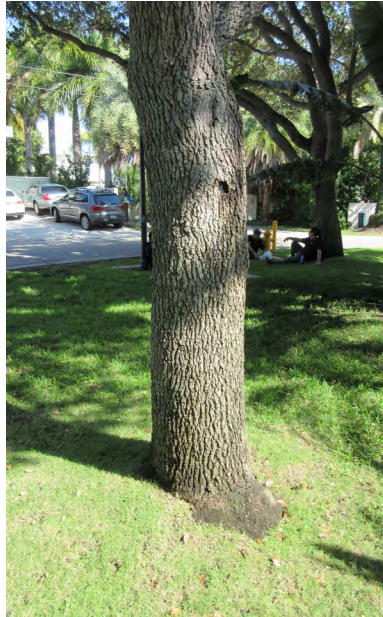
Tree #3 is a Live Oak located at the front of the property. It is in fair condition with low vigor. Old pruning cuts are not closing over well and have decay. There are patches on the trunk and limbs where the bark is coming off. Little deadwood is present. This tree is not a good candidate for relocation. This tree has not been incorporated into the landscape plan and will therefore be removed.

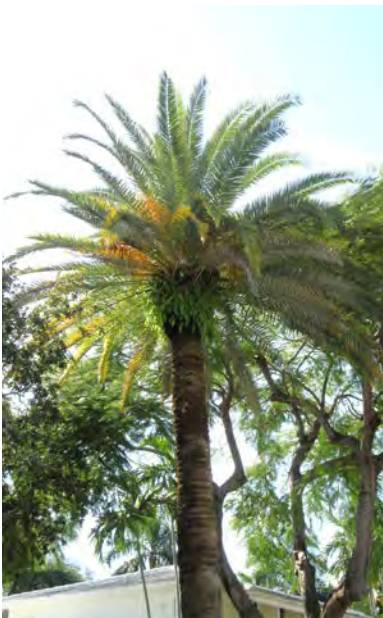
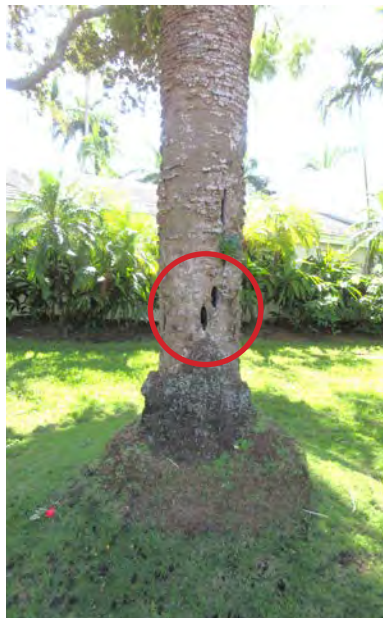
### Tree #4

Tree #4 is a Canary Island Date Palm street tree located along 22nd Street. It is in fair condition. There are a number of small cavities with decay (circled in red). There is yellowing on the fronds. This tree has not been incorporated into the landscape plan and will therefore be removed.

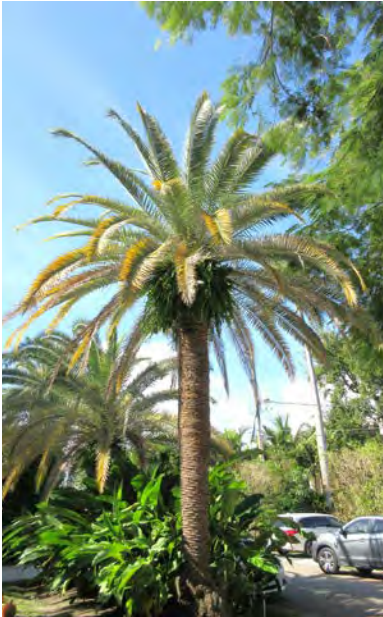
## Tree #5

Tree #5 is a Canary Island Date Palm street tree located along 22nd Street. It is in good condition. There is some yellowing on the fronds.

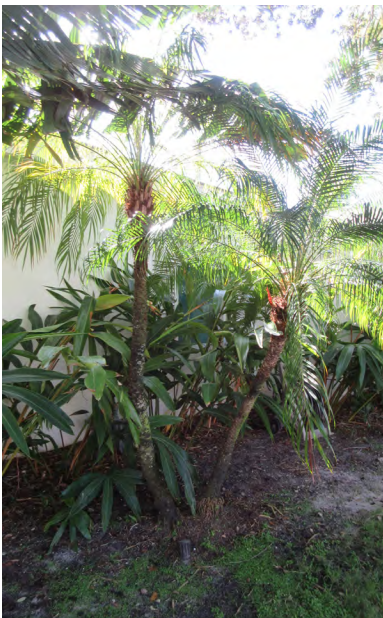
## Tree #6

Tree #6 is a double Pygmy Date Palm located at the front of the house. It is in fair condition with yellow fronds. This tree has not been incorporated into the landscape plan and will therefore be removed.

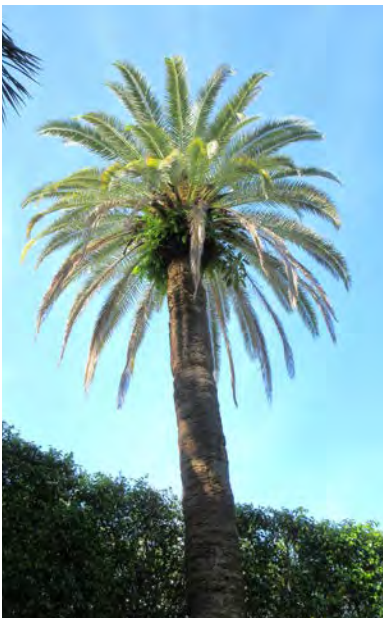
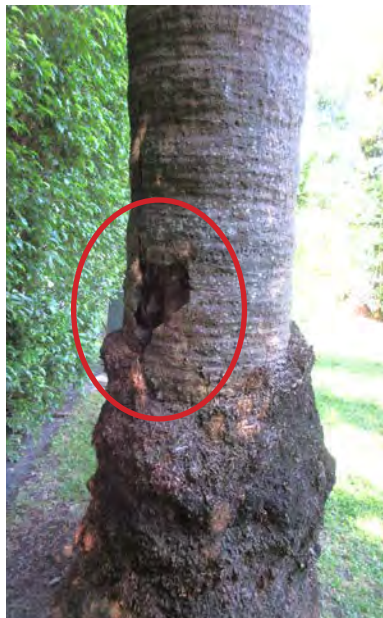
Tree #9 is a Canary Island Date Palm street tree located at the corner of 22nd Street and Sunset Drive. It is in fair condition - there is a cavity with decay on the trunk (circled in red). There is a trunk constriction and the pseudobark has sloughed off.

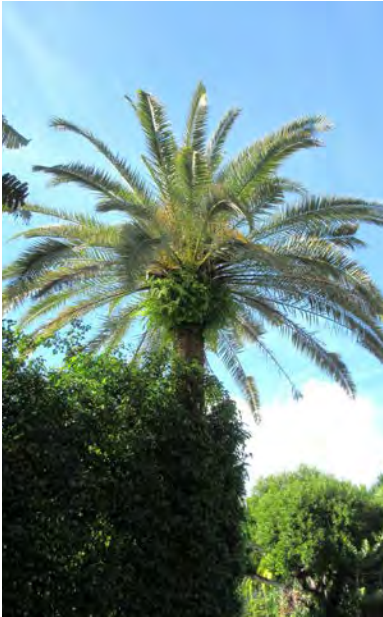
## Tree #10

Tree #10 is a Canary Island Date Palm street tree located along 22nd Street. It is in good condition with some off-color fronds.

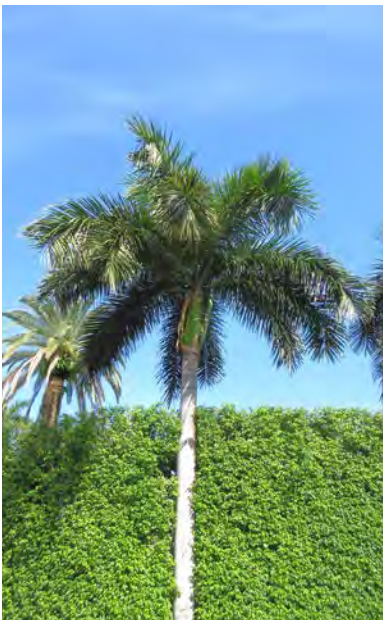
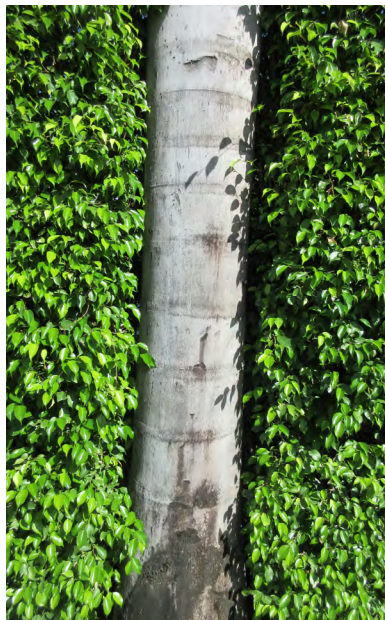
## Tree #11

Tree #11 is a Royal Palm street tree located along Sunset Drive. It is in good condition with a healthy canopy and straight trunk.

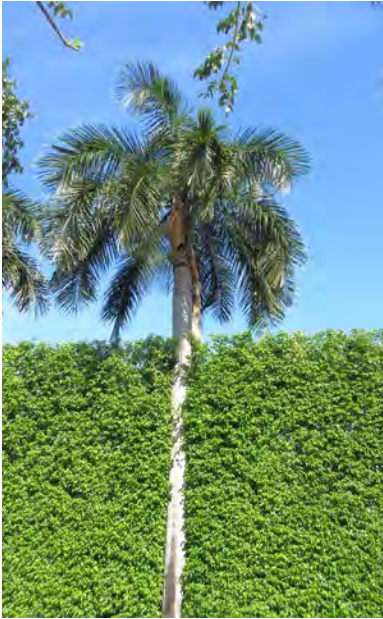
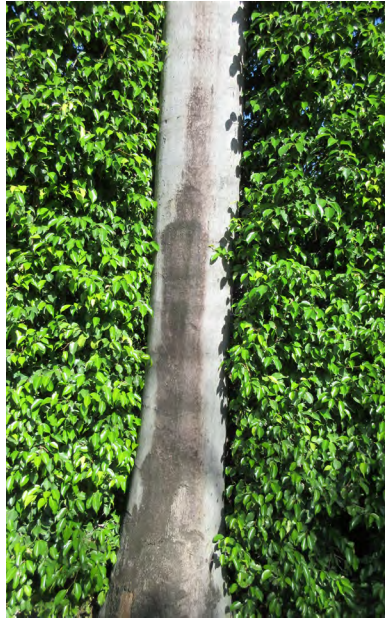
## Tree #12

Tree #12 is a Royal Palm street tree located along Sunset Drive. It is in good condition with a healthy canopy and straight trunk.

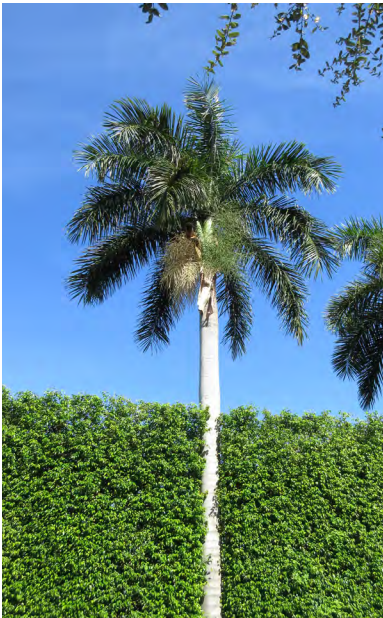
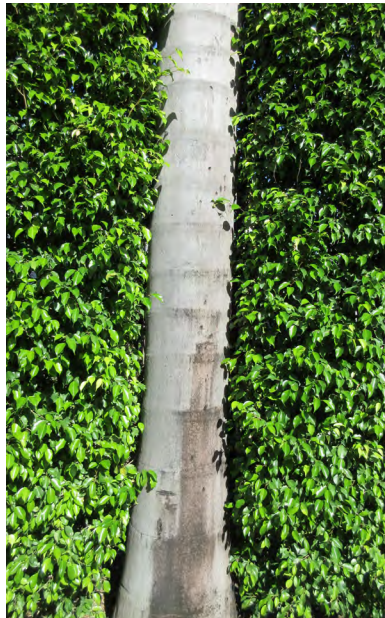
## Tree #13

Tree #13 is a Royal Palm street tree located along Sunset Drive. It is in good condition with a healthy canopy and straight trunk.

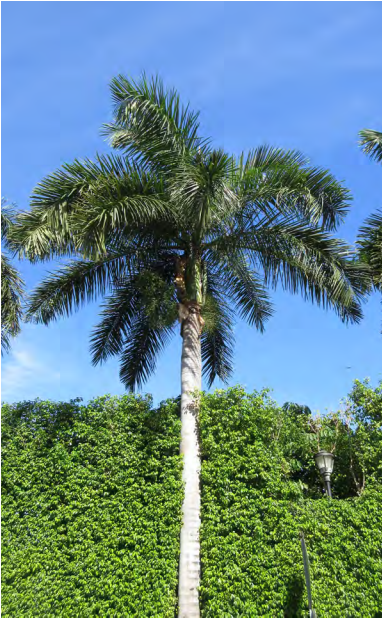
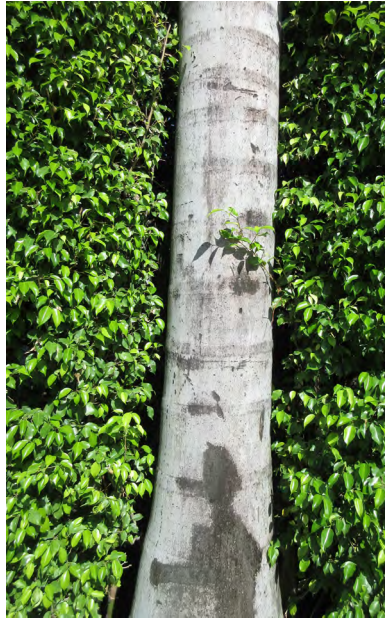
## Tree #14

Tree #14 is a Royal Palm street tree located along Sunset Drive. It is in good condition with a healthy canopy and straight trunk.

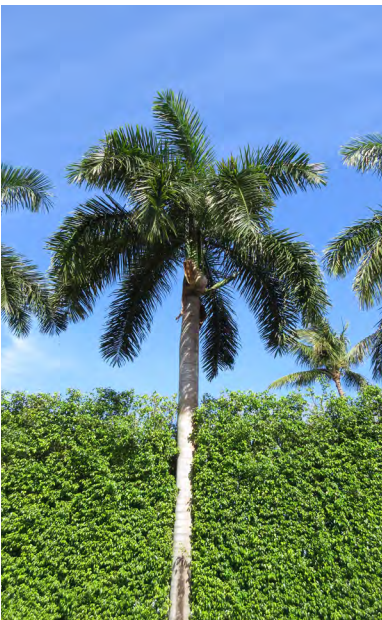
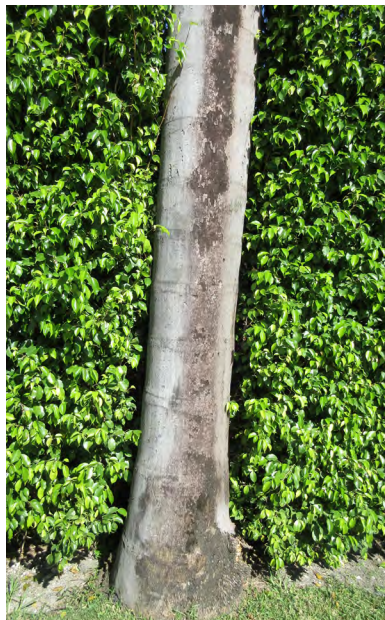
## Tree #15

Tree #15 is a Royal Palm street tree located along Sunset Drive. It is in good condition with a healthy canopy and straight trunk.

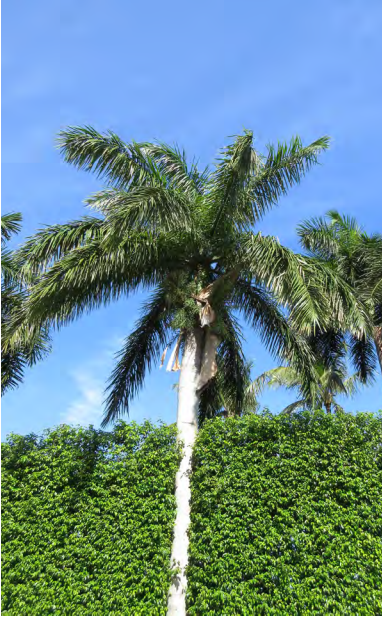
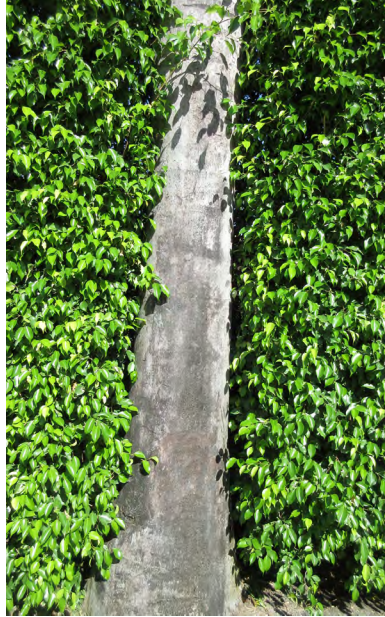
## Tree #16

Tree #16 is a Royal Palm street tree located along Sunset Drive. It is in good condition with a healthy canopy and straight trunk.

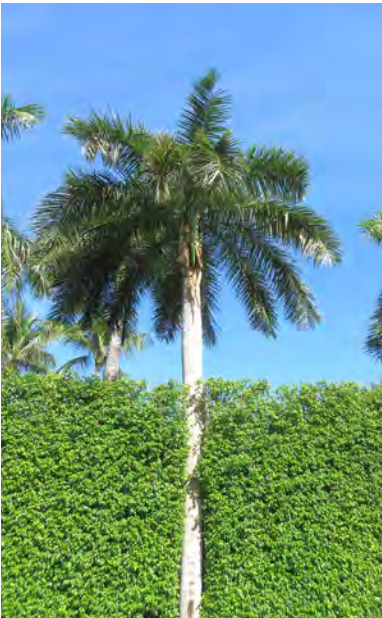
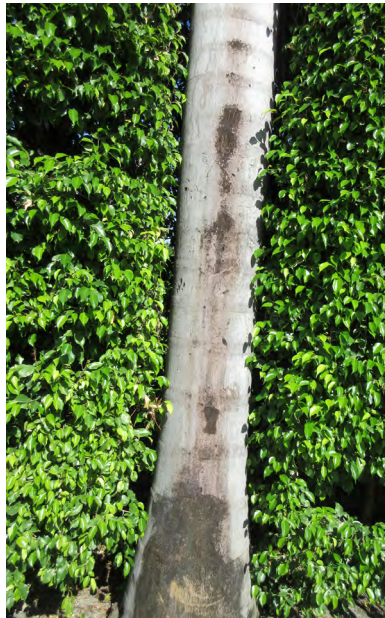
## Tree #17

Tree #17 is a Royal Palm street tree located along Sunset Drive. It is in good condition with a healthy canopy and straight trunk.

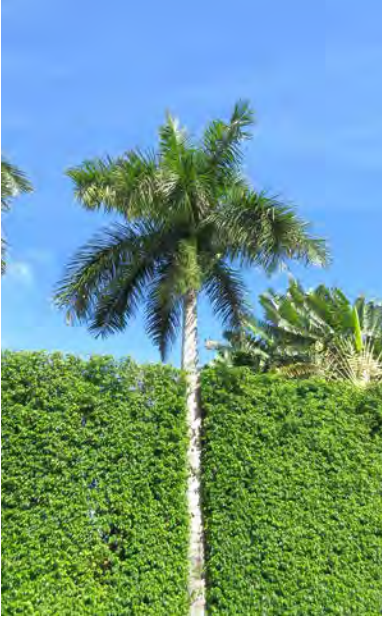
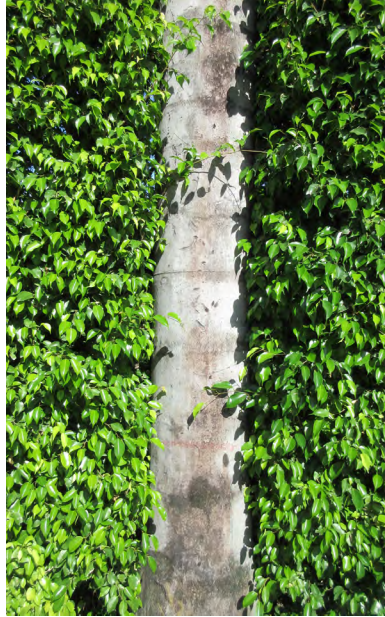
## Tree #18

Tree #18 is a Royal Palm street tree located along Sunset Drive. It is in good condition with a healthy canopy and straight trunk.

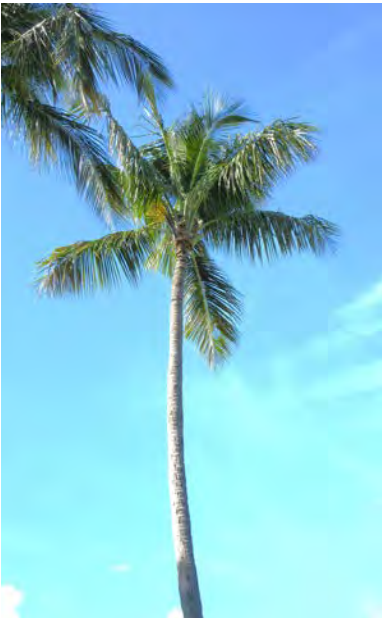
## Tree #19

Tree #19 is a Coconut Palm located in the backyard. It is in good condition. There are some climbing spike injuries to the trunk. This tree has not been incorporated into the landscape plan and will therefore be removed.

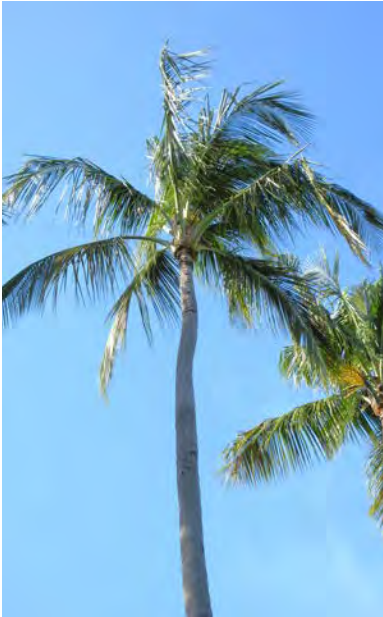
## Tree #20

Tree #20 is a Coconut Palm located in the backyard. It is in fair condition. There are some climbing spike injuries to the trunk and the trunk is pencilling. This tree has not been incorporated into the landscape plan and will therefore be removed.

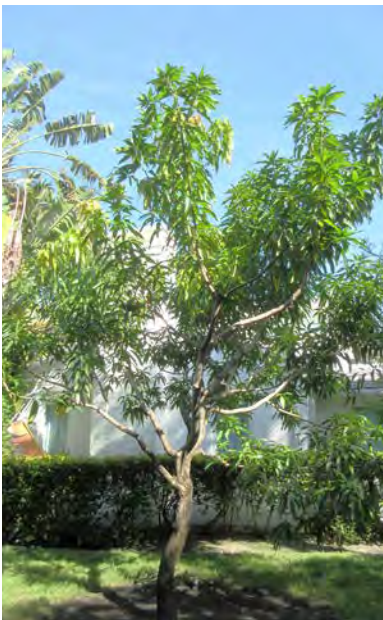
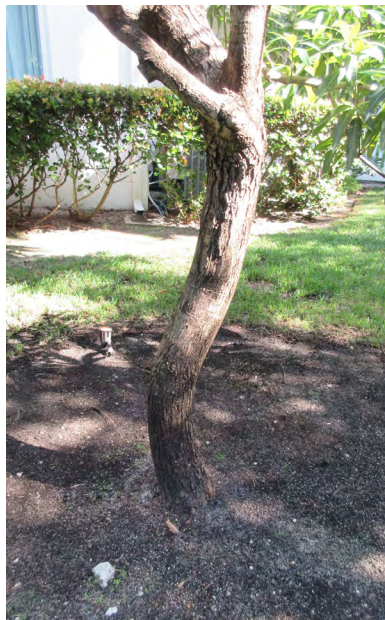
## Tree #21

Tree #21 is a Mango located on the west side of the property. It is small and in good condition. It is growing vigorously. This tree has not been incorporated into the landscape plan and will therefore be removed.

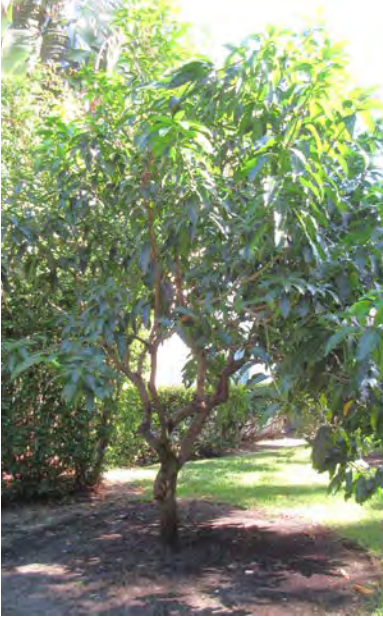
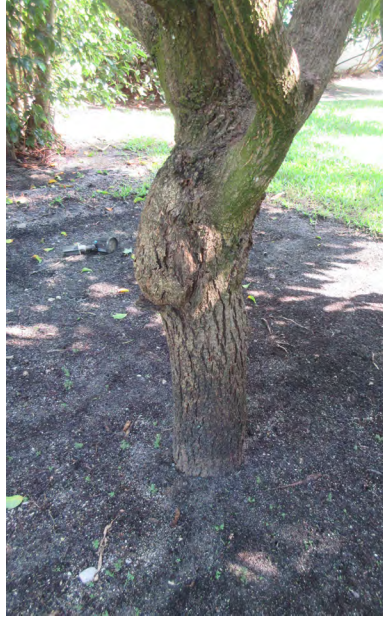
Tree #24 is a Mango located on the west side of the property. It is small and in good condition. It is growing vigorously.

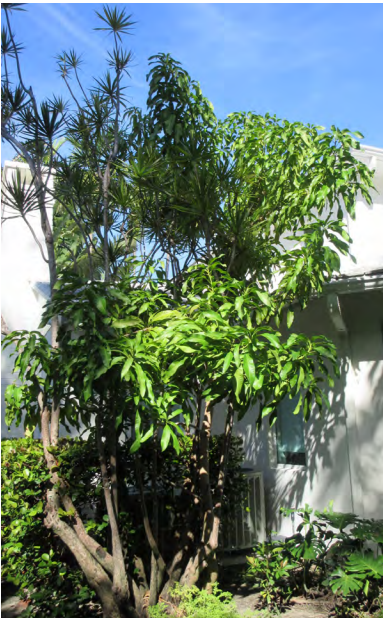
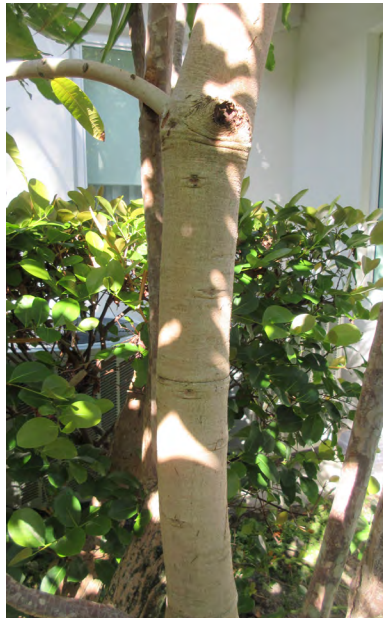
## Tree #27

Tree #27 is a Mango located at the southwest corner of the house. It is in fair condition with chlorotic foliage. It is growing through Dracaena #61. This tree has not been incorporated into the landscape plan and will therefore be removed.

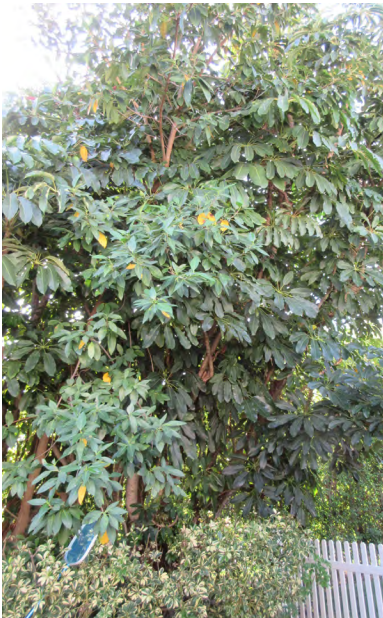
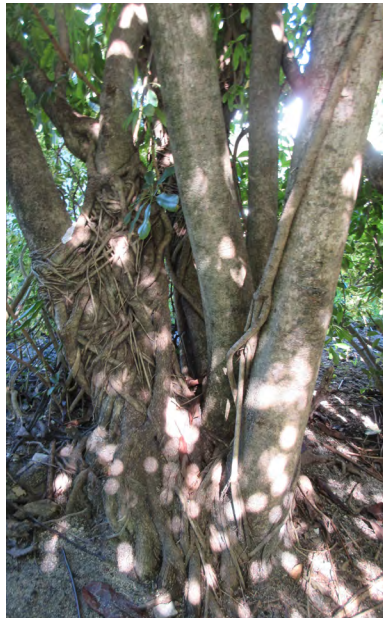
Tree #29 is an Umbrella Tree located in the backyard. It is multi-trunked and in good condition with a dense canopy. This species is highly invasive in South Florida and this tree will therefore need to be removed.

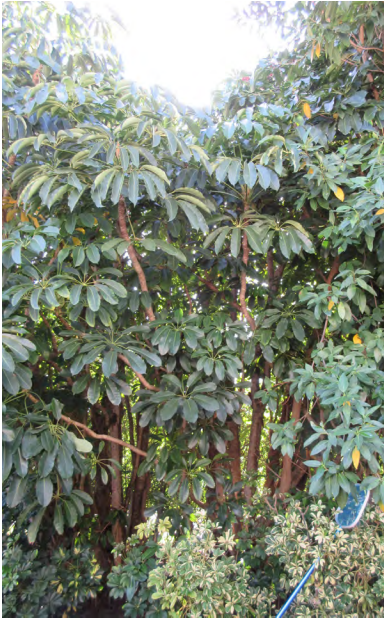
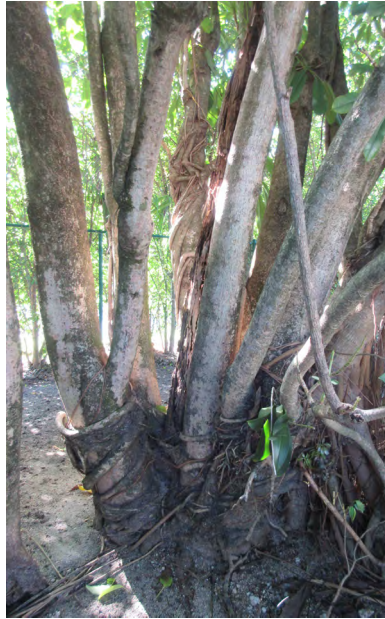
## Tree #30

Tree #30 is an Umbrella Tree located in the backyard. It is multi-trunked and in good condition with a dense canopy. This species is highly invasive in South Florida and this tree will therefore need to be removed.

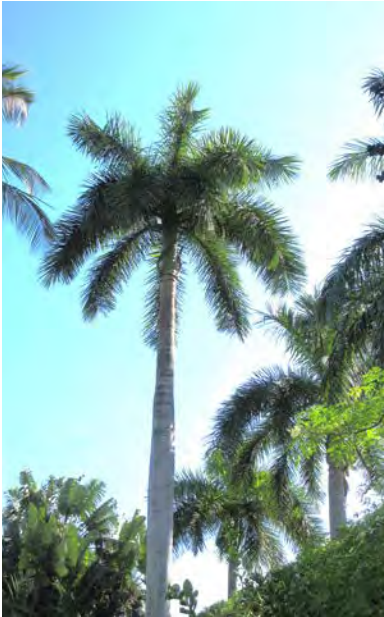
Tree #33 is a Royal Palm located in the backyard. It is in fair condition with a pencilling trunk.

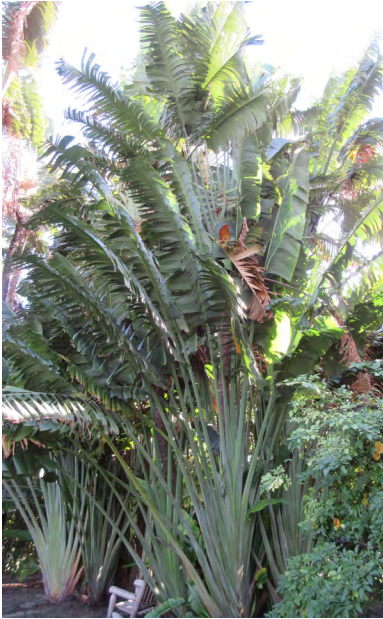
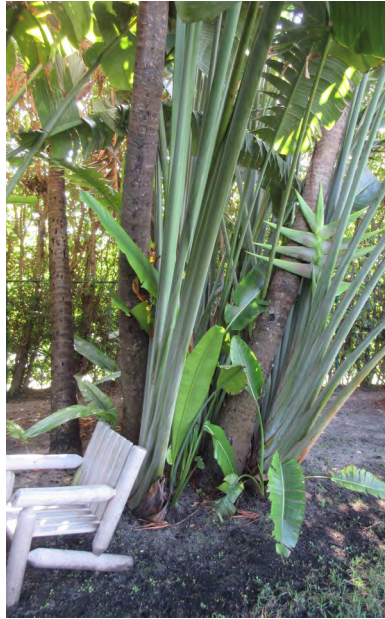
Tree #35-37 is one Traveler's Palm cluster located in the southeast corner of the backyard. It is in good condition with some tattered and brown fronds.

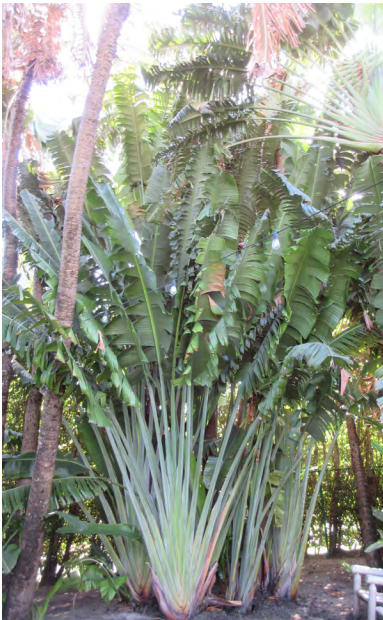
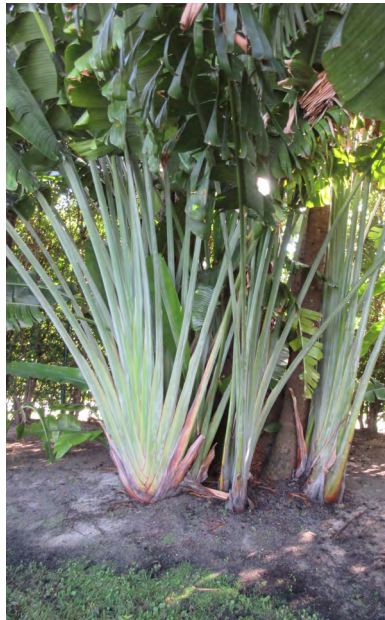
## Tree #38-40

Tree #38-40 is one Traveler's Palm cluster located in the southeast corner of the backyard. It is in good condition with some tattered and brown fronds.

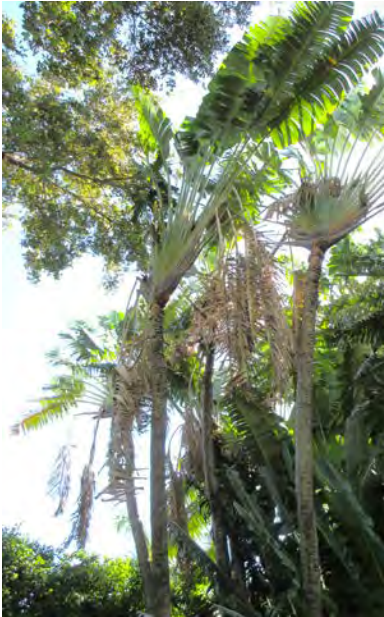
## Tree #41-43

Tree #41-43 is one Traveler's Palm cluster located in the southeast corner of the backyard. It is in fair condition with a small canopy, climbing spike injuries, and lower dead fronds.

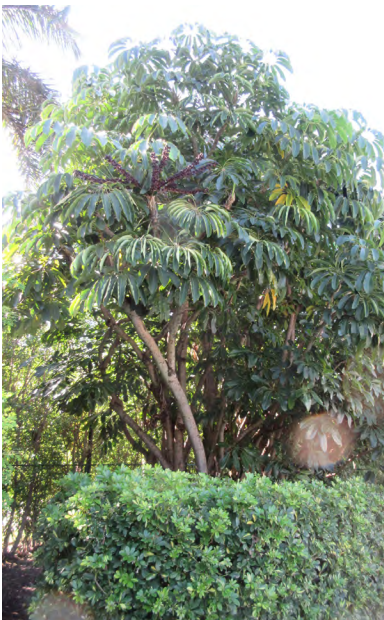
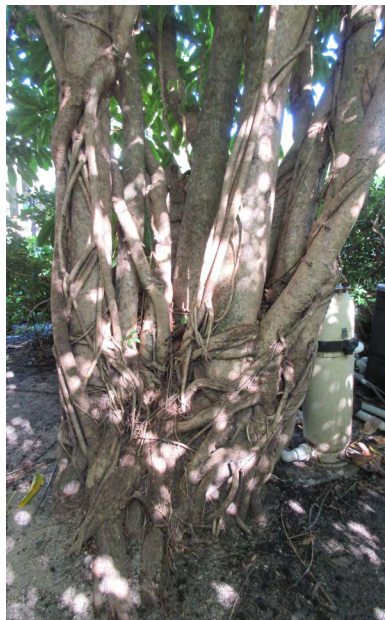
## Tree #46

Tree #46 is an Umbrella Tree located in the backyard. It is in good condition with a dense, green canopy. It is multi-trunked. This species is highly invasive in South Florida and this tree will therefore need to be removed.

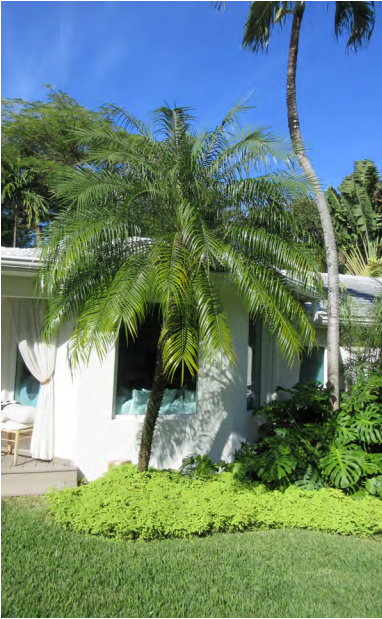
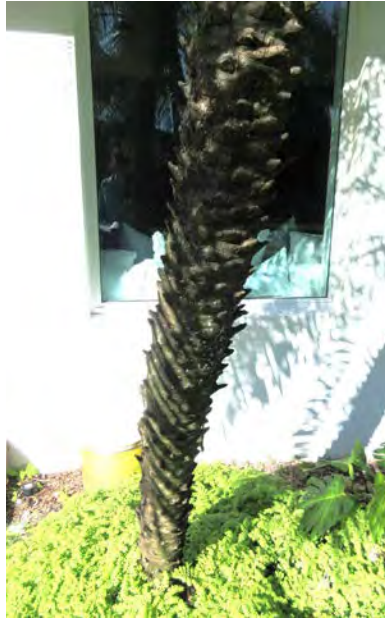
## Tree #47

Tree #47 is a Pygmy Date Palm located at the rear of the house. It is in good condition. This tree has not been incorporated into the landscape plan and will therefore be removed.

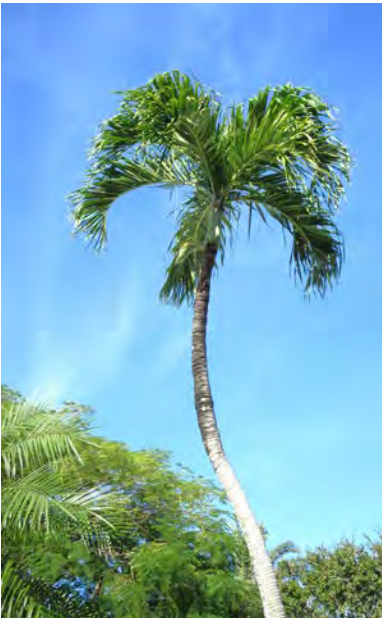
## Tree #48

Tree #48 is a Christmas Palm located at the rear of the house. It is in fair condition with a pencilling trunk. This tree has not been incorporated into the landscape plan and will therefore be removed.

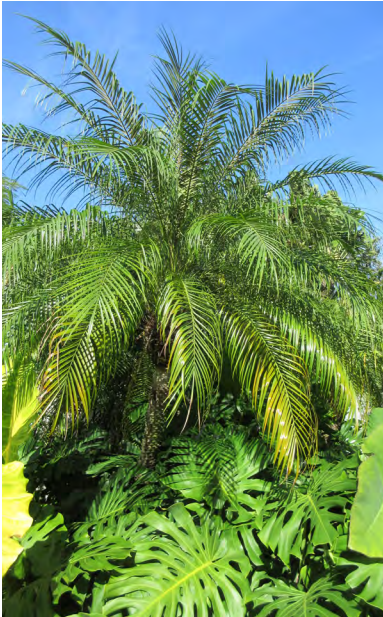
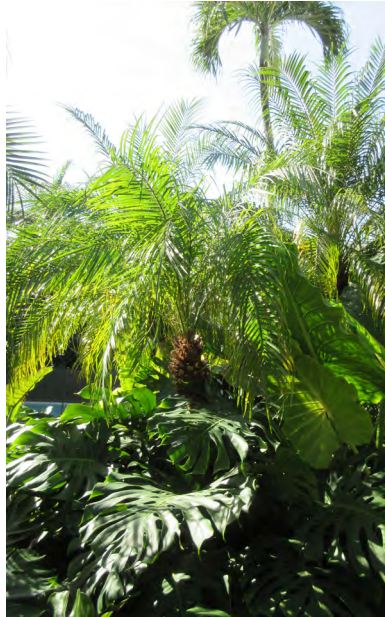
## Tree #49

Tree #49 is a triple Pygmy Date Palm located at the rear of the house. It is in good condition. This tree has not been incorporated into the landscape plan and will therefore be removed.

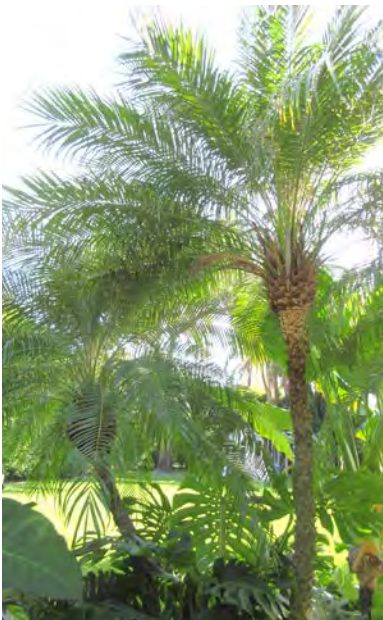
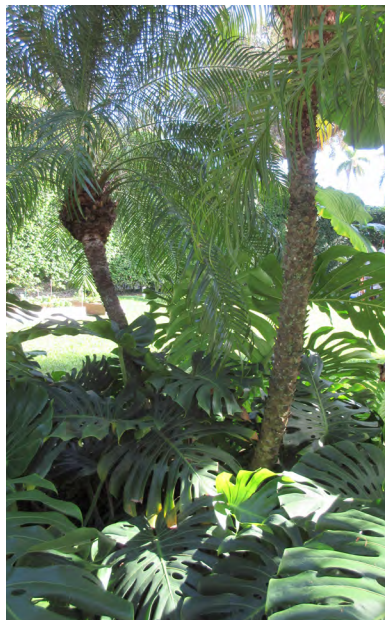
## Tree #50

Tree #50 is a double Pygmy Date Palm located at the rear of the house. It is in good condition. This tree has not been incorporated into the landscape plan and will therefore be removed.

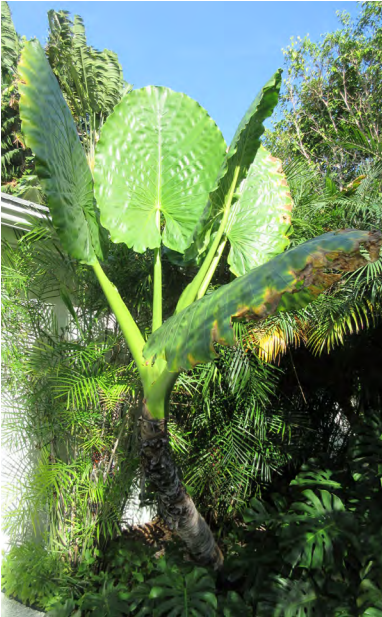
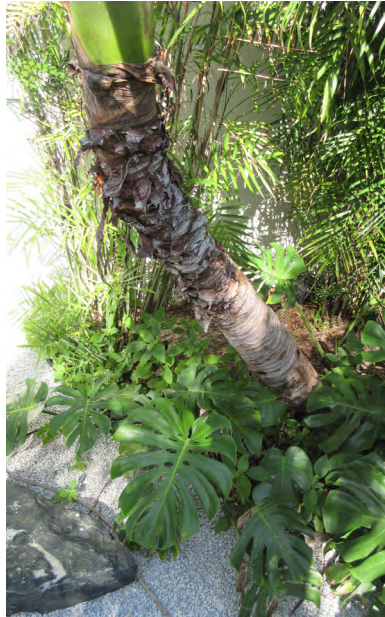
## Tree #51

Tree #51 is an Elephant Ear located at the rear of the house. It is in good condition. This plant has not been incorporated into the landscape plan and will therefore be removed.

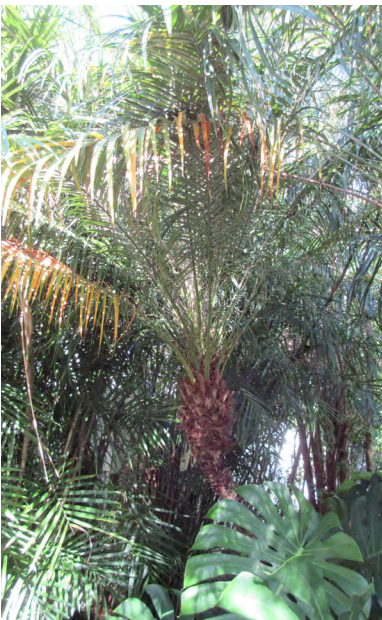
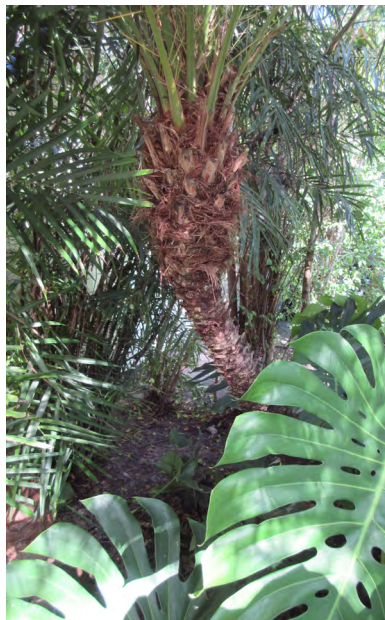
## Tree #52

Tree #52 is a Pygmy Date Palm located at the rear of the house. It is in fair condition and is competing with the nearby vegetation. This tree has not been incorporated into the landscape plan and will therefore be removed.

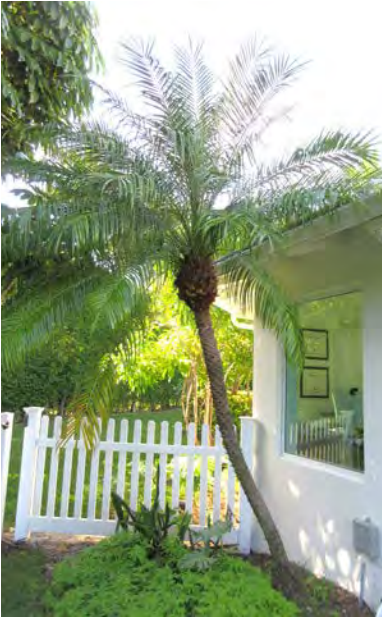
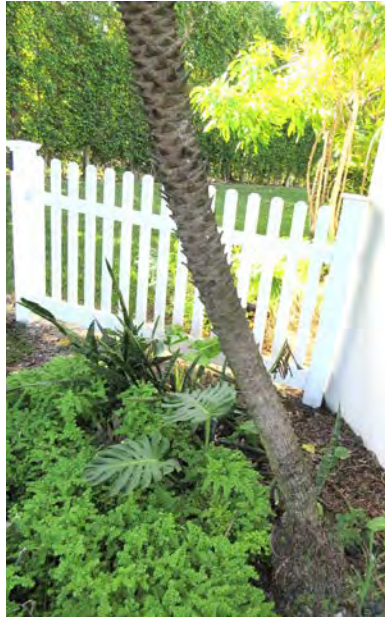
## Tree #53

Tree #53 is a Pygmy Date Palm located at the rear of the house. It is in fair condition with a thin canopy. This tree has not been incorporated into the landscape plan and will therefore be removed.

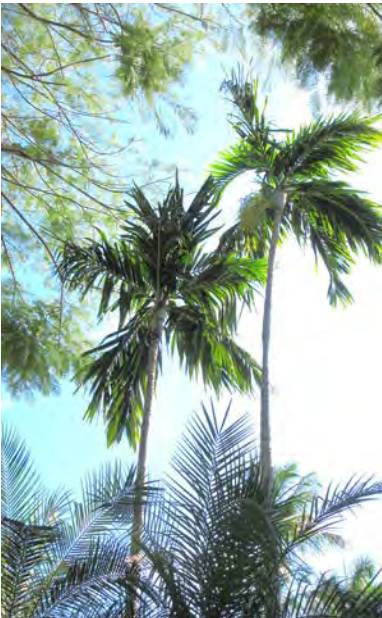
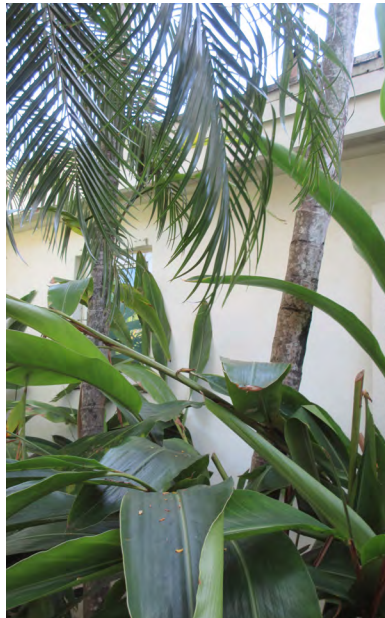
## Tree #54

Tree #54 is a double Alexander Palm located at the front of the house. It is in fair condition with chlorotic fronds. This tree has not been incorporated into the landscape plan and will therefore be removed.

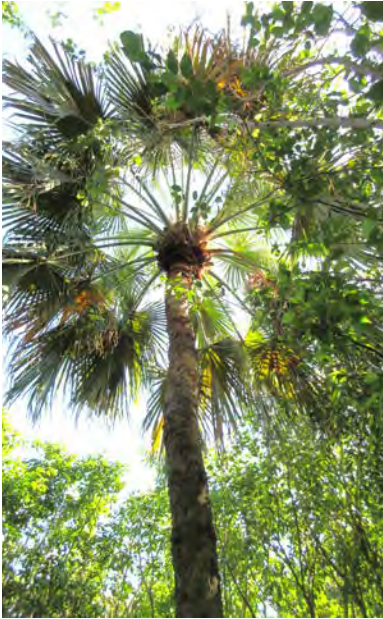
## Tree #55

Tree #55 is a Chinese Fan Palm located on the east side of the property. It is in fair condition with leaf skeletonizer damage and yellowing of the fronds.

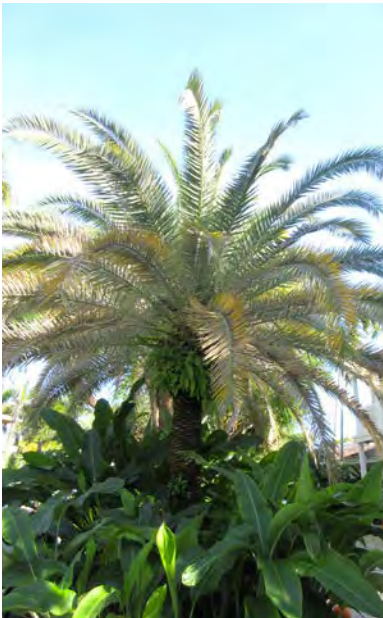
## Tree #56

Tree #56 is a Canary Island Date Palm street tree located along 22nd Street. It is in good condition. The foliage is off-color and there may be a pest issue.

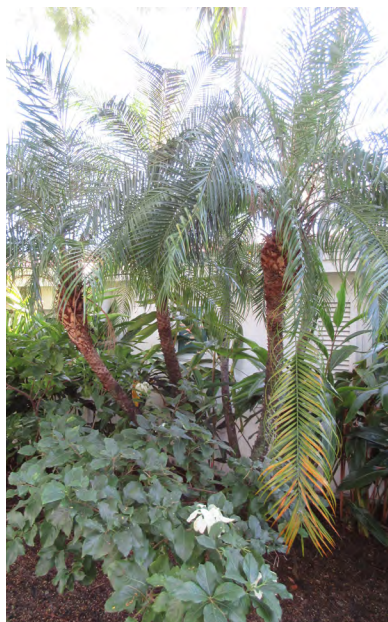
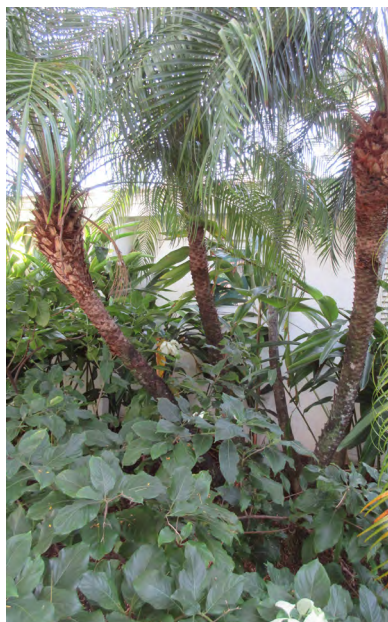
Tree #58 is a triple Pygmy Date Palm located at the front of the house. It is in good condition. This tree has not been incorporated into the landscape plan and will therefore be removed.

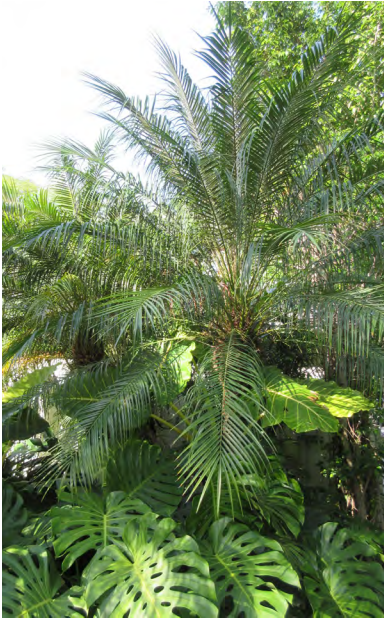
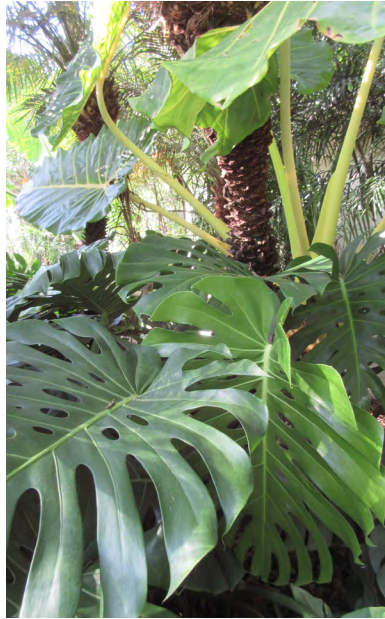
## Tree #59

Tree #59 is a double Pygmy Date Palm located at the rear of the house. It is in good condition. This tree has not been incorporated into the landscape plan and will therefore be removed.

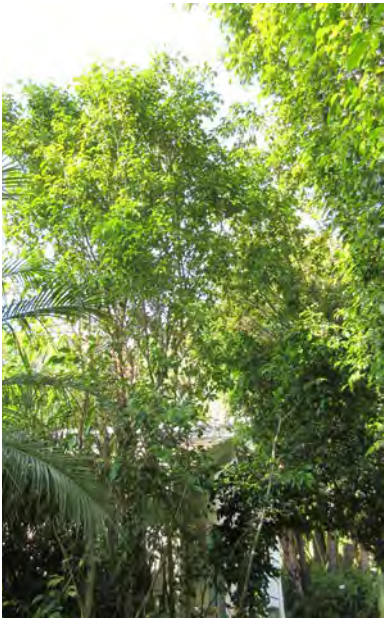
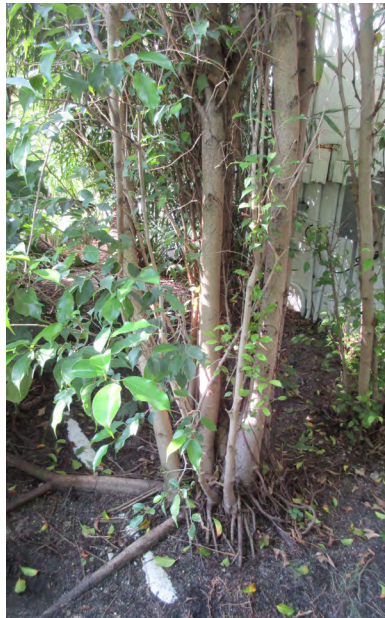
## Tree #60

Tree #60 is a Weeping Ficus and is part of the hedge that wraps around the property. It is multi-trunked and in good condition.

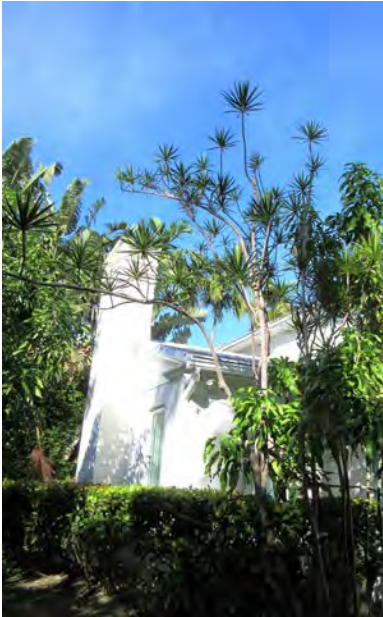
## Tree #61

Tree #61 is a Dragon Tree located at the rear southwest corner of the house. It is multi-trunked and in poor condition. The canopy is thin and there is decay in some of the trunks.

This tree has not been incorporated into the landscape plan and will therefore be removed.

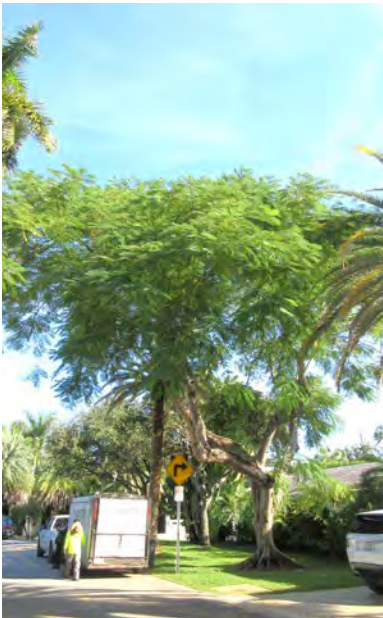
Tree #62 is a Royal Poinciana located at the front of the property. It is in good condition and has a wide-spreading canopy. Little deadwood is present. There are large surface roots. There are old burls present, formed from heading cuts. There is a large cavity on one of the main limbs with decay that is closing over.

Prune to maintain clearance over the street.

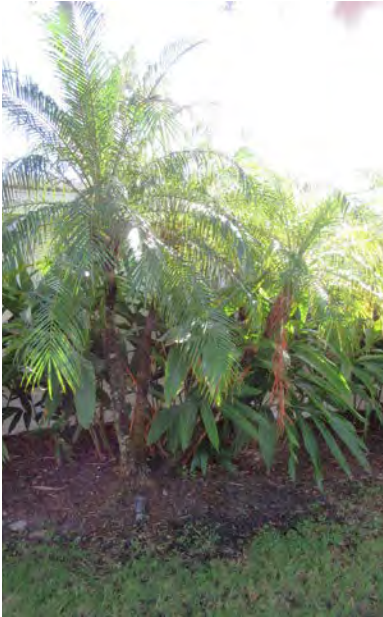
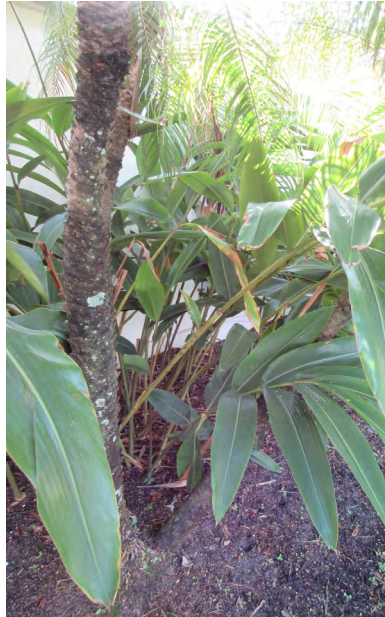
Tree #63 is a triple Pygmy Date Palm located at the front of the house. It is in good condition. This tree has not been incorporated into the landscape plan and will therefore be removed.

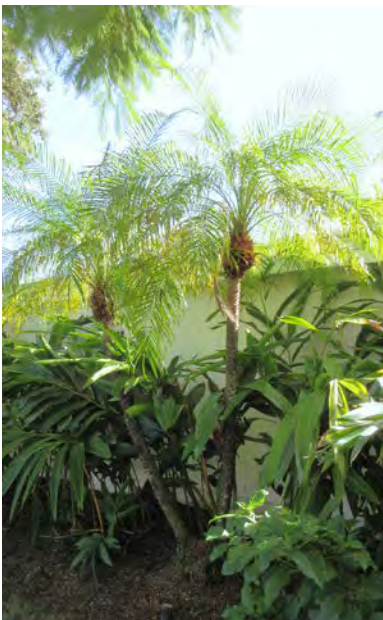
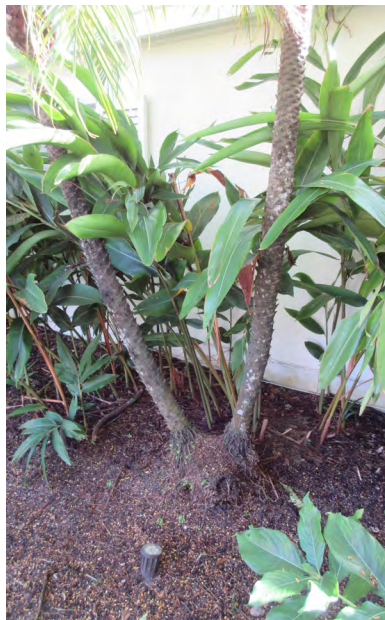
## Tree #64

Tree #64 is a double Pygmy Date Palm located at the front of the house. It is in fair condition with some yellowing of the fronds. This tree has not been incorporated into the landscape plan and will therefore be removed.

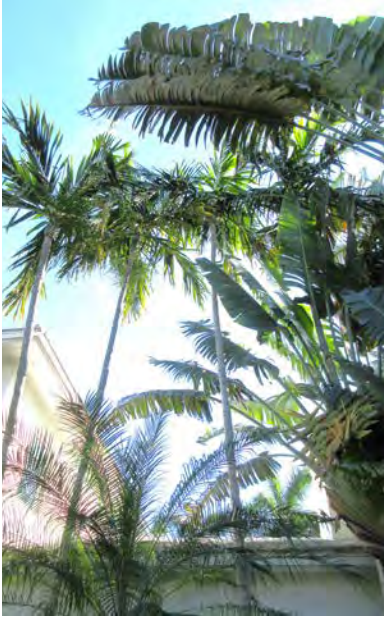
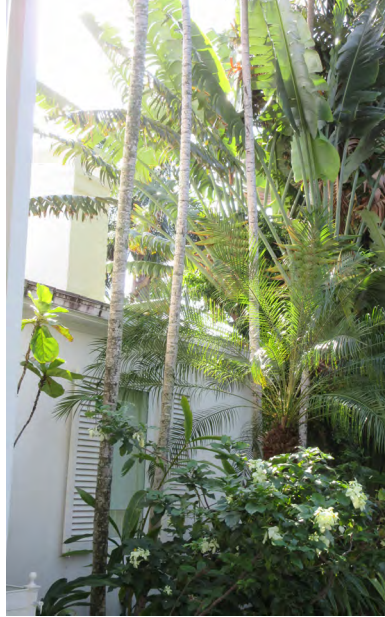
## Tree #65

Tree #65 is four Alexander Palms located at the front of the house. They are in good condition. This tree has not been incorporated into the landscape plan and will therefore be removed.

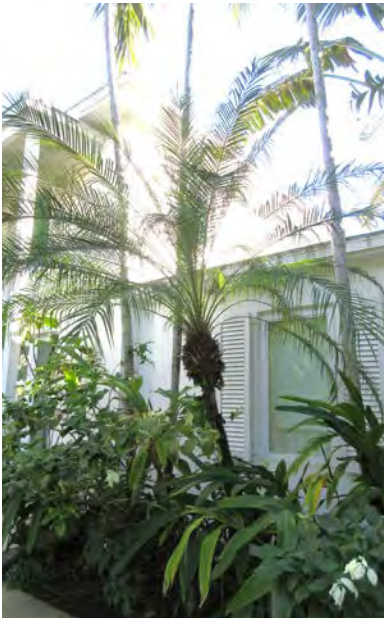
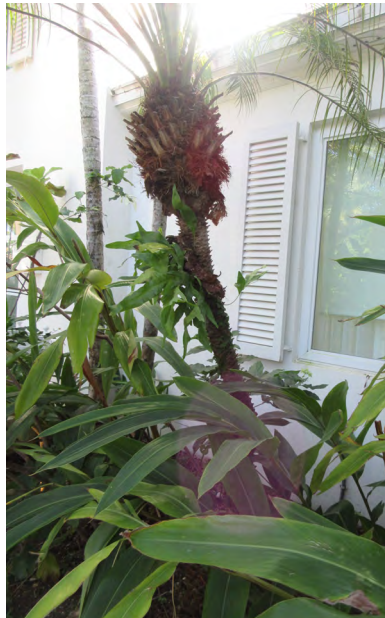
**Condition -**  
FAIR

Tree #66 is a Pygmy Date Palm located at the front of the house. It is in fair condition with a thin canopy. This tree has not been incorporated into the landscape plan and will therefore be removed.

**Disposition -**  
REMOVE

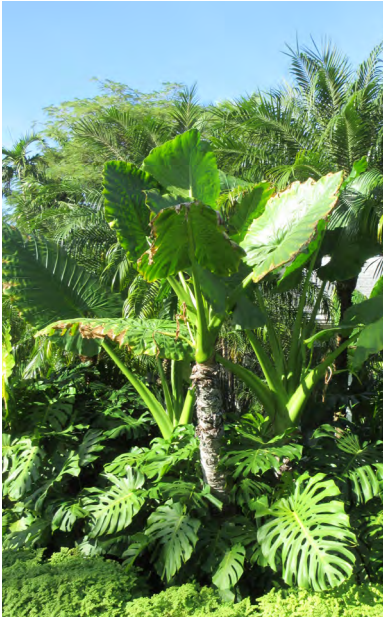
**Condition -**  
FAIR

Tree #69 is an Elephant Ear located at the rear of the house. It is in fair condition with some marginal necrosis. This plant has not been incorporated into the landscape plan and will therefore be removed.

**Disposition -**  
REMOVE

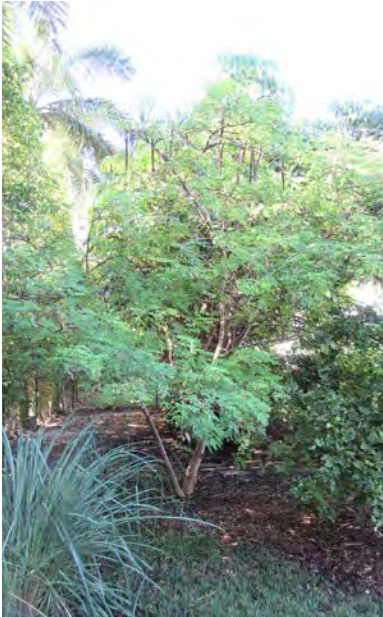
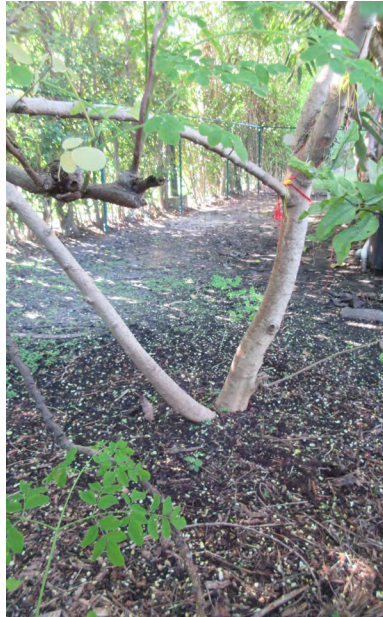
**Condition -**  
GOOD

Tree #71 is a Moringa located in the backyard. It is double-trunked and in good condition. This tree has not been incorporated into the landscape plan and will therefore be removed.

**Disposition -**  
REMOVE

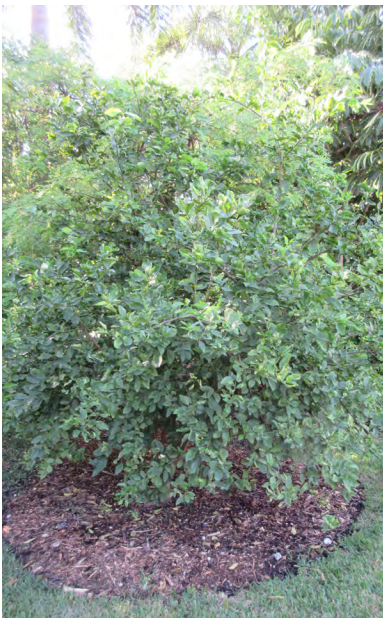
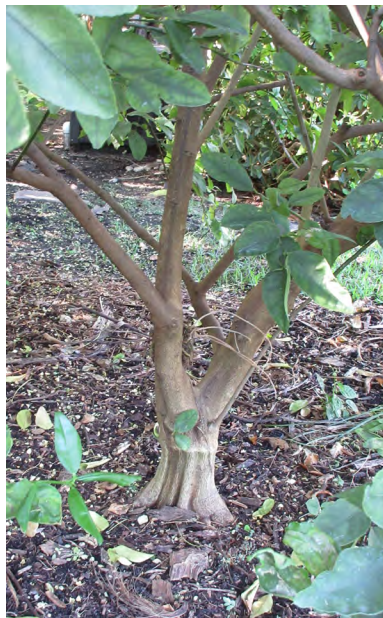
## Tree #72

**Condition -**  
FAIR

Tree #72 is a small Lime tree located in the backyard. It is in fair condition with chlorosis and some pest issues. This tree has not been incorporated into the landscape plan and will therefore be removed.

**Disposition -**  
REMOVE
