**GENERAL ASSESSMENT REPORT**

**EXISTING LOG CABIN  
8128 COLLINS AVENUE  
MIAMI BEACH, FLORIDA**

**SEPTEMBER 1, 2017**

PREPARED BY:  
**DOUGLAS WOOD ASSOCIATES, INC.**

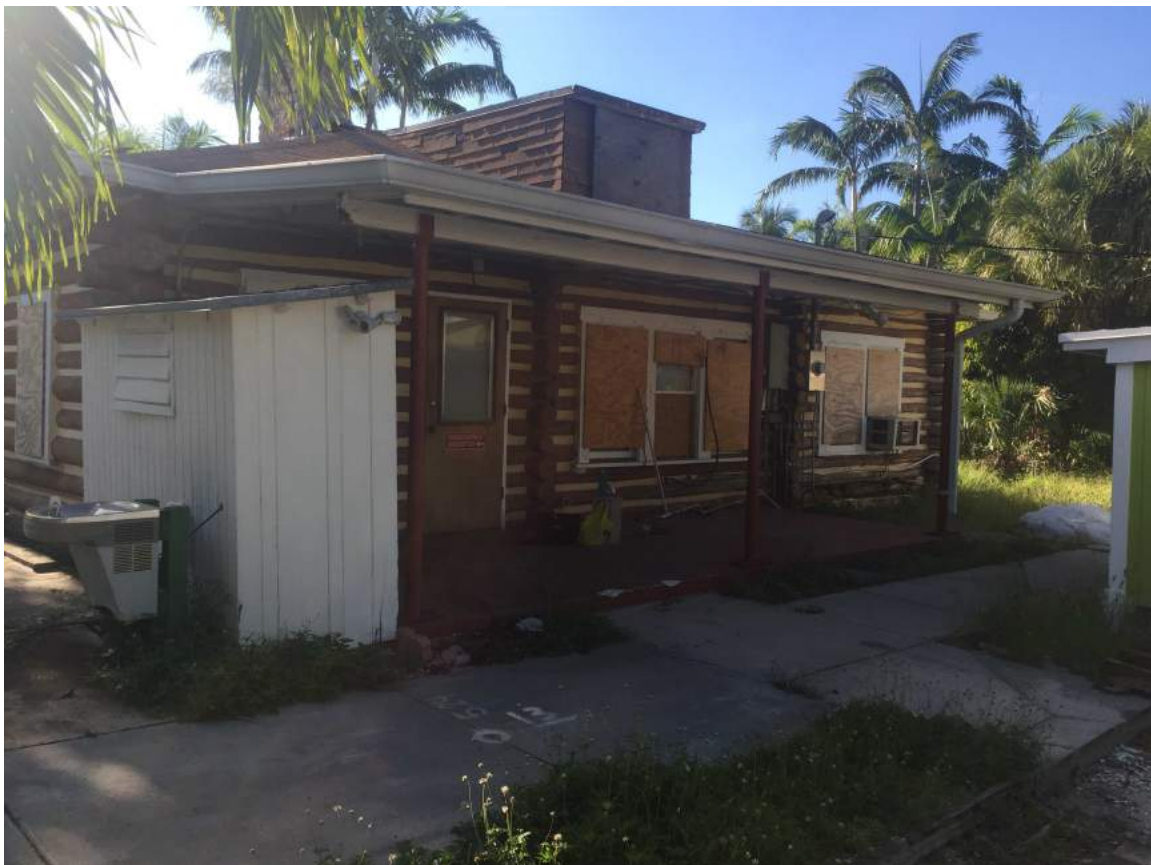
PHOTOGRAPH NO. 4

This building was originally constructed as a one-story residence. The overall configuration appears to remain generally as originally constructed (Refer to Photograph No. 4 through 8). A rear porch with flat roof and concrete floor slab appears to be an addition (Refer to Photograph No. 4).

There are also interior log walls along the north and south sides of the central living/dining room (Refer to Photograph No. 21). These walls provide some support for the roof and ceilings. These walls bear on wood beams, which bear on the concrete stemwalls and on concrete piers. These interior log walls interlock with the east and west exterior log walls, and their log ends are exposed on the exterior (Refer to Photographs Nos. 4, 7, 22 and 23).

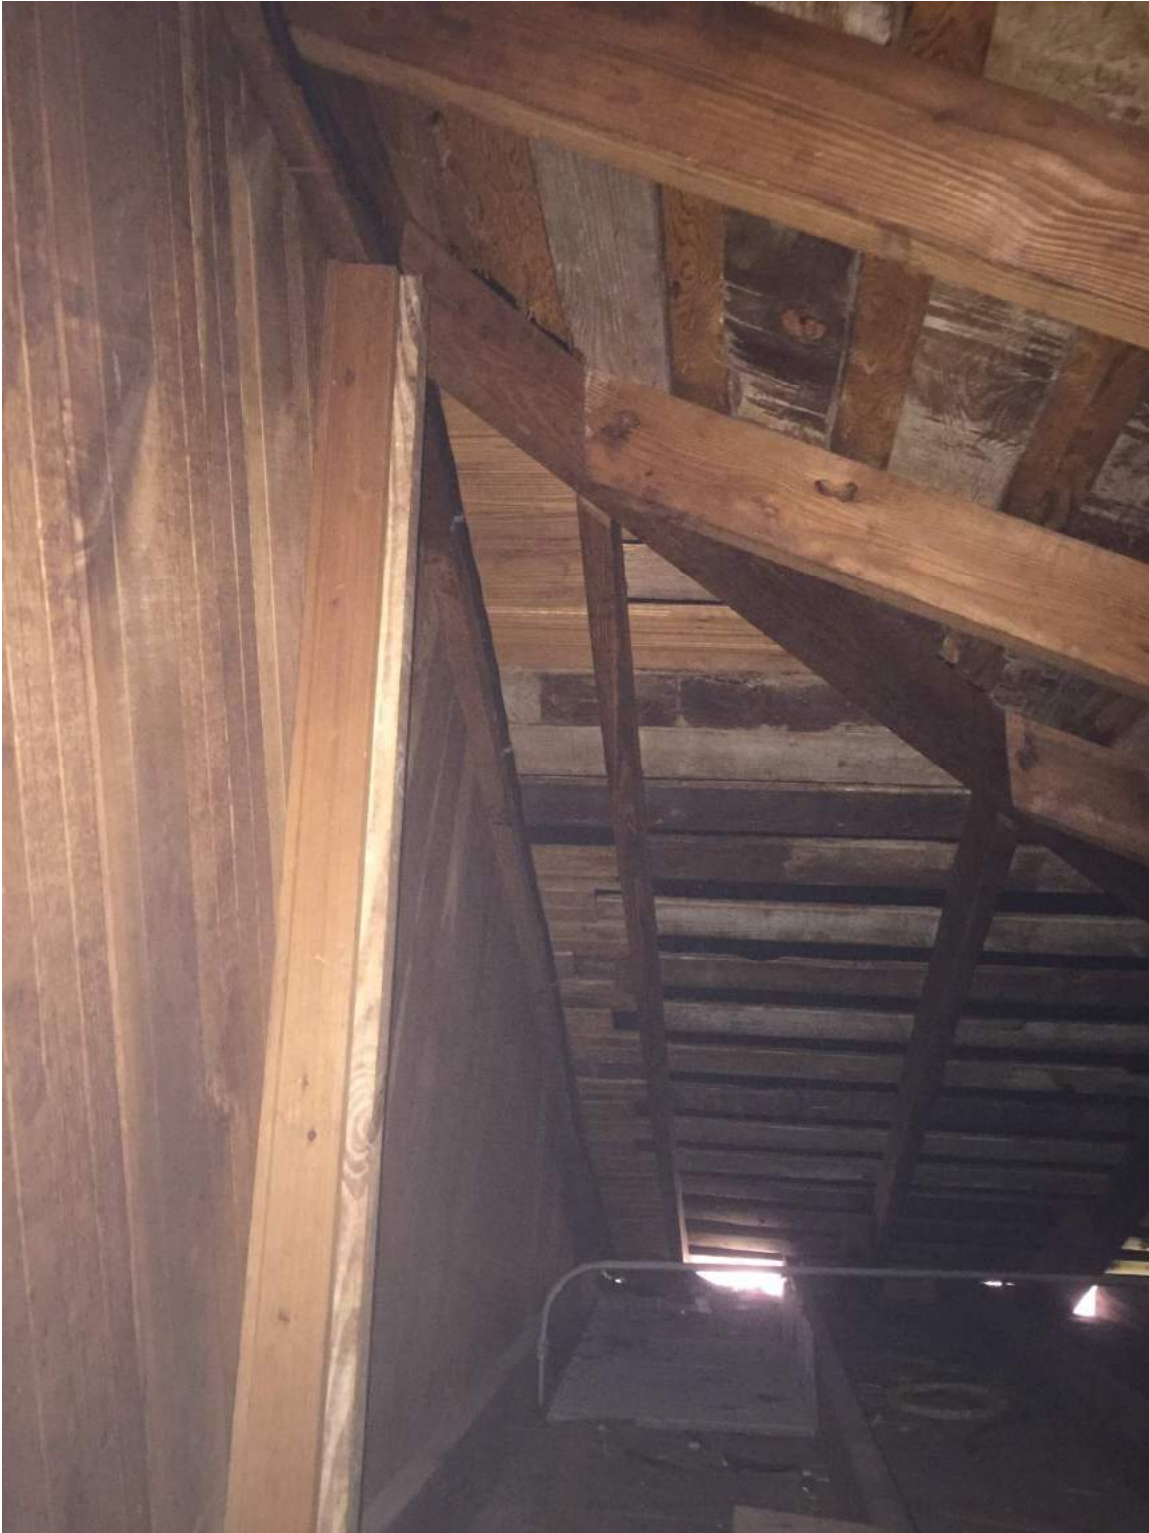
**PHOTOGRAPH NO. 13**

3. The hip ridge boards are long 2x6's. One must assume that they are supported by the geometry of the roof planes and by lateral resistance at the tops of the log walls. Each of these ridge boards is also supported by one 2x4 stud in the partition above the interior log walls (Refer to Photograph No. 13). In our opinion, this configuration and the associated members and connections are of questionable capacity.

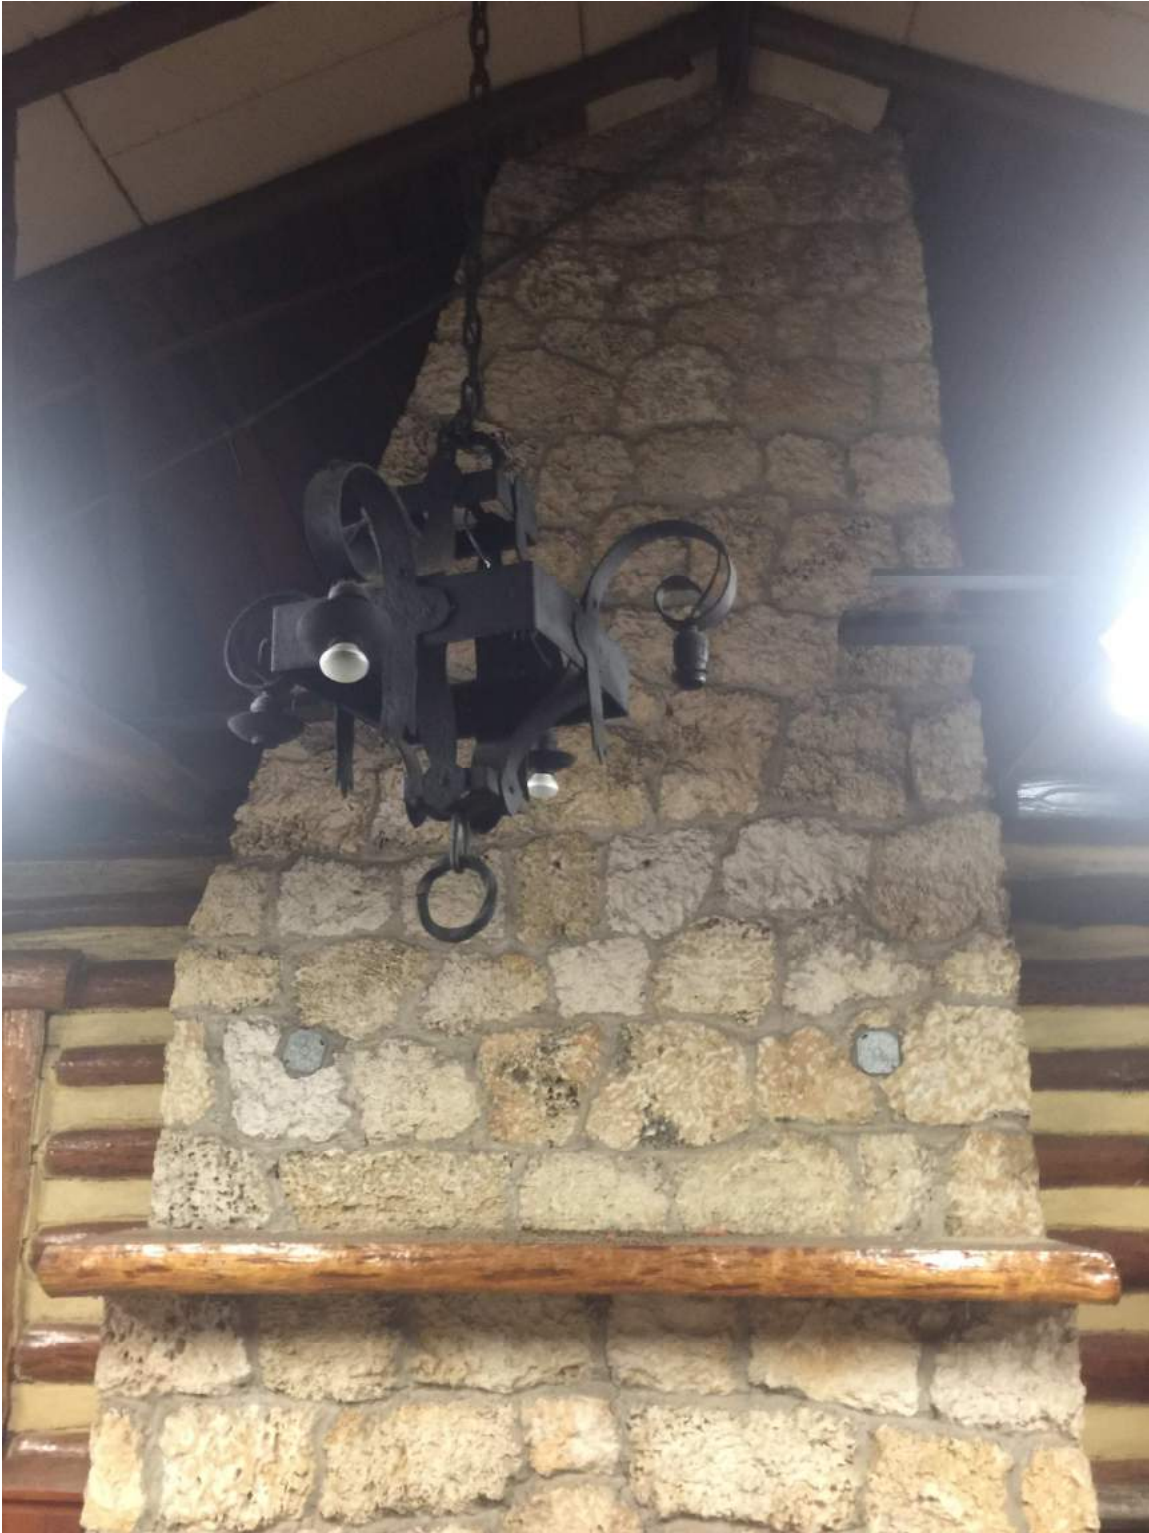
PHOTOGRAPH NO. 25

The fireplace and its chimney are constructed of oolitic limestone rubble (refer to Photographs Nos. 8 and 25). Below the floor, however, the stemwalls below the fireplace are constructed of concrete block (Refer to Photograph No. 26).

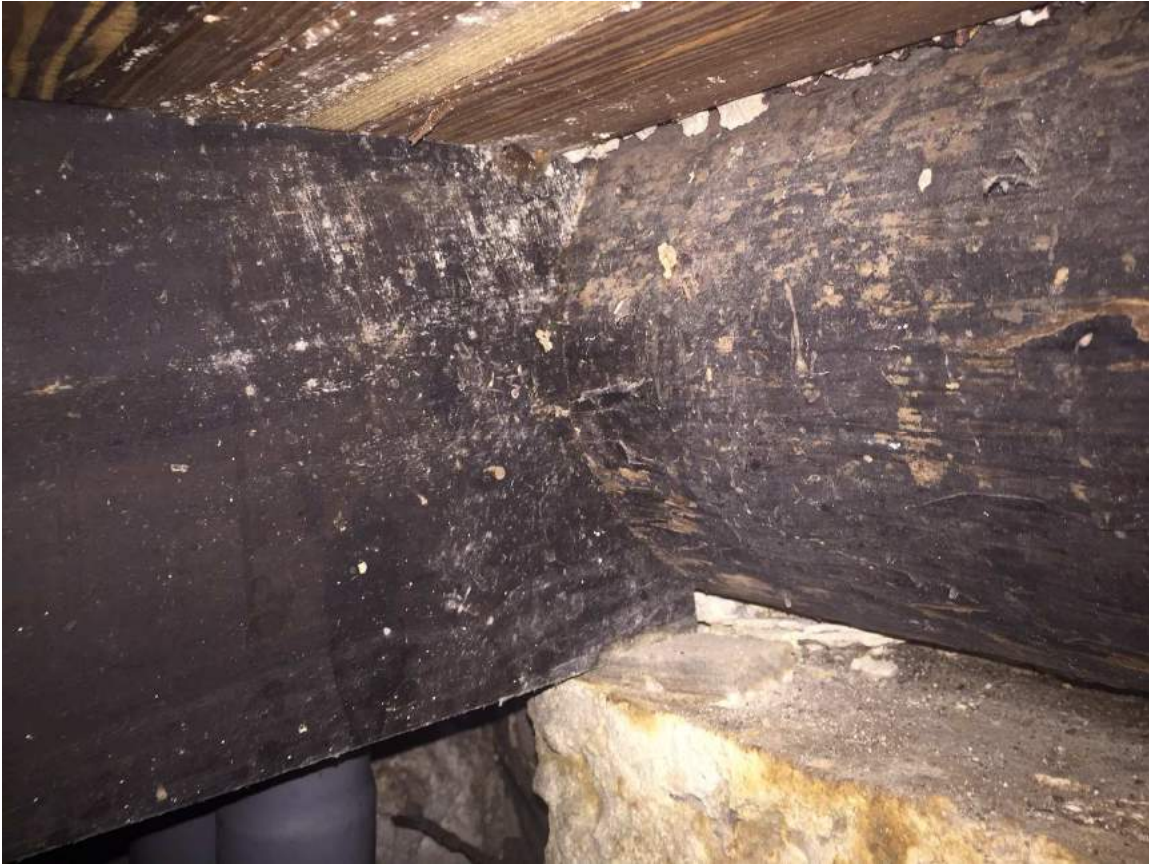
**PHOTOGRAPH NO. 28**

The interior floors consist of a single layer of wood flooring (no subfloor/sheathing) on wood joists (Refer to Photographs Nos. 1, 27, 28 and 29). The joists span in the north-south direction. The joists bear on top of the concrete stemwalls (set in notches in the lowest log) (Refer to Photograph No. 28), and they bear on interior wood beams (Refer to Photograph No. 27). The beams bear in pockets in the concrete stemwalls (Refer to Photograph No. 27) and on interior concrete piers, formed using 50-gallon steel drums (Refer to Photographs Nos. 27 and 29). The interior log walls (north and south sides of central room) bear on the floor joists above the beams (Refer to Photograph No. 30).
