## Historical Preservation Board Report

# 947 Lincoln Road

Miami Beach, Florida

January 31, 2017

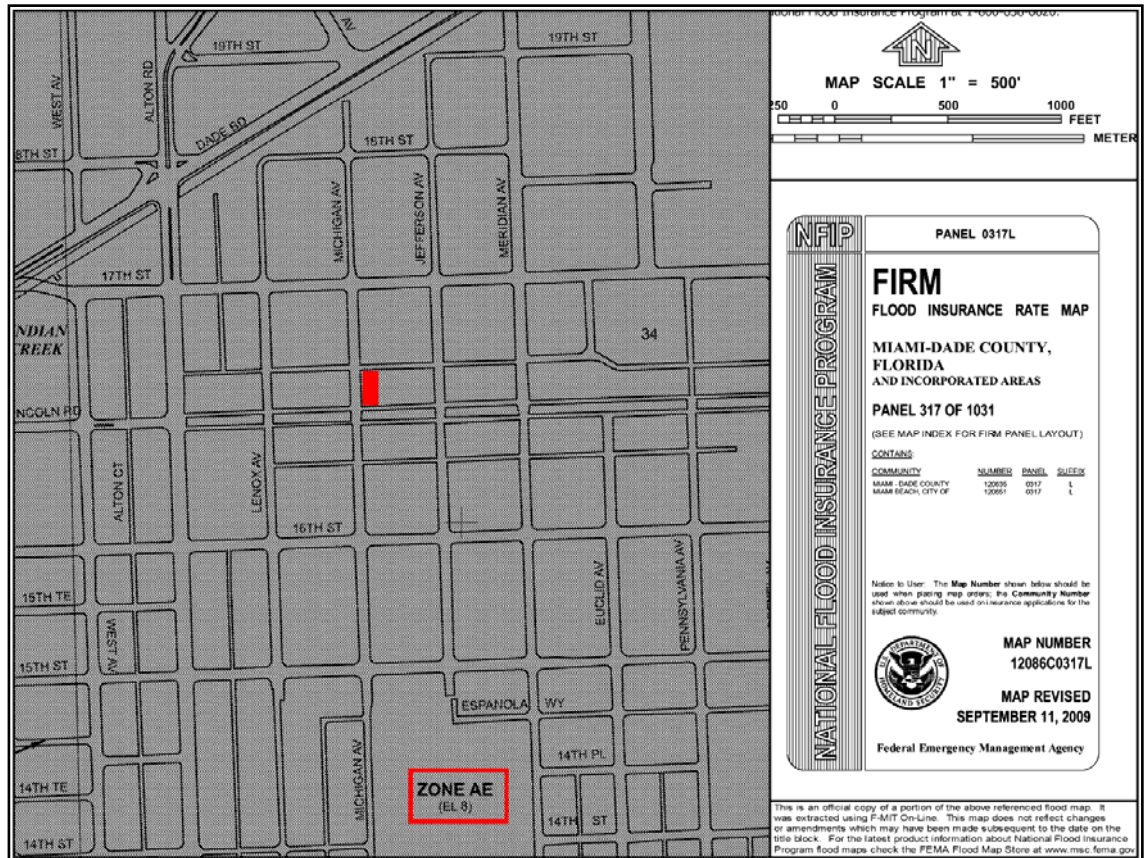
**FEMA – Flood Insurance Rate Map**

Per FEMA Flood Insurance Rate Map (FIRM), as shown below, the building is situated in Zone AE with a Base Flood Elevation (BFE) of +8.00' NGVD.

The Florida Building Code dictates that buildings with Risk Category II should have a Design Flood Elevation of BFE + 1'. Therefore, the entire ground floor should be designed for hydrostatic pressure based on water elevation of +9.00'.

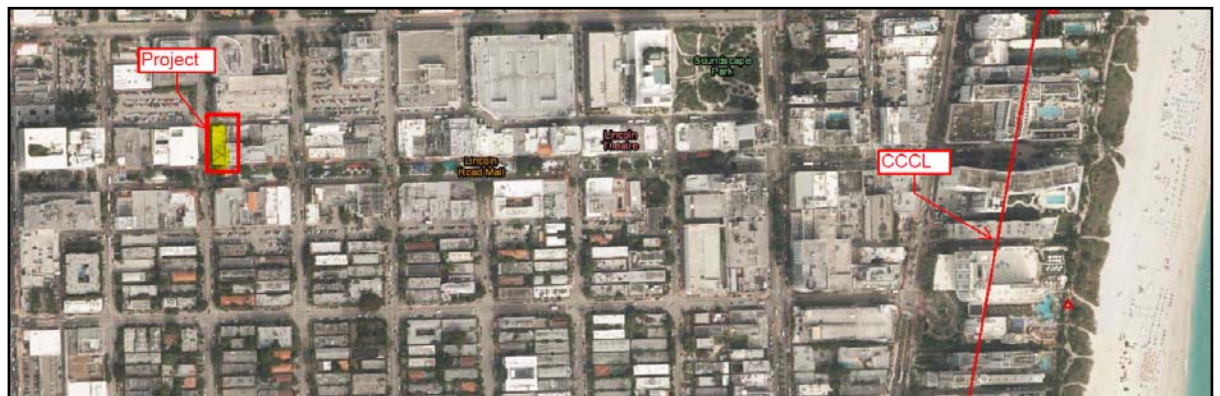
**FEMA – CCCL Map**

Per the State of Florida’s Department of Environmental Protection, the building is located outside of the Coastal Construction Control Line (CCCL). Therefore, the building will not be subjected to High-Velocity Wave Action.
