GENERAL ASSESSMENT REPORT

EXISTING STRUCTURAL SYSTEMS

**819 2ND STREET
MIAMI BEACH, FLORIDA**

JUNE 28, 2017

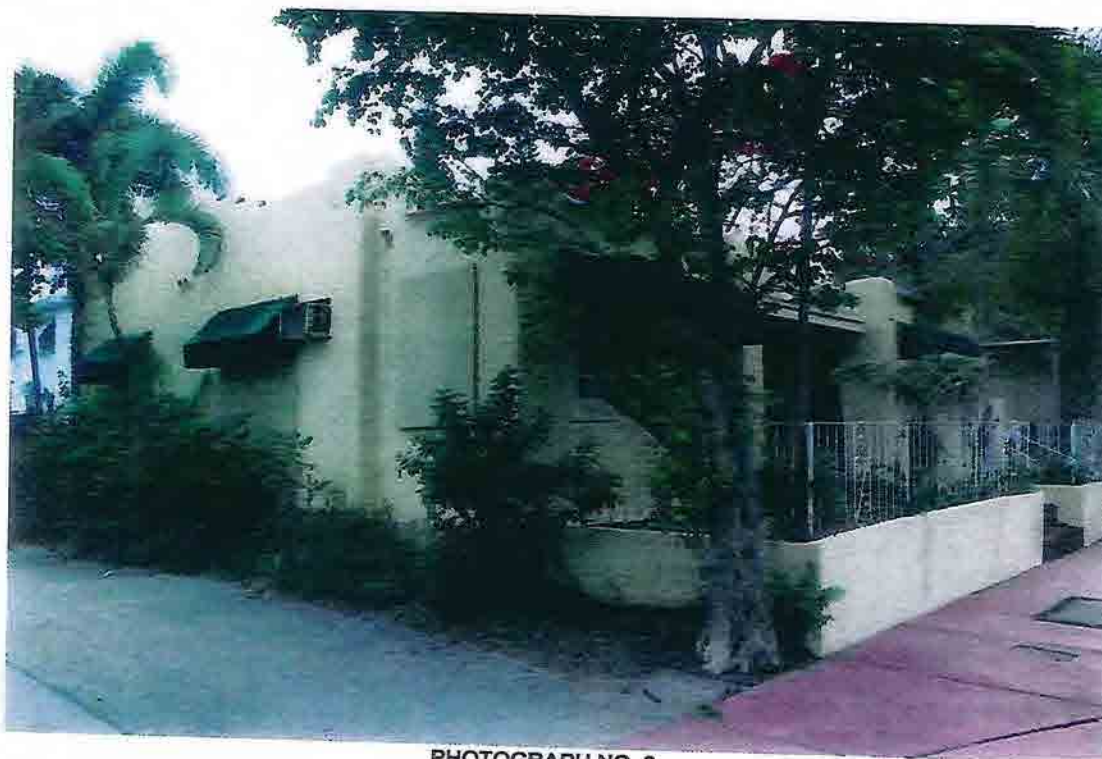
PHOTOGRAPH NO. 2

The front patio appears to be a concrete slab-on-ground. The front and rear steps also appear to be concrete on ground. The front planter/retaining walls appear to be stucco on 4-inch concrete brick. Refer to Photograph No. 2.

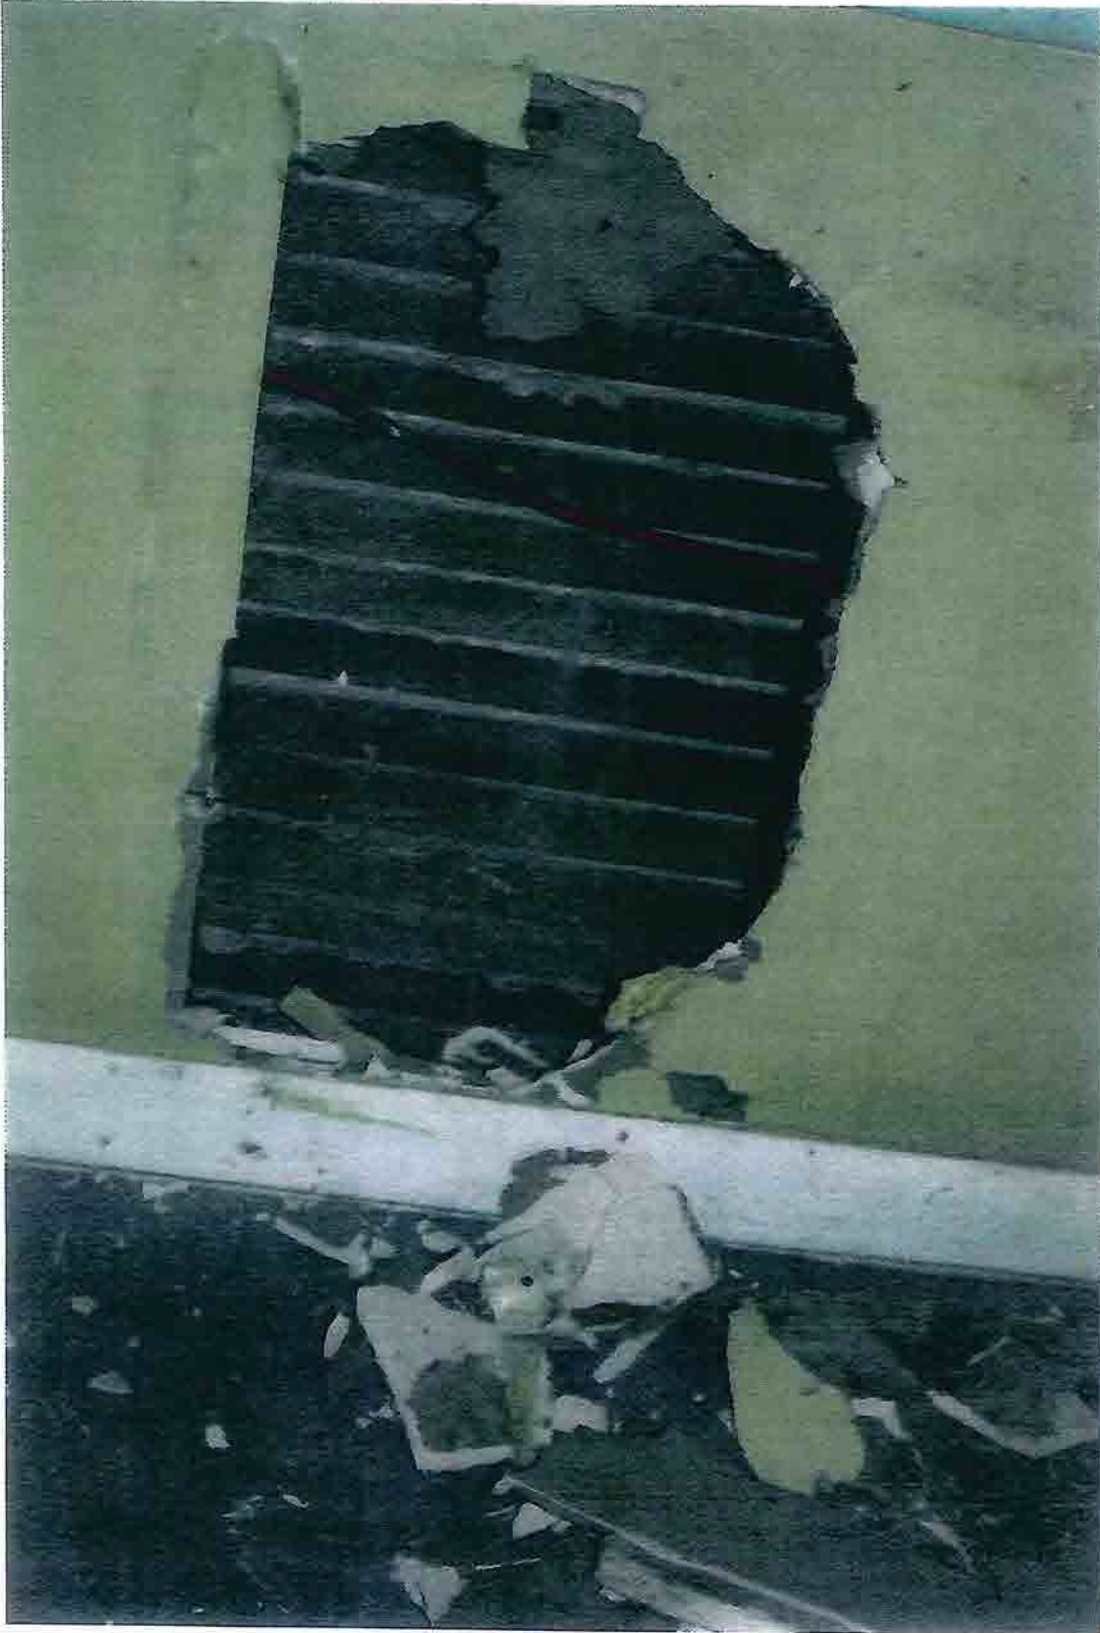
PHOTOGRAPH NO. 19

The original exterior walls are constructed of stucco on wood lath over 2x4 wood studs at 16 inches on center. Refer to Photograph No. 19. The wall studs appear to be continuous up to the tops of the parapets (a balloon frame configuration). Refer to Photograph No. 12. The main north-south interior partitions also appear to support the roof. It appears that portions of the original rear wall were removed to open to the rear addition. The walls of the rear addition are constructed of stucco on concrete block.

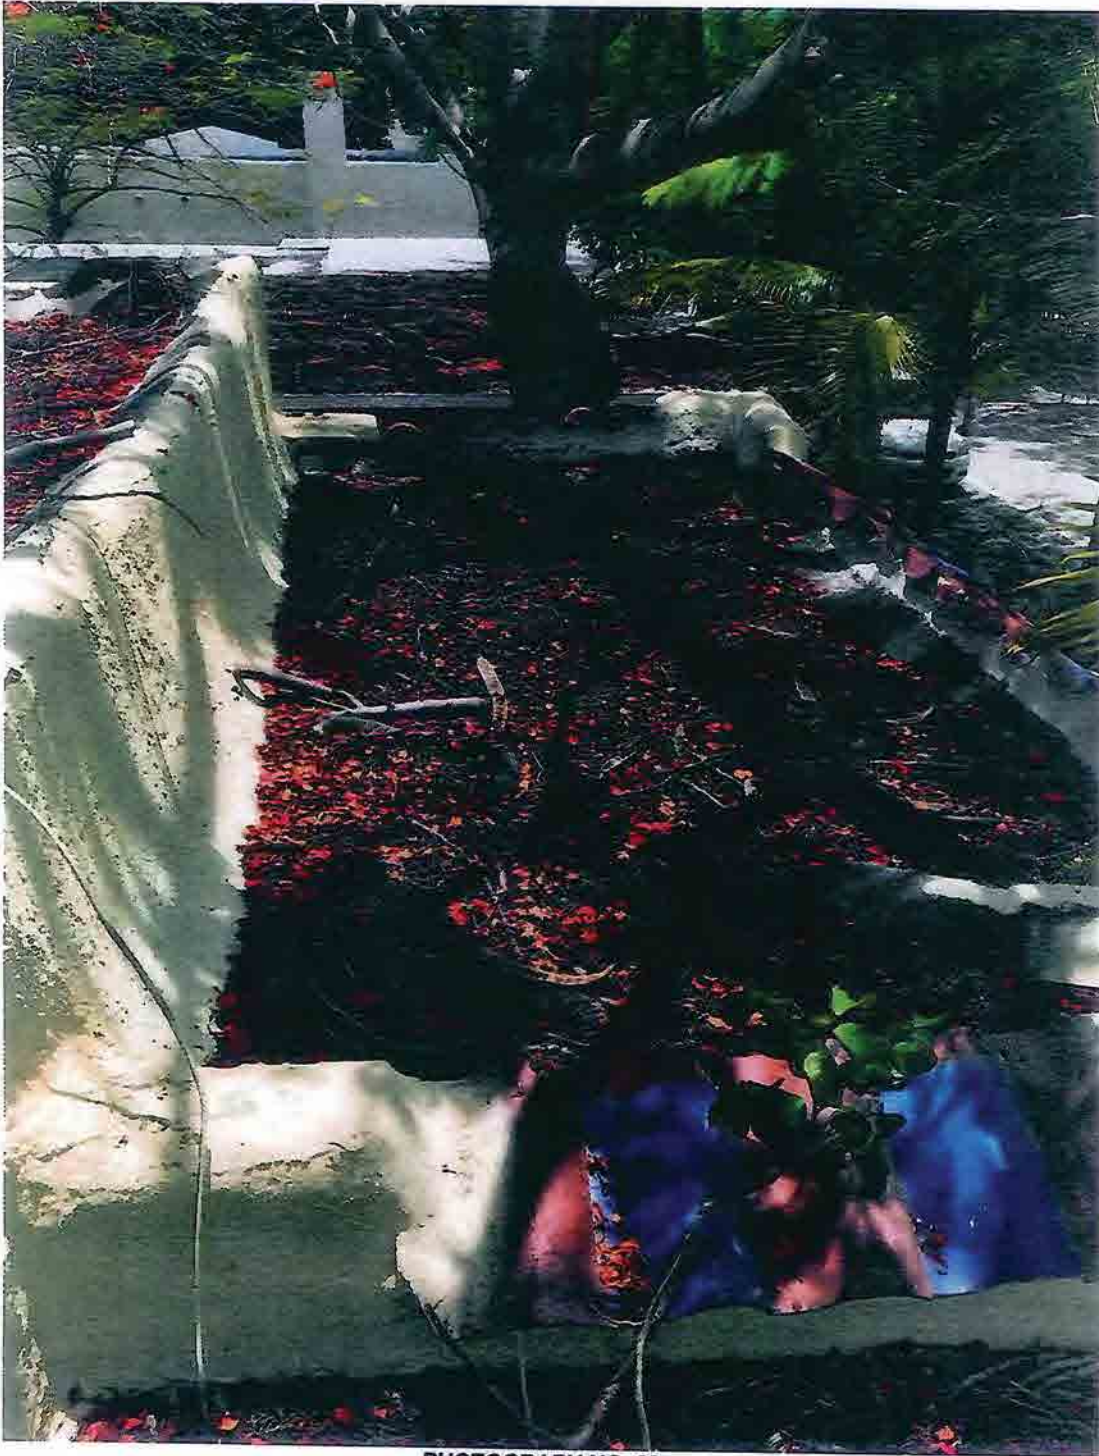
PHOTOGRAPH NO. 28

6. A large area of the main roof is covered in leaves, twigs and debris. Refer to Photograph No. 27. There are numerous plants growing in the debris. The lower roof of the front of the east wing is completely covered with leaves, twigs and debris. Refer to Photograph No. 28. The scupper for this roof is partially clogged. The scupper for the low roof at the front of the west wing is clogged. Refer to Photograph No. 29.

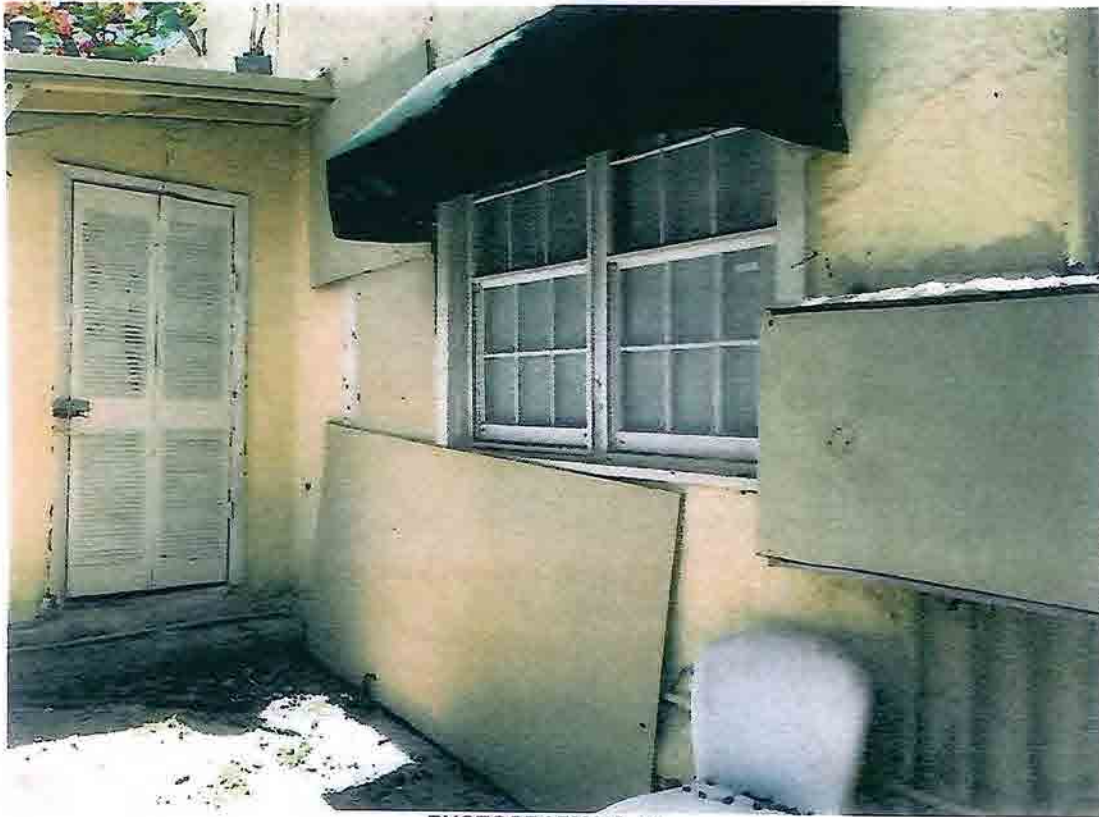
PHOTOGRAPH NO. 45

6. There is a large sheet of plywood screwed to the exterior rear wall of the west unit. Refer to Photograph No. 45. It is believed that this plywood covers the only possible access to the crawl space.

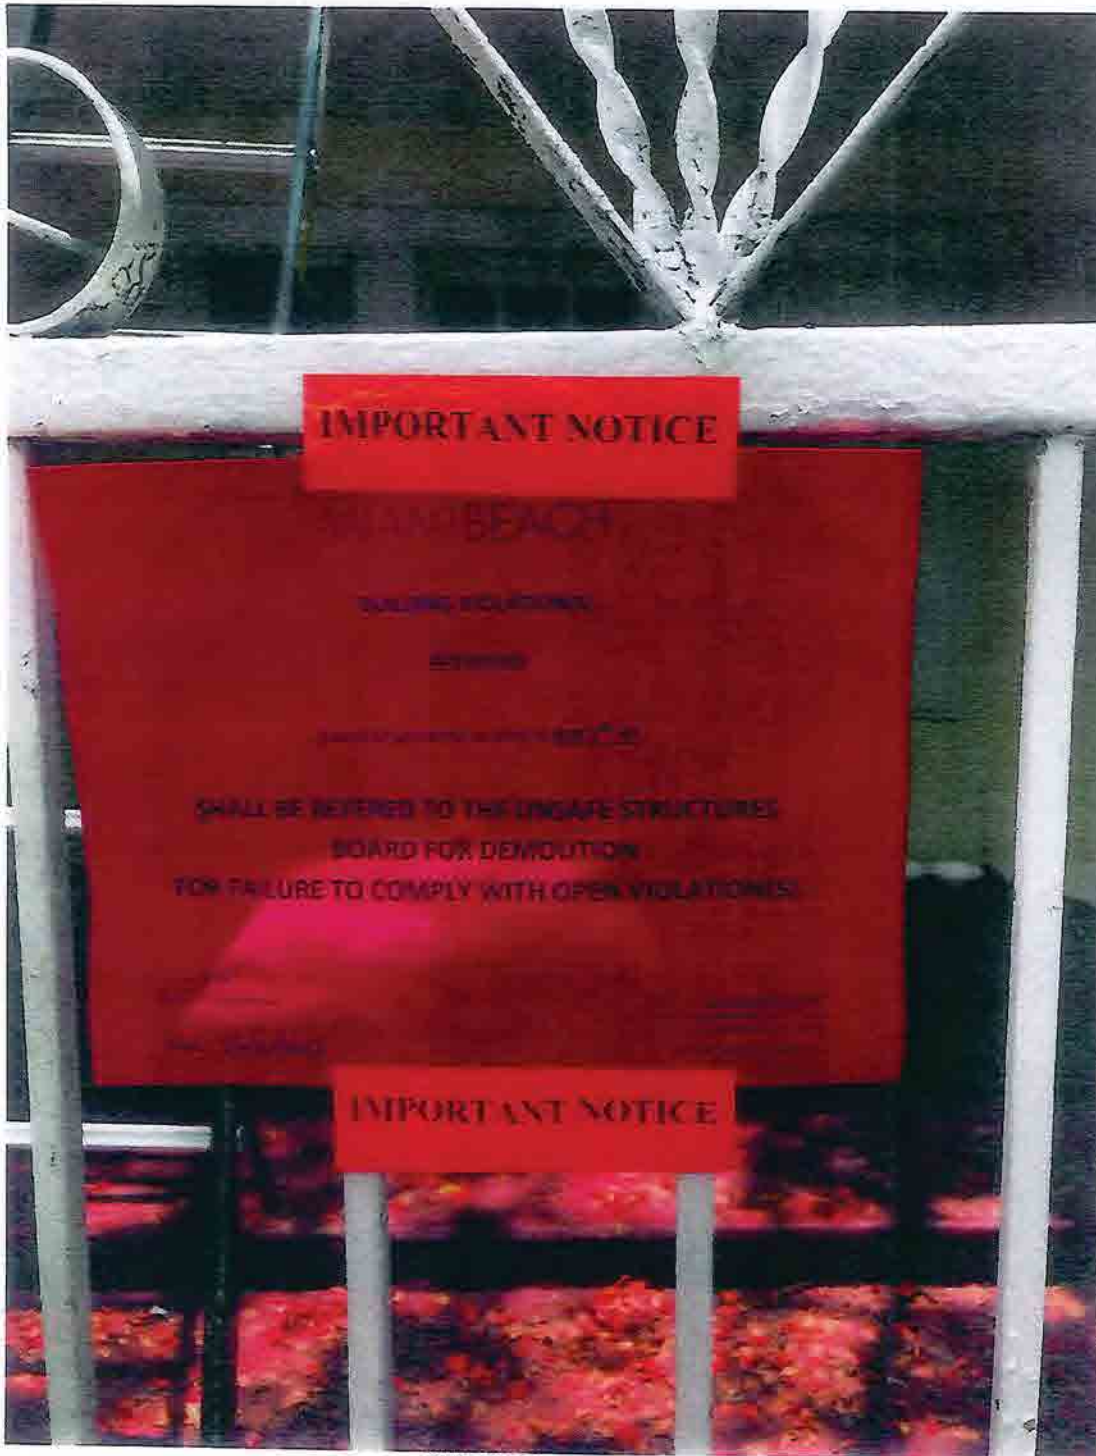
PHOTOGRAPH NO. 58

4. The door to the utility room (west end of rear addition) is a flimsy, bifold door, intended for interior closets.
5. A Building Violation has been issued on this building by the City of Miami Beach Building Department (Refer to Photograph No. 58). The notice states the building, "... shall be referred to the Unsafe Structures Board for Demolition..." The writer agrees that in its present condition, the building is an "Unsafe Structure".
