# Specimen Tree Report

5465 Pine Tree Drive  
Miami Beach

11/16/2017

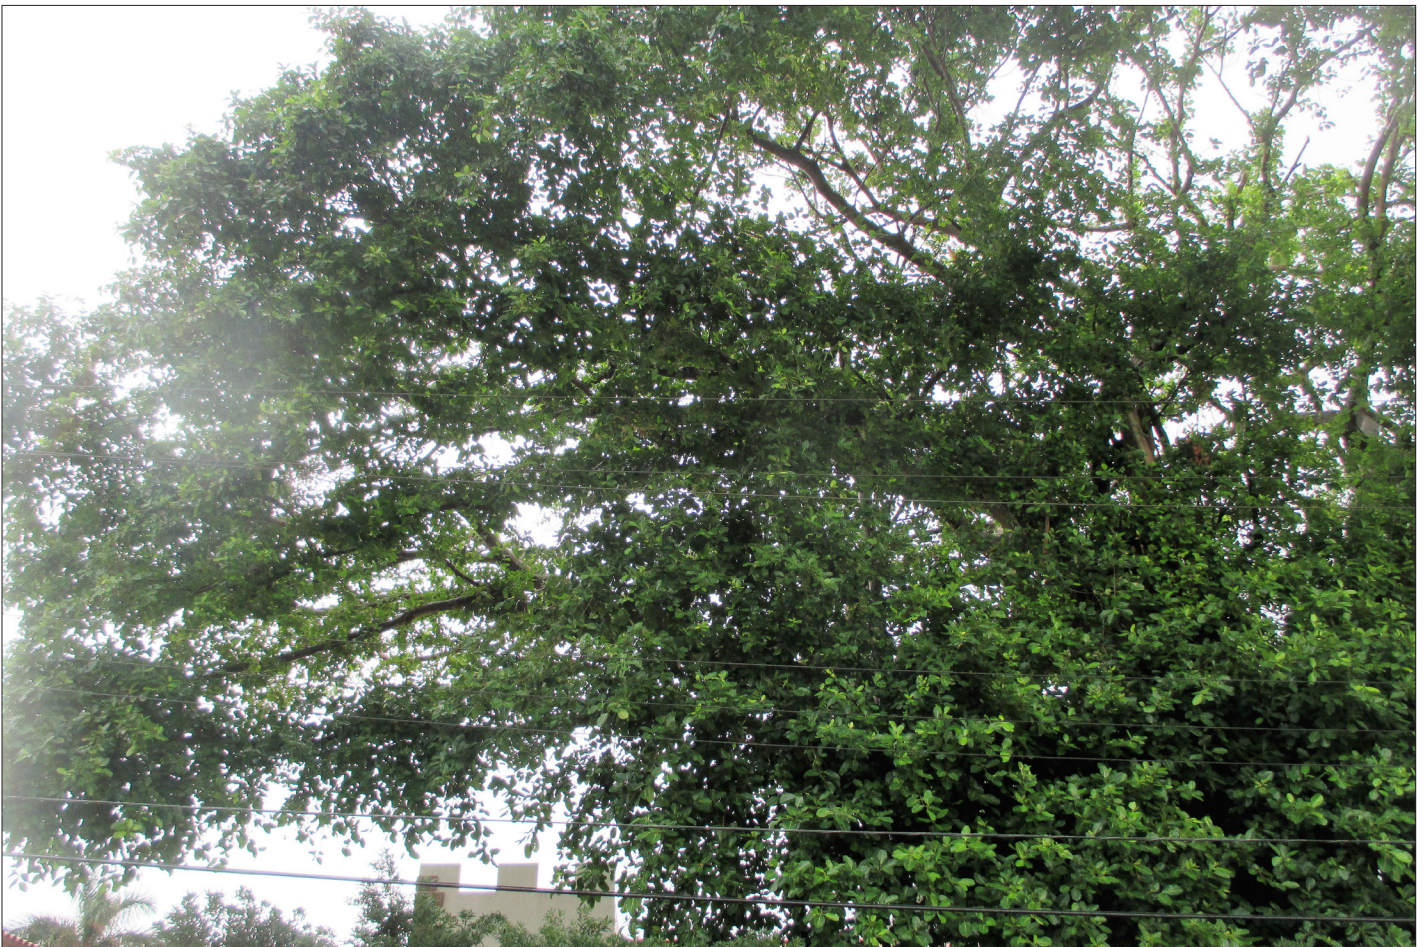
A small amount of small-diameter deadwood exists high in the canopy, like the branch circled in red.

The canopy can be crown cleaned to remove the small amount of deadwood that exists. Dead limbs are more likely to break and have the potential to host disease. The amount of live foliage to be removed should be minimized, especially since the tree lost a large percentage of foliage during Hurricane Irma. Annual pruning away from the powerlines and the house will ensure that only small diameter branches are cut at each pruning session. Some of the epicormic shoots in the lower canopy and main limbs can be removed for aesthetic purposes. The remaining shoots should be left to provide an important source of photosynthate for the tree. Epiphytic plants may be removed for aesthetic purposes if so desired. Canopy pruning shall be performed or supervised by a Certified Arborist and ANSI A300 Pruning Standards shall be followed.
