FEASIBILITY REPORT FOR PRINCE MICHAEL HOTEL 2618 COLLINS AVENUE MIAMI BEACH, FLORIDA

STRUCTURAL FEASIBILITY REPORT FOR

**PRINCE MICHAEL HOTEL
2618 COLLINS AVENUE
MIAMI BEACH, FLORIDA**

JANUARY 17, 2017

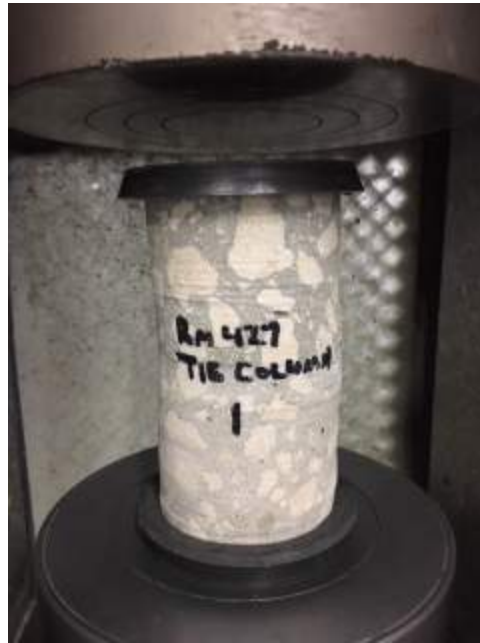
Figure 1: Core Sample – Compressive Strength Test

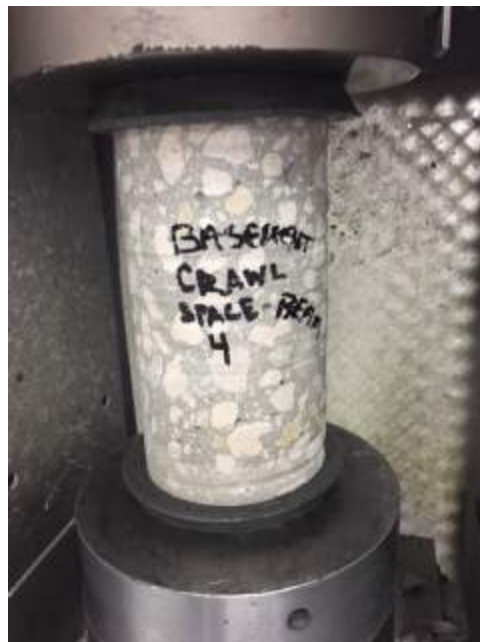
Figure 4: Core Sample – Compressive Strength Test

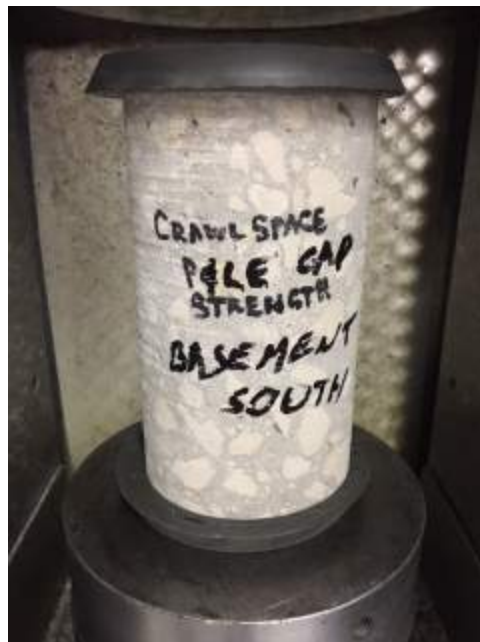
Figure 6: Core Sample – Compressive Strength Test

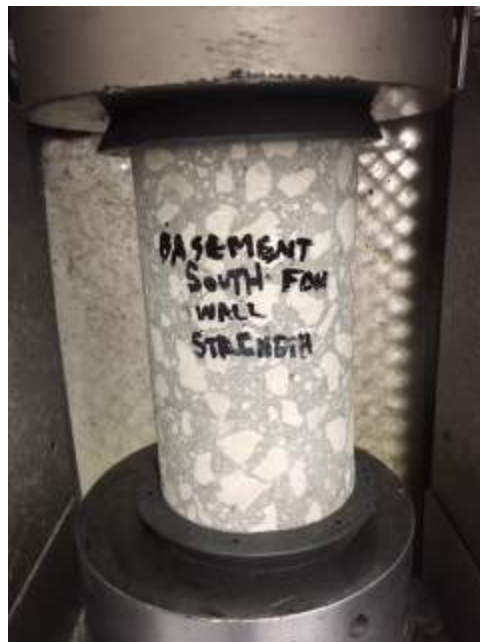
Figure 8: Core Sample – Compressive Strength Test

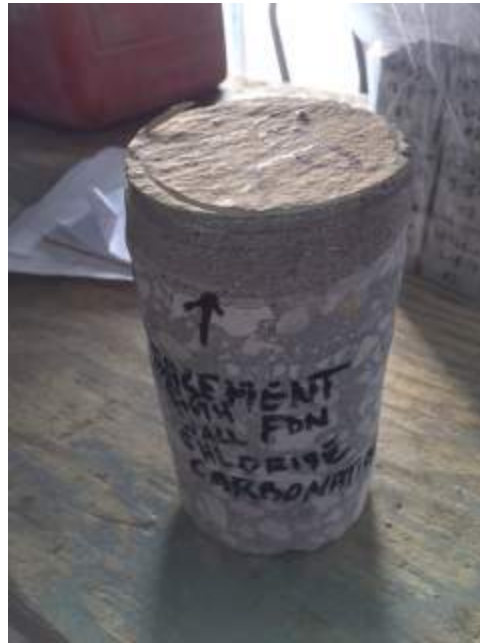
Figure 11: Core Sample – Chloride and Carbonation Tests

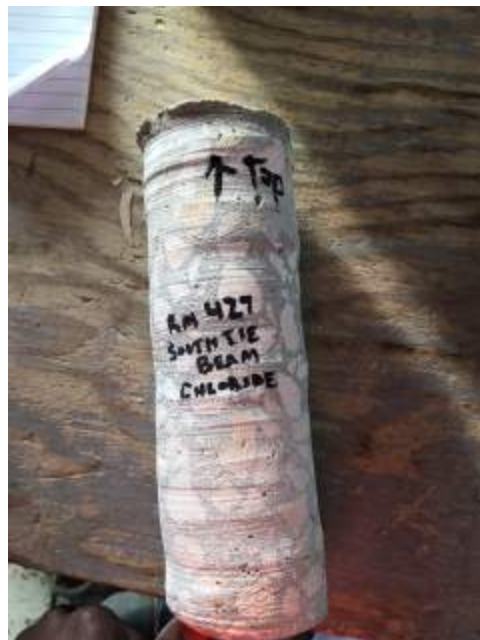
Figure 12: Core Sample – Chloride Test

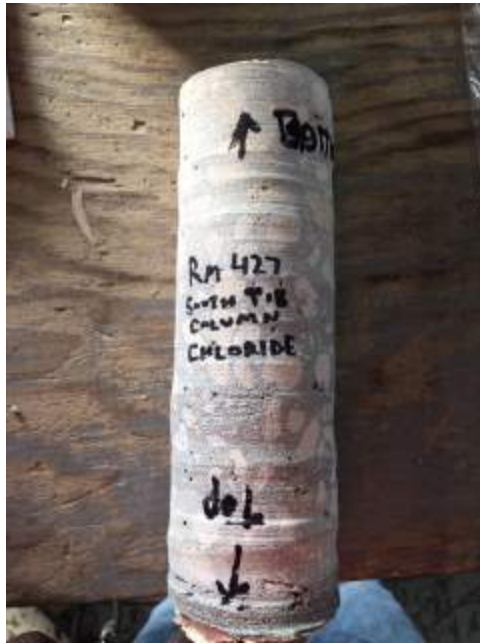
Figure 13: Core Sample – Chloride Test

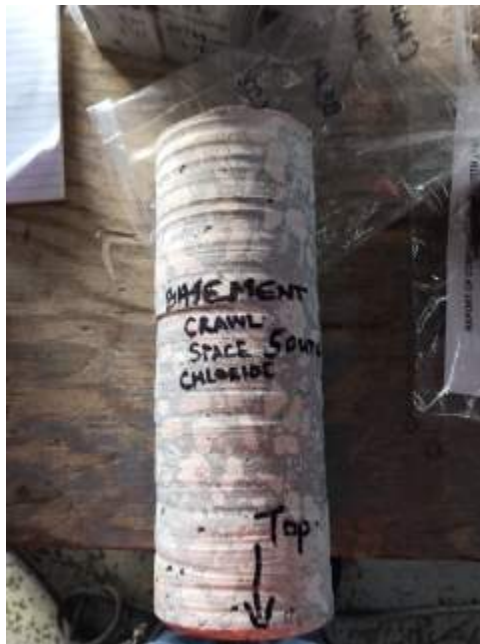
Figure 14: Core Sample – Chloride Test

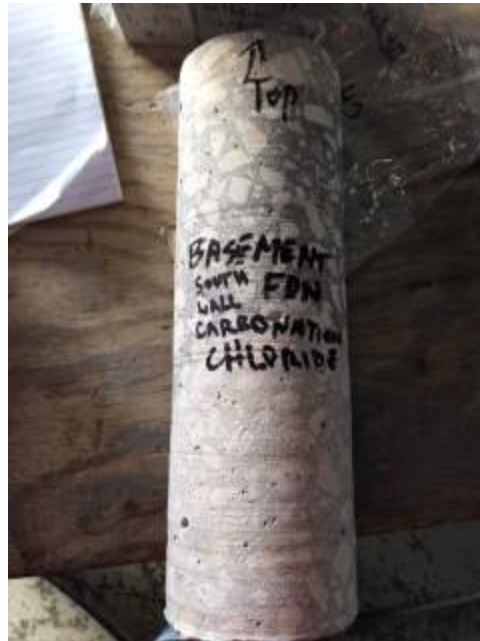
Figure 15: Core Sample – Chloride and Carbonation Tests

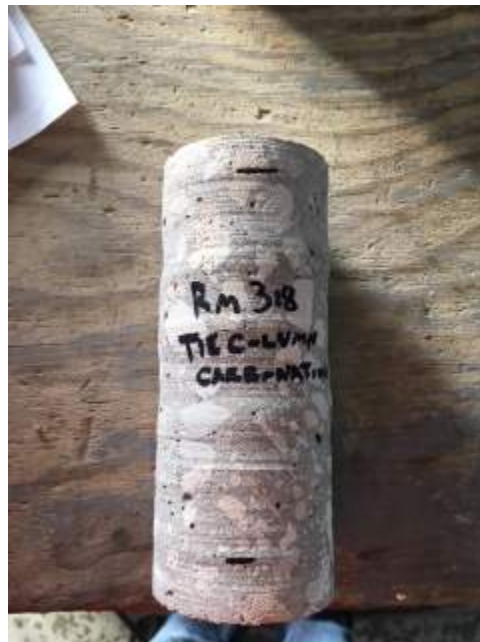
Figure 16: Core Sample – Carbonation Test

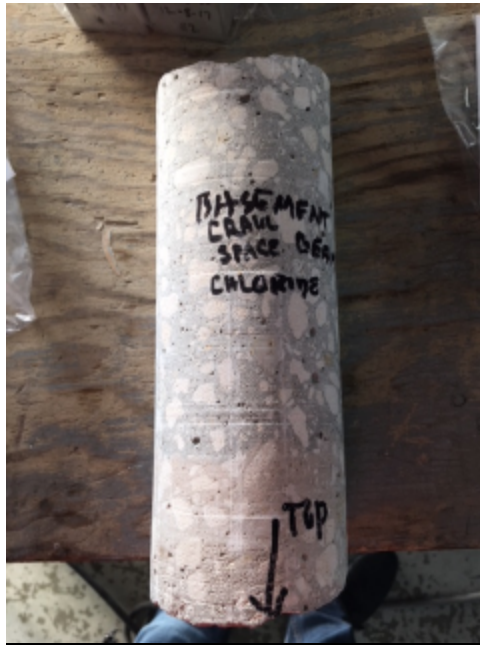
Figure 17: Core Sample – Chloride Test

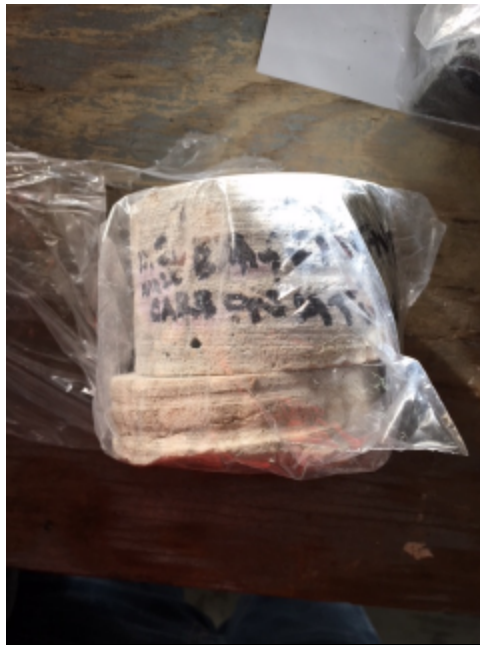
Figure 18: Core Sample – Carbonation Test
