# HISTORIC RESOURCES REPORT

7925-7031 + 7935-7041 CRESPI BOULEVARD

STRUCTURAL CONDITION ASSESSMENT  
7925-7935 Crespi Blvd  
Miami Beach, Florida 33141

STRUCTURAL CONDITION ASSESSMENT for  
7925-7935 Crespi Blvd  
Miami Beach, Florida

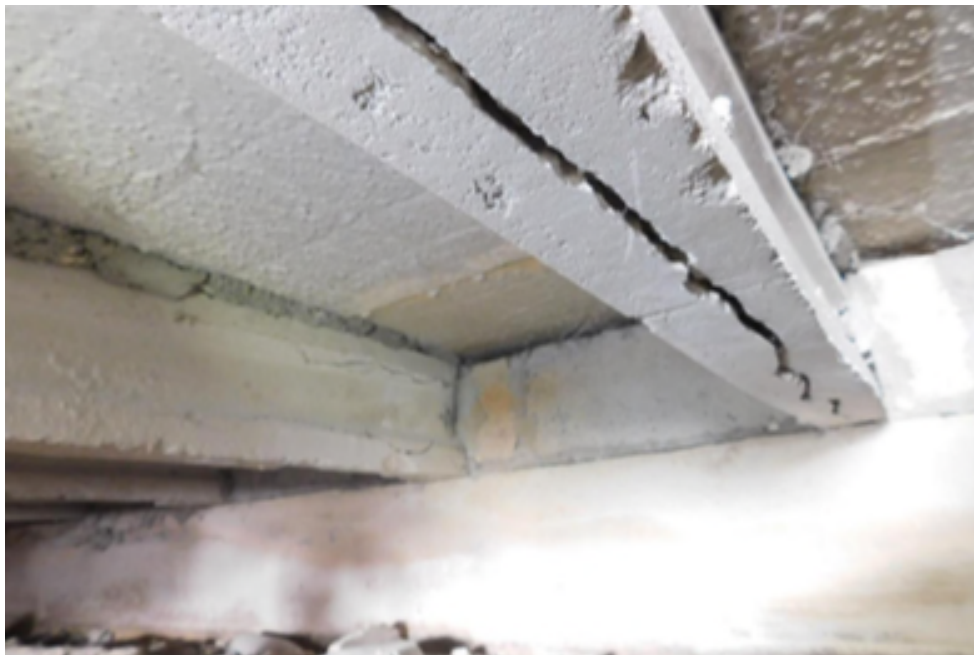
More concerning is the Engineering Report on the existing floor framing, which was completed after the floor recently collapsed in one apartment. The Report states that, "water intrusion damage, weathering, and aging has caused significant deterioration to most of the precast joists of the sub-floor system" and that "the deterioration becomes significant on numerous joists to the point where their integrity, stability, and load carrying ability are diminishing with time." (12)

MIDDLE PHOTO: STRUCTURAL DAMAGE AT UNDERFLOOR BEAMS (12)

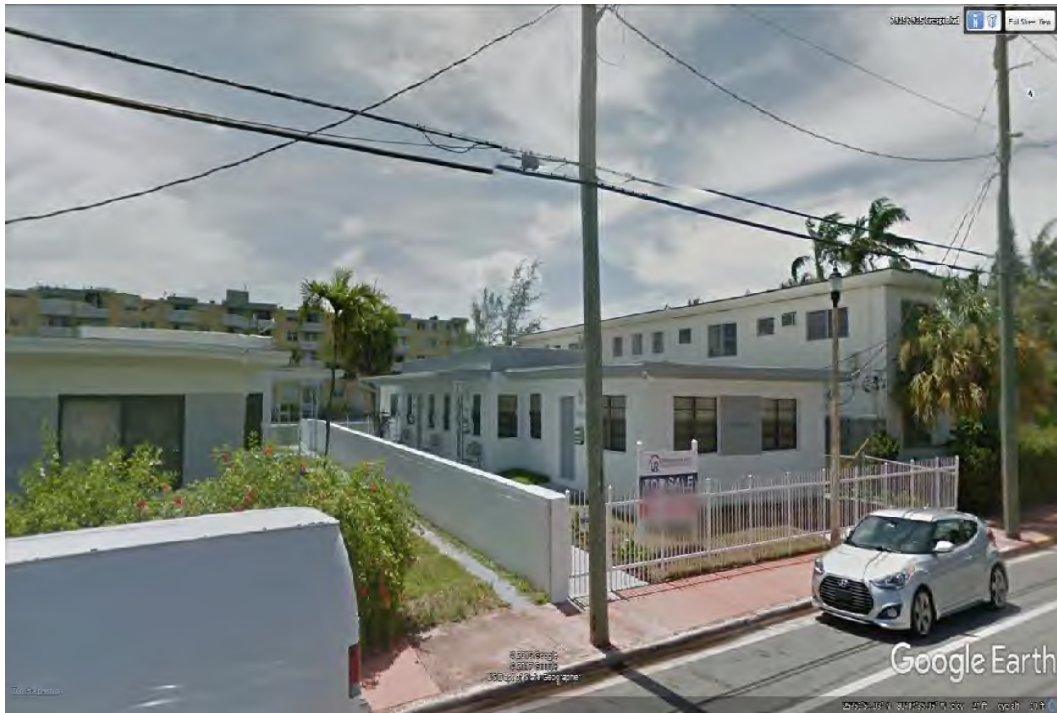
Street view of 7925 Crespi Blvd. building

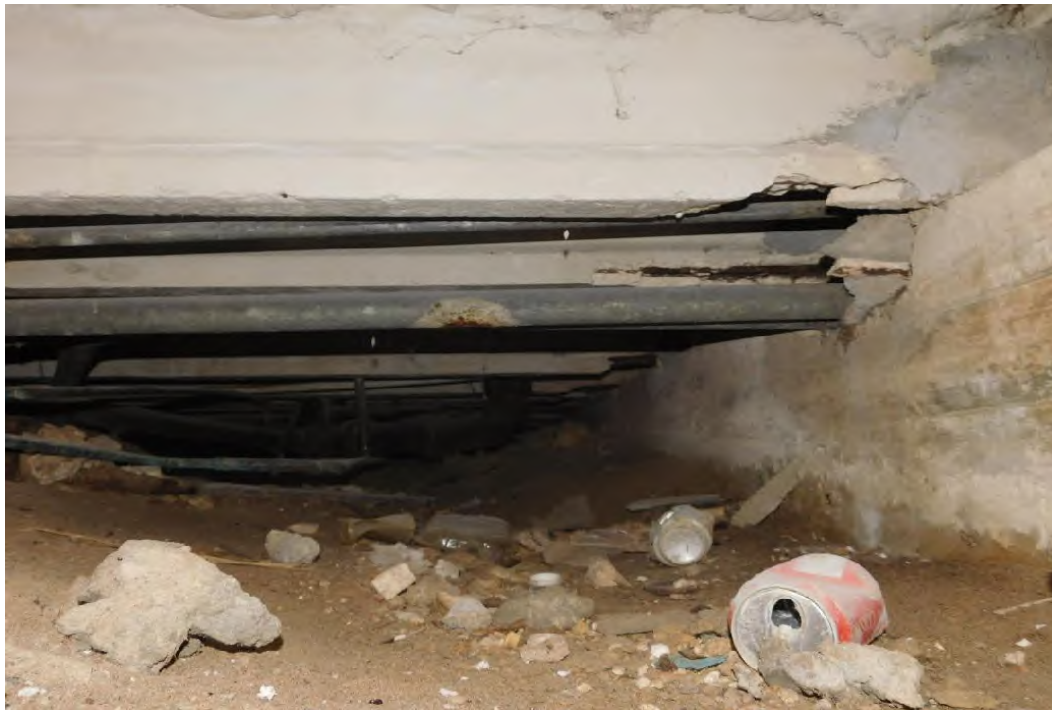
View of floor framing inside the crawlspace.

It is our opinion, that water intrusion damage, weathering, and aging has caused significant deterioration to most of the precast joists of the subfloor system. The deterioration is revealed through the cracking, deflection, and loss of structural section that are visible on the affected precast members. The deterioration was also revealed through spalling, delamination, and surface corrosion of the steel reinforcement of the concrete precast joists. The deterioration was more prevalent on the precast joists.

Based on our observations, the damage in most of the precast joists appears to be greater than 10% of their section, with numerous joists where the damage was greater than 20% of their section. The deterioration becomes significant on numerous joists to the point where their integrity, stability, and load carrying ability are diminishing with time. Evidence of local failure was revealed through excessive deflection observed on numerous precast joists and on the tiling system.

Alternatively, you could design and install a new wood floor frame. The new wood floor frame should be designed to support 100% of the floor load system in order to replace the structural function of the existing precast joist system. This option would allow leaving the precast joists on their existing conditions. In addition, we recommend that the existing precast joists remain in place.

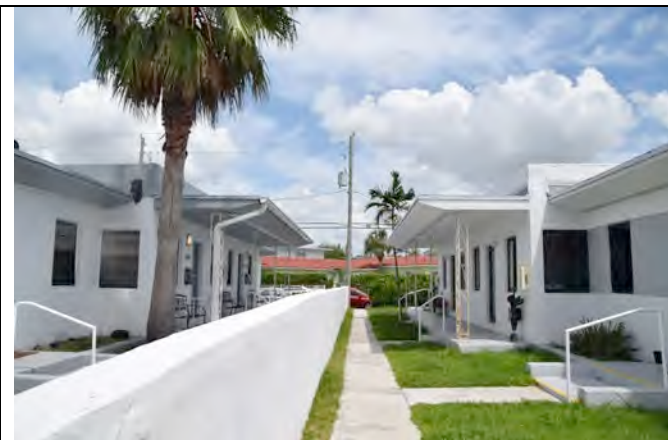
Photo 1- looking west between both buildings
