493-2018

SUBJECT: **BYRON CARLYLE FACILITY CONDITION UPDATE**

Reference: 50-Year Recertification
Byron Carlyle Theater
500 71 St., Miami Beach, Florida
Folio 02-3211-002-1070

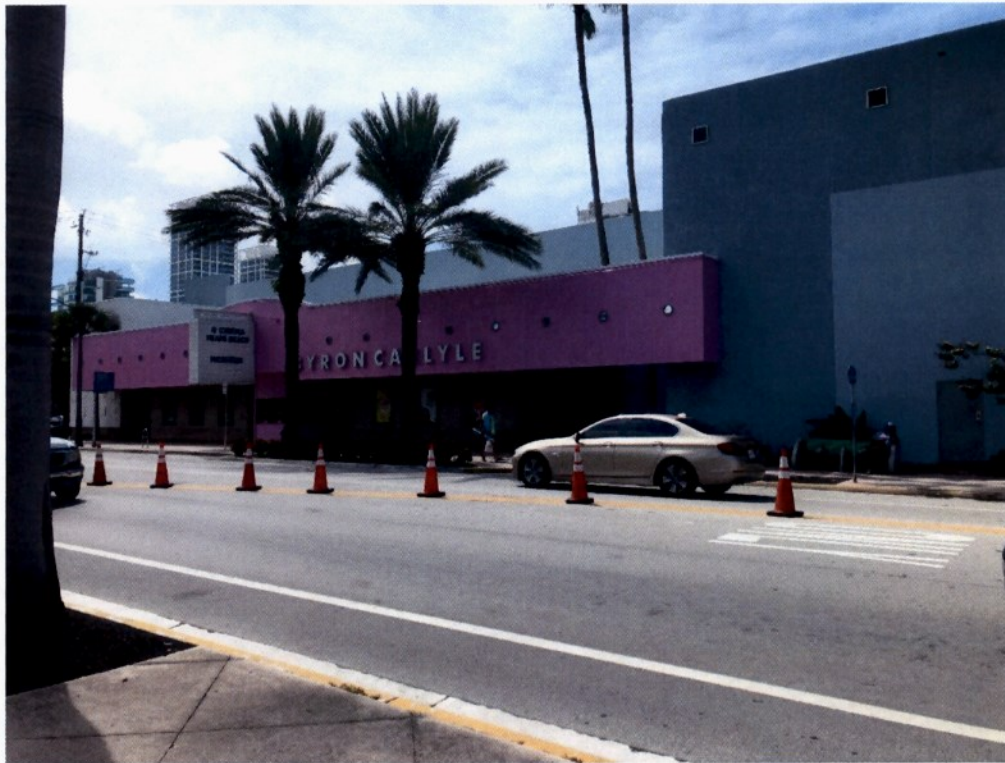
The building consists of two stories, two upper roofs, and five lower roofs (refer to Photograph No.1). The building is divided into two main areas (east and west sides). The east side is currently being used as a cinema theater (with occasional use as a venue for live music performance and religious services), and the west side was originally one cinema theater, but later divided into five cinema theaters. This western portion is currently unoccupied. The total floor area is approximately 28,300 sf. The building is generally constructed of masonry bearing walls with associated concrete tie beams and tie columns supporting the upper roofs (above theater spaces) which are framed out of steel deck on structural steel joists. Lower roofs are mostly framed out of reinforced concrete slabs supported by masonry bearing walls (and associated concrete tie beams and tie columns), except at the north façade (above lobby of currently active Cinema), with a portion consisting of steel deck on structural steel joists on structural steel beams and masonry bearing walls with associated concrete tie beams and columns. According to the drawings of the original construction, masonry walls are supported by grade beams and piles. Elevated floor systems consist of reinforced concrete slabs. The elevated floor of the east cinema theater consists of a stepped reinforced concrete slab supported by masonry walls. The floor system of the remaining portions of the east cinema theater and the west cinema theaters consist of sloped reinforced concrete slabs supported by grade beams on piles (not directly observed, deduced from illegible original plans). Portions of the building are below ground (i.e. restrooms near cinema lobby at east side and electrical room and adjacent areas). The floor systems of these underground portions consist of reinforced concrete slabs supported by grade beams on piles (not directly observed, deduced from illegible original plans), and walls are masonry with associated tie beams and tie columns. It is assumed that these underground walls are also supported by grade beams on piles. Additionally, there is an underground concrete-framed tank near the electrical room.

Photograph No. 1 - Overall Photograph of the Building

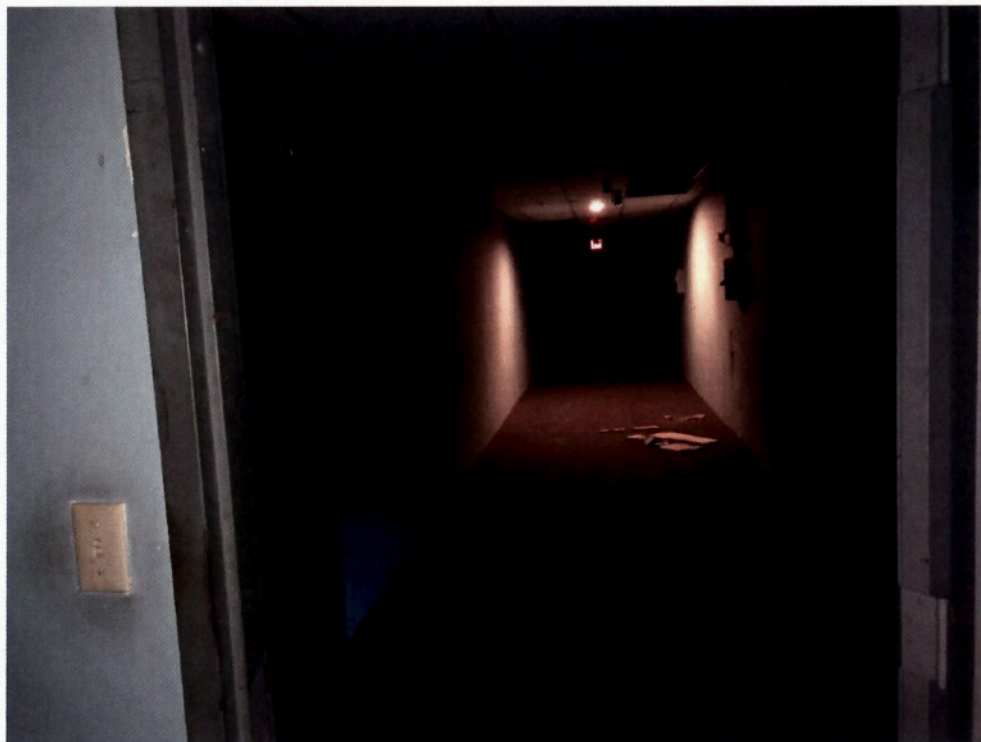
j. Additions to original structure:
1) Elevated cold-formed steel-framed projection room and walkway were added to service the cinema theaters on the west side of the building (see Photographs 2, 3, and 4). Structural steel-framed exit staircase (see Photographs No. 5 and 6) was constructed to provide direct access from this projection room to the outside (south façade).
2) Stage for theater on the east side of the building. This stage consists of a prefabricated aluminum-framed platform (see Photographs 7 and 8). According to a label observed (see Photograph 84), it was manufactured by Wenger and is part of their versatile (i.e. removable) platform systems. The stage was raised in height (about 1 foot) with wood framing consisting of plywood panels supported by 2x4 wood plate/studs/sleepers bearing assembly (see CONTINUE ON ATTACHED SHEET

Photograph No. 2- Walkway to Elevated Projection Room for West Cinema Theaters

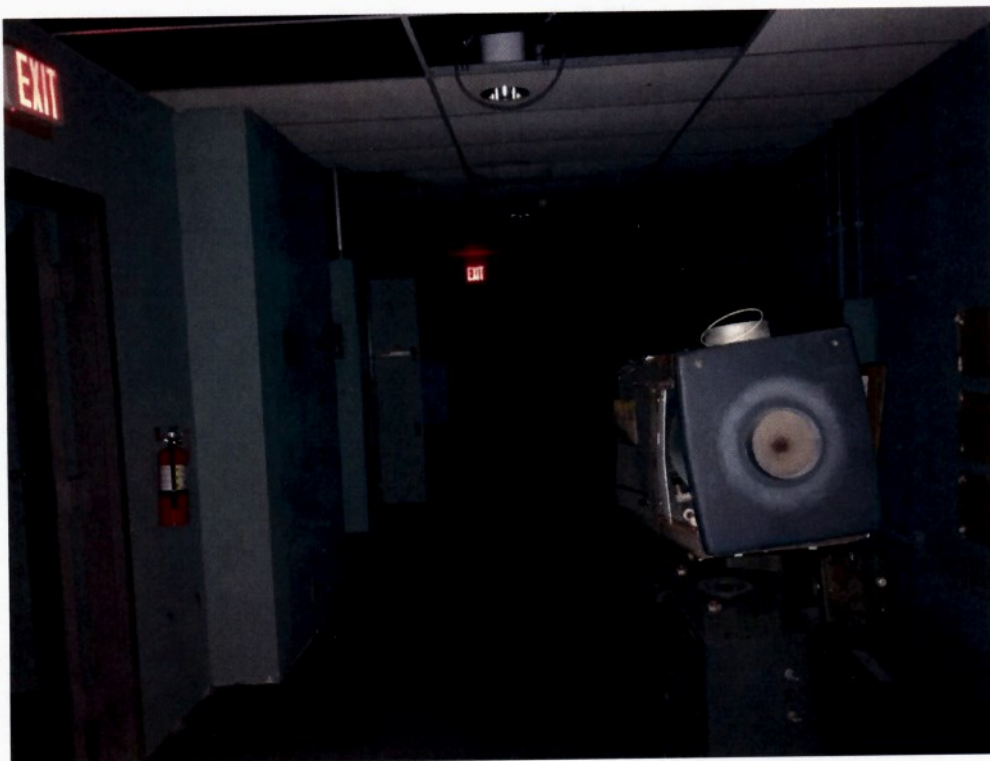
Photograph No. 3 - Projection Room for West Cinema Theaters

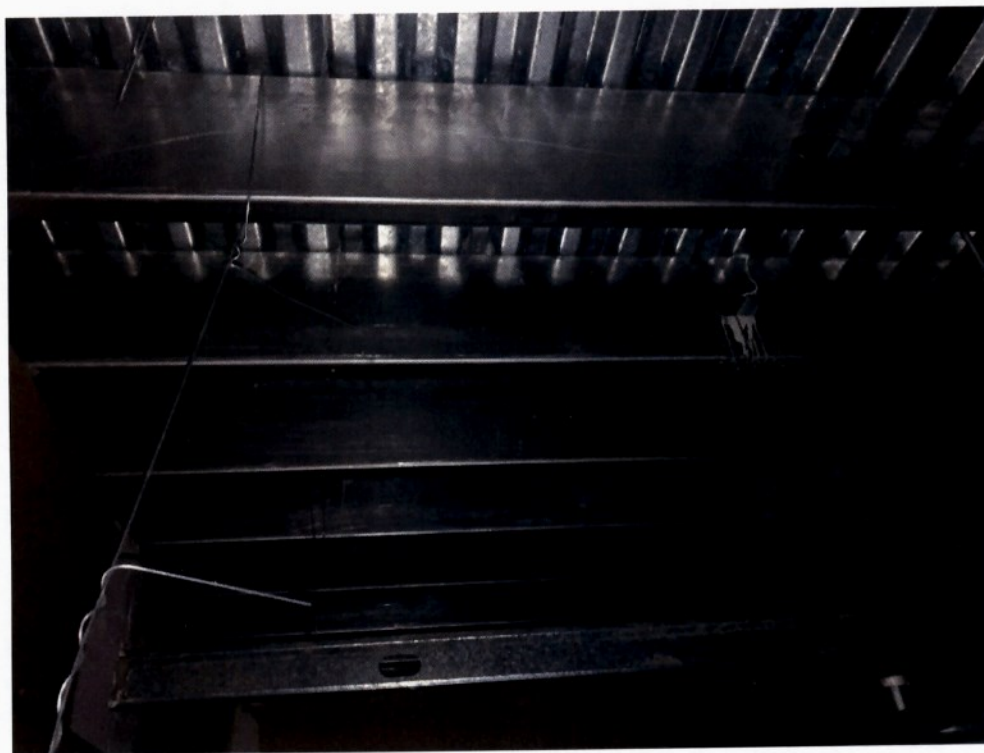
Photograph No. 4 – Floor framing of Projection Room for West Cinema Theaters

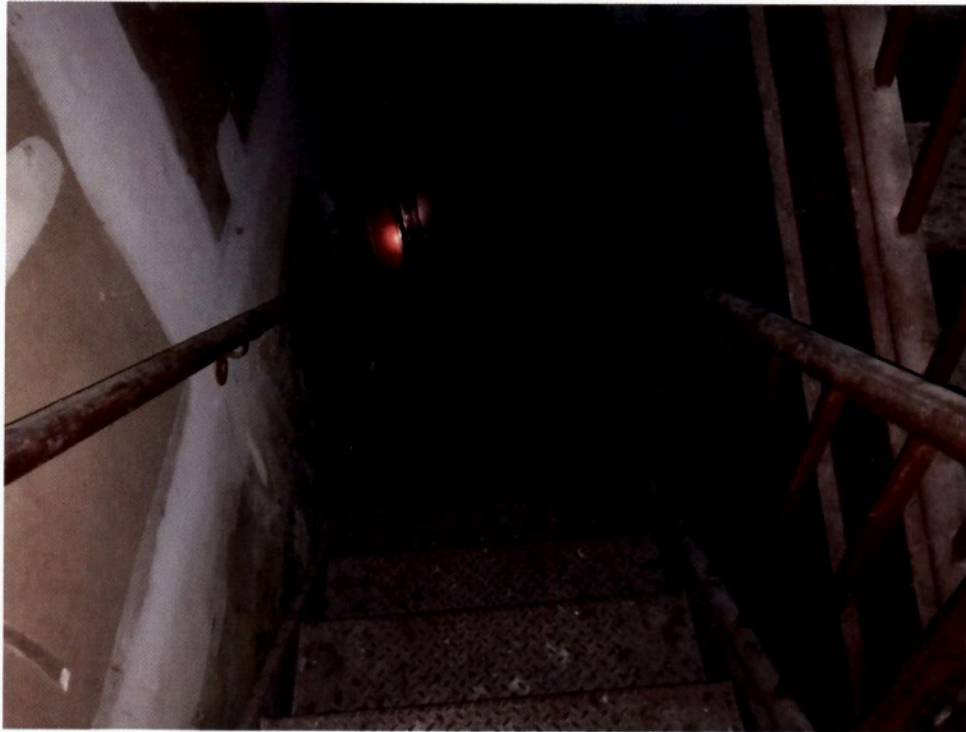
Photograph No. 5 – Steel-framed Exit Staircase for Projection Room of West Cinema Theaters

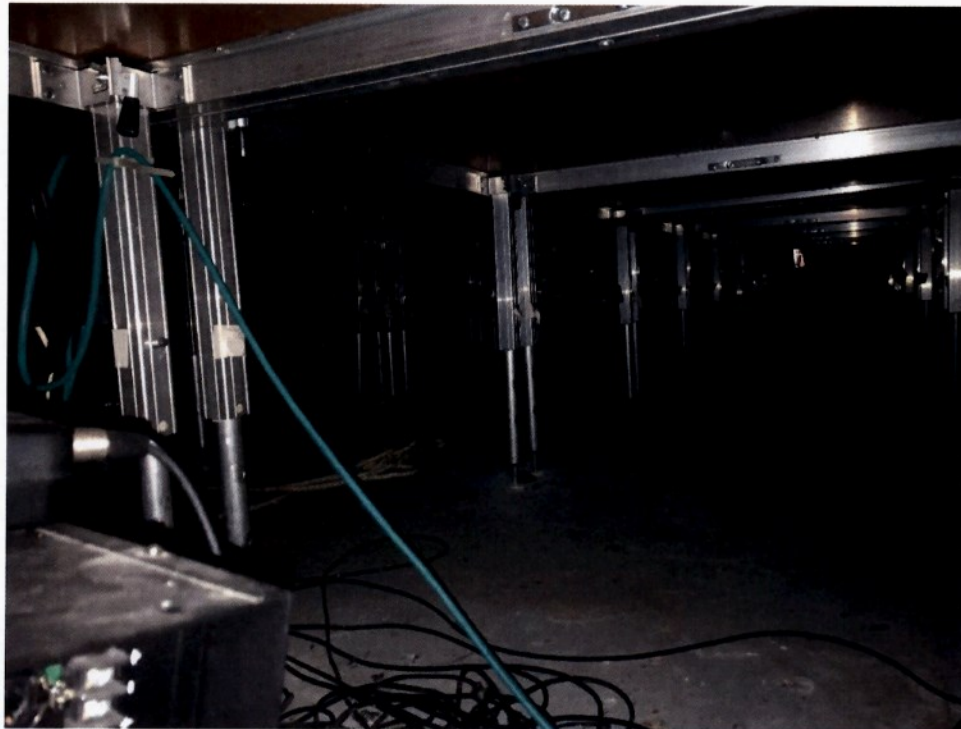
It is important to note that, as indicated before, the stage structure is a versatile (i.e. removable) prefabricated aluminum-framed platform (see Photographs 7 and 8). DWA could not find Building Department records for the construction/installation of this stage system. According to the manufacturer, Wegner, the load rating for a similar system is 125 PSF, which is a little below the 150 PSF required by the current Building Code. Additionally, the wood framing used to raise the platform does not appear to have been engineered nor permitted, nor does it appear to be an approved addition to the Wegner aluminum-framed stage system.

Photograph No. 7 - Aluminum-framed Stage Platform for East Cinema Theater

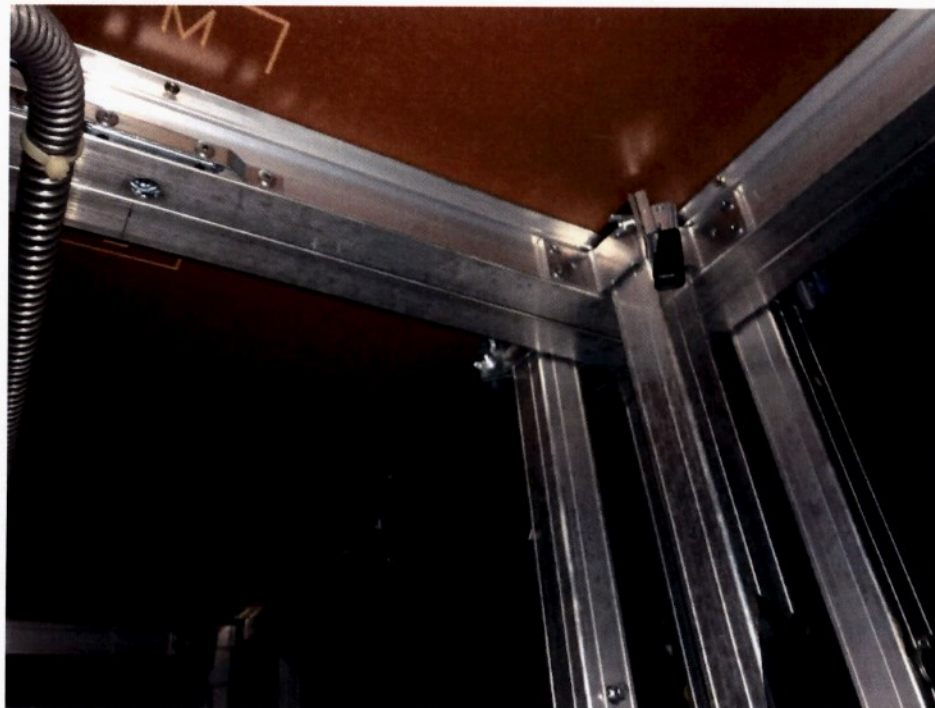
Photograph No. 8 - Aluminum-framed Stage Platform for East Cinema Theater

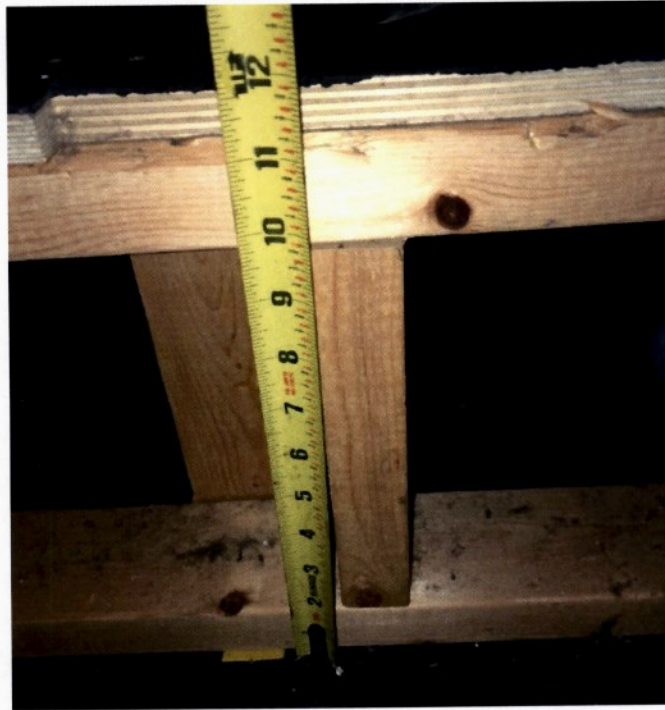
1.j ... Photograph 9).

Photograph No. 9 – Built-up Wood Framing over Stage Platform for East Cinema Theater

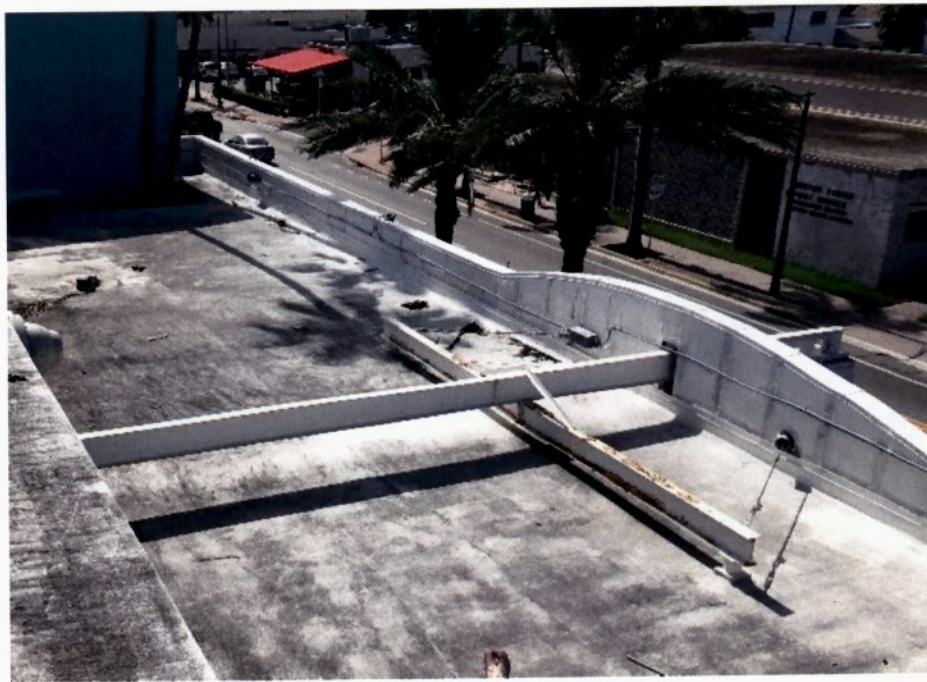
5) The steel structure supporting the exterior theater sign at the north side of the building appears to be an addition to the original structure (see Photographs 10 and 11).

Photograph No. 10 – Structural Steel supporting Theater Sign at North Façade

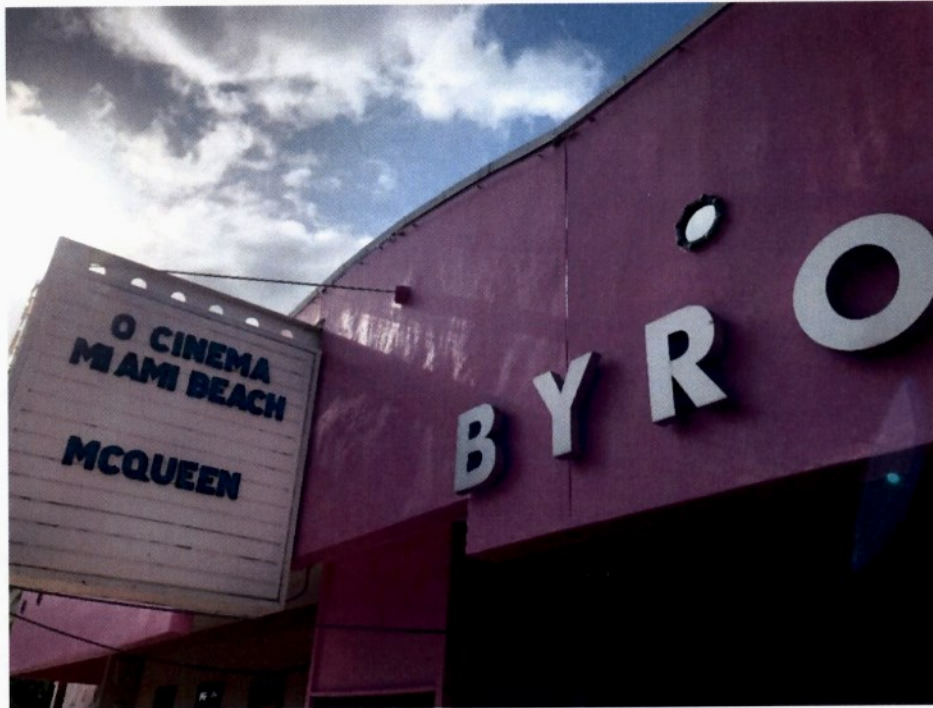
17) Cables providing lateral stability to the north façade's theater sign are loose (see Photograph 11).

Photograph No. 11 - Theater Sign at North Façade

- 19) Tighten cables that provide lateral stability to the north façade's theater sign (refer to Section 2.b.17).
 - 20) Stand-mounted condensing unit in lower roof at the east side is missing a clip connector (at a corner) to the aluminum-framed stand (see Photograph 32).

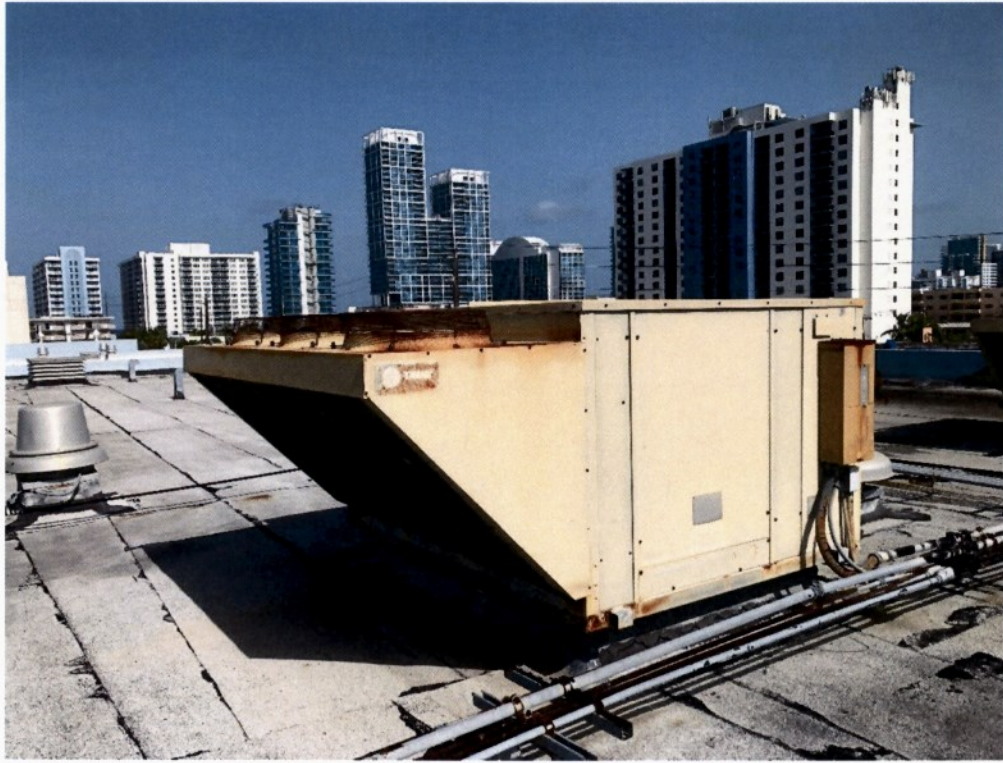
- 5) ... façade) is mildly corroded (see Photographs 18, 19, and 20).
- 6) Rooftop A/C package units at western upper roof are mildly corroded (see Photographs 21 and 22).

Photograph No. 21 - Rooftop Package Unit at Western Upper Roof

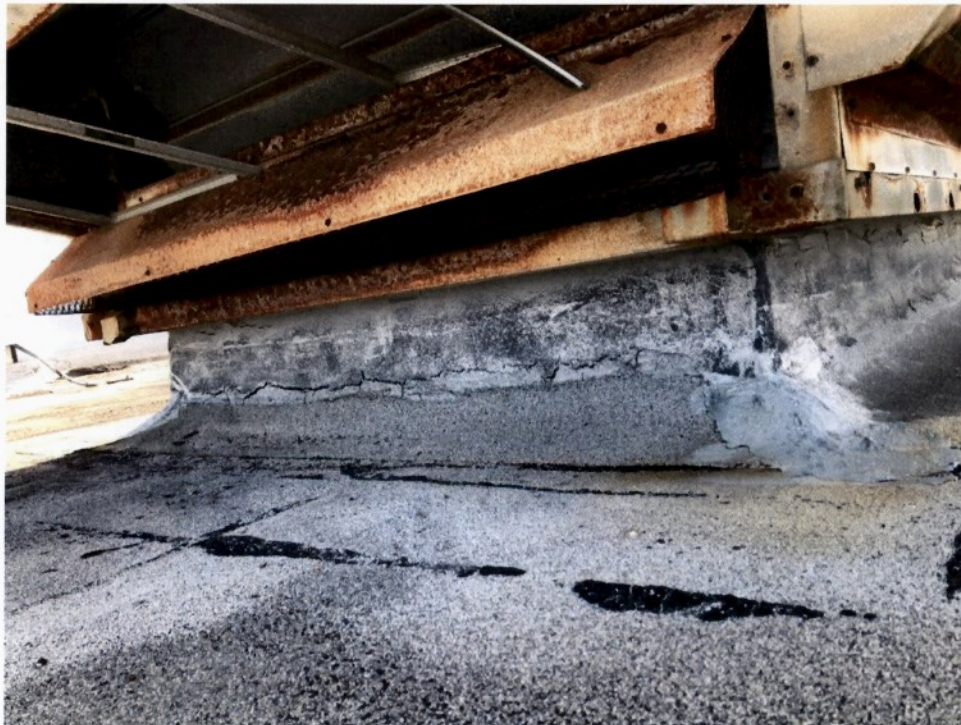
Photograph No. 22 - Rooftop Package Unit at Western Upper Roof

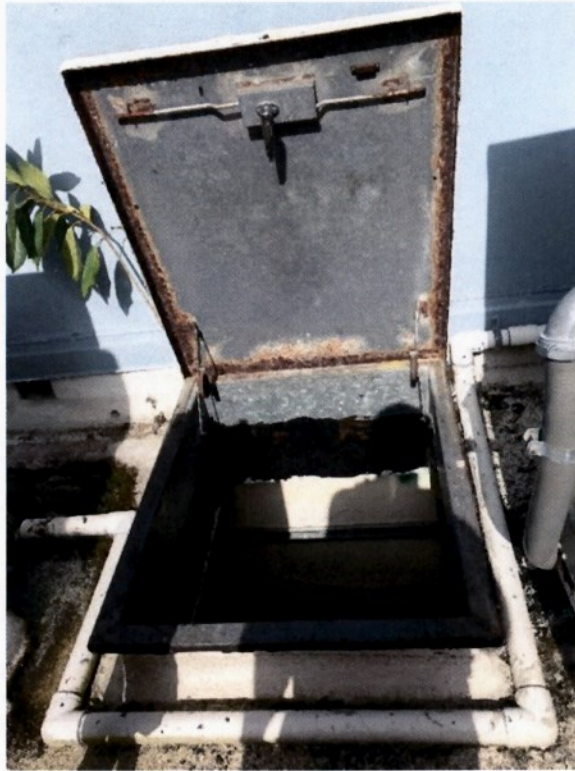
- 9) Drain of low roof at 2nd floor is missing protective cover. Debris could potentially clog the drain (see Photograph 70).
- 10) Access roof hatch located at the east low roof is mildly corroded (see Photograph 29).

Photograph No. 29 – Roof Access Hatch (Lower Roof at East Side)

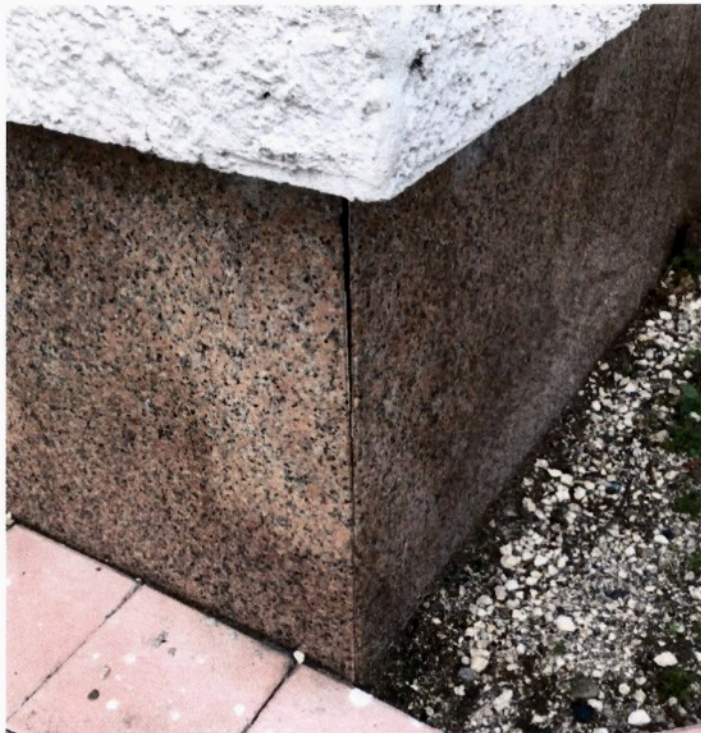
Photograph No. 30 – Gap at Exterior Tile at Northeast Corner

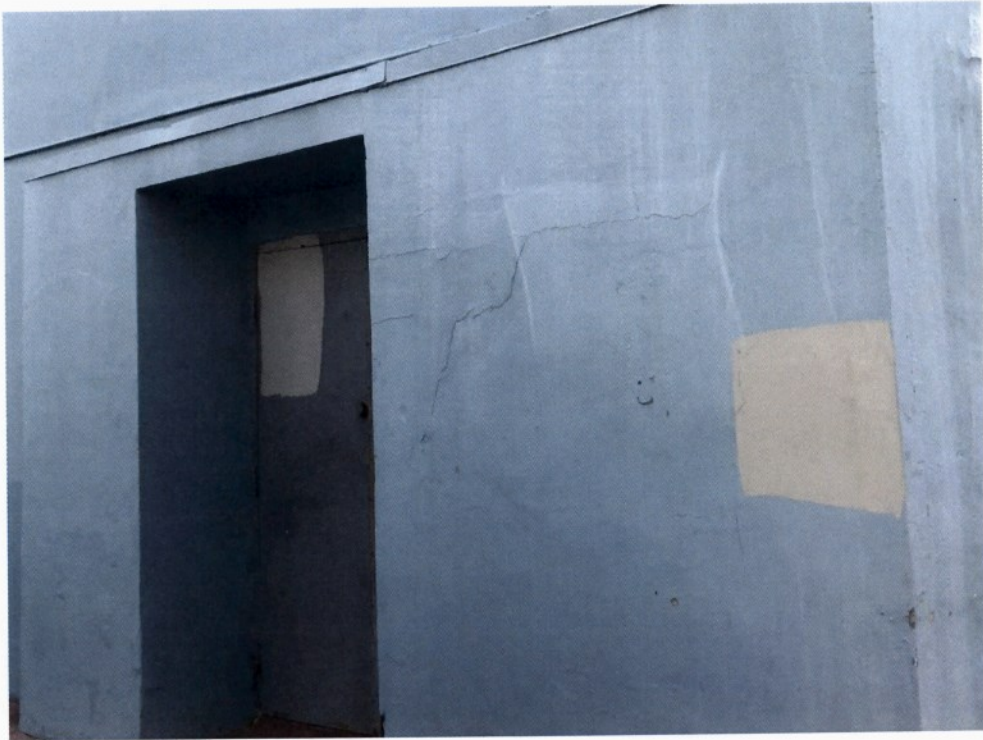
Photograph No. 31

- 12) Wall at northwest corner is cracked (see Photograph 31).
- 13) Steps to access stage of east cinema theater from the seating area are constructed of wood framing (see Photograph 34). The vertical members of this wooden staircase are constructed so that they transfer the load to the bottom wood plates that are bearing directly on the theater's carpet (see Photograph 35). Some of the vertical members, however, are not connected to the bottom plate (see Photograph 36). The framing of steps lacks bracing (they are not connected to the stage structure), and the assembly is not anchored to the floor.

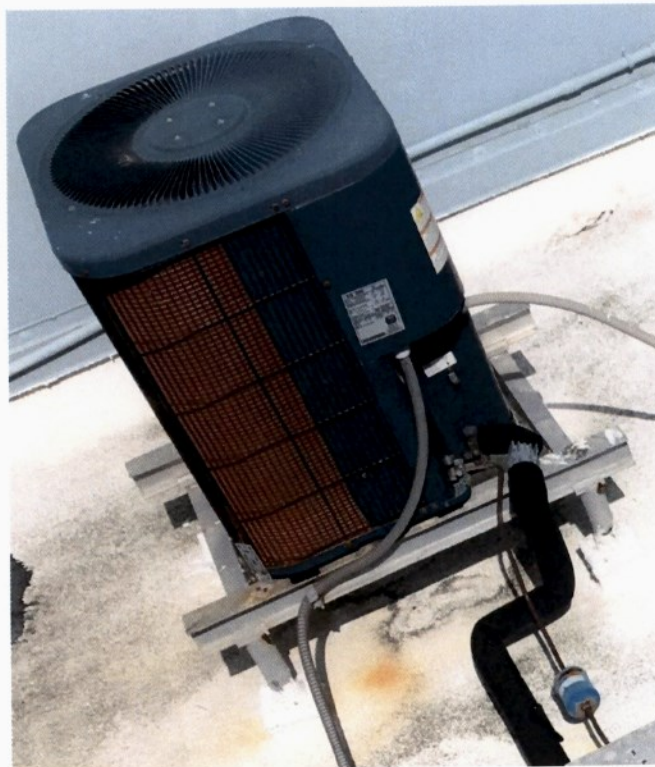
Photograph No. 32 – Stand-mounted AC unit at Lower Roof at East Side

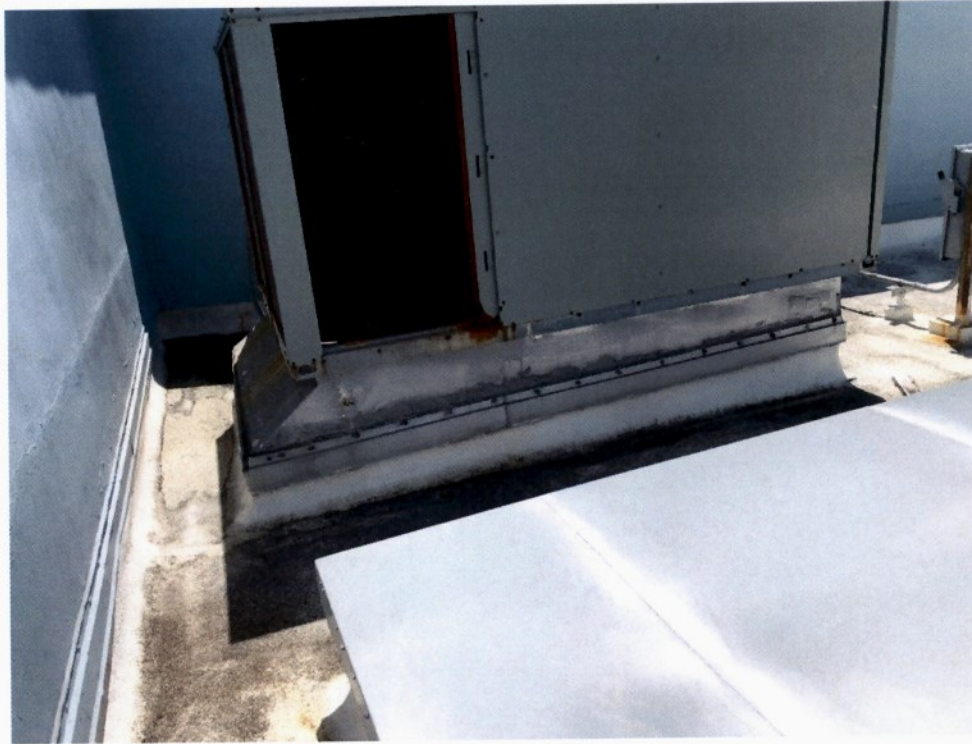
Photograph No. 33 – Rooftop Package Unit at Lower Roof between East and West Portions

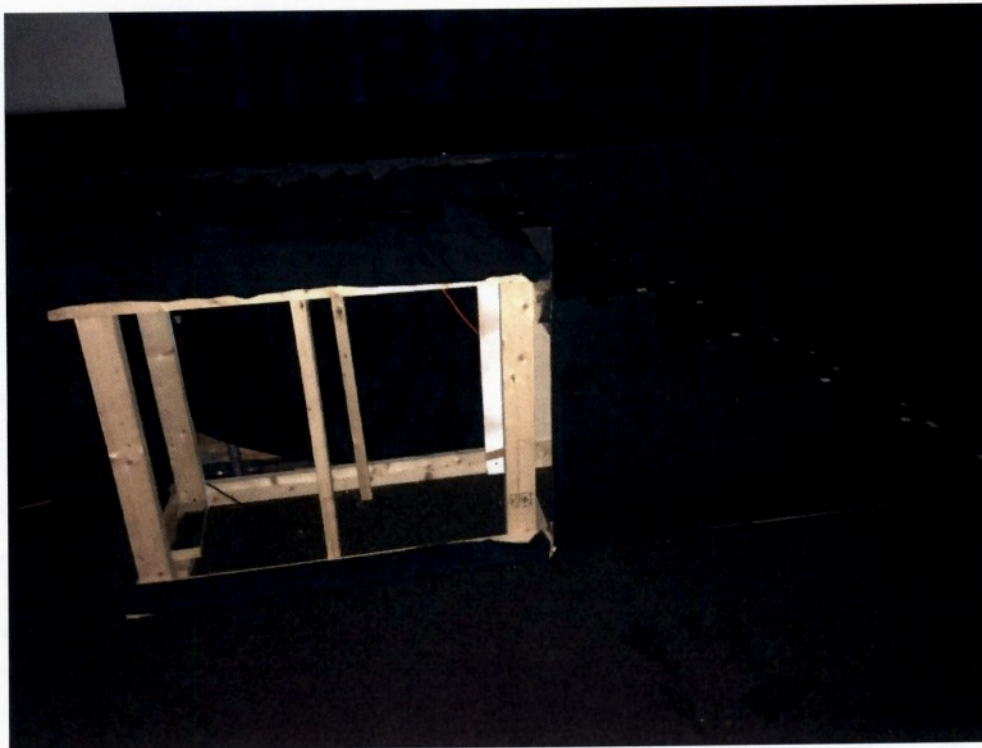
The steps to access the stage of the east theater from the seating area are constructed of wood framing (see Photograph 34). This wood framing consists of plywood panels supported by 2x4 horizontal ... CONTINUED ON ATTACHED SHEET

Photograph No. 34 – Wood-framed staircase (East Cinema Theater)

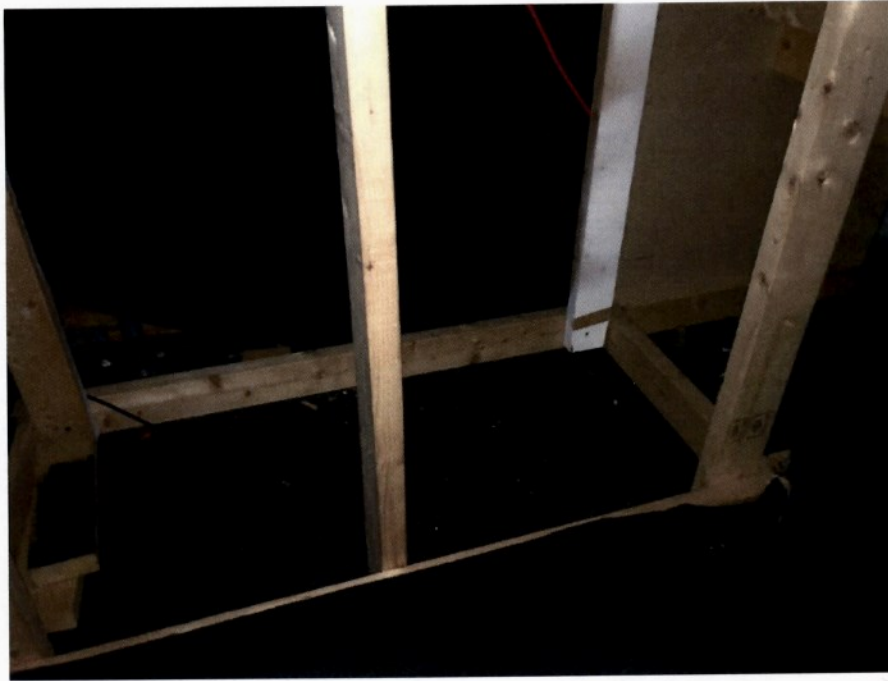
Photograph No. 35 – Wood-framed staircase (East Cinema Theater)

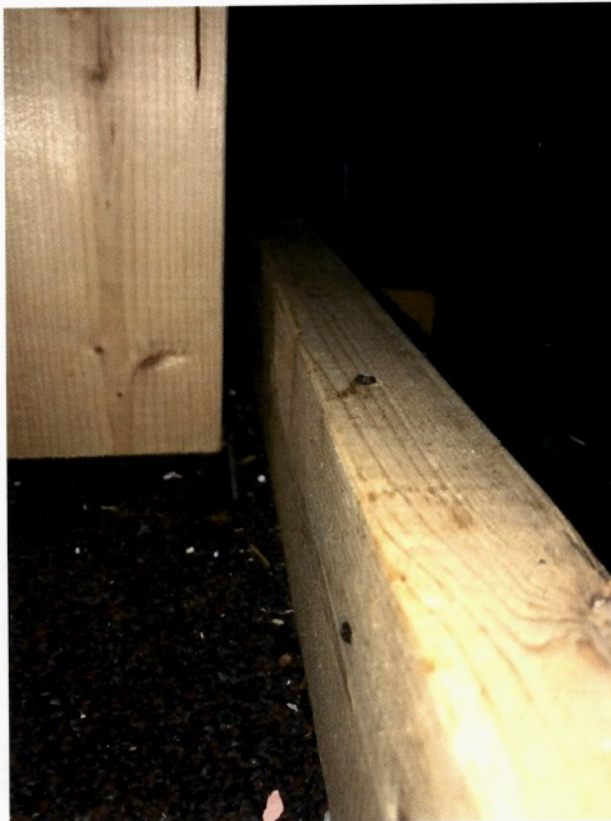
Photograph No. 36 – Gap between vertical member and bottom plate

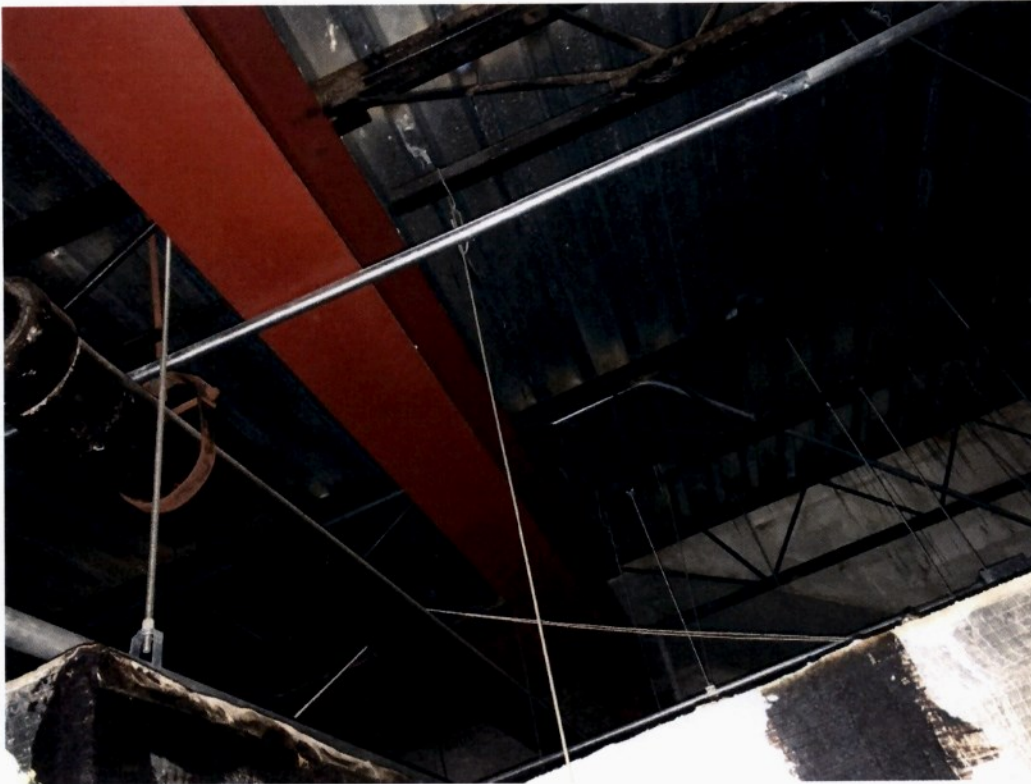
Photograph No. 41 – Underside of roof structure of Low Roof at North Façade

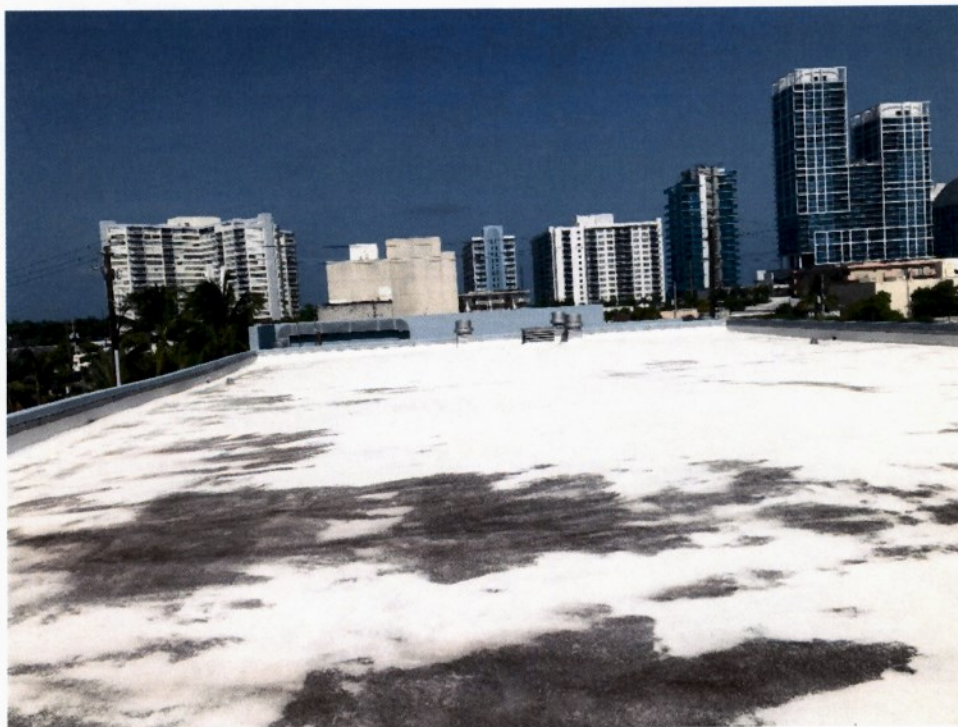
Photograph No. 42– Upper Roof of East Cinema Theater

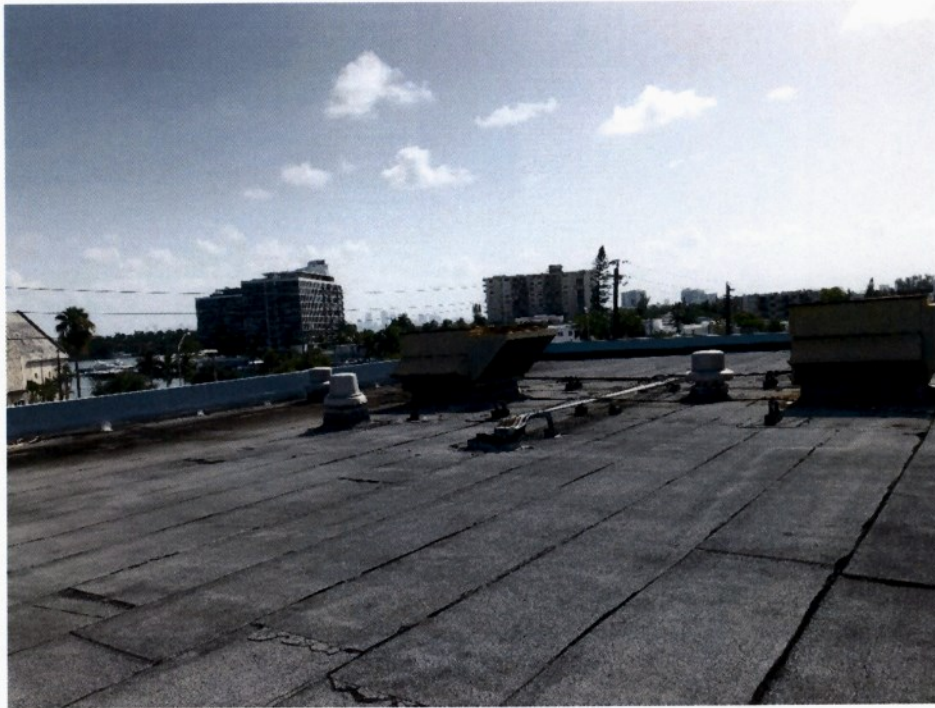
Photograph No. 43– Upper Roof of West Cinema Theater

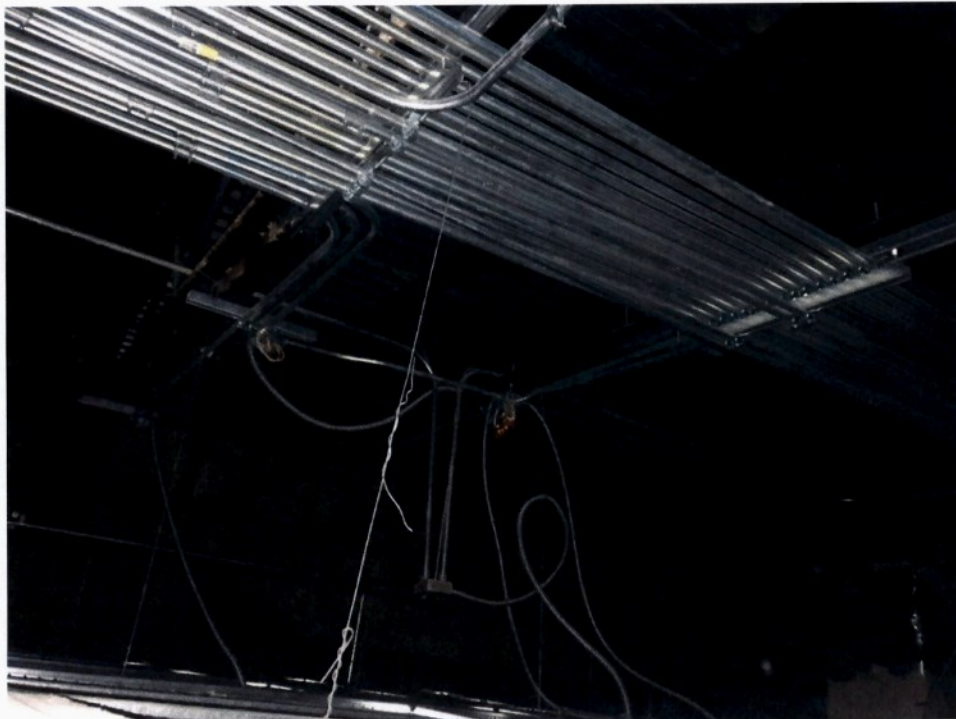
Photograph No. 44 – Underside of East Upper Roof Structure

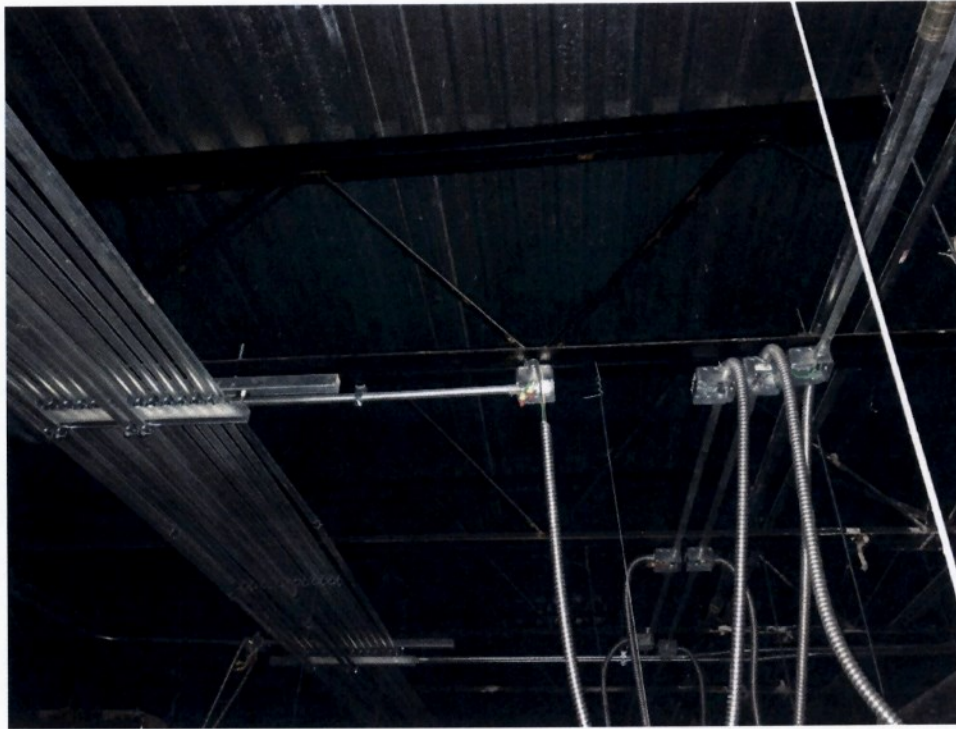
Photograph No. 45 – Underside of East Upper Roof Structure

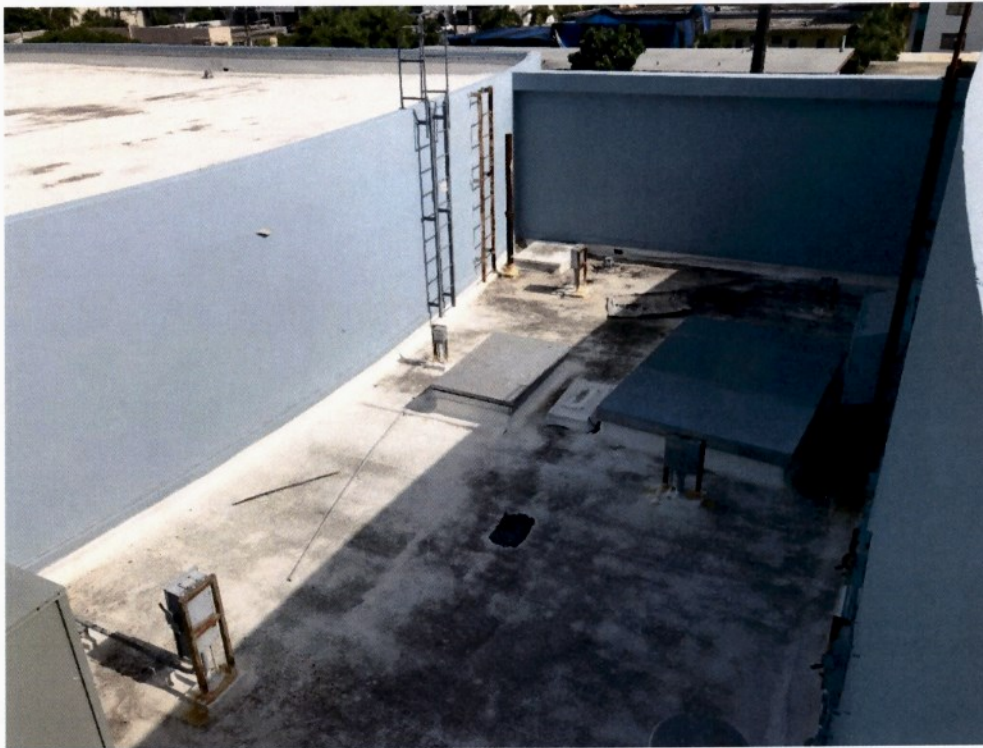
Photograph No. 46 – Lower roof between the East and West Portions of Building

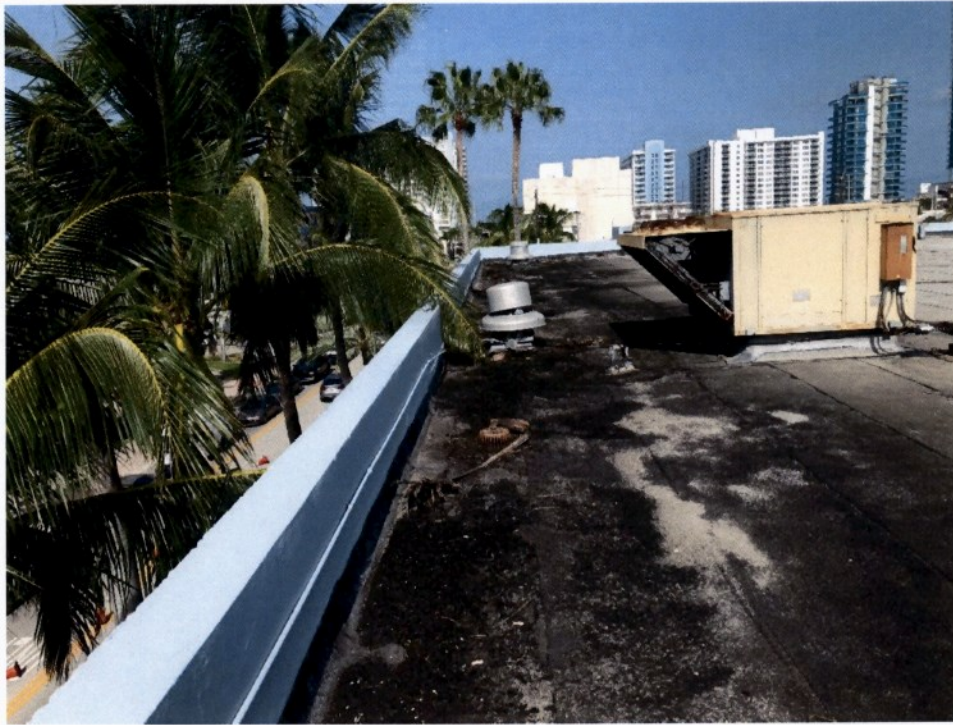
Photograph No. 56 – Underside of Low Roof at East Side of Building

Photograph 56). The roofing over the two upper roofs and five lower roofs consists of built-up roofing systems. The roofing systems over all upper roofs and lower roofs are old and in need of maintenance (see photographs 23-27 and 57-59). No active water leaks were observed.

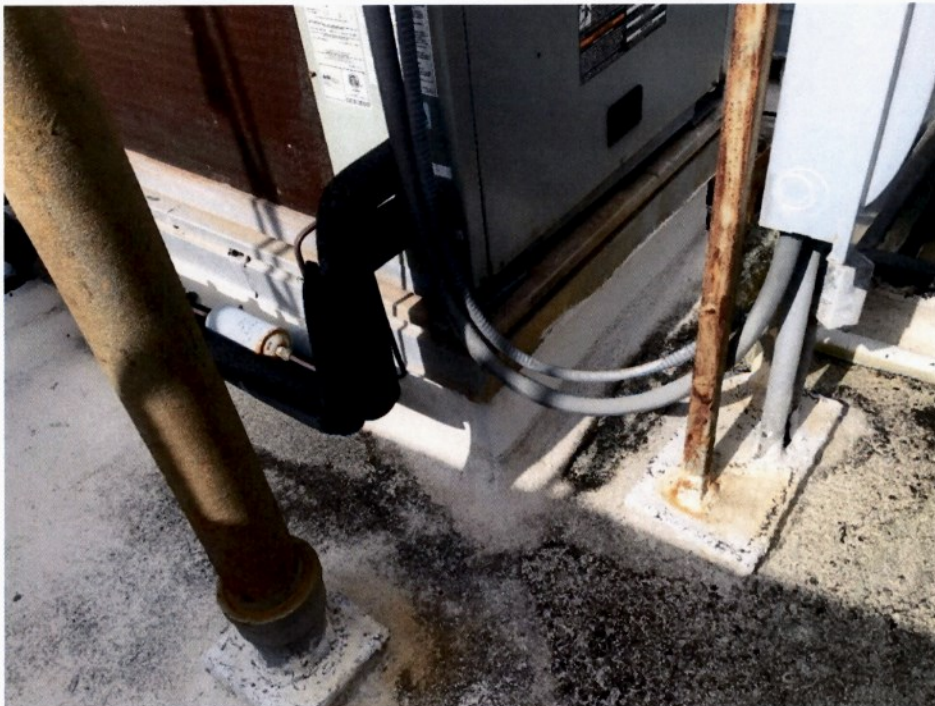
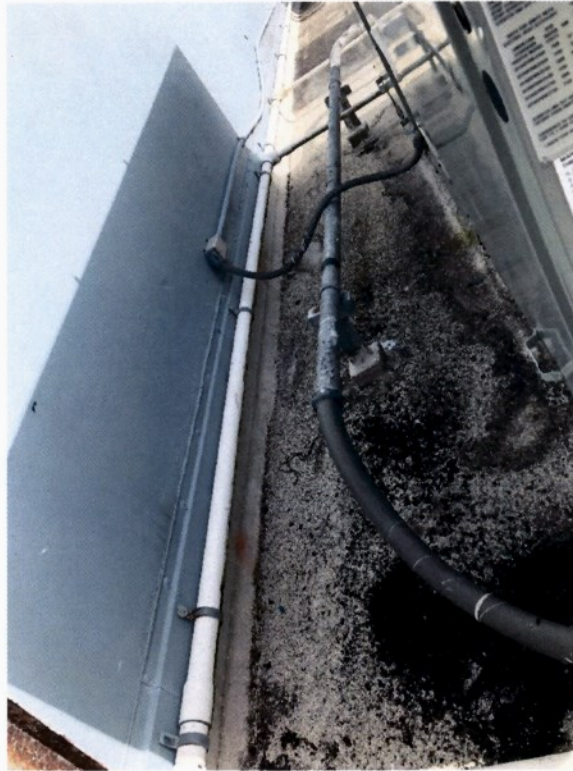
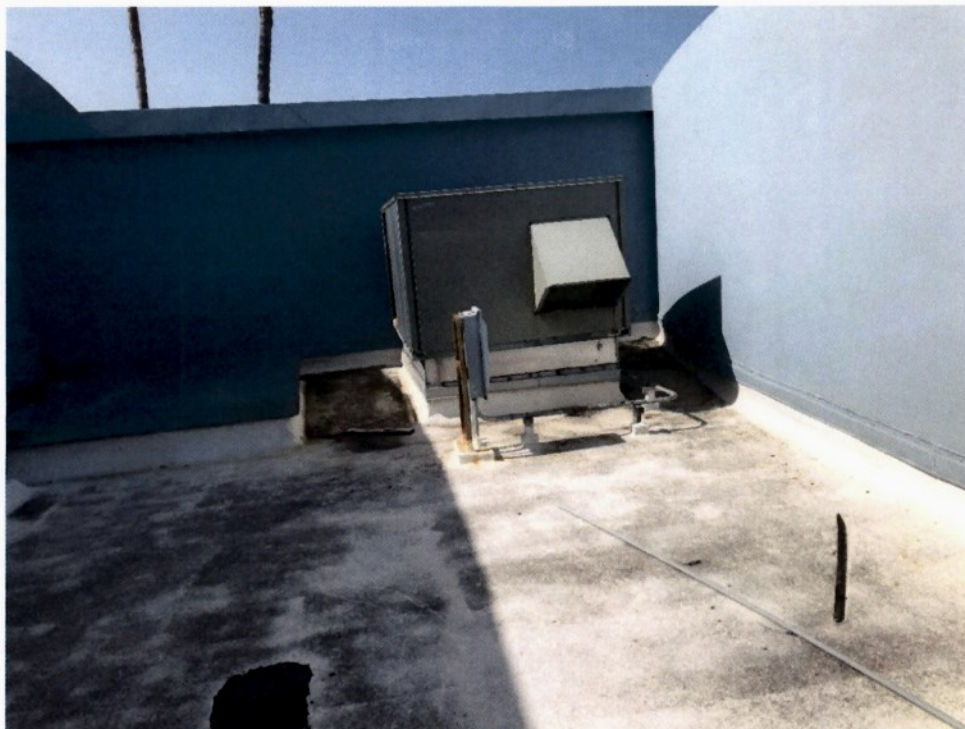
Photograph No. 57 - Upper roof at west side of the building

Photograph No. 58 - Lower roof at east side of the building

Photograph No. 59 – Lower roof at east side of the building

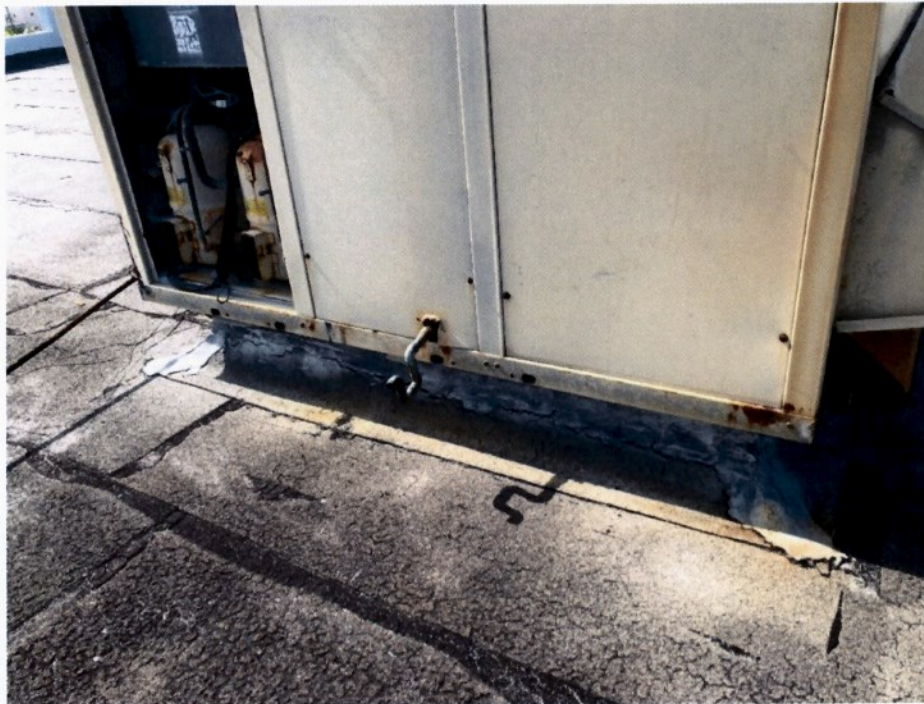
- 6.a.2 ... Condensing unit in lower roof at the east side of the building is supported on metal stands. One of the package units in the lower roof at the east side is being supported on a roof curb that is bigger than the unit (see Photograph 62). Several package units are not connected to their roof curbs, especially in the western upper roof and the lower roof between the east and west portions of the building (see Photographs 63, 64, and 65). Some units are missing enclosure panels (see Photographs 63 & 64).

Photograph No. 62 – Condensing Unit Supported on Larger Roof Curb at Low Roof at East Side
