493-2018

SUBJECT: **BYRON CARLYLE FACILITY CONDITION UPDATE**

Reference: 50-Year Recertification
Byron Carlyle Theater
500 71 St., Miami Beach, Florida
Folio 02-3211-002-1070

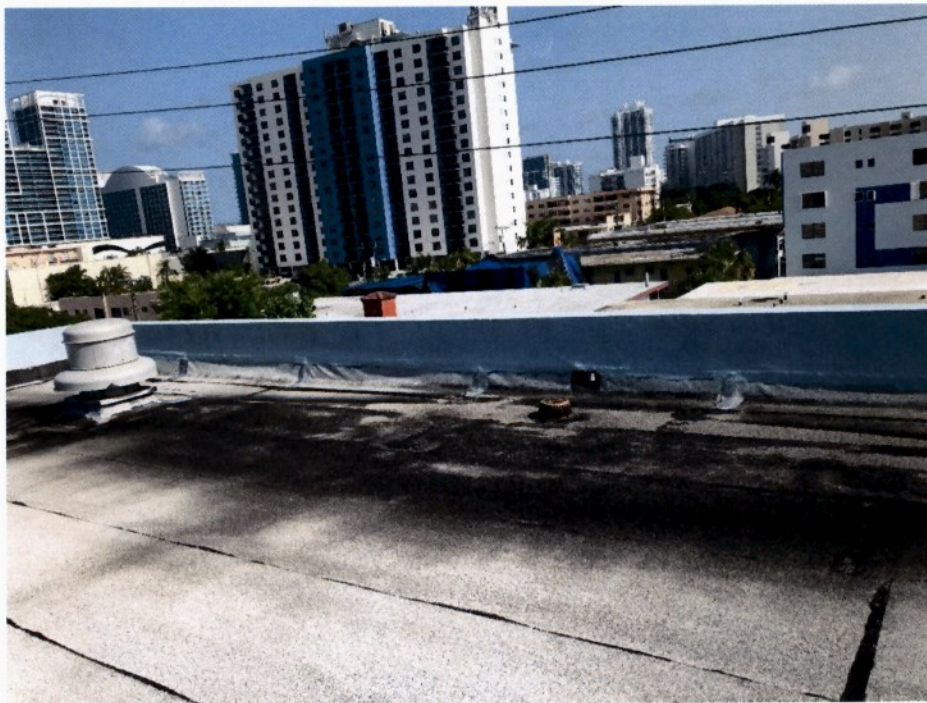
- 6.a.2 ... Condensing unit in lower roof at the east side of the building is supported on metal stands. One of the package units in the lower roof at the east side is being supported on a roof curb that is bigger than the unit (see Photograph 62). Several package units are not connected to their roof curbs, especially in the western upper roof and the lower roof between the east and west portions of the building (see Photographs 63, 64, and 65). Some units are missing enclosure panels (see Photographs 63 & 64).

Photograph No. 65 – Package Unit Unconnected to Roof Curb at Low Roof between East and West Portions

- 21) Connect rooftop package unit in the lower roof between the east and west portions of the building (see Photograph 65) and three rooftop package units in the western upper roof (see Photographs 63 and 64) to the supporting curbs (refer to Section 6.a.2). Seal openings at missing enclosure panel locations with properly fastened sheet metal.

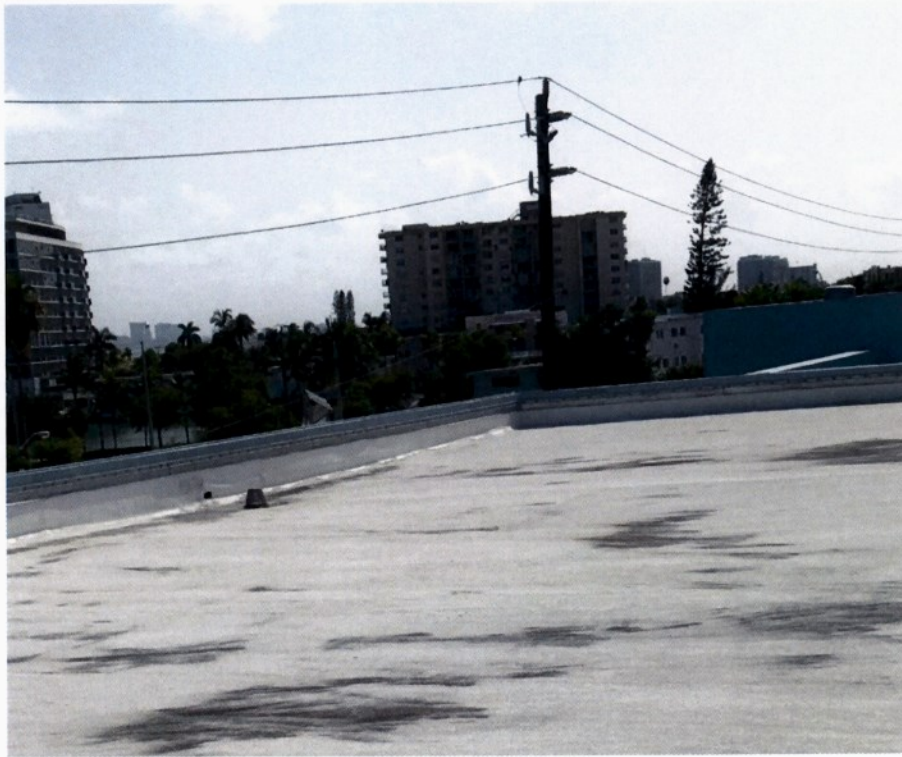
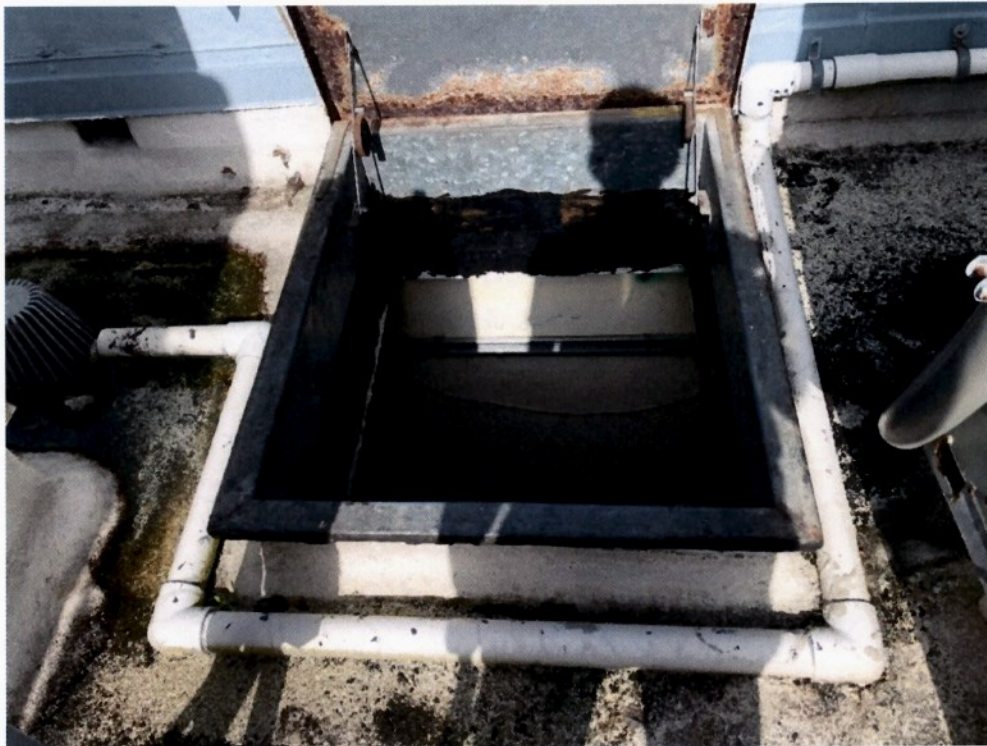
3. Note types of drains and scuppers and condition:
There are drains throughout the upper roofs with overflow scuppers around the perimeter curb (see Photographs 66 and 67). These drains are mostly located near the corners. Lower roofs also have drains with...CONTINUED ON ATTACHED SHEET

Photograph No. 66 – Westside upper roof

Photograph No. 67 – Eastside upper roof

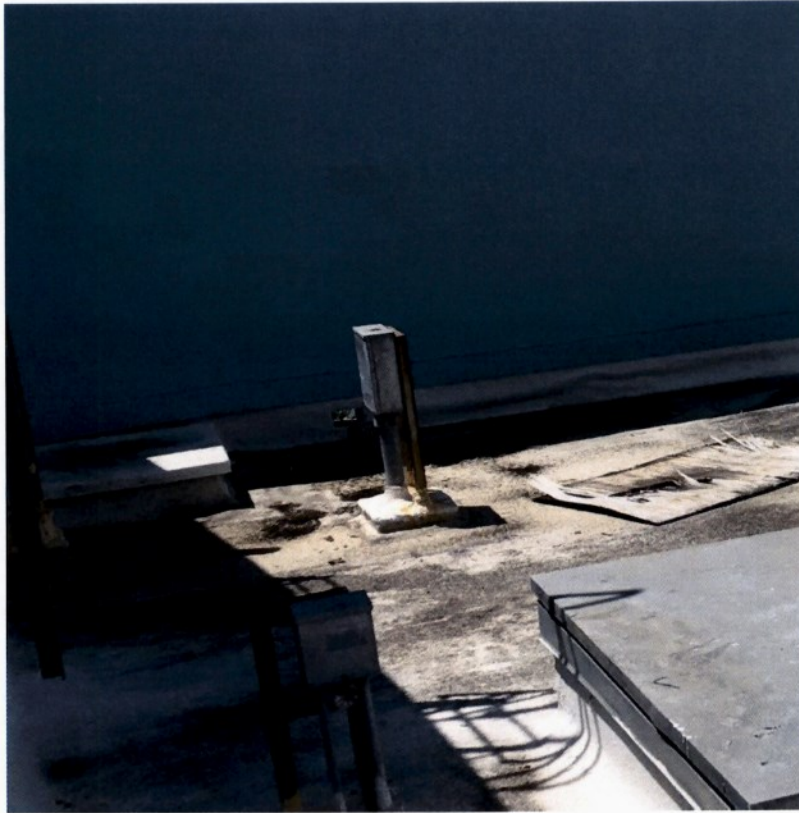
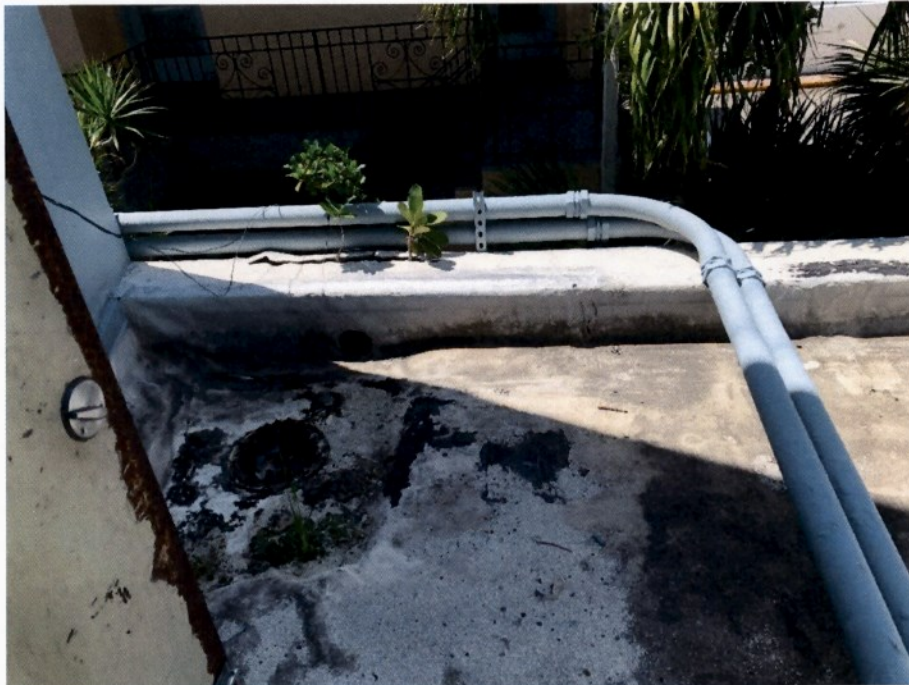
- 6.a.3 ... overflow scuppers (see photographs 68, 69, and 70), except the lower roof at the second level in the north portion of the building, where there are only drains but no overflow scuppers (see Photographs 71 and 72). It is important to note that this low roof has an exterior opening on the inside (see Photograph 73) which would facilitate overflow drainage.

Photograph No. 68 – Low roof at east side of building

Photograph No. 69 – Low roof between east and west sides of the building

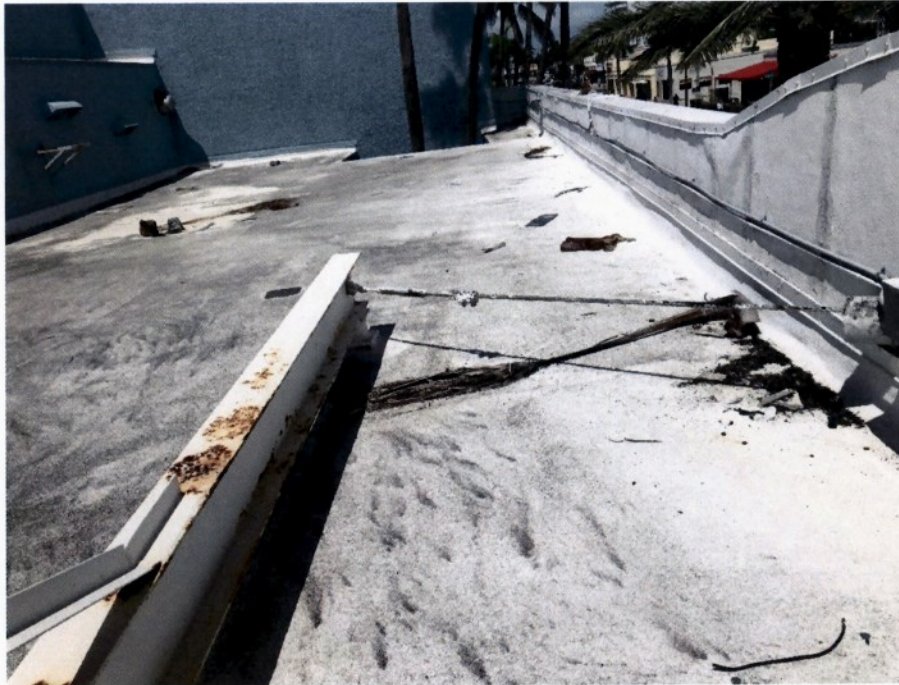
Photograph No. 70 – Low roof at the second floor

- 9) Drain of low roof at 2nd floor is missing protective cover. Debris could potentially clog the drain (see Photograph 70).
- 10) Access roof hatch located at the east low roof is mildly corroded (see Photograph 29).

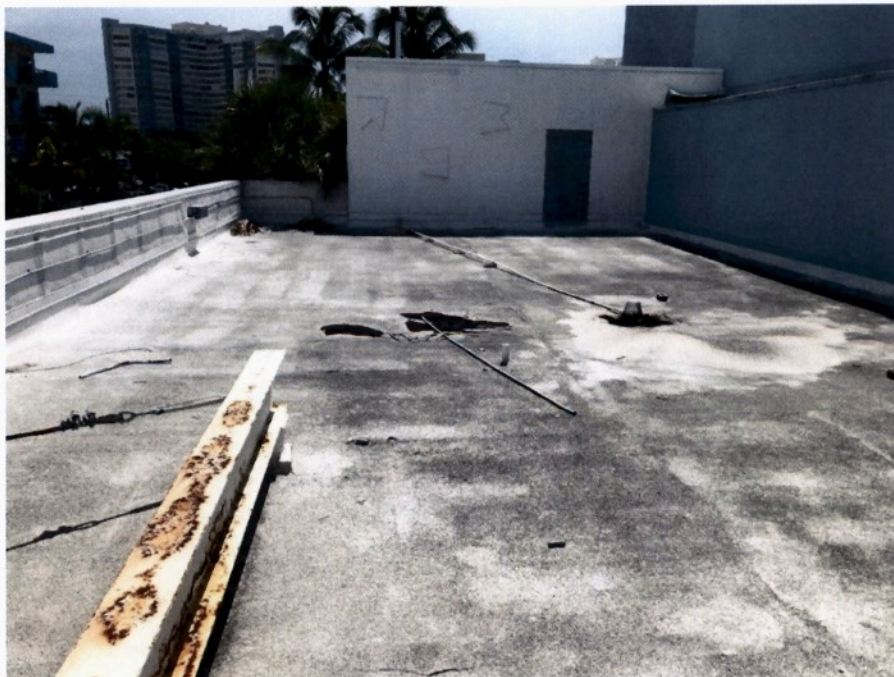
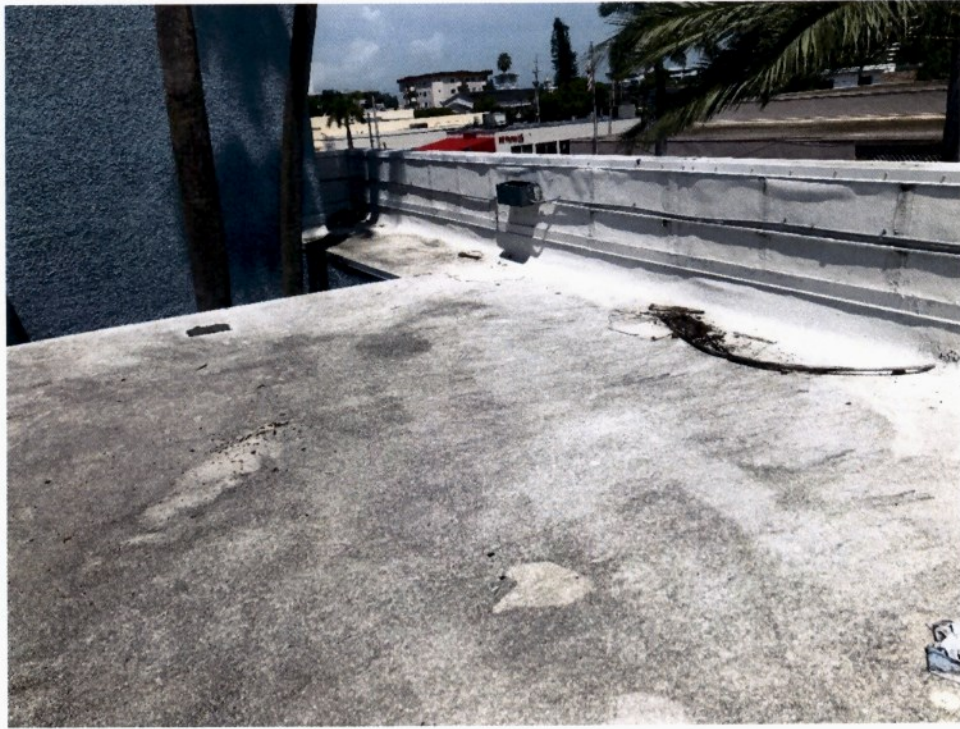
Photograph No. 71 – Low roof at the second floor (north)

Photograph No. 72 – Low roof at the second floor (north)

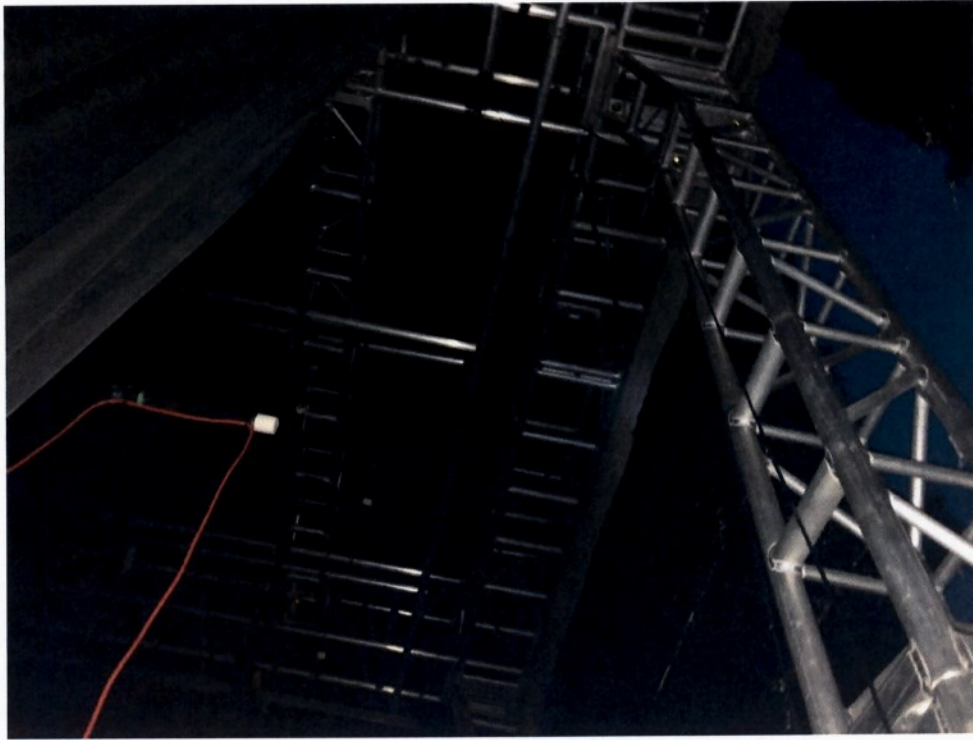
14) The main stage structure, a versatile (i.e. removable) prefabricated aluminum-framed platform (see Photographs 7 and 8), has some legs that are bent or crooked (see Photograph 78).

Photograph No. 78 – Crooked Leg of Stage's Aluminum-framed Platform

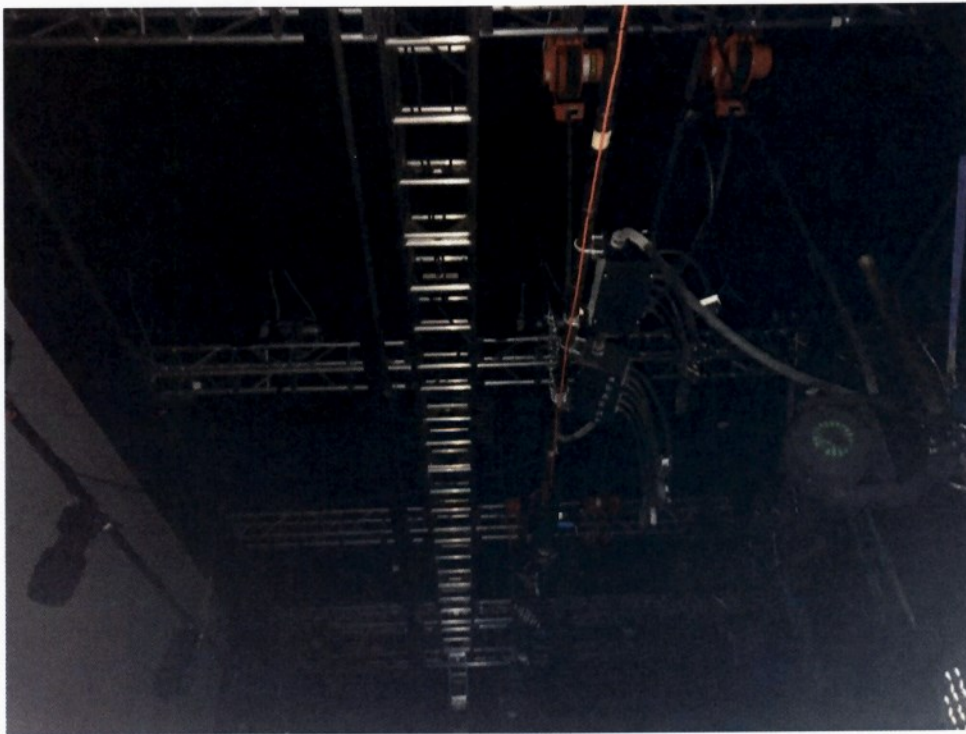
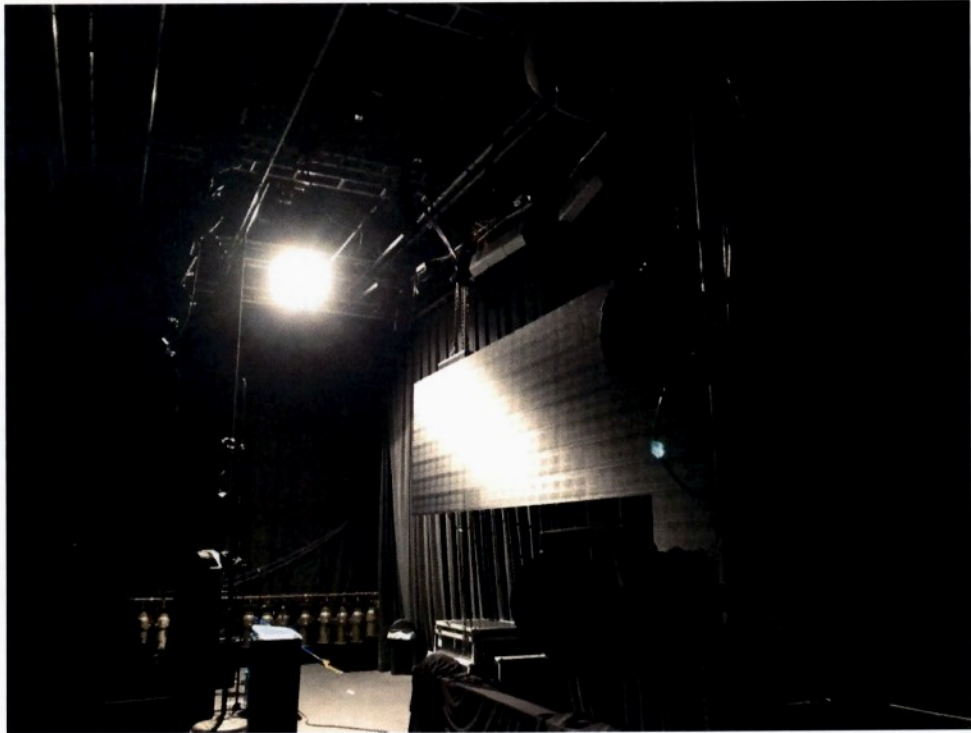
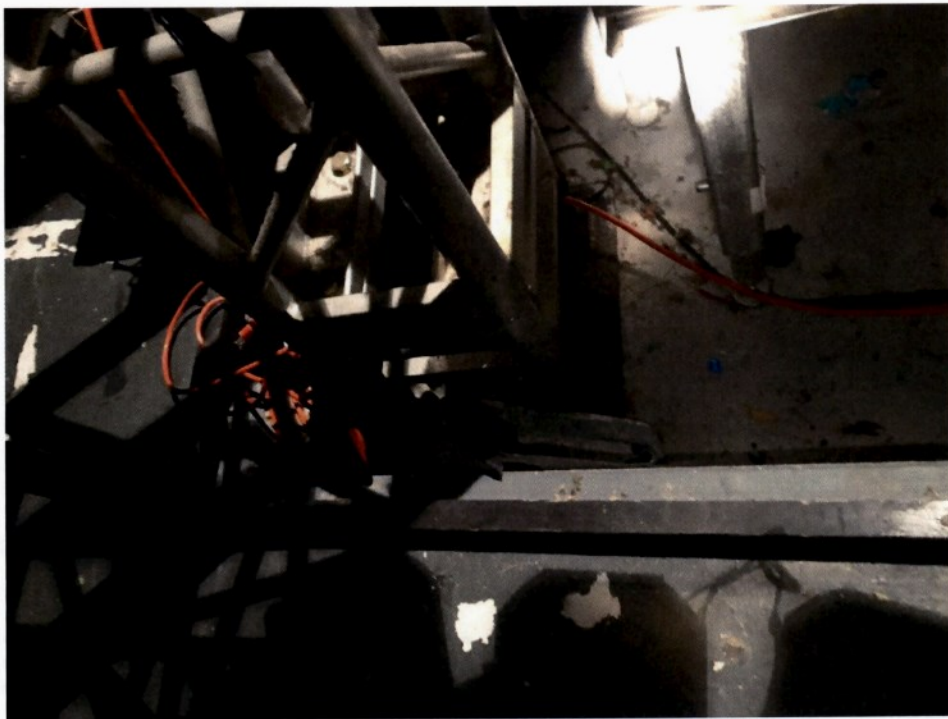
3) An independent (not connected to the structure laterally) aluminum truss frame was installed above the stage to support lighting and other theater equipment (see Photographs 79 to 82).

Aluminum Truss Frame: The truss frame that supports the lighting, and other theater equipment, over the stage also represents significant additional load to the original floor structure that was likely not designed to resist this loading (see Photographs 79 to 81). These additional loads are of importance as the vertical loads from the frame are transferred to the floor structure through a limited area (base plate of the vertical member, see Photograph No. 82), and hence they are considered point loads rather than distributed loads. These vertical loads may be bearing on grade beams not designed for these loads, or directly on the reinforced concrete slab, which was most likely not designed for these point loads.

Photograph No. 79 – Aluminum Truss Frame for Lighting Support
