STRUCTURAL CONDITION ASSESSMENT  
1235 Lenox Ave  
Miami Beach, Florida

H200440

March 13, 2020

STRUCTURAL CONDITION ASSESSMENT for  
1235 Lenox Ave  
Miami Beach, Florida

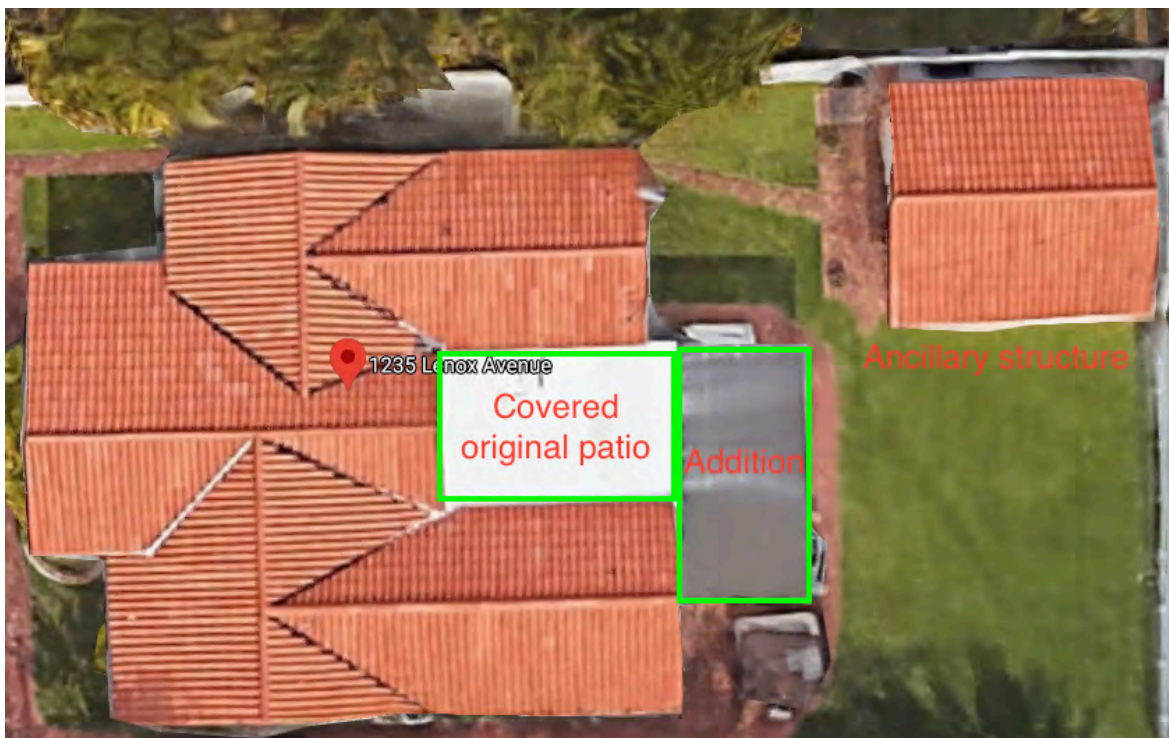
The photo depicts the original house, with its now covered patio and addition to the east of the structure.

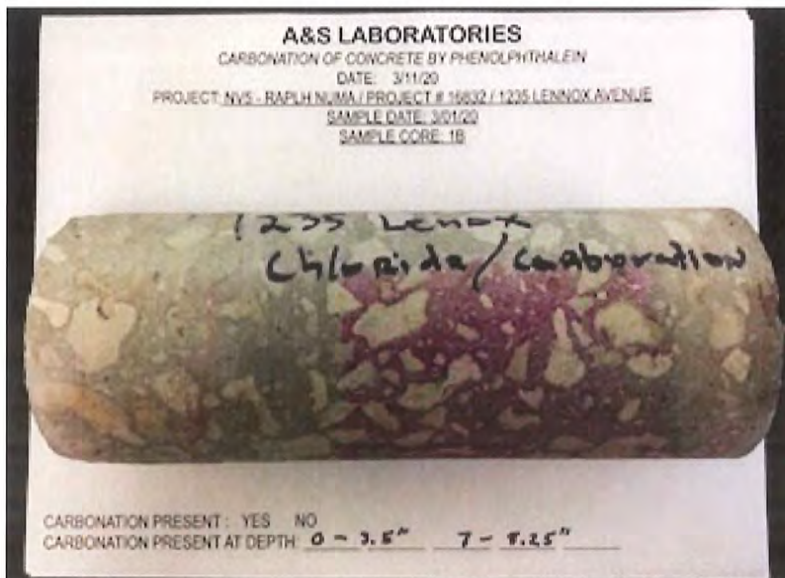
Figure 12: Carbonation Core Sample No. 1B: South Beam

These carbonation depths numbers are deep, and exposes the rebars to corrosion.

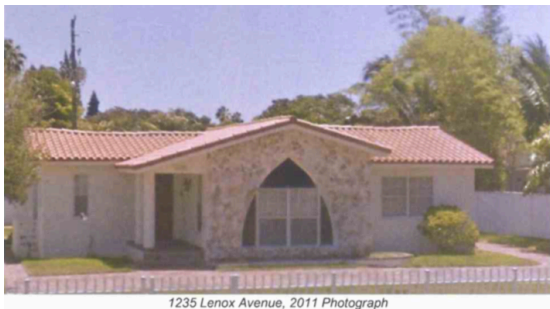
Modifications to the front façade in 1990 appear to include the introduction of rough-hewn stone cladding and the removal of the chimney structure along with retaining the unfortunate insertion of windows inside the arched opening. And this opening apparently mimics the original windows shown in left above photo.
