# HOME INSPECTION REPORT

Client Name: **Jacqueline Sankowski**  
Property Address: **828 4th Street**  
Address Line 2:  
City (State): **Miami Beach (FL)**  
ZIP: **33139**  
Phone:

Inspection #: **060320-828**  
Inspection Date: **06/03/2020**  
Inspector: **Jorge Garcia**  
License: **HI 9540**  
Time: **10:00 AM**  
Weather/Temp: **Rainy**

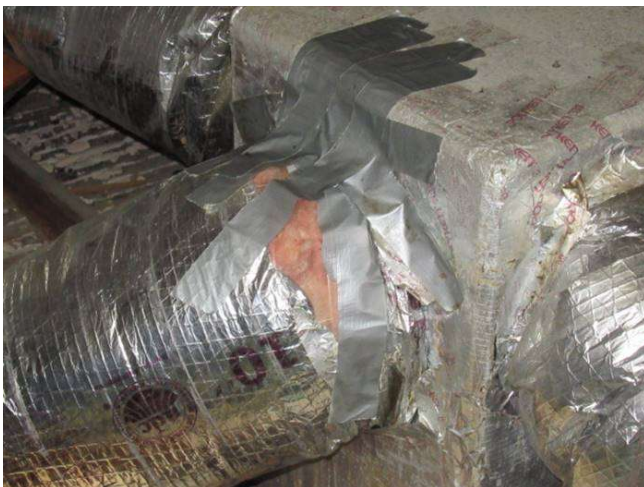
TORN DUCT WORK

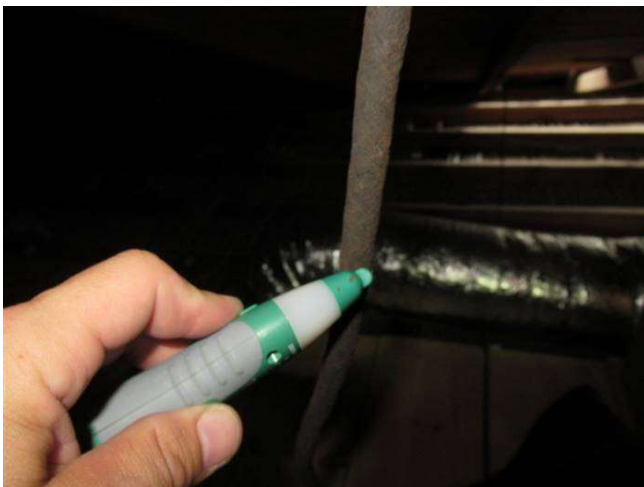
ABANDONED CLOTH WIRING
