# Arborist Report

92 La Gorce Circle  
Miami Beach

4/16/2021

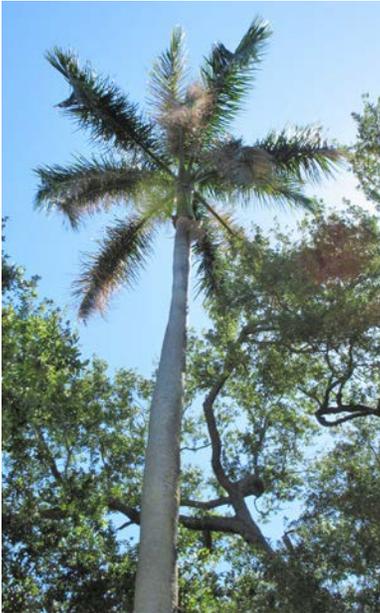
Tree #3 is a Royal Palm street tree located along La Gorce Circle. It is in fair condition - the canopy is small and the trunk is pencilling.

This tree is to remain and protective barriers shall be placed 10ft from the tree trunk. Barriers shall be installed prior to the start of construction, and shall remain in place until development is completed and until the department authorizes their removal. Barriers shall be a minimum of 4ft high, and shall be constructed of continuous chain link fence with metal posts at 8ft spacing, or of 2x4 posts with three equally spaced 2x4 rails. Posts may be shifted to avoid roots. No materials shall be placed or disposed of within the TPZ. Natural grade shall be maintained within the TPZ.

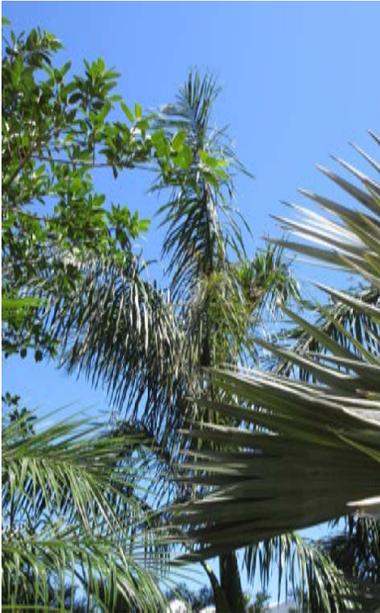
Tree #7 is a Royal Palm located in the front northwest corner of the property. It is small and in fair condition. Some of the foliage is frizzled. This tree has not been incorporated into the landscape plan and will therefore be removed.

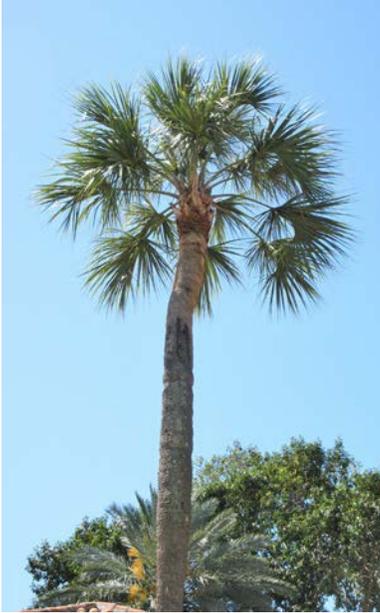
Tree #11 is a Sabal Palm located on the north side of the house. It is growing in a small raised planter and has a very small rooting space. It is in poor condition with a thin canopy and bleeding cankers on the trunk. This tree has not been incorporated into the landscape plan and will therefore be removed.

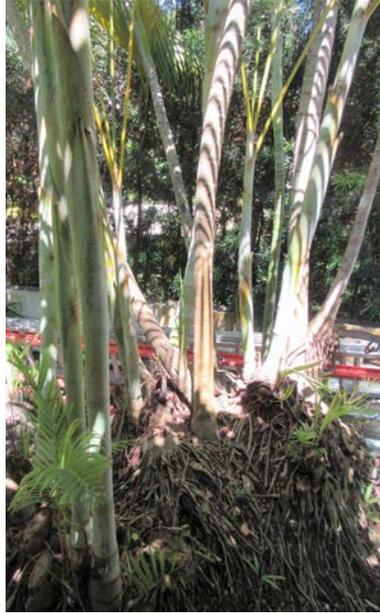
Tree #17 is two Areca Palm clusters located on the north side of the property. It is in poor condition with a thin canopy and chlorotic and frizzled fronds. This tree has not been incorporated into the landscape plan and will therefore be removed.

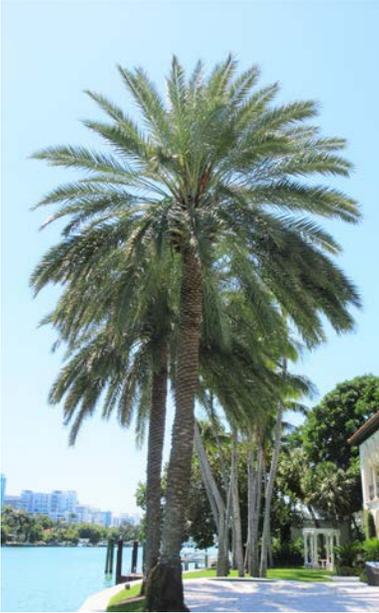
Tree #19 is a Date Palm located at the rear of the property. It is in good condition with a symmetrical, healthy canopy. This tree has not been incorporated into the landscape plan and will therefore be removed.

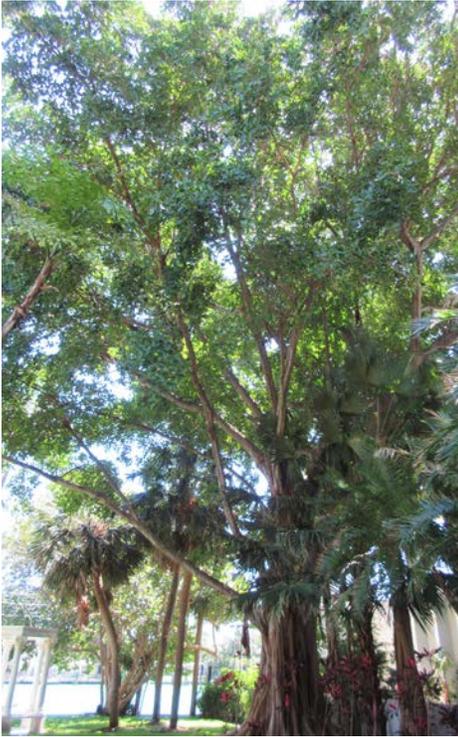
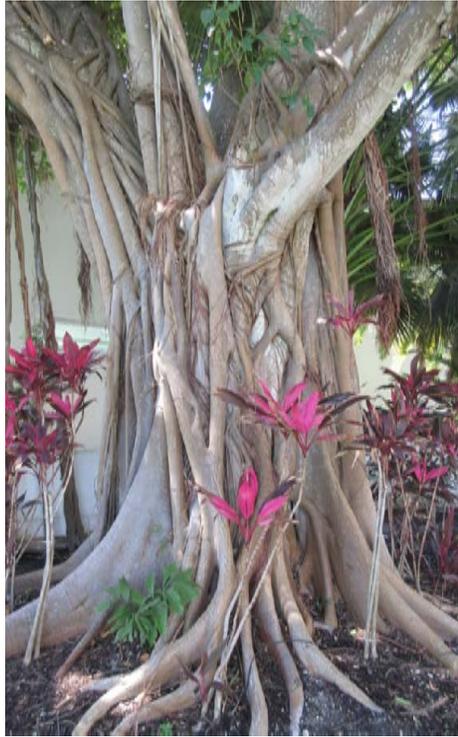
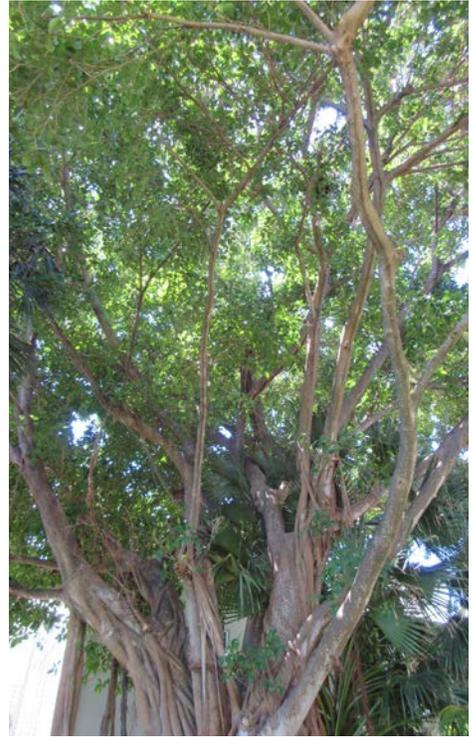
## Tree #40/42 contd.

Tree #40/42 is a Strangler Fig located on the south side of the property. It is in good condition. It has a wide-spreading canopy that is symmetrical with a nice form. There are a number of aerial roots, including where #42 is marked on the survey. The tree has good vigor and no cavities nor decay were observed. There is little deadwood. Prune to remove deadwood.

This tree is to remain and protective barriers shall be placed 35ft from the center of the tree trunk. Barriers shall be installed prior to the start of construction, and shall remain in place until development is completed and until the department authorizes their removal. Barriers shall be a minimum of 4ft high, and shall be constructed of continuous chain link fence with metal posts at 8ft spacing, or of 2x4 posts with three equally spaced 2x4 rails. Posts may be shifted to avoid roots. No materials shall be placed or disposed of within the TPZ. Natural grade shall be maintained within the TPZ. This tree should be monitored on a periodic basis for health and structural integrity.

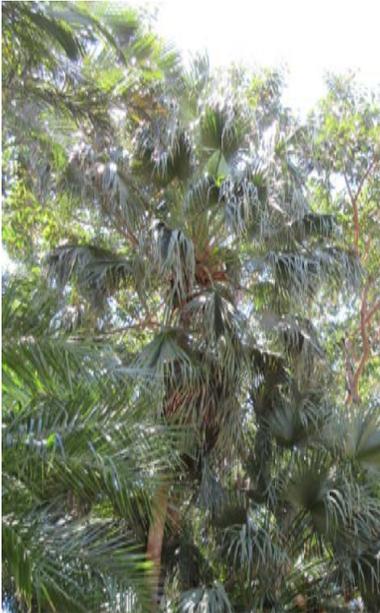
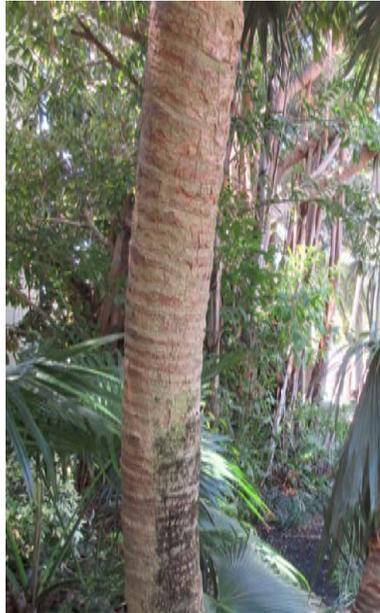
Tree #60 is a Chinese Fan Palm located on the south side of the property. It is in good condition with a healthy canopy. This tree has not been incorporated into the landscape plan and will therefore be removed.

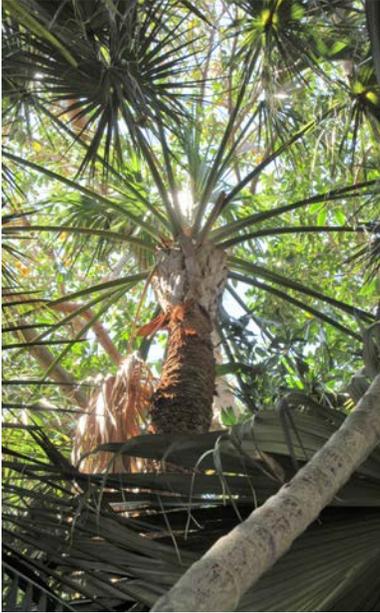
Tree #62 is a Sabal Palm located on the south side of the property. It is in poor condition with a thin canopy. This tree has not been incorporated into the landscape plan and will therefore be removed.

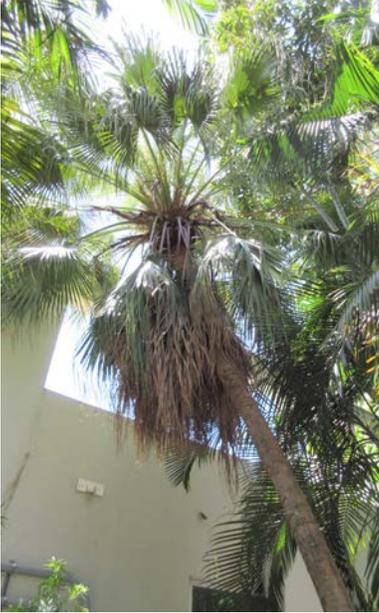
Tree #64 is a Chinese Fan Palm located on the south side of the property. It is in fair condition - the trunk is leaning and there are many lower dead fronds. This tree has not been incorporated into the landscape plan and will therefore be removed.

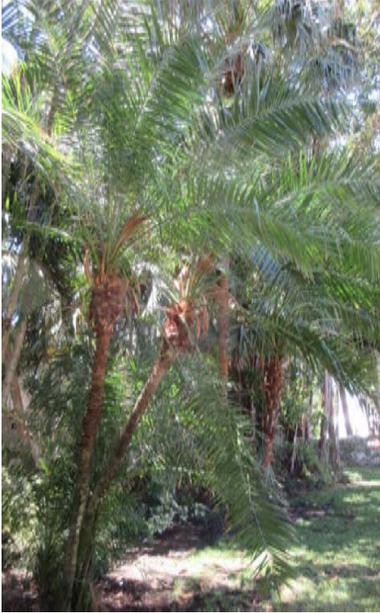
Tree #66 is a Senegal Date Palm located on the south side of the property. It is in good condition. This tree has not been incorporated into the landscape plan and will therefore be removed.
