# GENERAL ASSESSMENT REPORT

EXISTING STRUCTURAL SYSTEMS

803 2<sup>ND</sup> STREET  
MIAMI BEACH, FLORIDA

APRIL 5, 2021

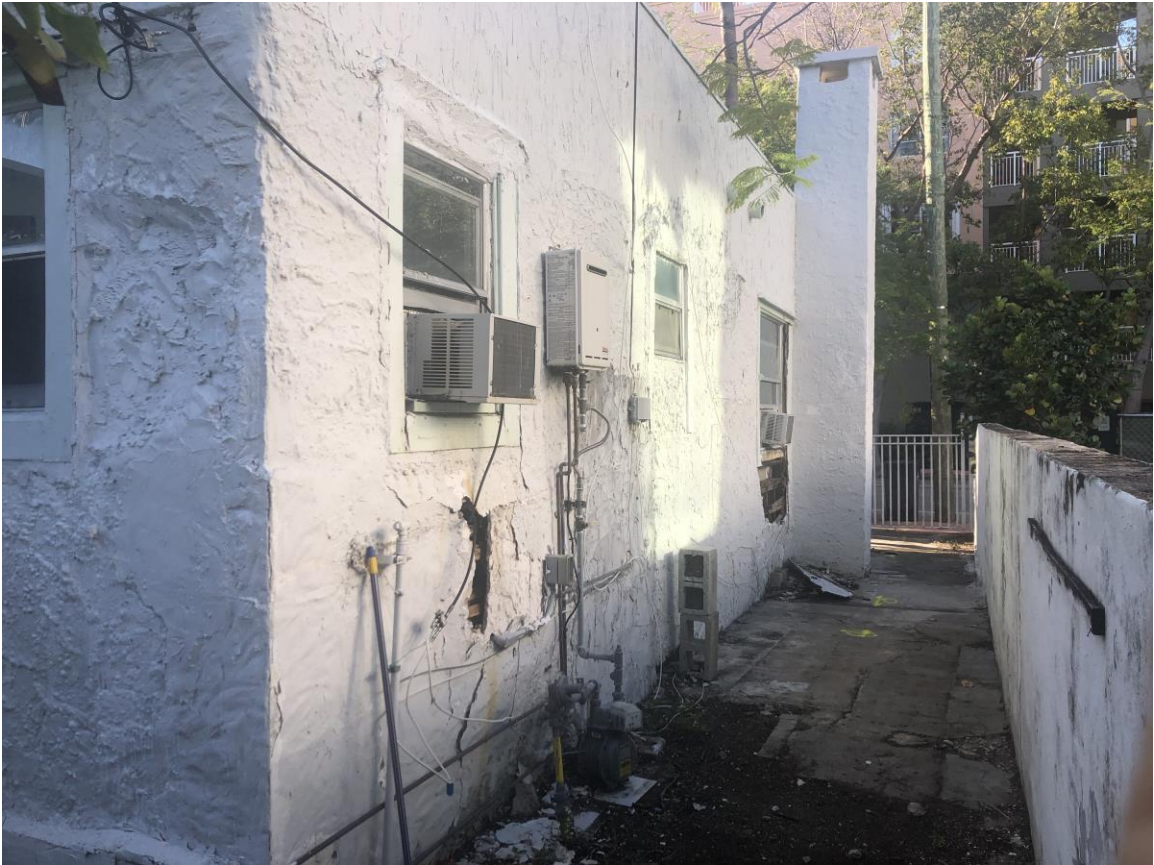
**PHOTOGRAPH NO. 6**

The exterior chimney/flue on the west side of the building is constructed of masonry. Refer to Photograph No. 6.

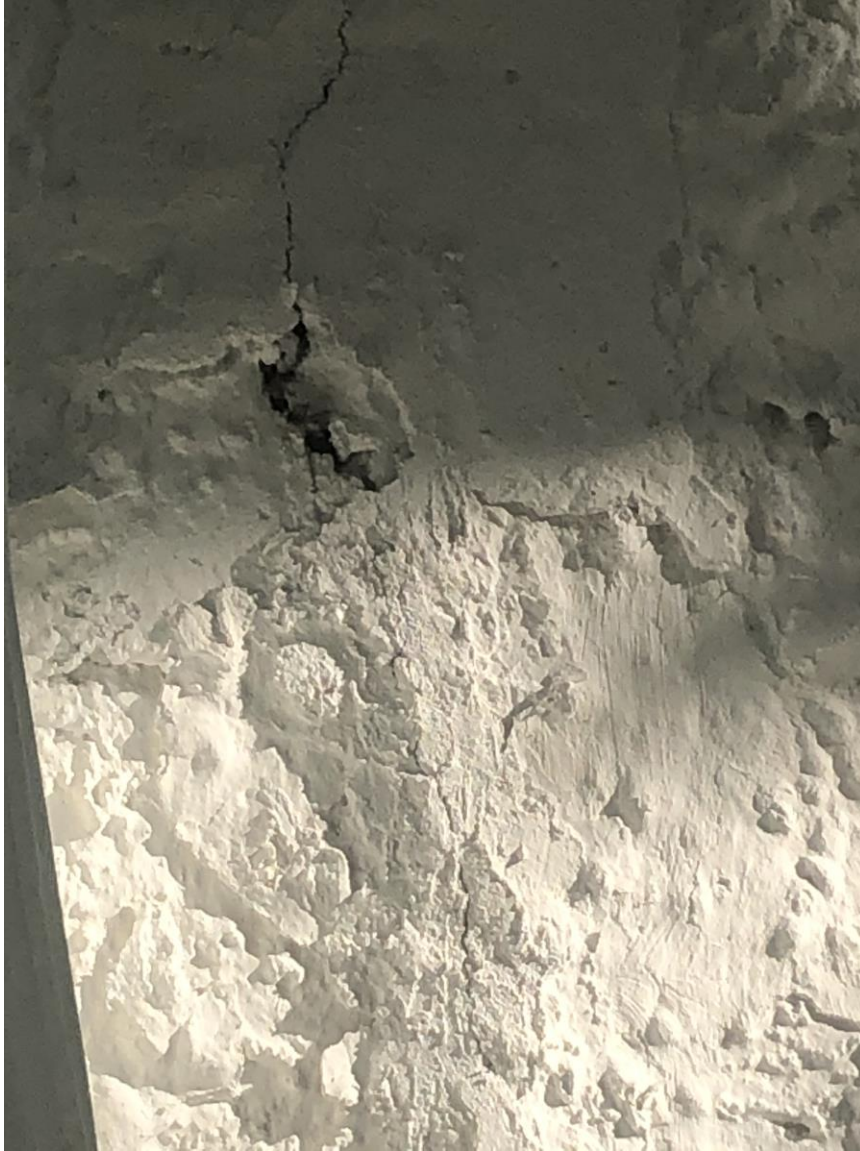
**PHOTOGRAPH NO. 9**

7. There is a hive of live bees inside the wall cavity at the east end of the south wall. The bees enter and leave through a hole in the exterior stucco. Refer to Photograph No. 9.

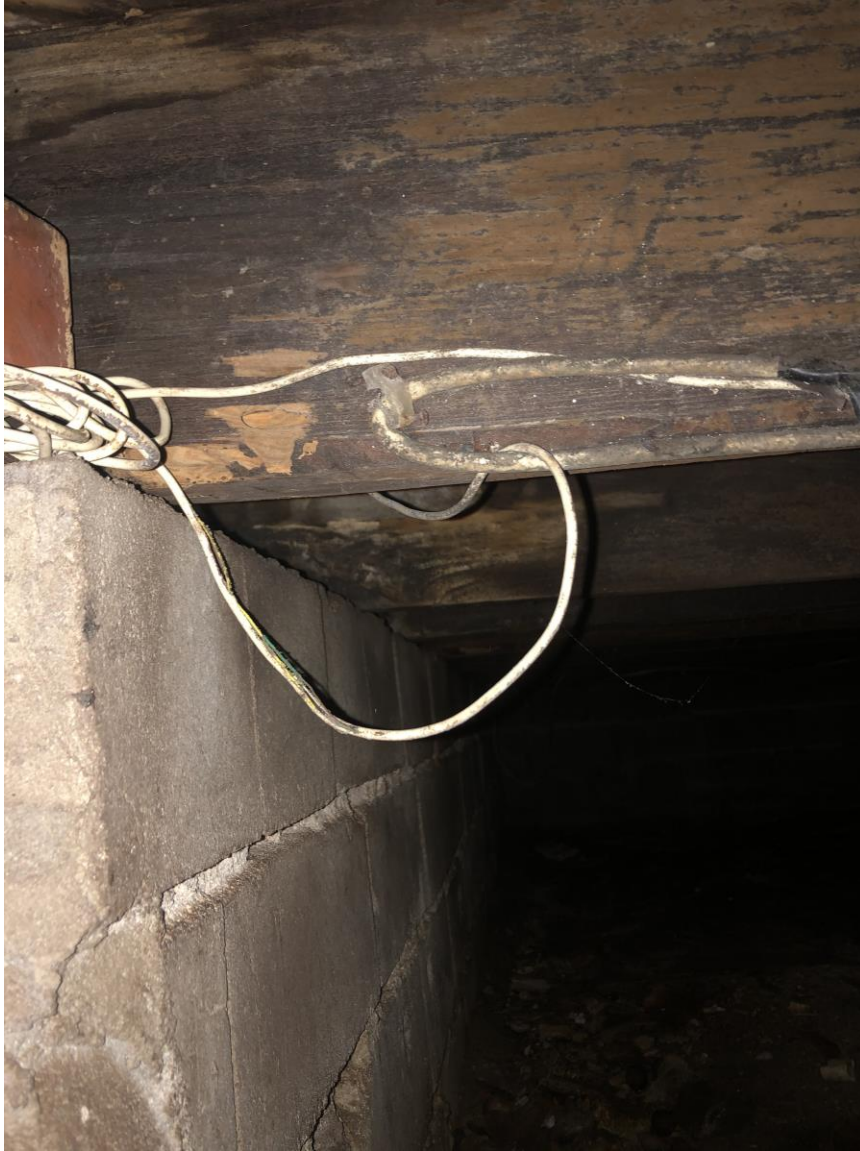
PHOTOGRAPH NO. 97

The exterior stem-walls, on which the floor joists bear, are constructed of concrete block. Refer to Photograph No. 97.

Direct observation of the floor structure was limited to one vent/access opening on the east side of the building. The original floors generally consist of wood board sheathing over wood joists. The joists generally bear on the exterior concrete block stem-wall (refer to Photograph No. 97) and on interior wood beams, which bear on wood shims on concrete blocks on concrete pads. Refer to Photographs Nos. 96 and 99.

5. In the area under the floor that was visible, there is insect damage in some of the wood joists and sheathing. Refer to Photographs Nos. 96, 97 and 98.
