*EVALUATION REPORT*

*For Project located at: 7801 ATLANTIC WAY. MIAMI BEACH, FLORIDA. 33141*

The inspection of the building in reference (See Exhibit 1 for graphical representation), located at 7801 Atlantic Way, Miami Beach Fl 33141, took place on Wednesday February 22nd, 2023 and was performed by Mr. Alioskar Ganem P.E. The main objective of the inspection was to identify general areas and critical details of the building components that may compromise the integrity of the Structure and represent a hazard to the users of this property and to ensure that all its components were built following the minimum standards of the Florida Building Code current at the time of construction, including a proper evaluation for the city of Miami Beach Building Department for the construction plans and construction inspections .

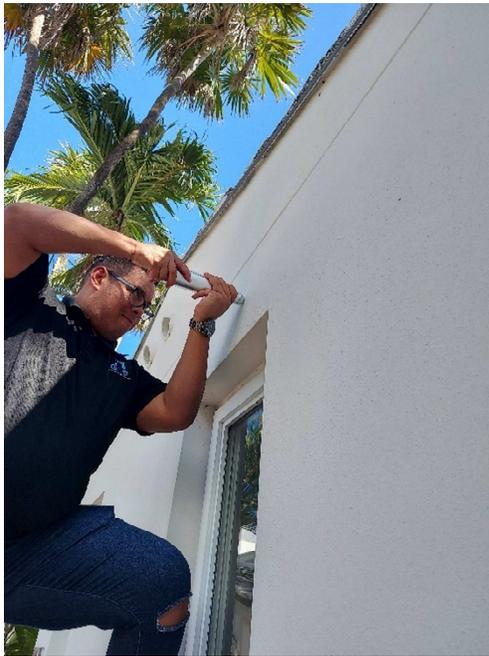
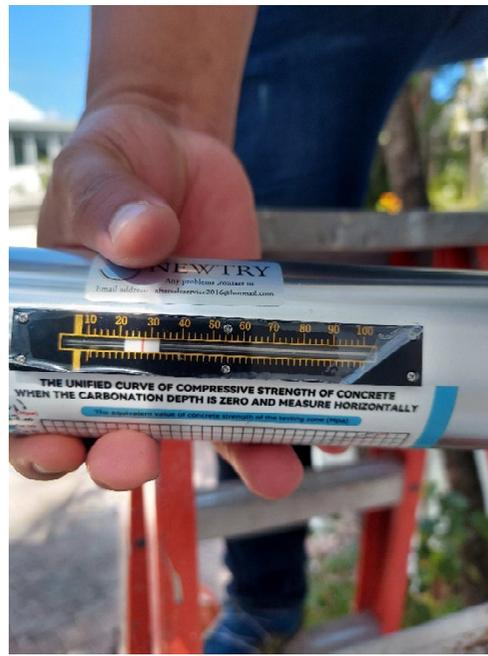
# Sclerometer test

Additionally, as a result of the visual inspection, cracks were observed in bearing elements of reinforced concrete. This is produced as a consequence of the increase in volume of the reinforcing steel produced by an oxidation state. Sulfates attack concrete, forming expansive compounds that cause cracking. Chlorides, if they reach the rebars, cause its corrosion. The cracking caused by sulfates facilitates the penetration of chlorides and the corrosion of the reinforcement. Once the concrete cracks, the integrity and design capacity of the structural element are not guaranteed.

It is possible to selectively restore, repair or reconstruct some structural elements in the case of localized failure. However, Failure to meet the required concrete resistance cannot be solved; That is why, based on the results obtained from the tests carried out, a total demolition of the structure is recommended. Future and more exhaustive tests can be carried out to determine additional concealed damages in the different structural elements.
