*EVALUATION REPORT*

*For Project located at: 7801 ATLANTIC WAY. MIAMI BEACH, FLORIDA. 33141*

The inspection of the building in reference (See Exhibit 1 for graphical representation), located at 7801 Atlantic Way, Miami Beach Fl 33141, took place on Wednesday February 22nd, 2023, and was performed by Mr. Alioskar Ganem P.E. The main objective of the inspection was to identify general areas and critical details of the building components that may compromise the integrity of the Structure and represent a hazard to the users of this property. The following report examines the strength and viability of the structure from the slab to the roof.

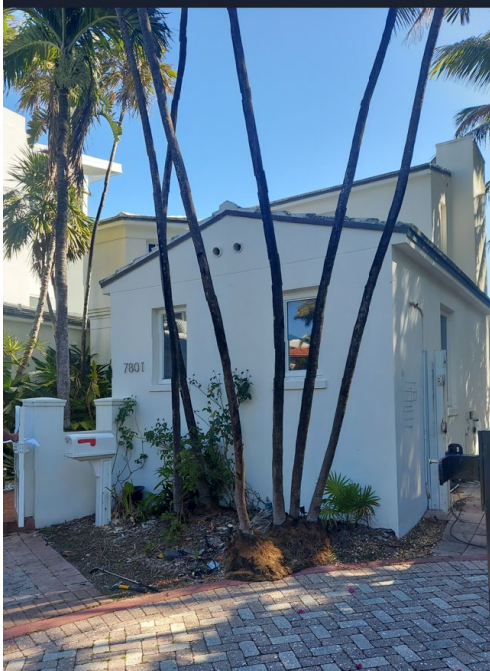
Existing Building conditions:

The House foundation: Elevated Crawl space. Based on photo evidence the existing building has flood vents.

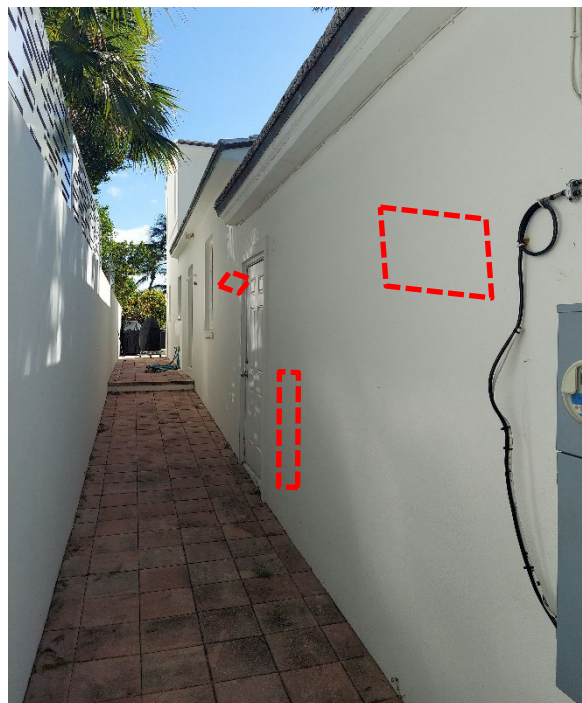
Cracked area.

Hairline crack.
