TECHNICAL DRAWINGS (TREE MITIGATION SCHEDULE)

TECHNICAL DRAWINGS (TREE MITIGATION PLAN 1)

TECHNICAL DRAWINGS (OVERALL SITE PLAN)

TECHNICAL DRAWINGS (HARDSCAPE SCHEDULE)

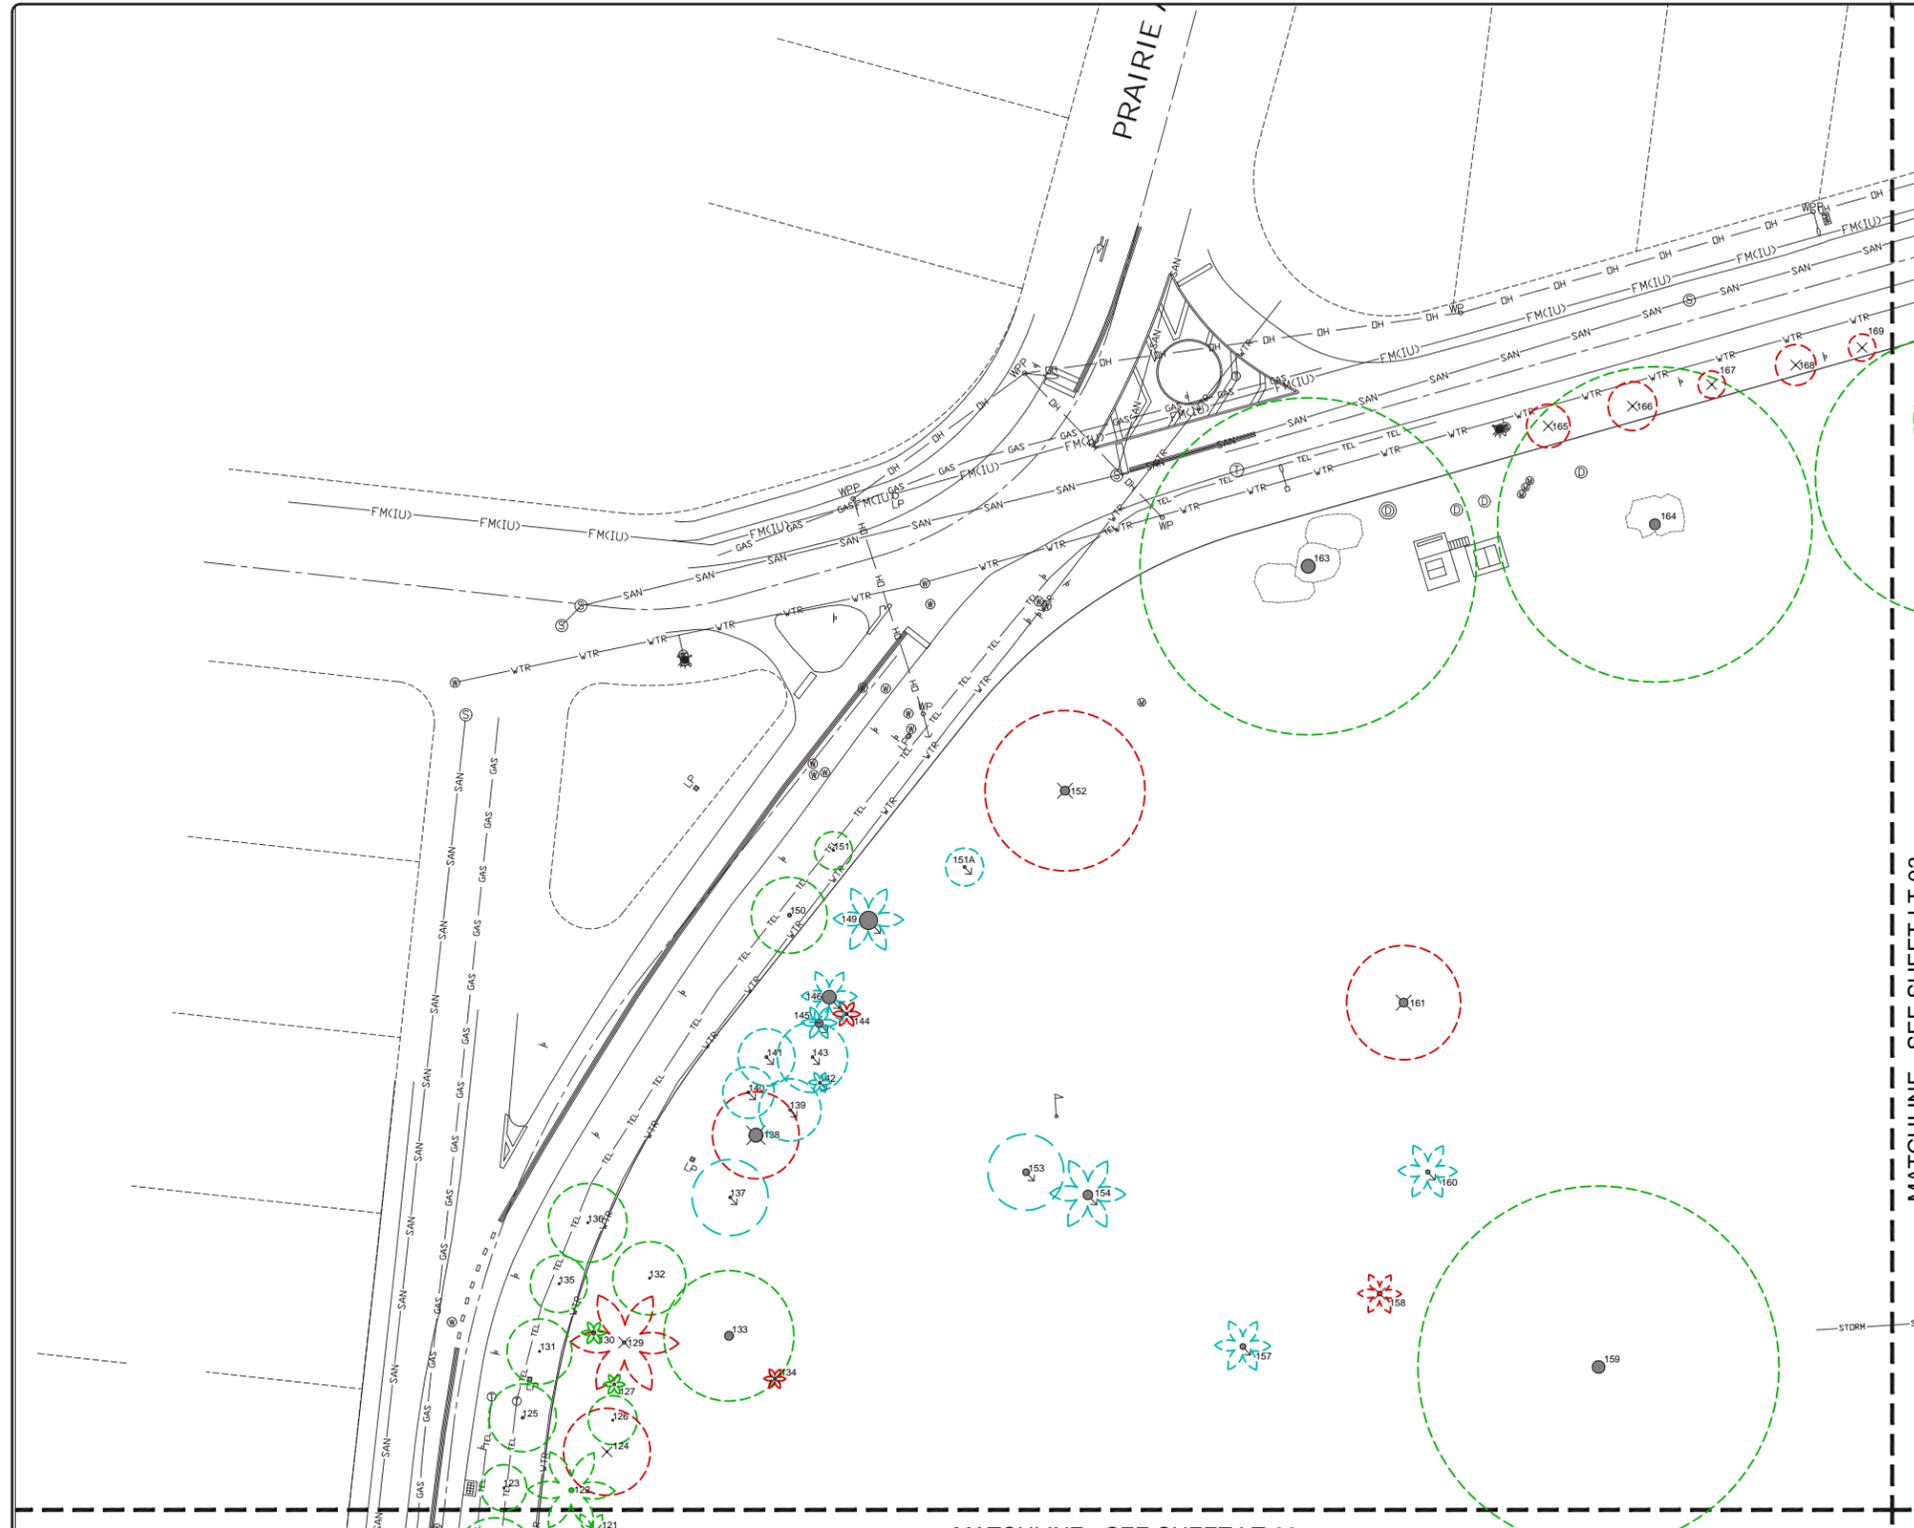
*FOR TREE DISPOSITION SCHEDULE, SEE SHEET LT-00
 *PLEASE REFER TO PLANTING PLAN SHEETS FOR RELOCATED TREE LOCATIONS.

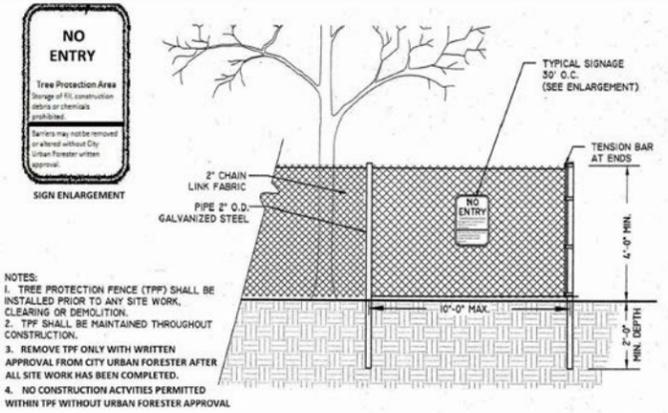
CITY OF MIAMI BEACH: TREE PROTECTION FENCE DETAIL
 TREE PROTECTION FENCES WILL BE PLACED TO ALL EXISTING TREES AND RELOCATED TREES AS PER CITY OF MIAMI BEACH CODE. FINAL LAYOUT TO BE APPROVED BY CERTIFIED ARBORIST.
 PLEASE REFER TO TREE PROTECTION SPECIFICATIONS.

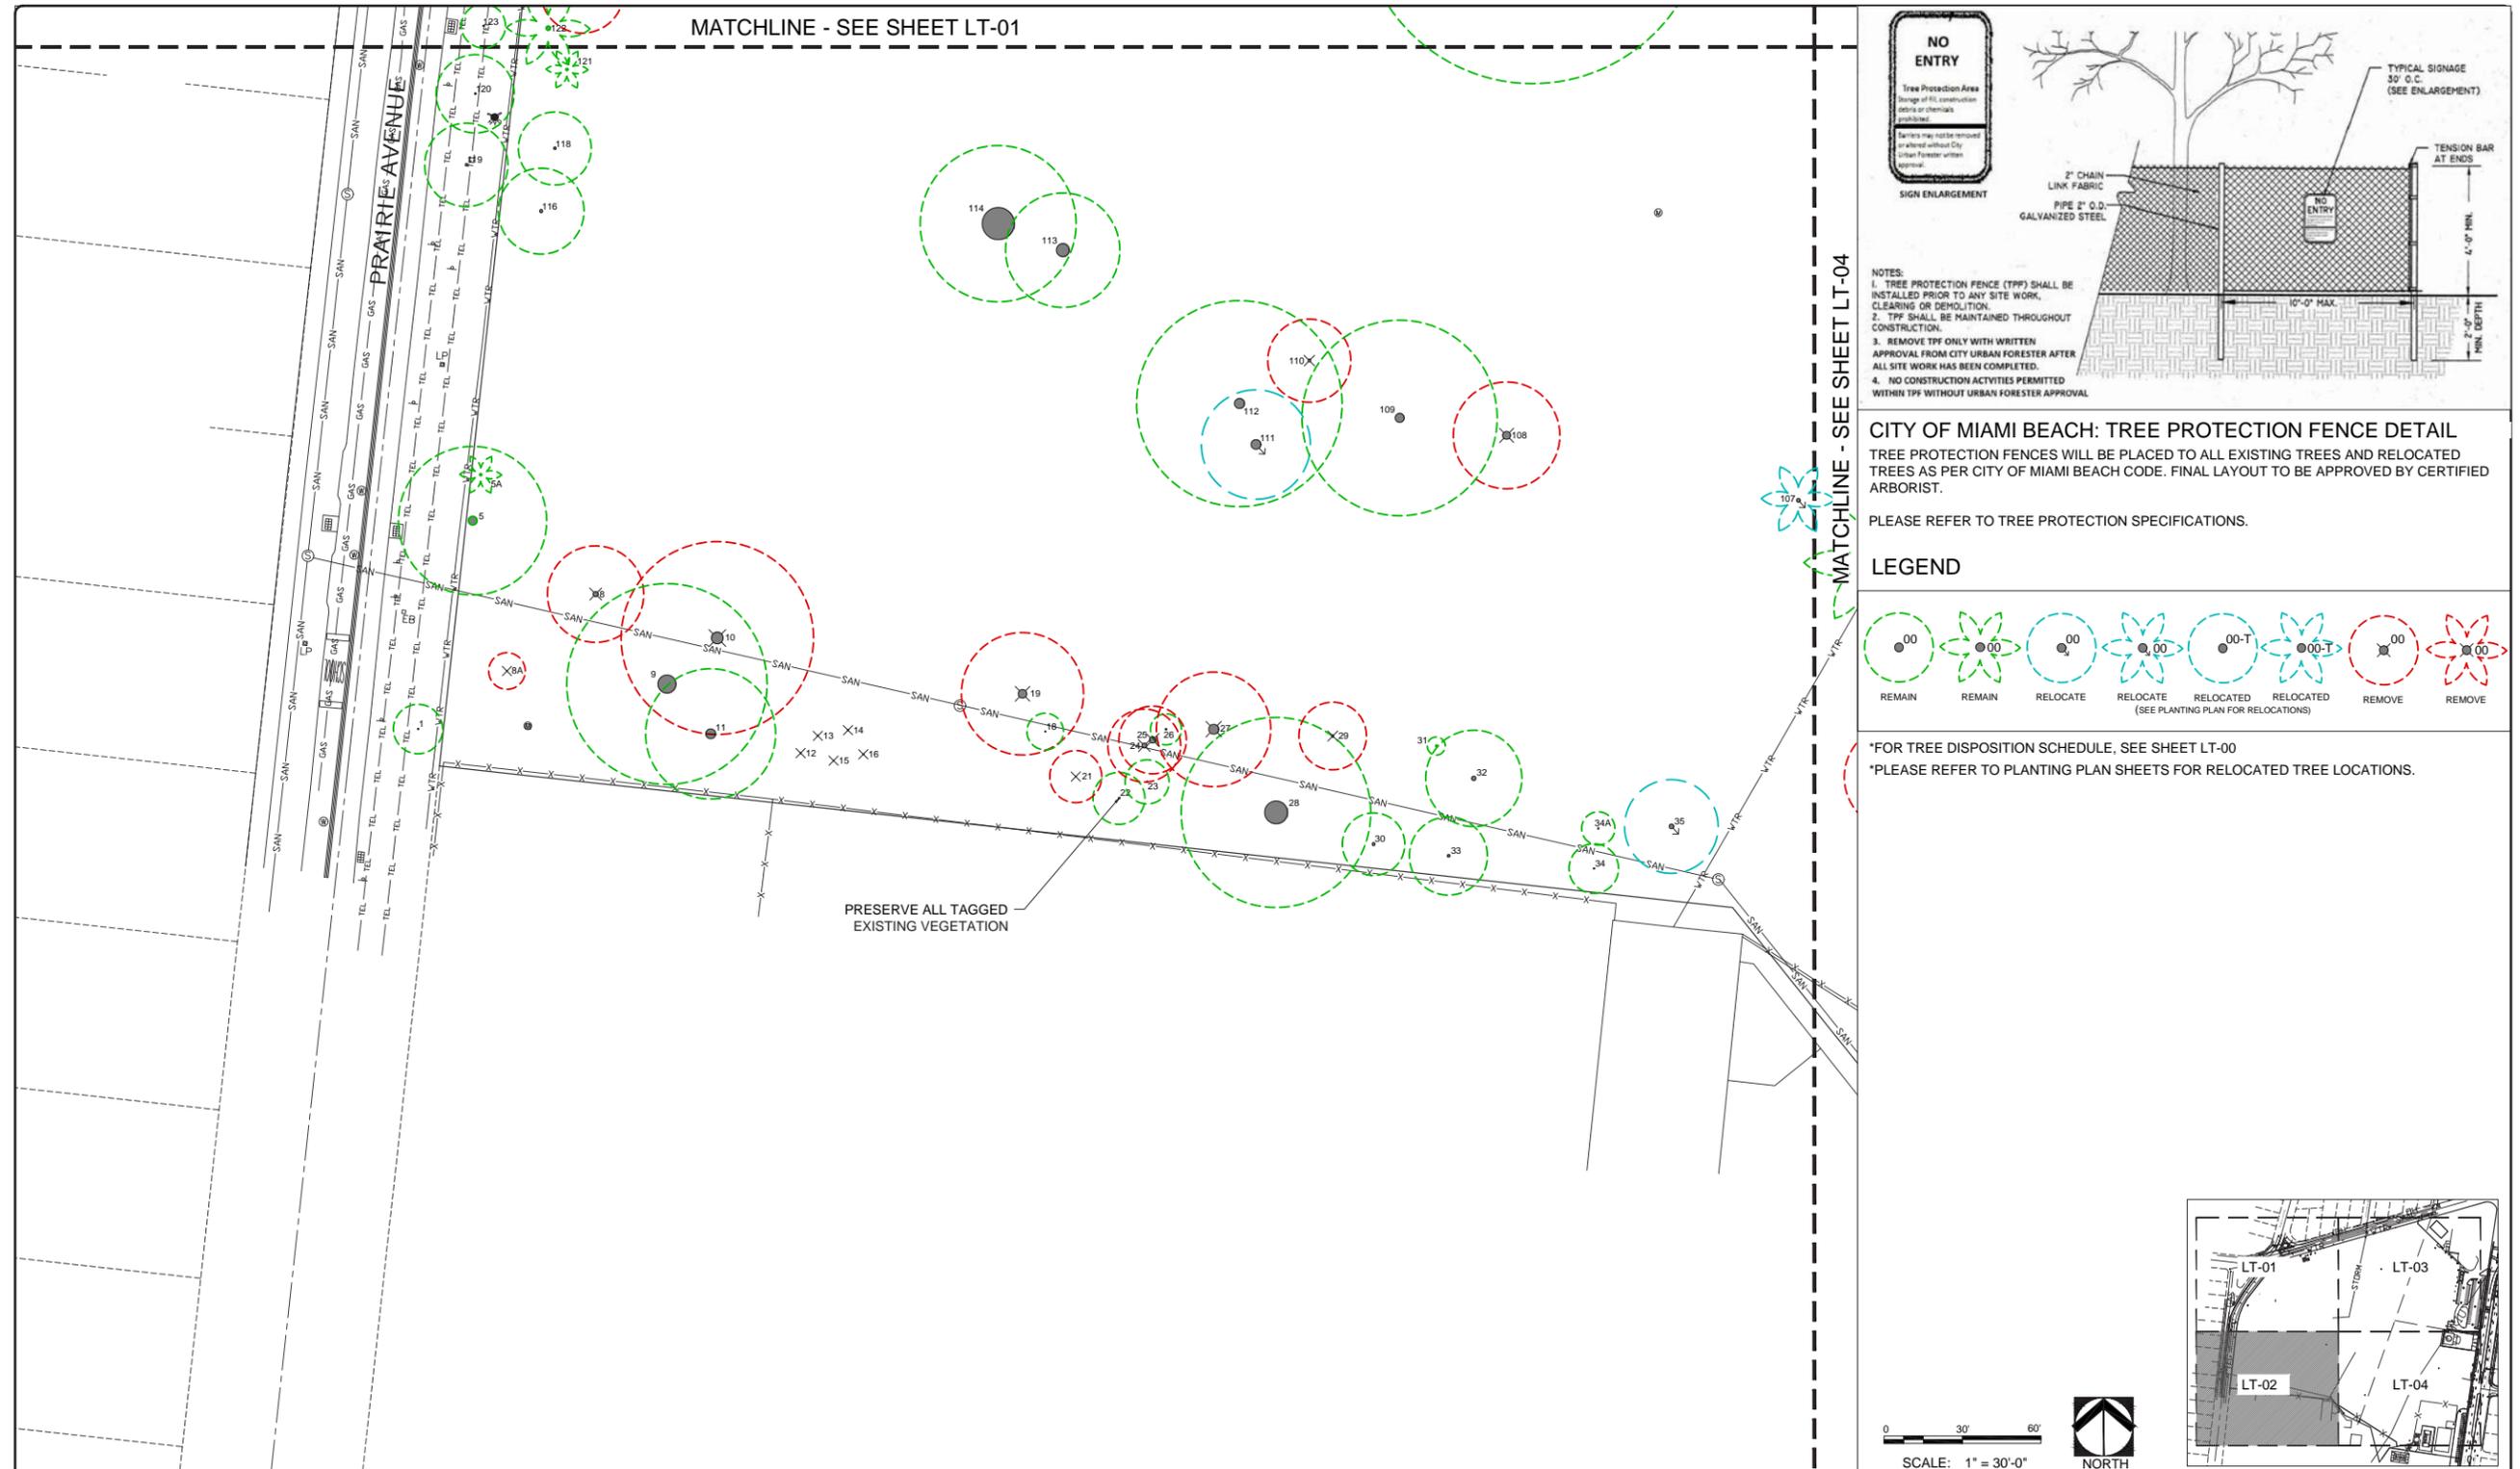
TECHNICAL DRAWINGS (TREE MITIGATION PLAN 2)

*FOR TREE DISPOSITION SCHEDULE, SEE SHEET LT-00
*PLEASE REFER TO PLANTING PLAN SHEETS FOR RELOCATED TREE LOCATIONS.

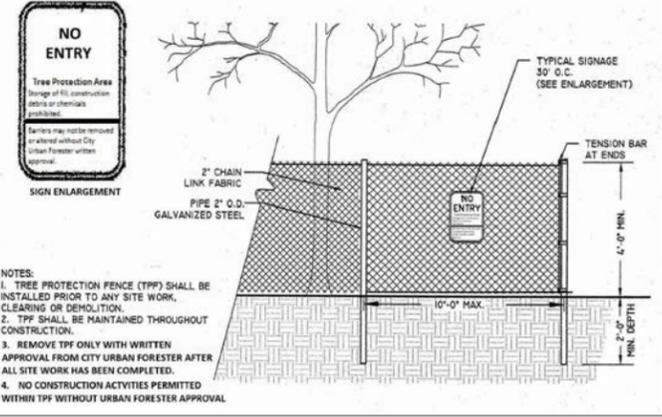
CITY OF MIAMI BEACH: TREE PROTECTION FENCE DETAIL
TREE PROTECTION FENCES WILL BE PLACED TO ALL EXISTING TREES AND RELOCATED TREES AS PER CITY OF MIAMI BEACH CODE. FINAL LAYOUT TO BE APPROVED BY CERTIFIED ARBORIST.
PLEASE REFER TO TREE PROTECTION SPECIFICATIONS.

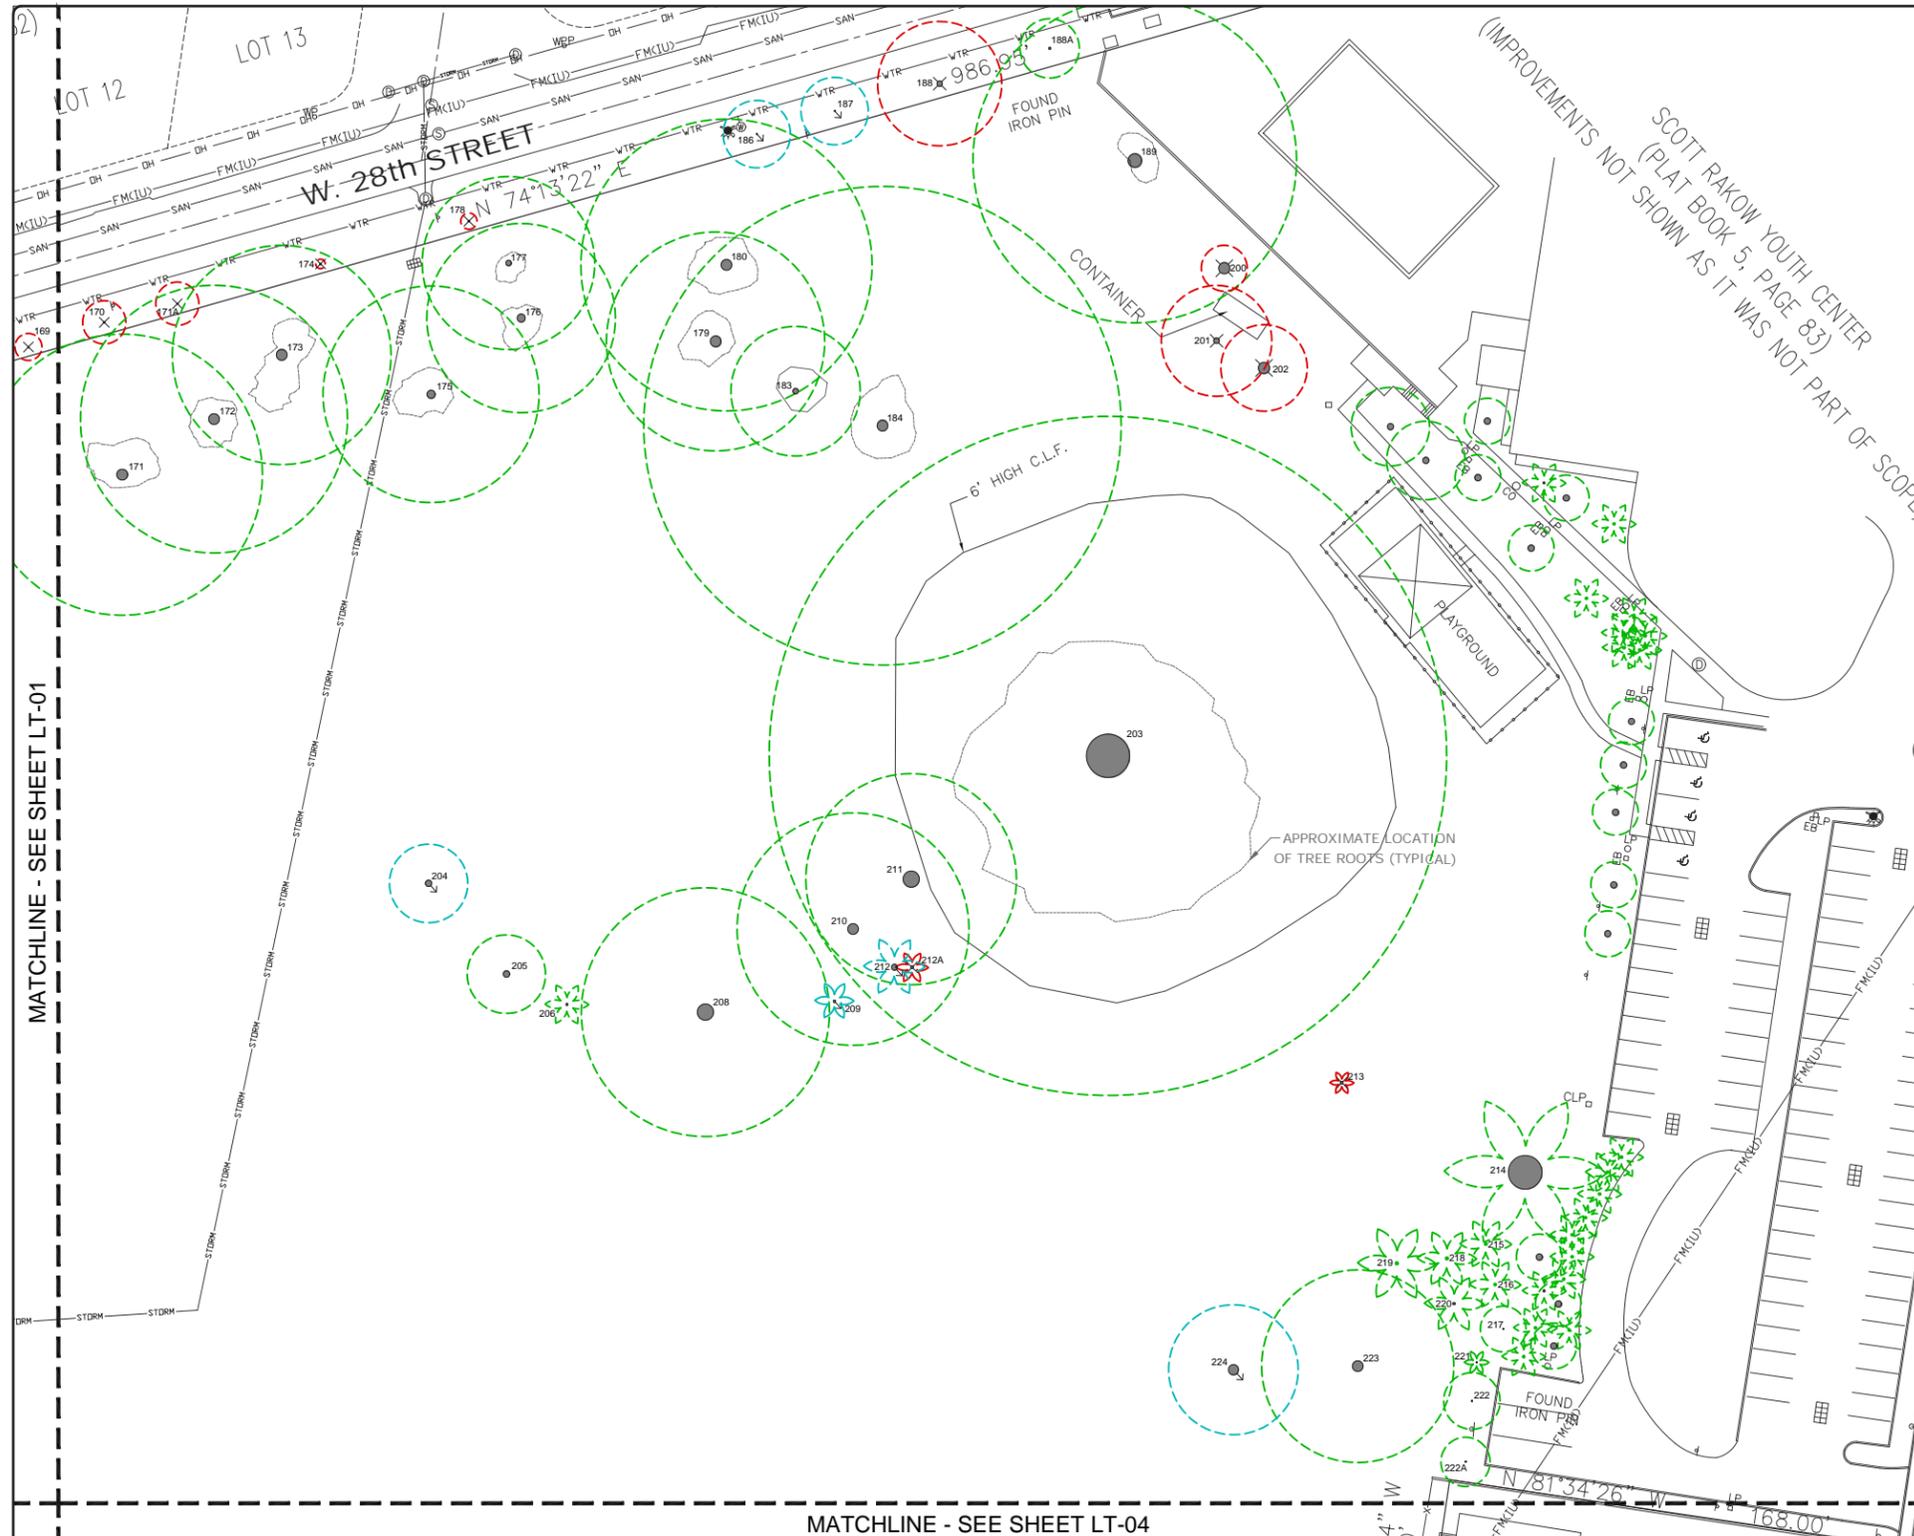
TECHNICAL DRAWINGS (TREE MITIGATION PLAN 3)

*FOR TREE DISPOSITION SCHEDULE, SEE SHEET LT-00

*PLEASE REFER TO PLANTING PLAN SHEETS FOR RELOCATED TREE LOCATIONS.

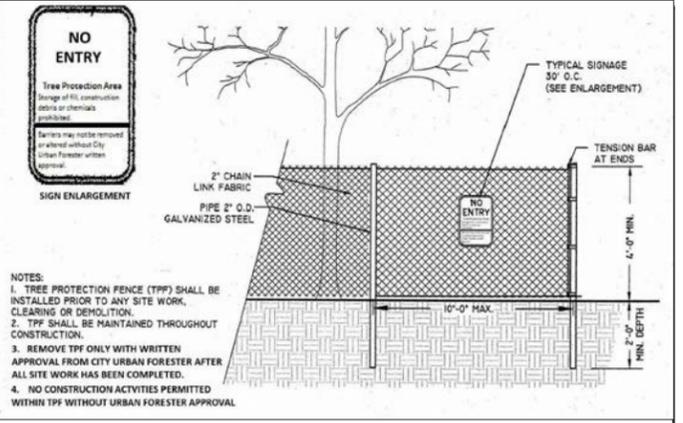
CITY OF MIAMI BEACH: TREE PROTECTION FENCE DETAIL

TREE PROTECTION FENCES WILL BE PLACED TO ALL EXISTING TREES AND RELOCATED TREES AS PER CITY OF MIAMI BEACH CODE. FINAL LAYOUT TO BE APPROVED BY CERTIFIED ARBORIST.

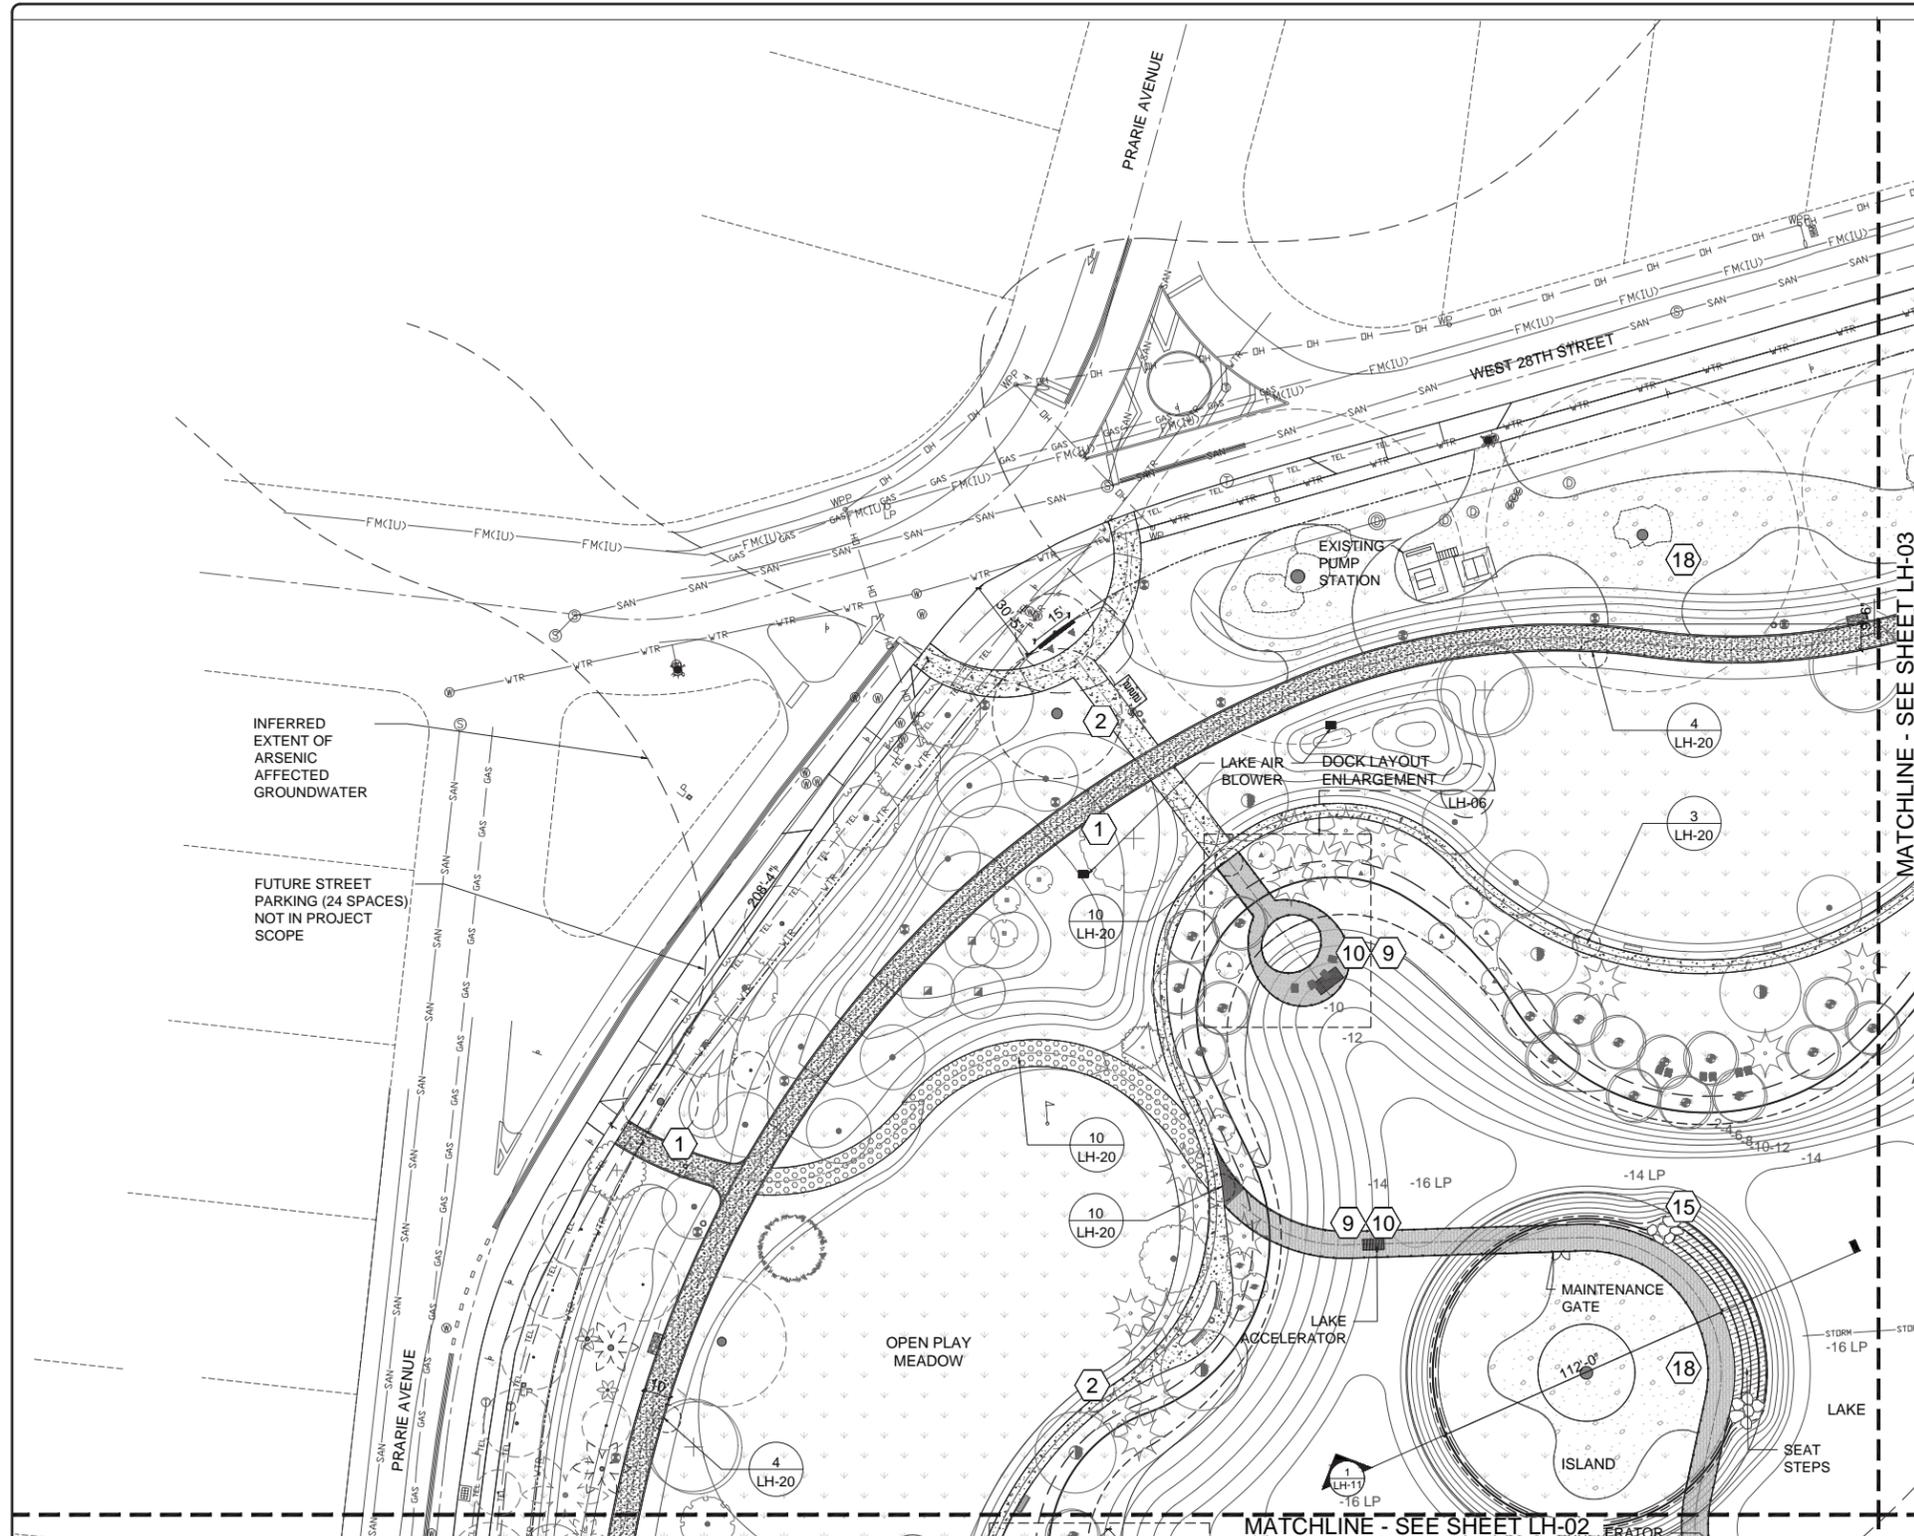
TECHNICAL DRAWINGS (HARDSCAPE 1)

PATTERN	KEY	DESCRIPTION	DETAIL KEY
[Pattern 1]	1	HANDOVER ASPHALT BLOCK WITH DECORATIVE AGGREGATE AND CONCRETE CURB ALT: FLEX PAVE/VTR PAVE	3 LH-20
[Pattern 2]	2	CONCRETE WITH ROCK SALT FINISH	3 LH-20
[Pattern 3]	3	EARTH SURFACES OF AMERICA CONCRETE PAVER	3 LH-20
[Pattern 4]	4	BELGARD AQUA-BRIC PERMEABLE PAVERS	3 LH-20
[Pattern 5]	5	ASPHALT WITH ACRYLIC SURFACE	3 LH-20
[Pattern 6]	6	LANDSCAPE STRUCTURE'S PEBBLEFLEX 2.0 POURED IN PLACE PLAYGROUND SURFACE OVER CONCRETE BASE	3 LH-20
[Pattern 7]	7	LANDSCAPE STRUCTURE'S PEBBLEFLEX 2.0 POURED-IN PLACE RUBBERIZED PLAYGROUND SURFACE	3 LH-20
[Pattern 8]	8	MCMCHOLS CO. ADA BAR GRATING ITEM# 6702319912 - ELEVATED METAL GRATING PATHWAY	3 LH-20
[Pattern 9]	9	BEDFORD TECHNOLOGIES FIBER FORCE RECYCLED PLASTIC LUMBER DECKING OVER CONCRETE STRUCTURE	3 LH-20
[Pattern 10]	10	METAL RAIL WITH WIRE MESH FENCE	3 LH-20
[Pattern 11]	11	EARTH SURFACES OF AMERICA CONCRETE PAVER ON WATER FEATURE STEPS	3 LH-20

[Pattern 12]	12	RIVER ROCK, MORTARED IN PLACE	3 LH-20
[Pattern 13]	13	5050 COOLINA SHELL AND CRUSHED RECYCLED CONCRETE	3 LH-20
[Pattern 14]	14	CAST IN PLACE CONCRETE SEAT WALLS	3 LH-20
[Pattern 15]	15	OOOLITE STONE SLABS	3 LH-20
[Pattern 16]	16	CHAIN LINK FENCE	3 LH-20
[Pattern 17]	17	METAL PICKET FENCE	3 LH-20
[Pattern 18]	18	MULCH	3 LH-20
[Pattern 19]	19	OOOLITE BOULDERS	3 LH-20
[Pattern 20]	20	PERVIOUS CONCRETE	3 LH-20
[Pattern 21]	21	WEBBED NET	3 LH-20

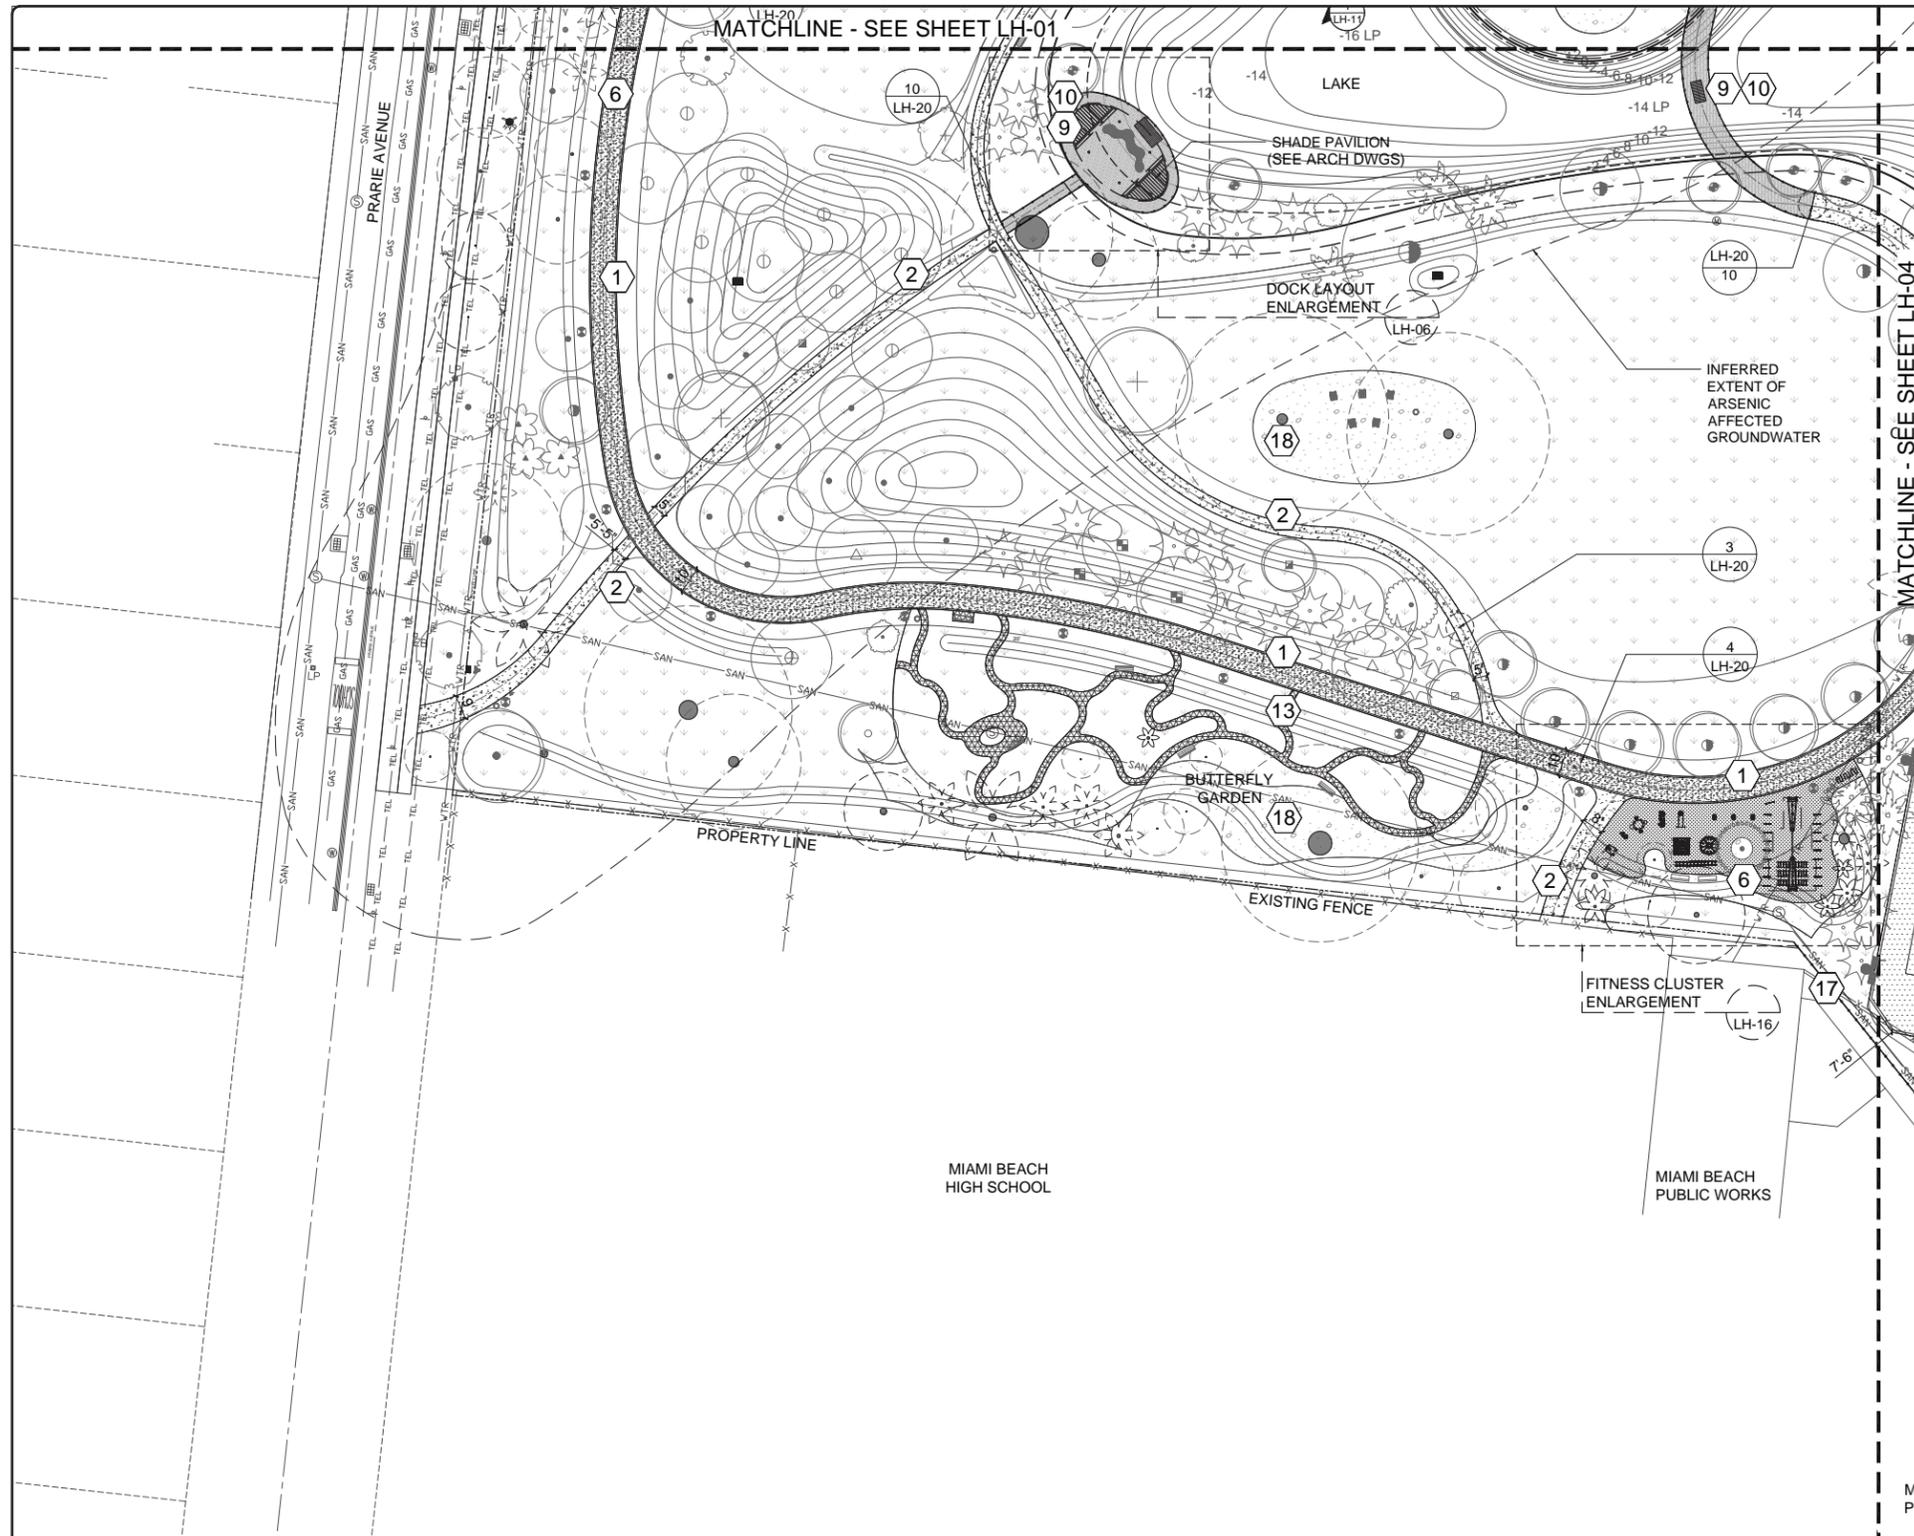
TECHNICAL DRAWINGS (HARDSCAPE 2)

PATTERN	KEY	DESCRIPTION	DETAIL KEY
[Pattern 1]	1	HANOVER ASPHALT BLOCK WITH DECORATIVE AGGREGATE AND CONCRETE CURB ALT: FLEXI PAVE/VITRI PAVE	3 LH-20
[Pattern 2]	2	CONCRETE WITH ROCK SALT FINISH	3 LH-20
[Pattern 3]	3	EARTH SURFACES OF AMERICA CONCRETE PAVER	3 LH-20
[Pattern 4]	4	BELGARD AQUA-BRIC PERMEABLE PAVERS	3 LH-20
[Pattern 5]	5	ASPHALT WITH ACRYLIC SURFACE	3 LH-20
[Pattern 6]	6	LANDSCAPE STRUCTURE'S: PEBBLEFLEX 2.0 POURED IN PLACE PLAYGROUND SURFACE OVER CONCRETE BASE	3 LH-20
[Pattern 7]	7	LANDSCAPE STRUCTURE'S: PEBBLEFLEX 2.0 POURED-IN PLACE RUBBERIZED PLAYGROUND SURFACE	3 LH-20
[Pattern 8]	8	MANHOLLS GO ADA BAR GRATING ITEM# 6702319912 - ELEVATED METAL GRATING PATHWAY	3 LH-20
[Pattern 9]	9	BEDFORD TECHNOLOGIES FIBER FORCE RECYCLED PLASTIC LUMBER DECKING OVER CONCRETE STRUCTURE	3 LH-20
[Pattern 10]	10	METAL RAIL WITH WIRE MESH FENCE	3 LH-20
[Pattern 11]	11	EARTH SURFACES OF AMERICA CONCRETE PAVER ON WATER FEATURE STEPS	3 LH-20

[Pattern 12]	12	RIVER ROCK, MORTARED IN PLACE	3 LH-20
[Pattern 13]	13	50/50 COQUINA SHELL AND CRUSHED RECYCLED CONCRETE	3 LH-20
[Pattern 14]	14	CAST IN PLACE CONCRETE SEAT WALLS	3 LH-20
[Pattern 15]	15	COOLITE STONE SLABS	3 LH-20
[Pattern 16]	16	CHAIN LINK FENCE	3 LH-20
[Pattern 17]	17	METAL PICKET FENCE	3 LH-20
[Pattern 18]	18	MULCH	3 LH-20
[Pattern 19]	19	COOLITE BOULDERS	3 LH-20
[Pattern 20]	20	PERVIOUS CONCRETE	3 LH-20
[Pattern 21]	21	WEBBED NET	3 LH-20

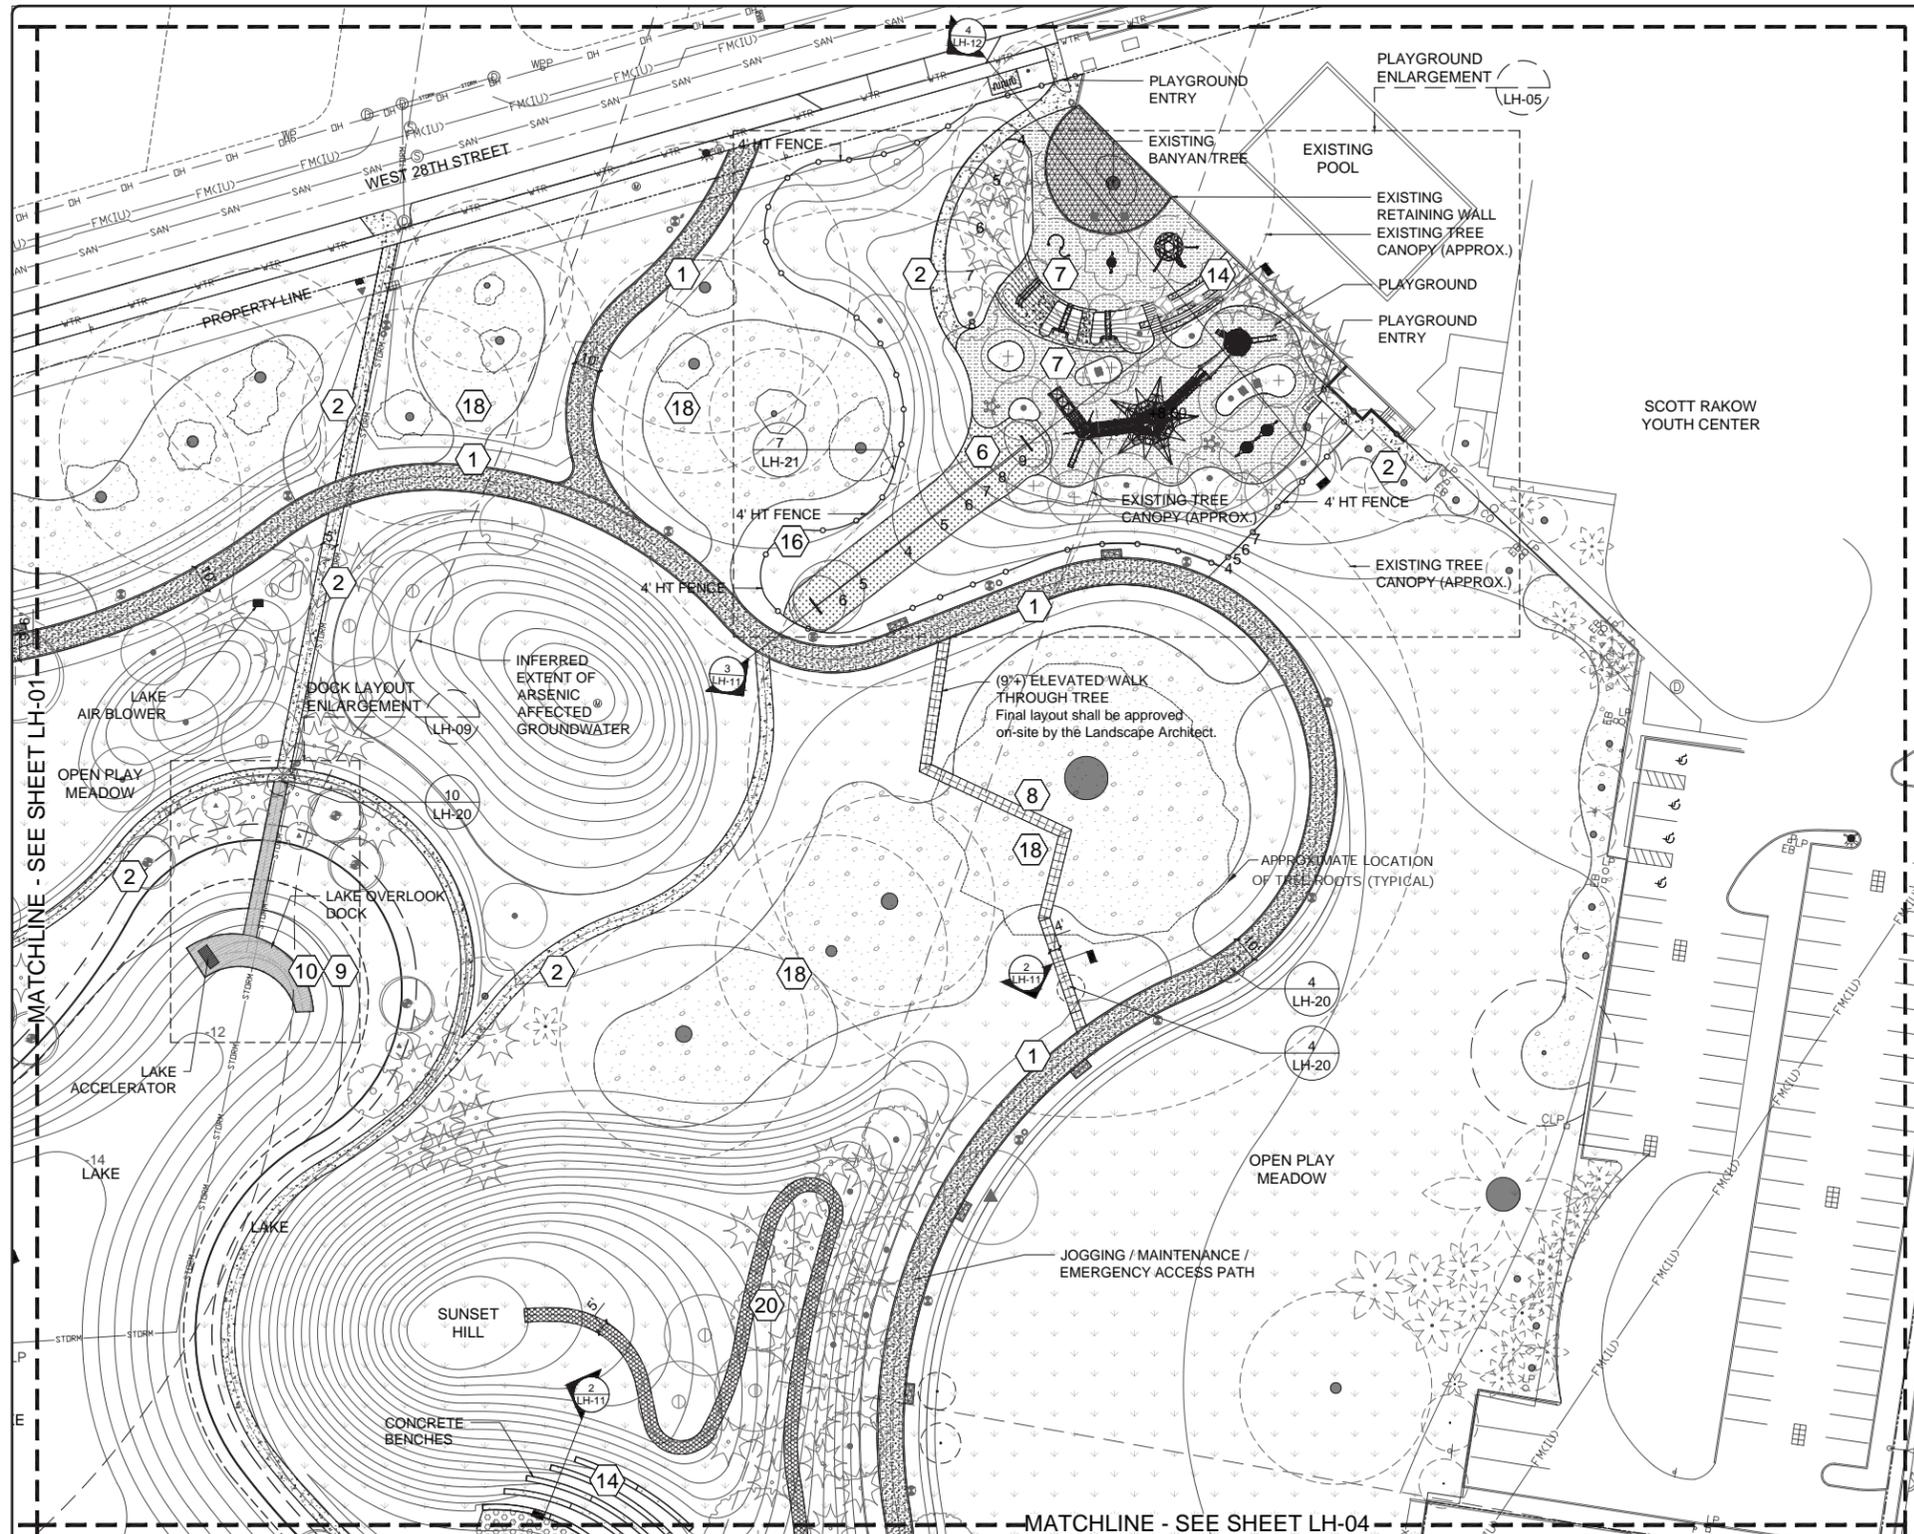
TECHNICAL DRAWINGS (HARDSCAPE 3)

PATTERN	KEY	DESCRIPTION	DETAIL KEY
[Pattern 1]	1	HANDOVER ASPHALT BLOCK WITH DECORATIVE AGGREGATE AND CONCRETE CURB ALT. FLEXI PAVE/VITR PAVE	3 LH-20
[Pattern 2]	2	CONCRETE WITH ROCK SALT FINISH	3 LH-20
[Pattern 3]	3	EARTH SURFACES OF AMERICA CONCRETE PAVER	3 LH-20
[Pattern 4]	4	BELGARD AQUA-BRIC PERMEABLE PAVERS	3 LH-20
[Pattern 5]	5	ASPHALT WITH ACRYLIC SURFACE	3 LH-20
[Pattern 6]	6	LANDSCAPE STRUCTURE'S PEBBLE FLEX 2.0 POURED-IN PLACE PLAYGROUND SURFACE OVER CONCRETE BASE	3 LH-20
[Pattern 7]	7	LANDSCAPE STRUCTURE'S PEBBLE FLEX 2.0 POURED-IN PLACE RUBBERIZED PLAYGROUND SURFACE	3 LH-20
[Pattern 8]	8	MUNCHOLS CO. ADA BAR GRATING ITEM #702315912 - ELEVATED METAL GRATING PATHWAY	3 LH-20
[Pattern 9]	9	BEDFORD TECHNOLOGIES FIBER FORCE RECYCLED PLASTIC LUMBER DECKING OVER CONCRETE STRUCTURE	3 LH-20
[Pattern 10]	10	METAL RAIL WITH WIRE MESH FENCE	3 LH-20
[Pattern 11]	11	EARTH SURFACES OF AMERICA CONCRETE PAVER ON WATER FEATURE STEPS	3 LH-20

[Pattern 12]	12	RIVER ROCK, MORTARED IN PLACE	3 LH-20
[Pattern 13]	13	50/50 COQUINA SHELL AND CRUSHED RECYCLED CONCRETE	3 LH-20
[Pattern 14]	14	CAST IN PLACE CONCRETE SEAT WALLS	3 LH-20
[Pattern 15]	15	COOLITE STONE SLABS	3 LH-20
[Pattern 16]	16	CHAIN LINK FENCE	3 LH-20
[Pattern 17]	17	METAL PICKET FENCE	3 LH-20
[Pattern 18]	18	MULCH	3 LH-20
[Pattern 19]	19	COOLITE BOULDERS	3 LH-20
[Pattern 20]	20	PERVIOUS CONCRETE	3 LH-20
[Pattern 21]	21	WEBBED NET	3 LH-20
