TECHNICAL DRAWINGS (TREE MITIGATION SCHEDULE)

TECHNICAL DRAWINGS (TREE MITIGATION PLAN 1)

TECHNICAL DRAWINGS (OVERALL SITE PLAN)

TECHNICAL DRAWINGS (HARDSCAPE SCHEDULE)

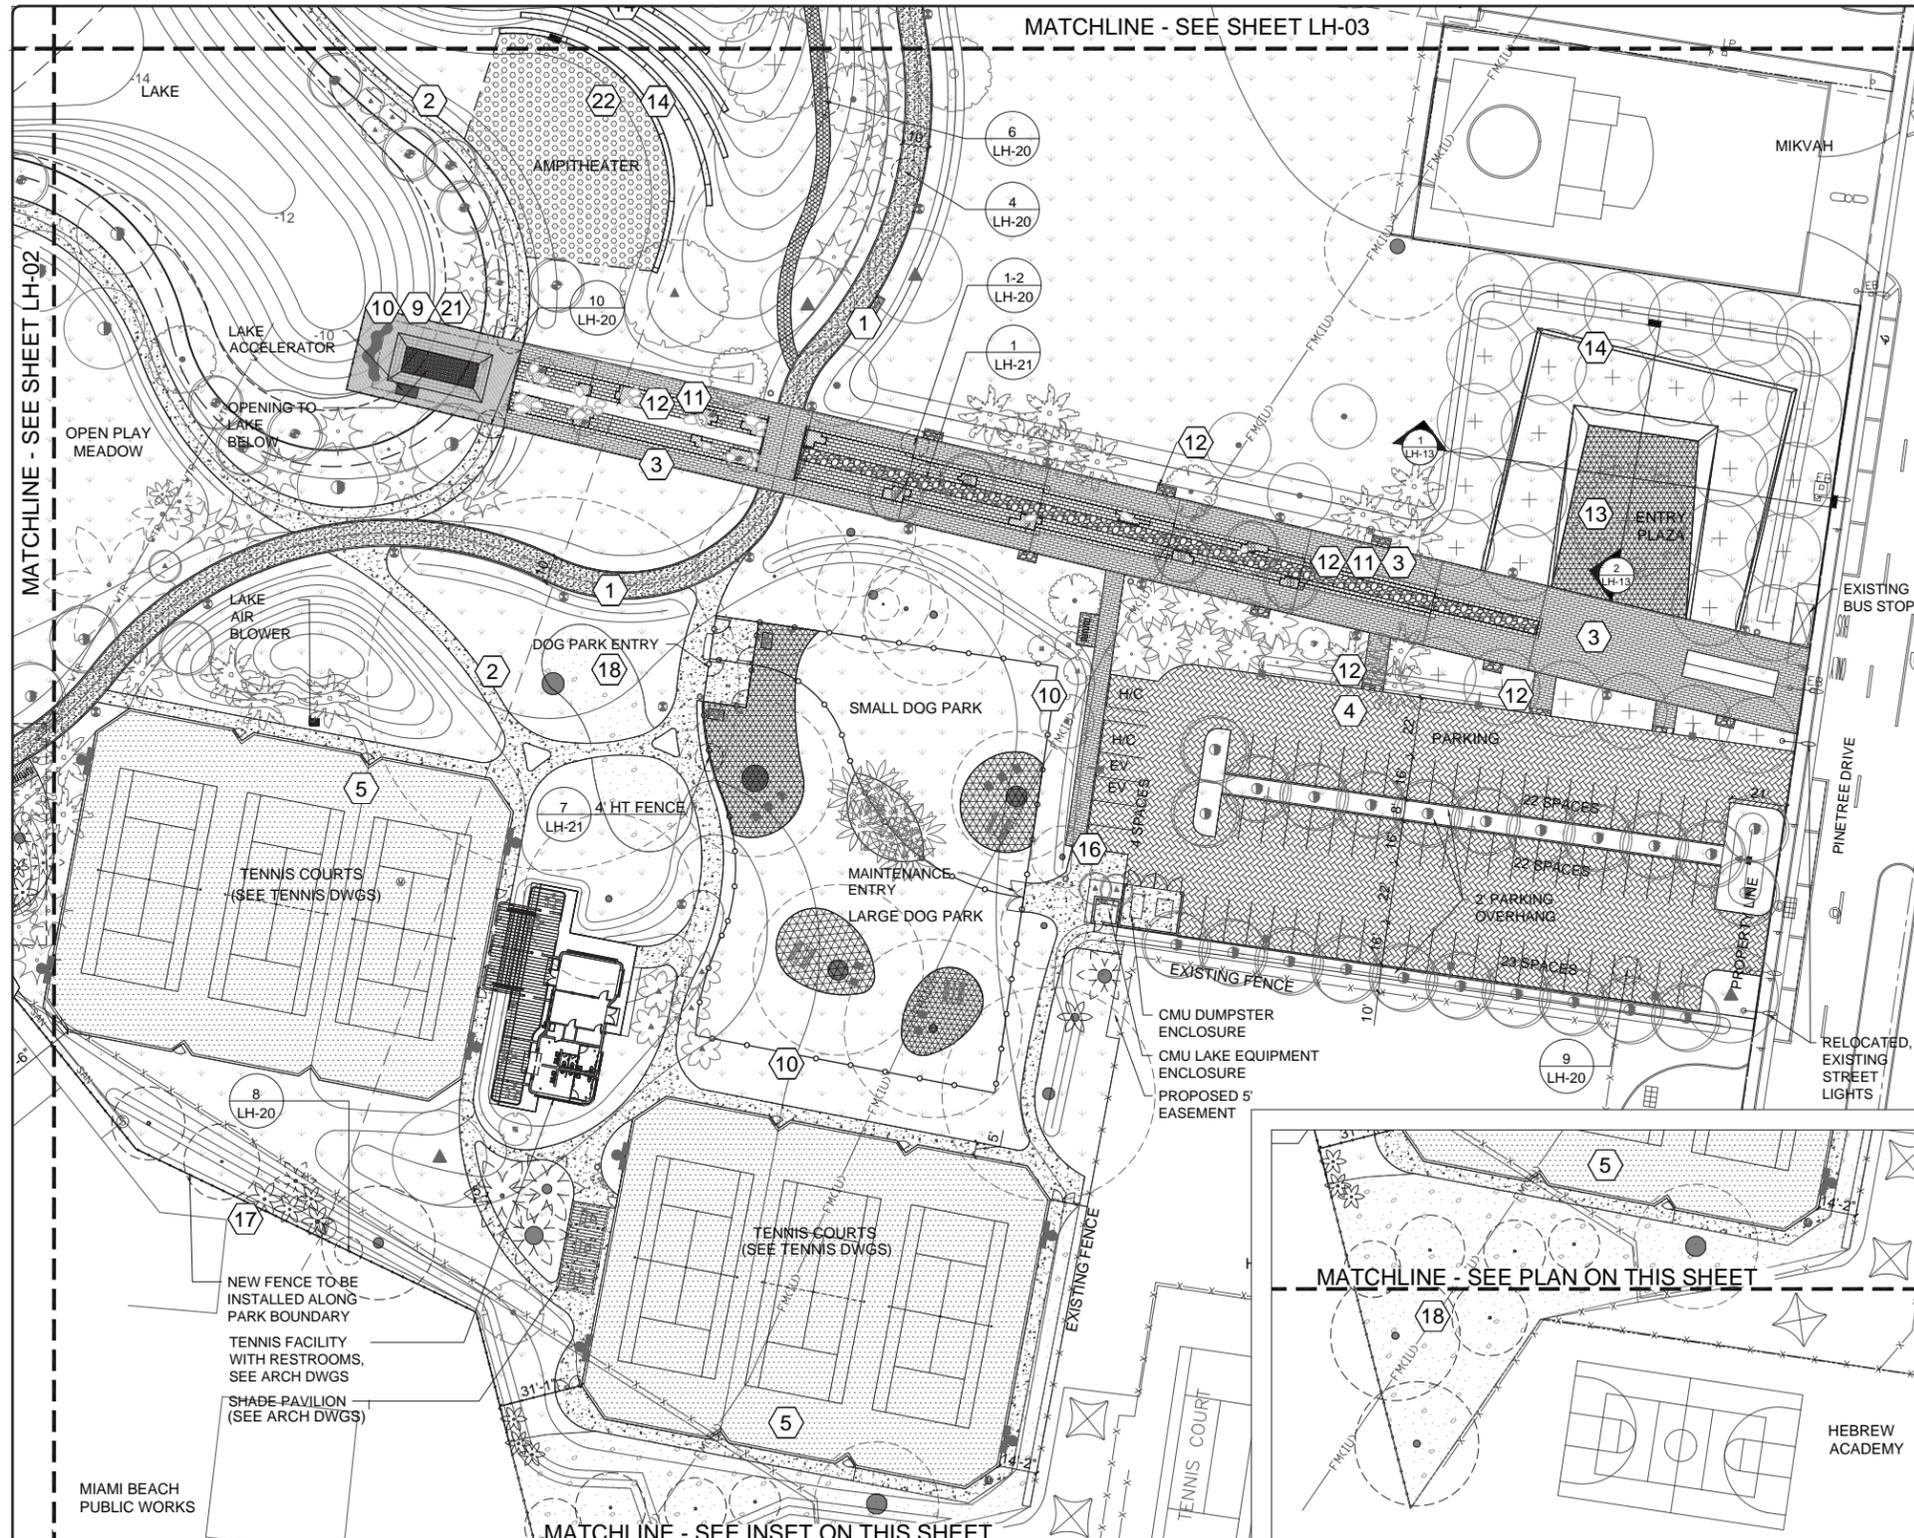
TECHNICAL DRAWINGS (HARDSCAPE 4)

PATTERN	KEY	DESCRIPTION	DETAIL KEY
[Pattern 1]	1	HANOVER ASPHALT BLOCK WITH DECORATIVE AGGREGATE AND CONCRETE CURB ALT. FLEX PAVE/VITRI PAVE	3 LH-20
[Pattern 2]	2	CONCRETE WITH ROCK SALT FINISH	3 LH-20
[Pattern 3]	3	EARTH SURFACES OF AMERICA CONCRETE PAVER	3 LH-20
[Pattern 4]	4	BELGARD AQUA-BRIC PERMEABLE PAVERS	3 LH-20
[Pattern 5]	5	ASPHALT WITH ACRYLIC SURFACE	3 LH-20
[Pattern 6]	6	LANDSCAPE STRUCTURE'S: PEBBLEFLEX 2.0 POURED IN PLACE PLAYGROUND SURFACE OVER CONCRETE BASE	3 LH-20
[Pattern 7]	7	LANDSCAPE STRUCTURE'S: PEBBLEFLEX 2.0 POURED-IN PLACE RUBBERIZED PLAYGROUND SURFACE	3 LH-20
[Pattern 8]	8	MUNCHOLS CO. ADA BAR GRATING ITEM# 6702319912 - ELEVATED METAL GRATING PATHWAY	3 LH-20
[Pattern 9]	9	BEDFORD TECHNOLOGIES FIBER FORCE RECYCLED PLASTIC LUMBER DECKING OVER CONCRETE STRUCTURE	3 LH-20
[Pattern 10]	10	METAL RAIL WITH WIRE MESH FENCE	3 LH-20
[Pattern 11]	11	EARTH SURFACES OF AMERICA CONCRETE PAVER ON WATER FEATURE STEPS	3 LH-20

[Pattern 12]	12	RIVER ROCK, MORTARED IN PLACE	3 LH-20
[Pattern 13]	13	5059 COQUINA SHELL AND CRUSHED RECYCLED CONCRETE	3 LH-20
[Pattern 14]	14	CAST IN PLACE CONCRETE SEAT WALLS	3 LH-20
[Pattern 15]	15	OOOLITE STONE SLABS	3 LH-20
[Pattern 16]	16	CHAIN LINK FENCE	3 LH-20
[Pattern 17]	17	METAL PICKET FENCE	3 LH-20
[Pattern 18]	18	MULCH	3 LH-20
[Pattern 19]	19	OOOLITE BOULDERS	3 LH-20
[Pattern 20]	20	PERVIOUS CONCRETE	3 LH-20
[Pattern 21]	21	WEBBED NET	3 LH-20
