8701 Collins Sculpture Setback DRB20-0550

8701 COLLINS

Project No. 219420338 SCULPTURE PHOTOS

SITE PLAN + SCULPTURE LOCATION

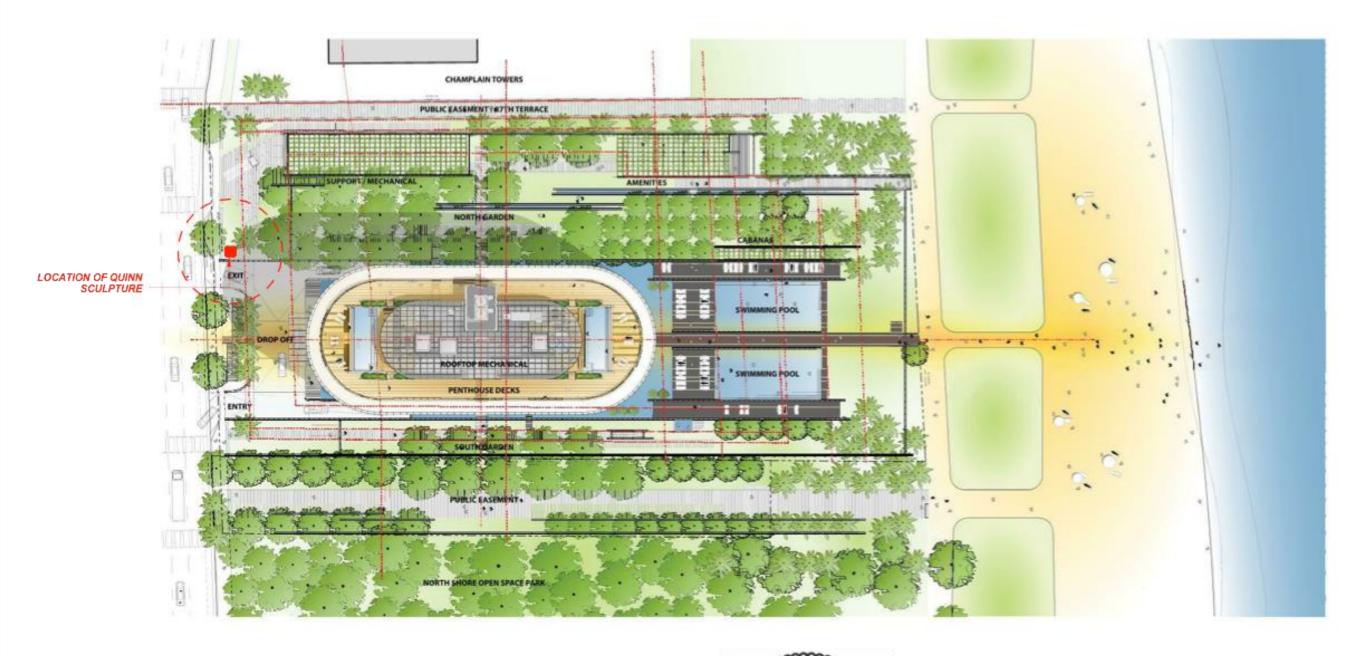
Project No. Sheet No. QV.02

Sculpture Location

Located 7'4" from Front Property Line

Under 7 feet in Width

Represents Less than 3 Percent of Frontage

Practical Difficulties

Wind Load — Requires Deep Footer

Subterranean Garage Structure — Prevents Installation of Deep Footer

Solution — Locate Sculpture in Earth Soil Area
