Status of existing structure

Site Plan Evaluation

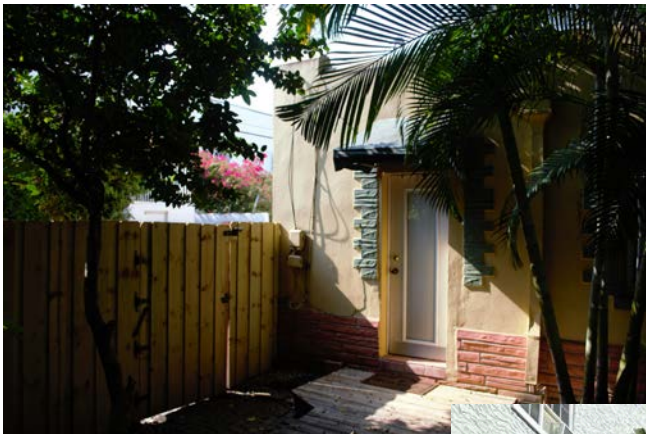
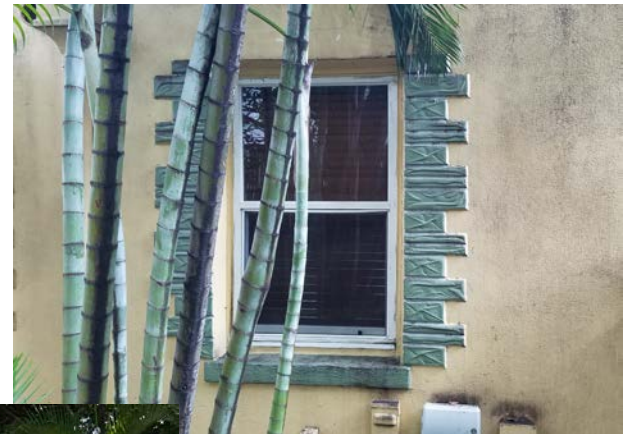
Lack of Mission style

Modern windows

Remodeled facade

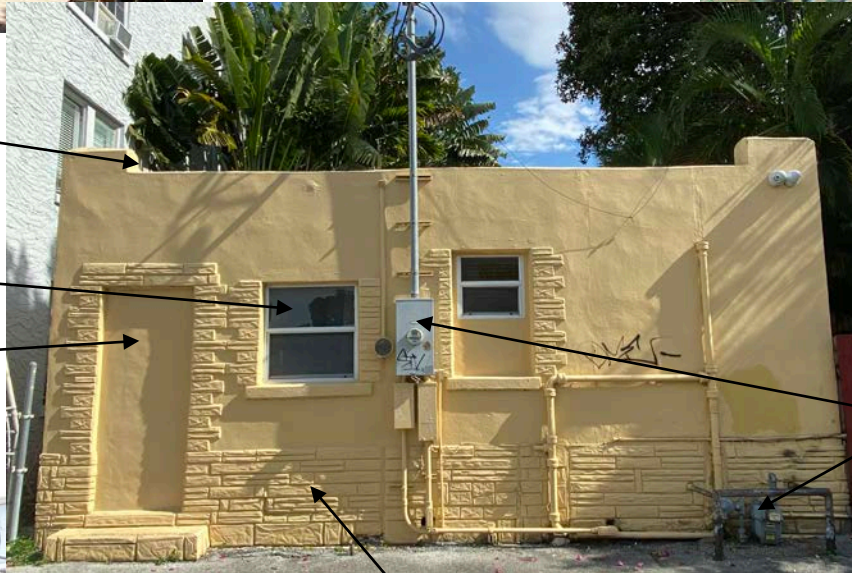
Service meters on alley ROW

Fake stone cladding
