Lots 5 and 7 of Block E of the AMENDED MAP OF THE OCEAN FRONT PROPERTY OF THE MIAMI BEACH IMPROVEMENT COMPANY, according to the Plat thereof, recorded in Plat Book 5, at Pages 7 and 8, of the Public Records of MIAMI-DADE County, Florida.

PREPARED FOR: Plymouth Hotel, LLC, 336 21 Street, Miami Beach, FL 33139

BOUNDARY SURVEY

MOJARENA & ASSOCIATES, INC.

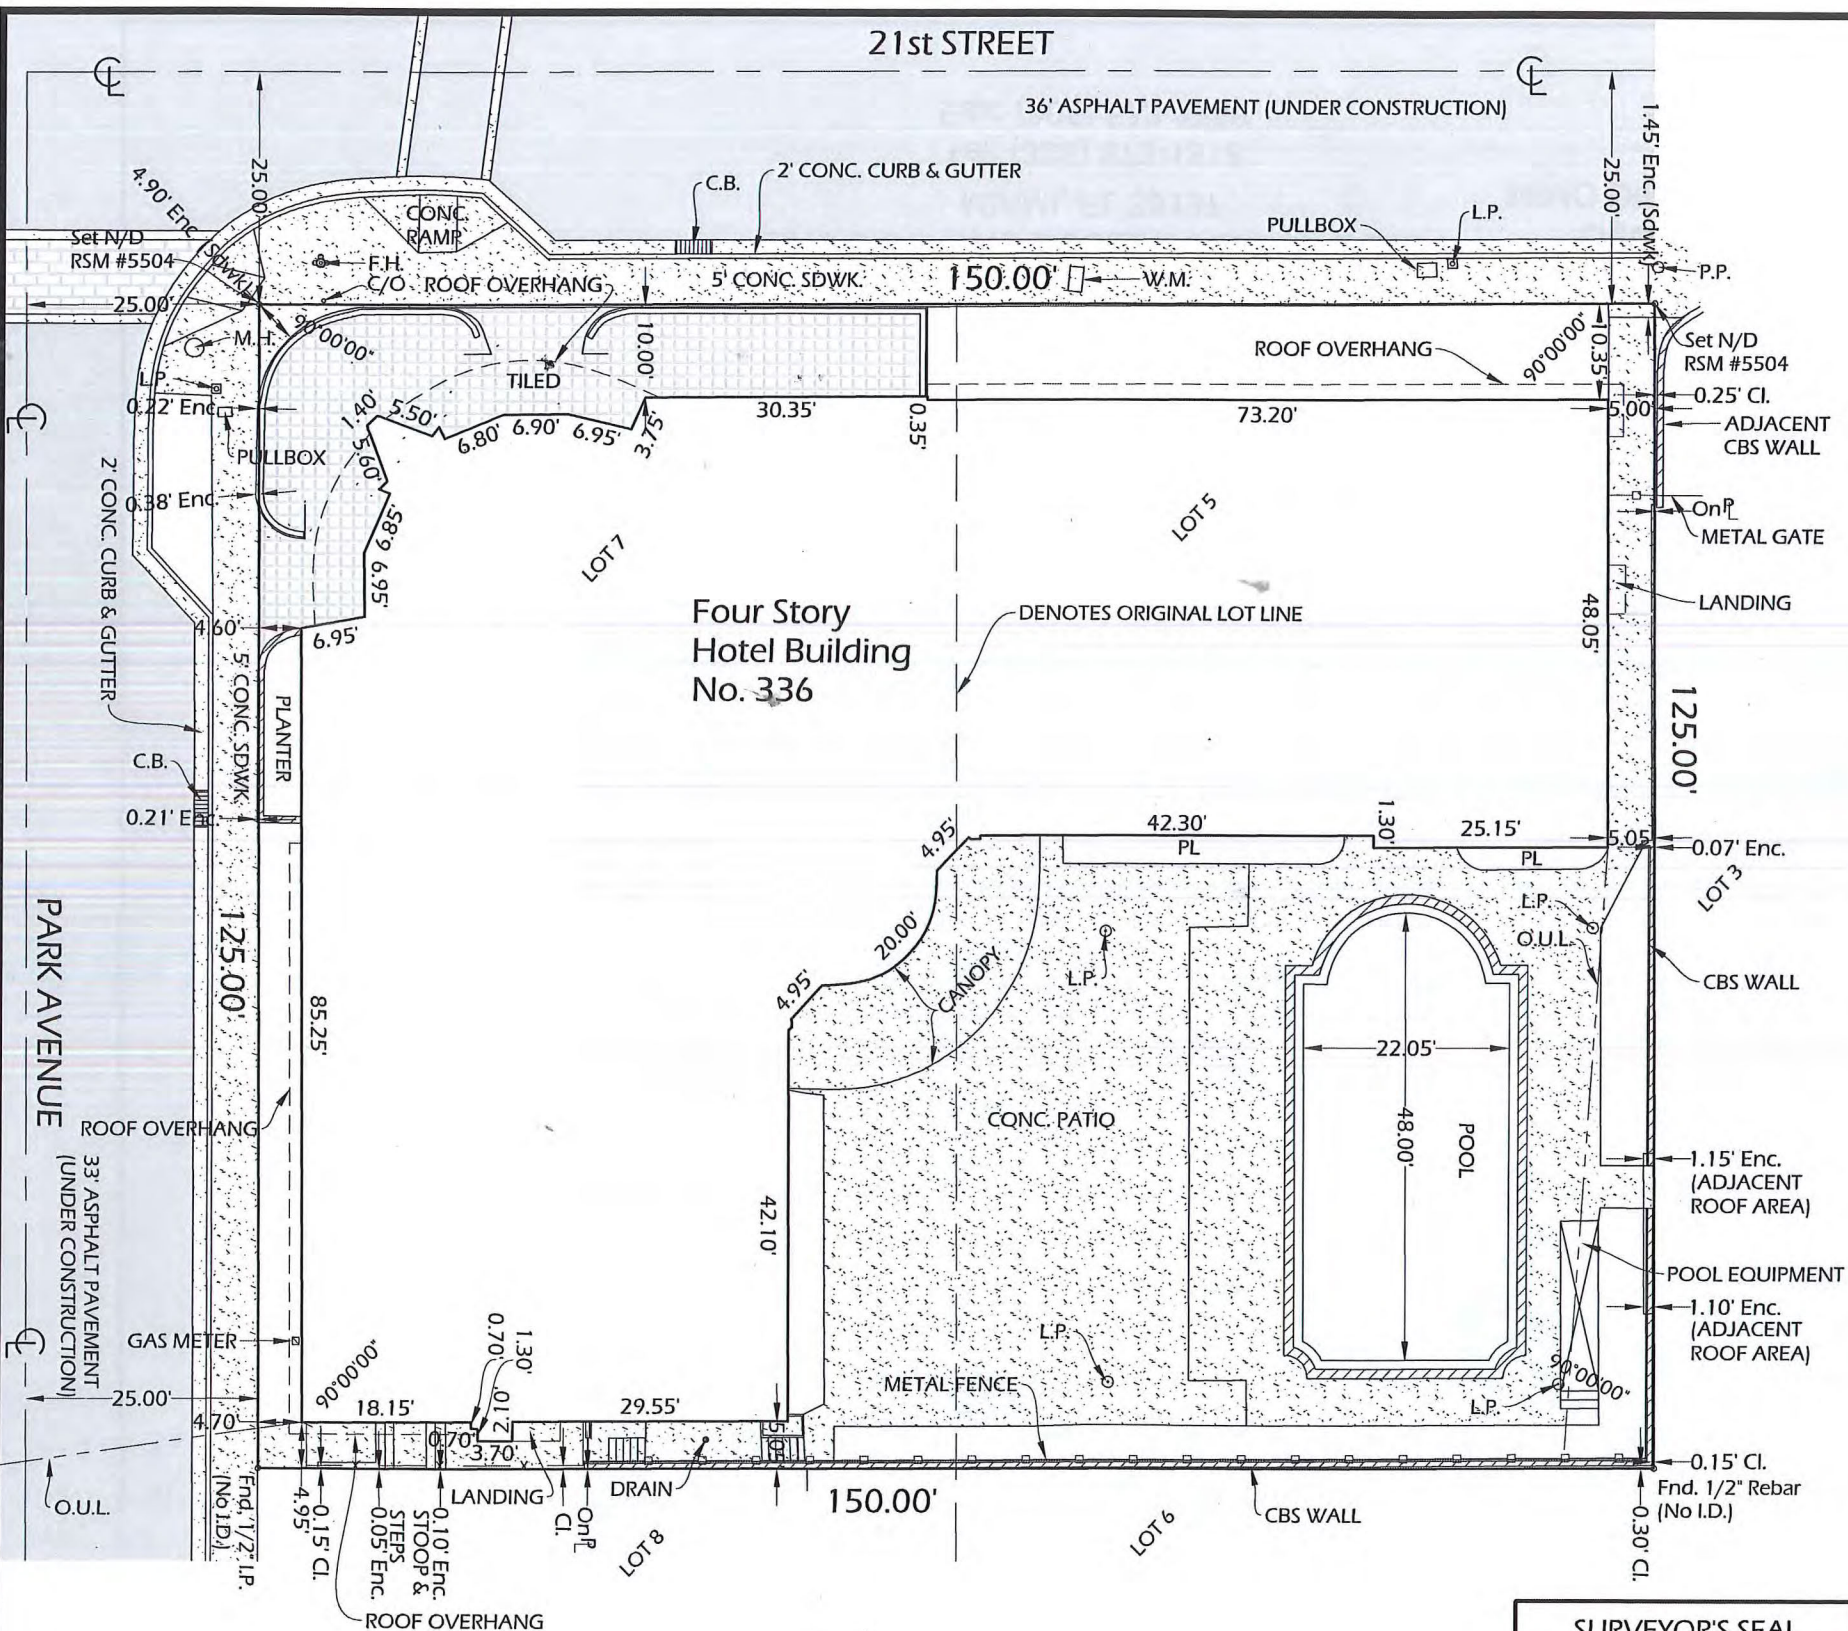
Encroachments:

1. Overhead utility lines.
2. Portion of the abutting concrete sidewalk is encroaching over the Northwest corner of the property.
3. Portion of the abutting concrete sidewalk is encroaching over the Northerly boundary line.
4. Portion of the tiled concrete and portion of a planter are encroaching over the Westerly boundary line.
5. Portion of the concrete stoop and steps are encroaching over the Southerly boundary line.
6. Portion of the CBS walls and portion of the adjacent roof area are encroaching over the Easterly boundary line.

- All clearances and/or encroachments shown hereon are of apparent nature. Fence ownership by visual means. Legal ownership of fences not determined.
- Encroachments Noted: 6
