HISTORIC RESOURCES REPORT

**7801 Atlantic Way
Miami Beach, Florida**

March 15, 2023

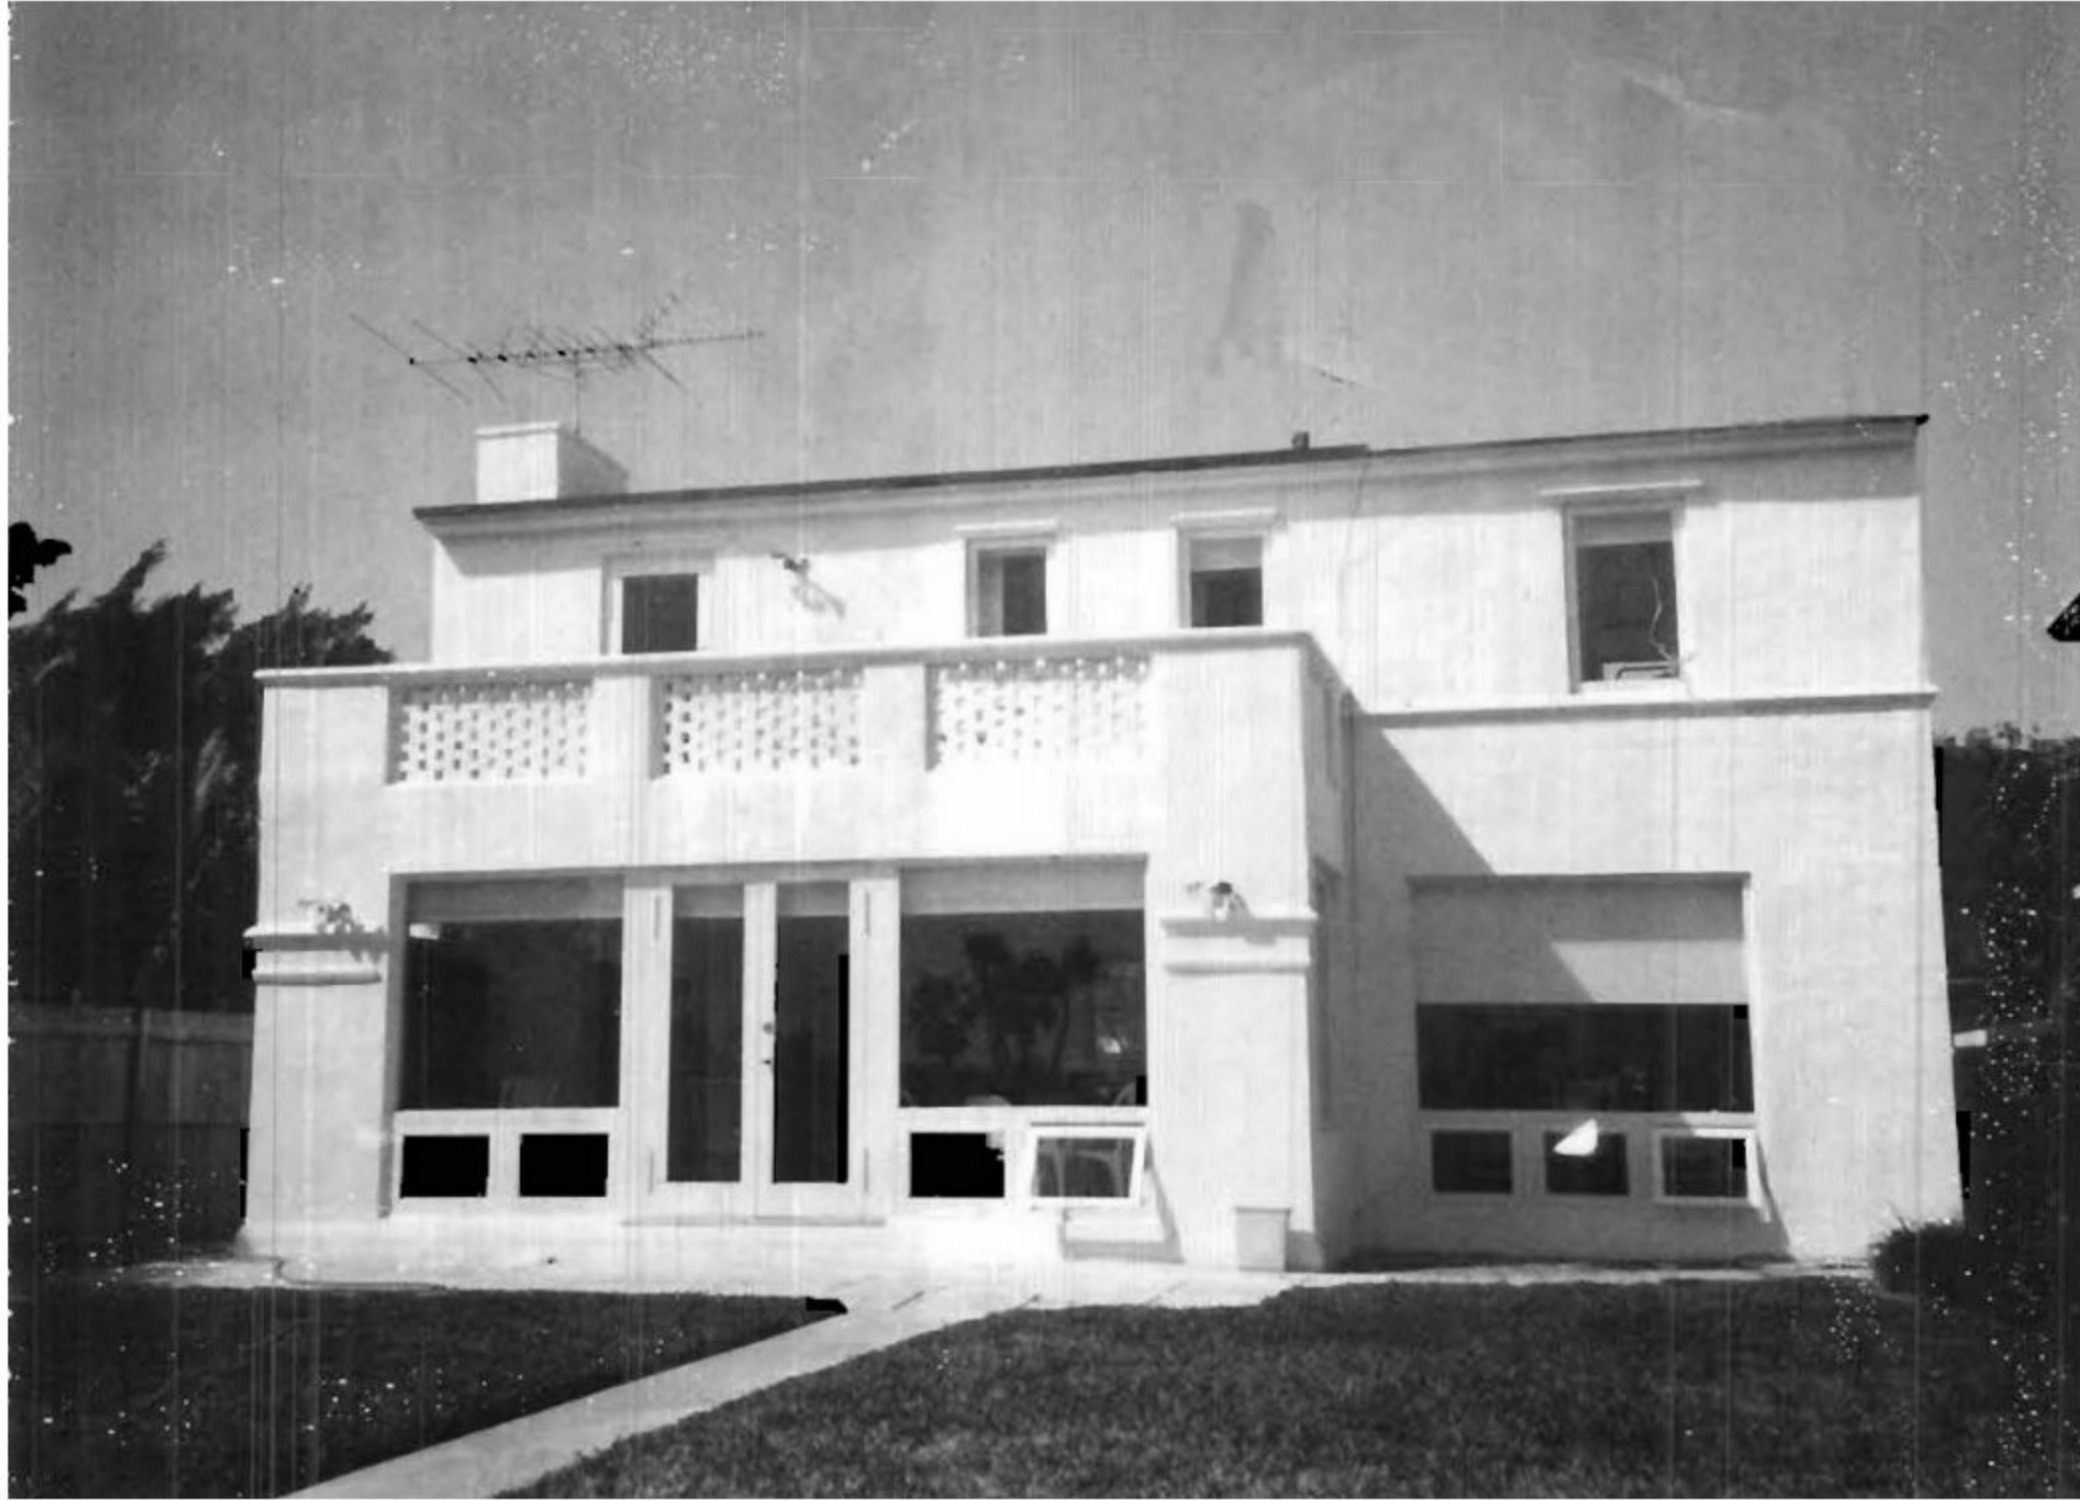
*Figure 42. View of east elevation showing enclosed porch, February 1995.
(Office of the Property Appraiser, Miami-Dade County)*

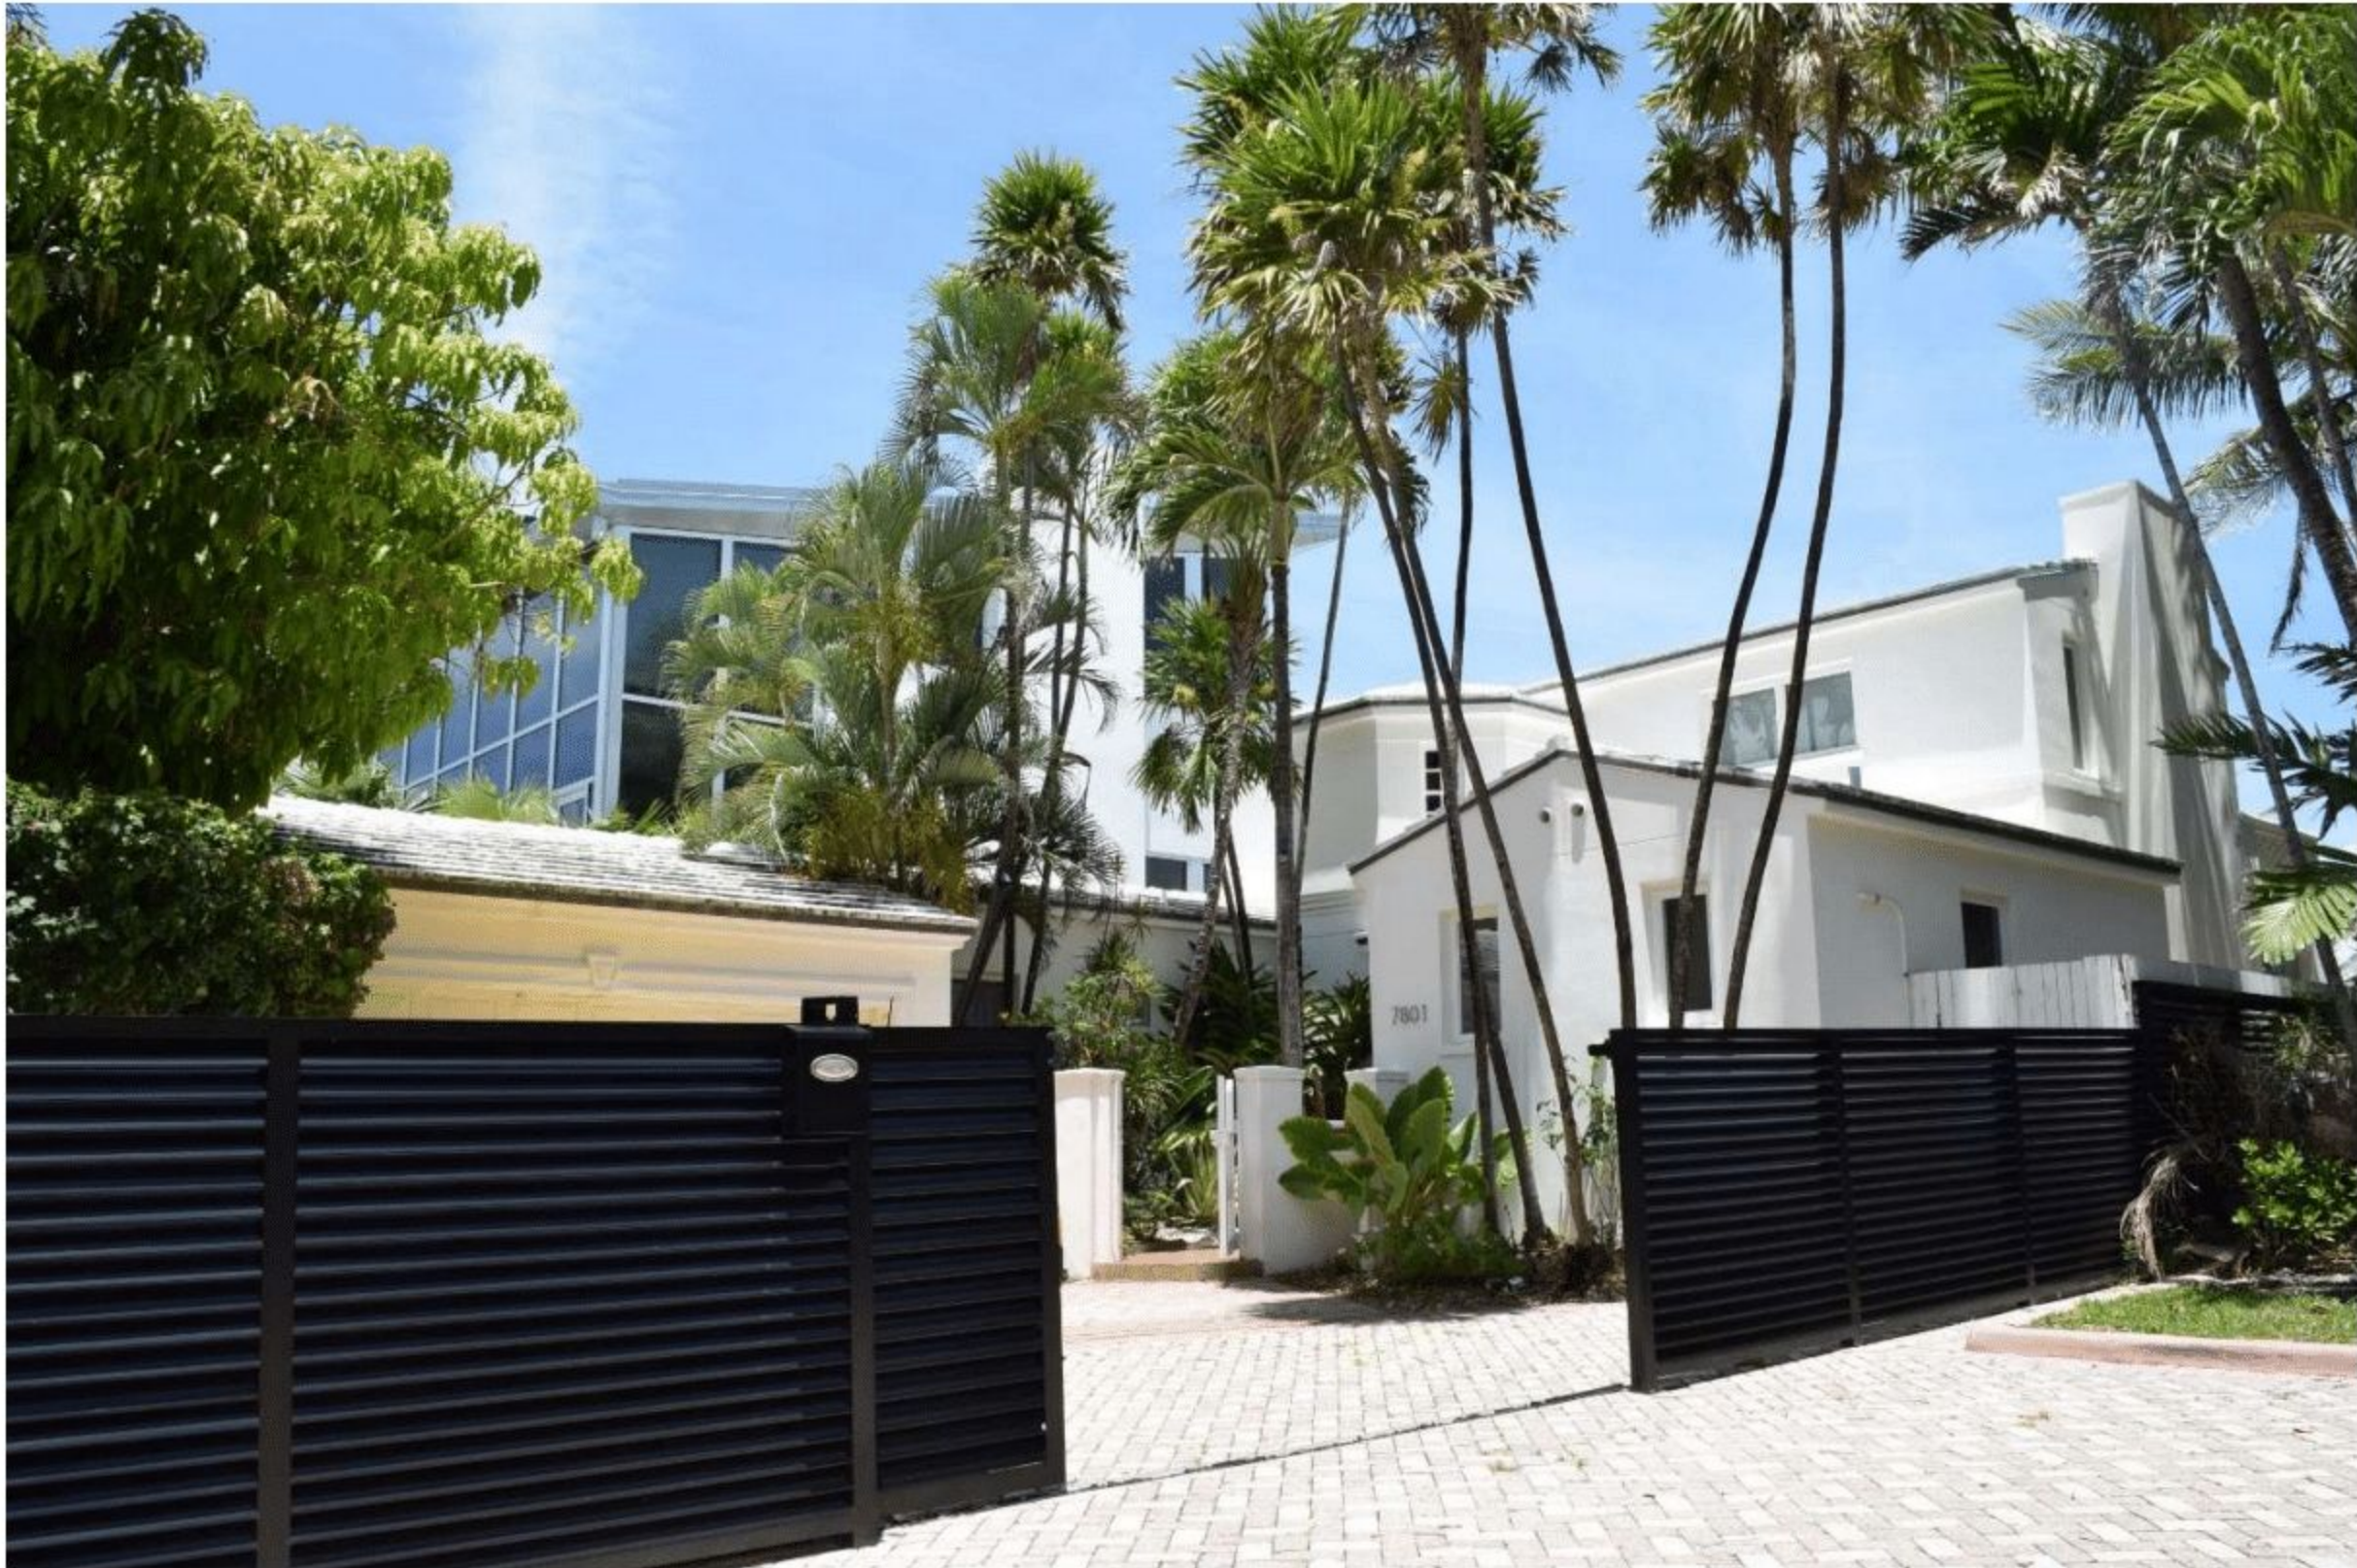
Figure 73. 7801 Atlantic Way, Miami Beach, May 2021.

The building at 7801 Atlantic Way is a stucco-clad one- and two-story irregularly-shaped residence with Mediterranean-Revival styling. (Figure 73) The two-story portion of the residence is oriented north-south and has a low-pitched side gable roof. One-story gable-roofed wings project west from the northwest and southwest corners of the two-story block, forming a J-shape. The northern wing, which is longer than the southern wing, is connected to a south-facing double garage. A one-story enclosed porch at the east elevation has a flat roof that serves as a 2nd story veranda.

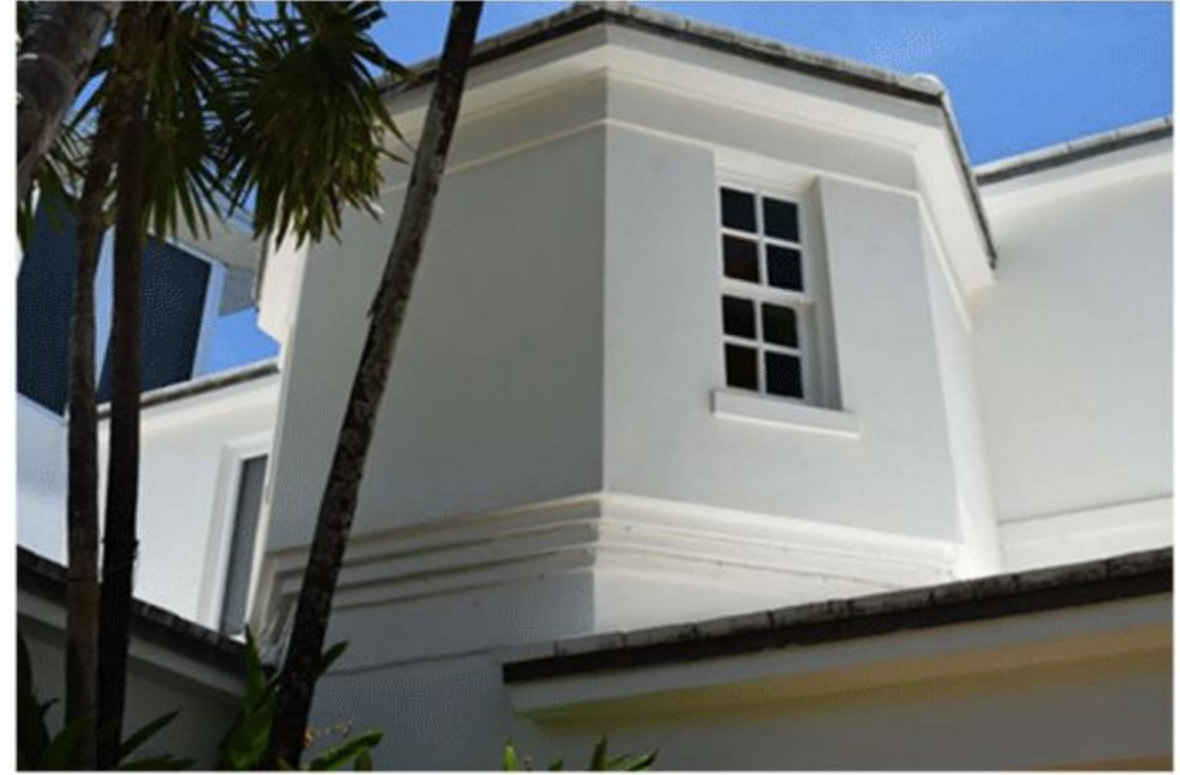
Figure 75. Detail of octagonal stair tower with cornice and corbelled detailing, May 2021.

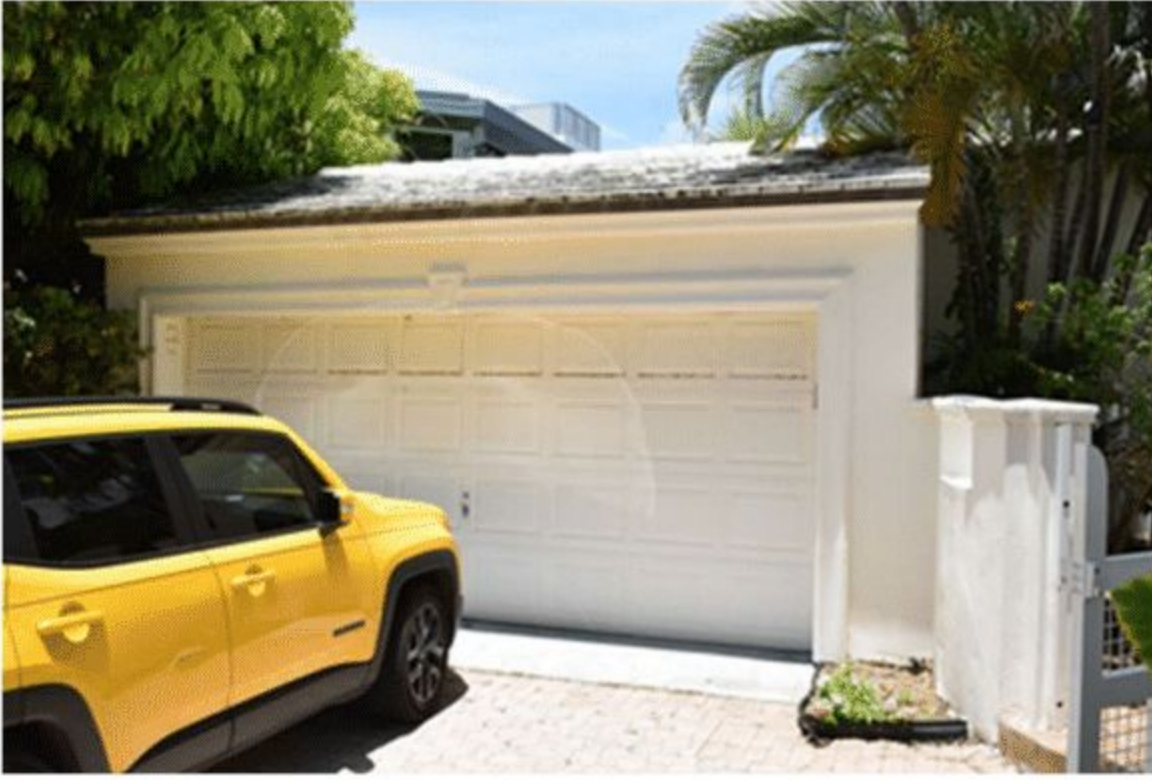
Figure 78. View of garage with wood molding and centered "keystone" detail, May 2021.

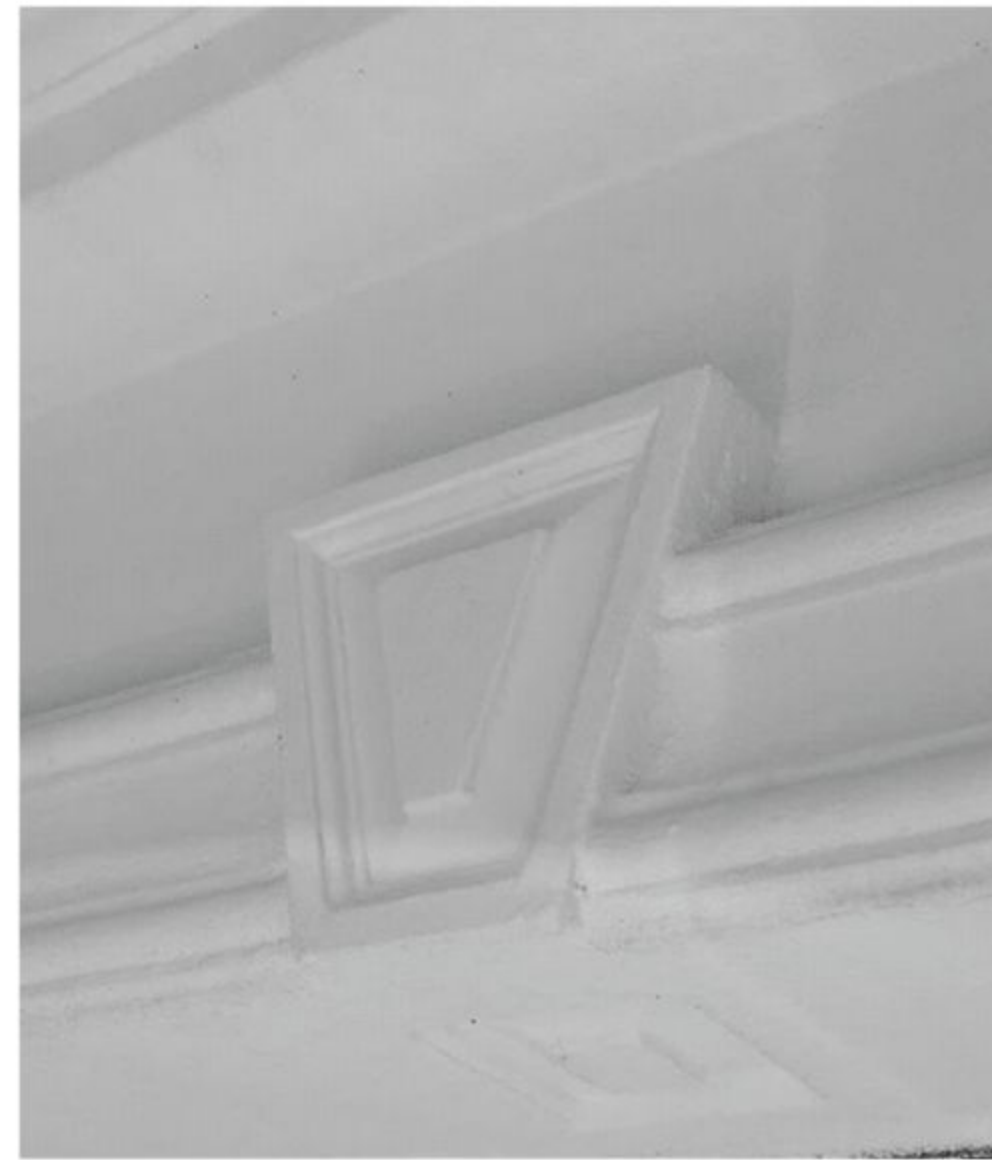
Figure 81. Detail of keystone at garage door, May 2021.

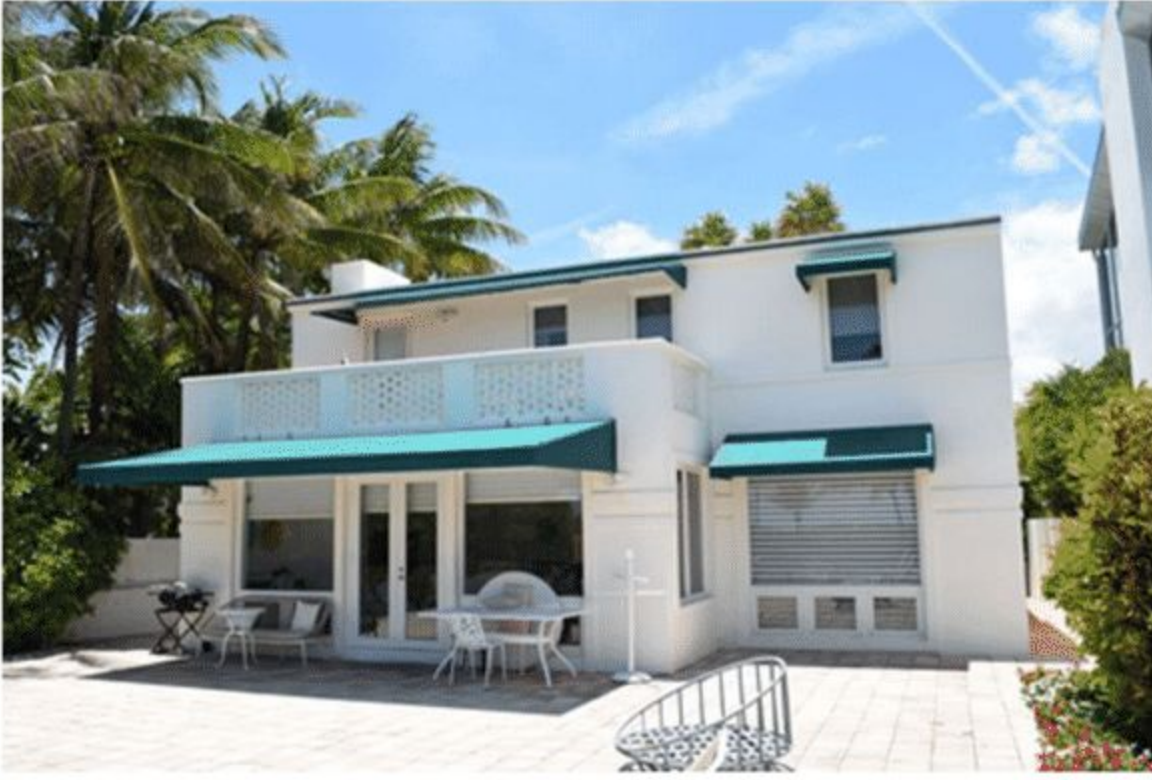
Figure 82. View of east elevation with one-story enclosed porch, May 2021.

The two-story east elevation has an attached one-story enclosed porch that spans two-thirds of the width of the elevation. (Figure 82) It features picture and slider windows and a pair of single-light doors. The veranda on the roof of the porch is enclosed by knee walls with sections of rectangular breeze block. (Figure 83) The two-story block features picture and casement windows, and a door at the second level leads to the veranda. The windows and doors on this elevation appear to be replacement. Paired horizontal moldings are situated approximately six feet above grade (Figure 84), and a belt course is situated below the second story windows. (Figure 85)

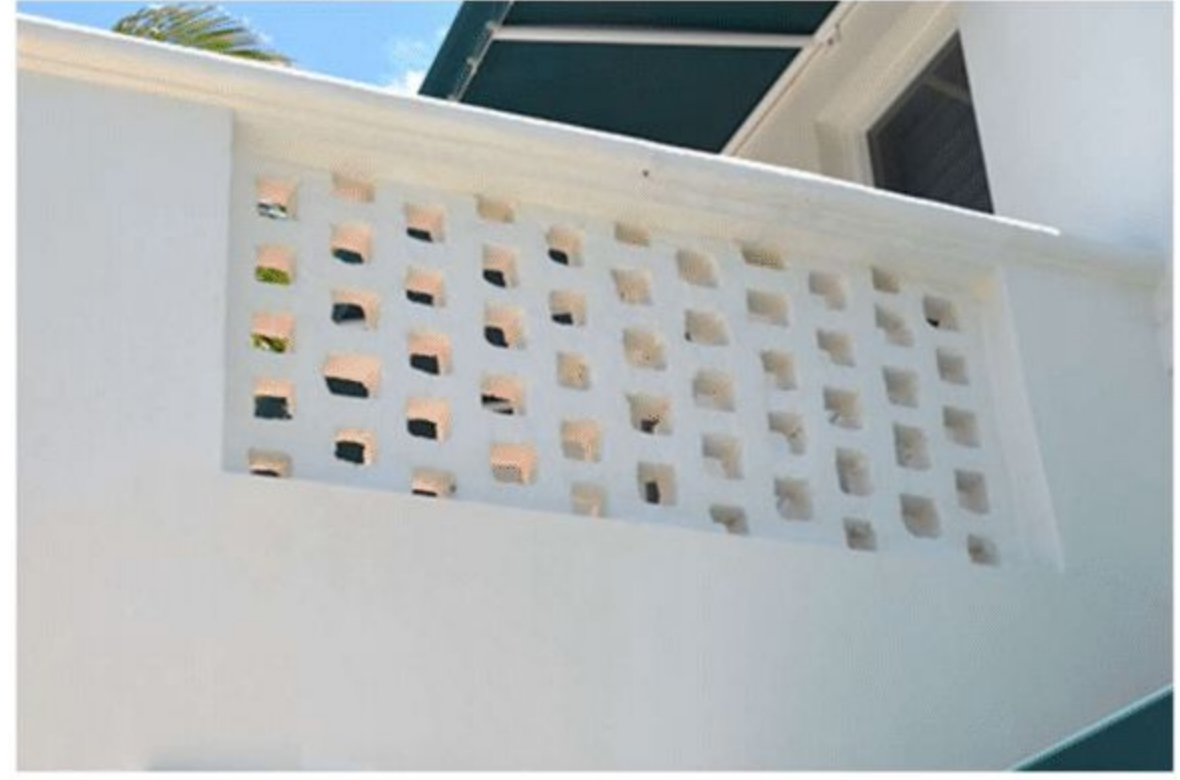
Figure 83. Detail of breezeblock at veranda, May 2021.

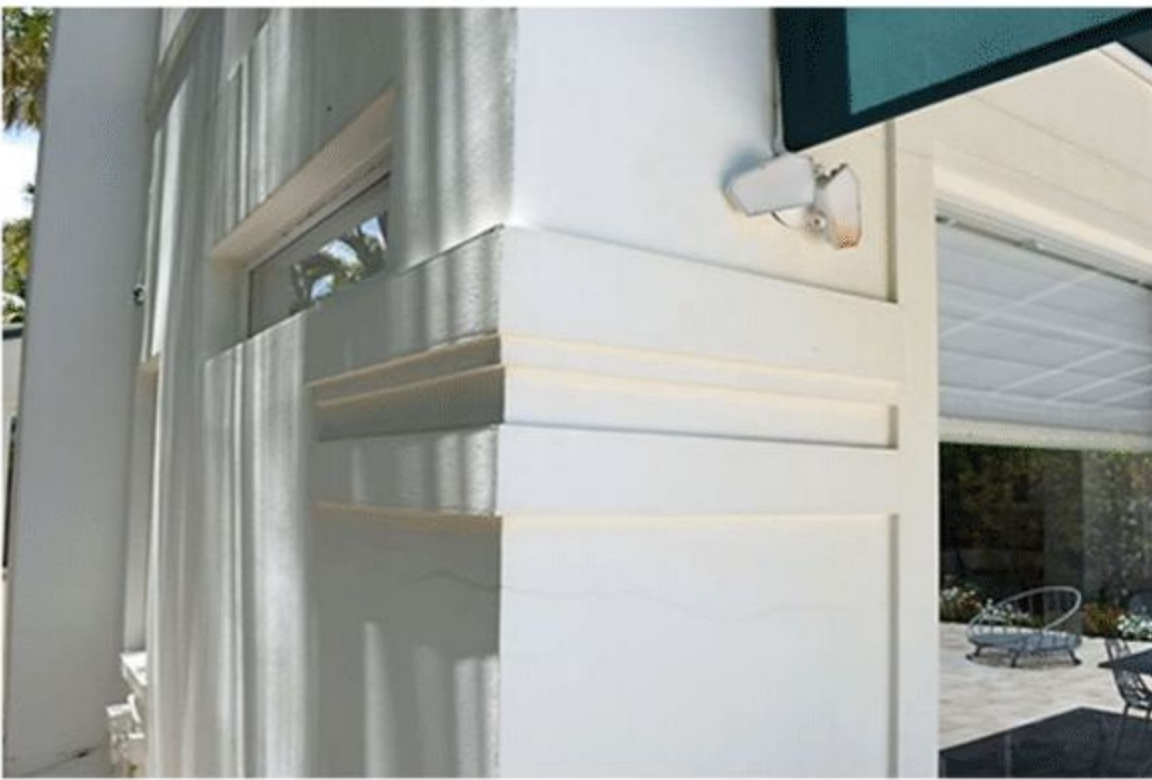
Figure 84. Detail of paired horizontal molding, May 2021.

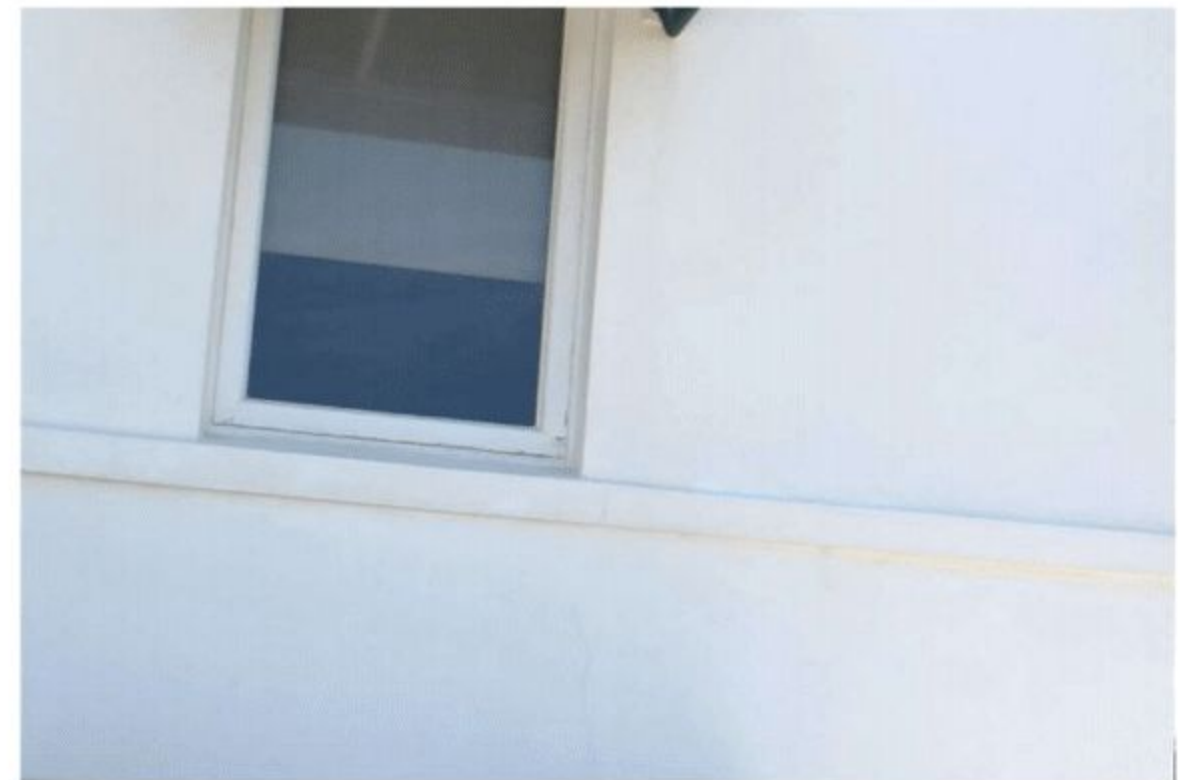
Figure 85. Detail of belt course below second story windows, May 2021.
