7401 - 7425 HARDING AVENUE  
MIAMI BEACH, FL  
HISTORIC PRESERVATION BOARD  
FINAL SUBMISSION  
Wednesday, July 3, 2024

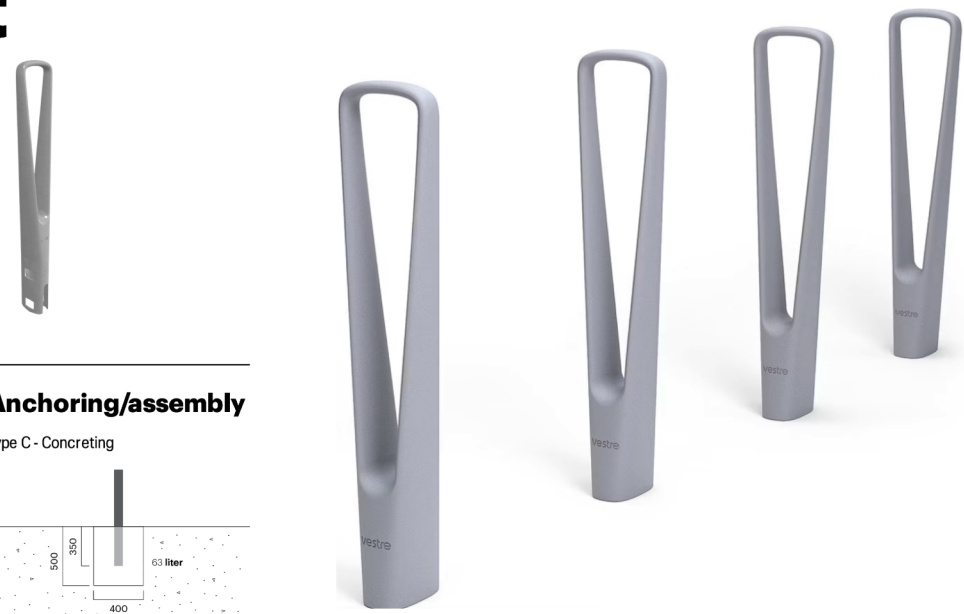
### Anchoring/assembly

Type C - Concreting

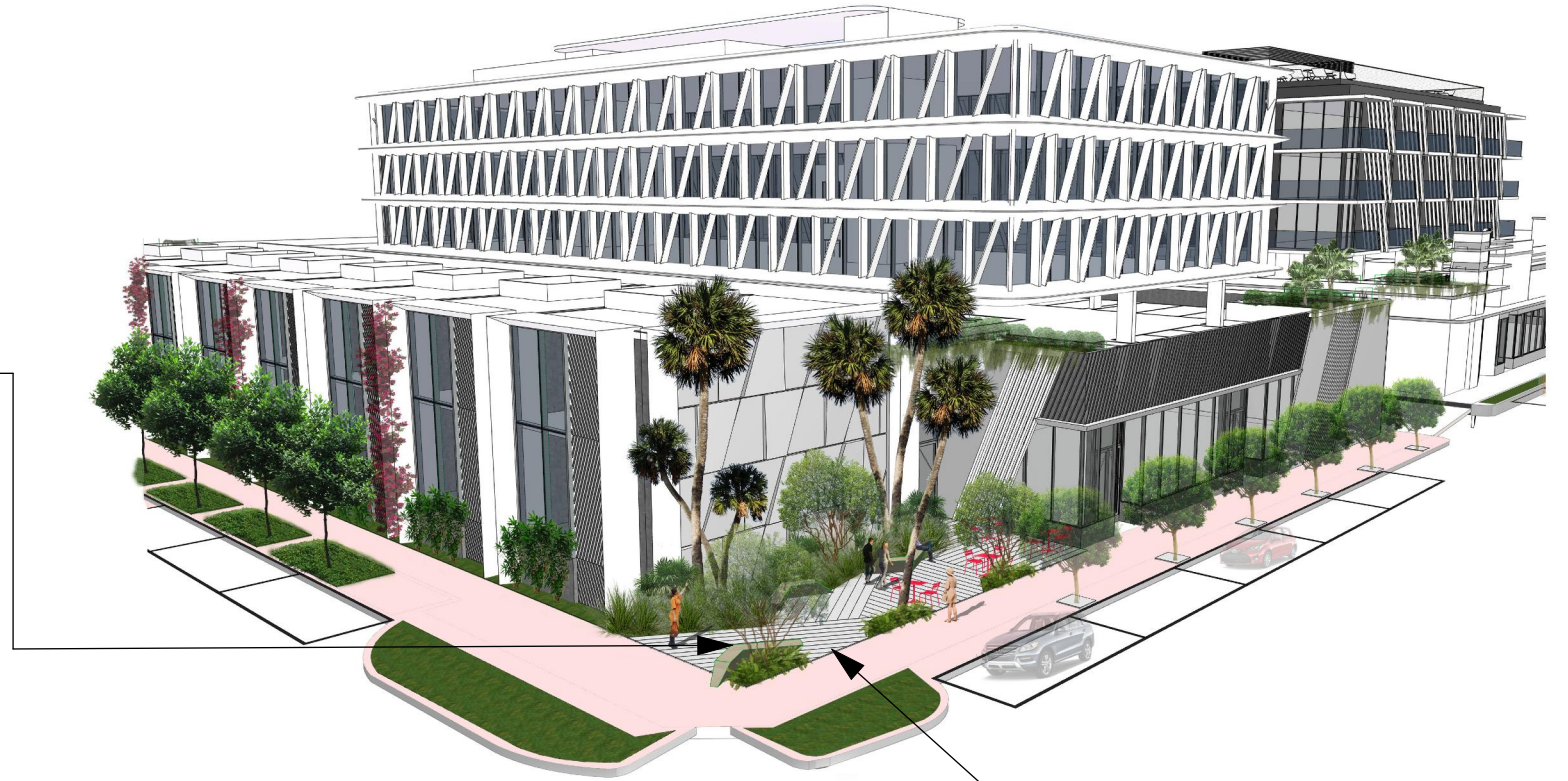
### Bench

This reinforced stone bench, named after Millenium Square in the City of Valladolid where it was first used, is a flexible modular system of geometric elements that can be used in diverse ways. One can sit on it, or on the ground beside it, where it serves as a space-definer and backrest. Straight, left-angled and right-angled modules can be used singly or in multiples to form creative combinations.

- Milenio is a Reinforced Cast Stone bench.
- This backless bench is available in Grey, Black White and Beige, with an acid-etched/waterproofed finish.
- Milenio is offered in a straight, angled right, or angled left modules, and is freestanding.
- Visit [landscapeforms.com](https://landscapeforms.com) and review drawings to determine right and left configurations of bench.

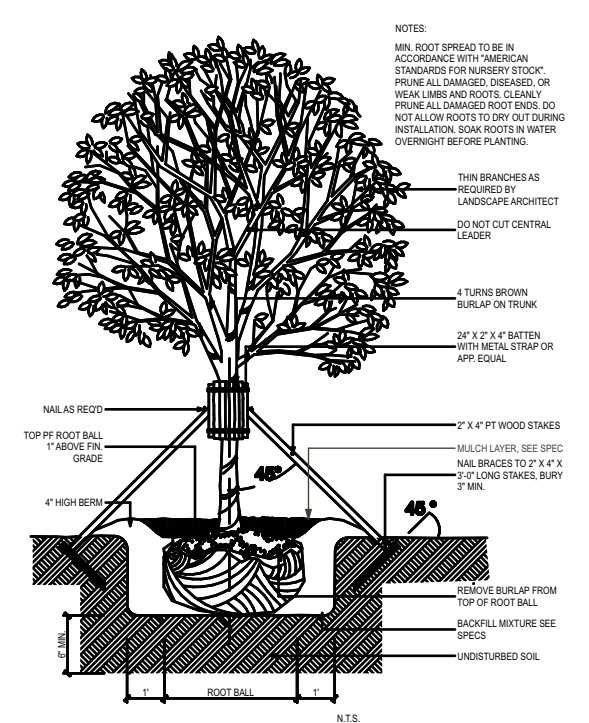
**2** LARGE TREE STAKE DETAIL  
NOT TO SCALE
